REPORT NUMBER: SINCAP-CAL-21-008

**NEW CAR ASSESSMENT PROGRAM (NCAP)
MOVING DEFORMABLE BARRIER SIDE IMPACT TEST**

**Volkswagen AG
2021 Volkswagen ID.4 Pro
Five Door SUV**

NHTSA No: M20215802

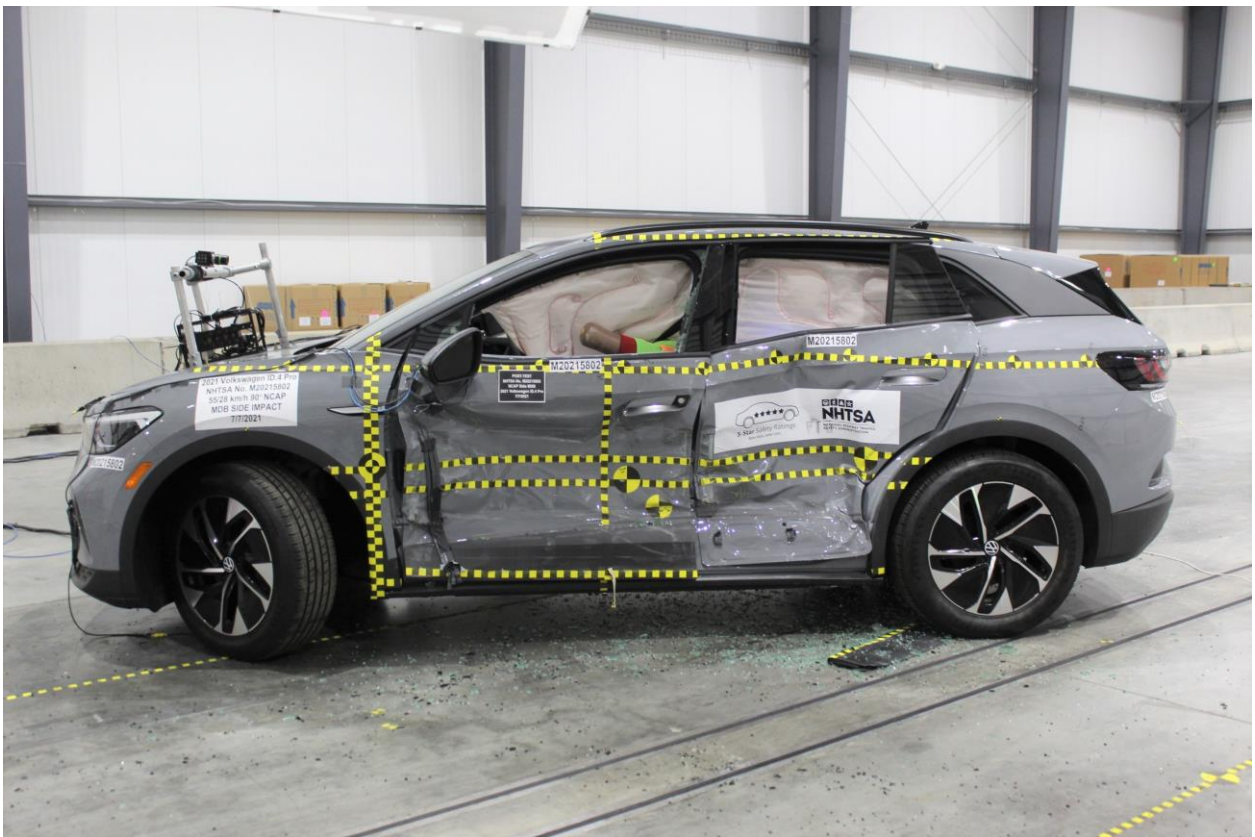
Figure A-8: Post-Test Left Side View of Test Vehicle

Critical Areas of Performance	Observations and Conclusions
Pillar Performance	B-Pillar Buckled
Sill Separation	None
Windshield Damage	None
Side Window Damage	Driver and Rear Passenger Window Shattered Completely
Other Notable Effects	None

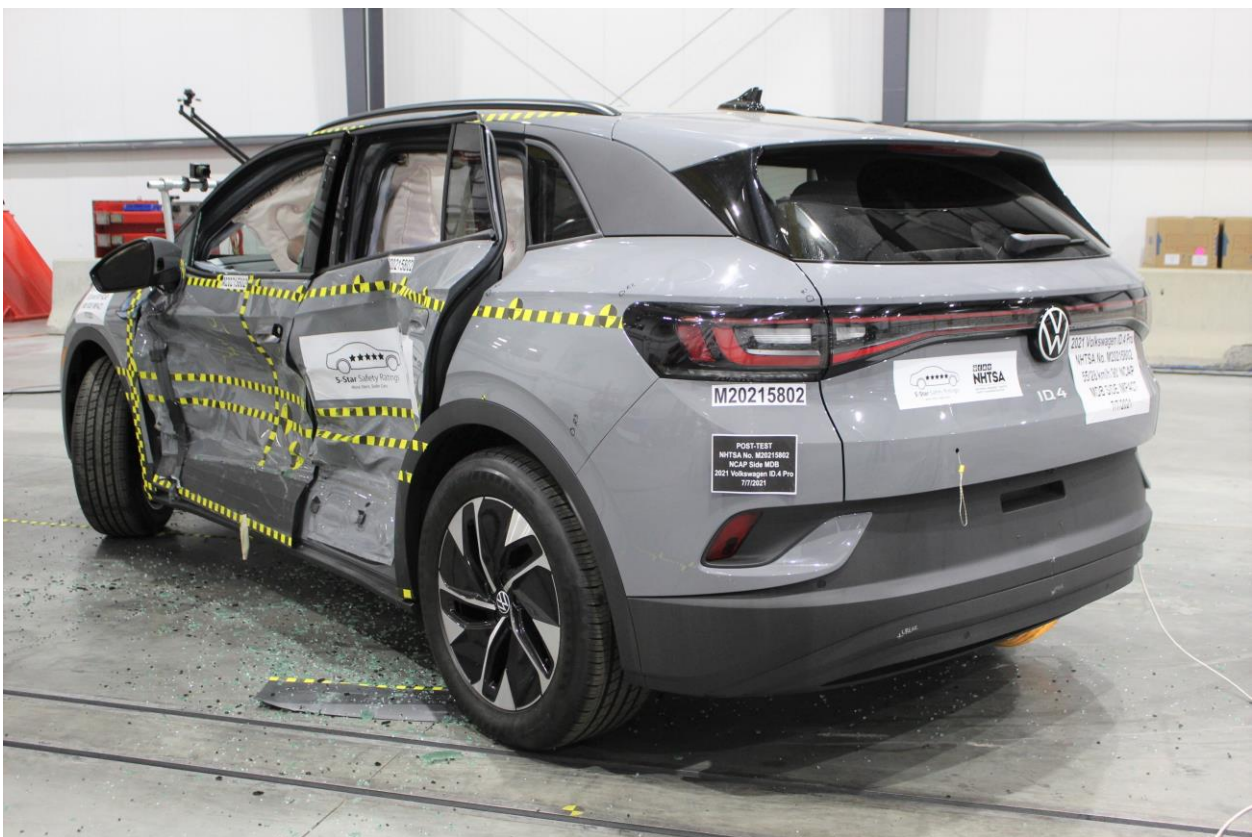
Figure A-10: Post-Test Left Rear $\frac{3}{4}$ View of Test Vehicle

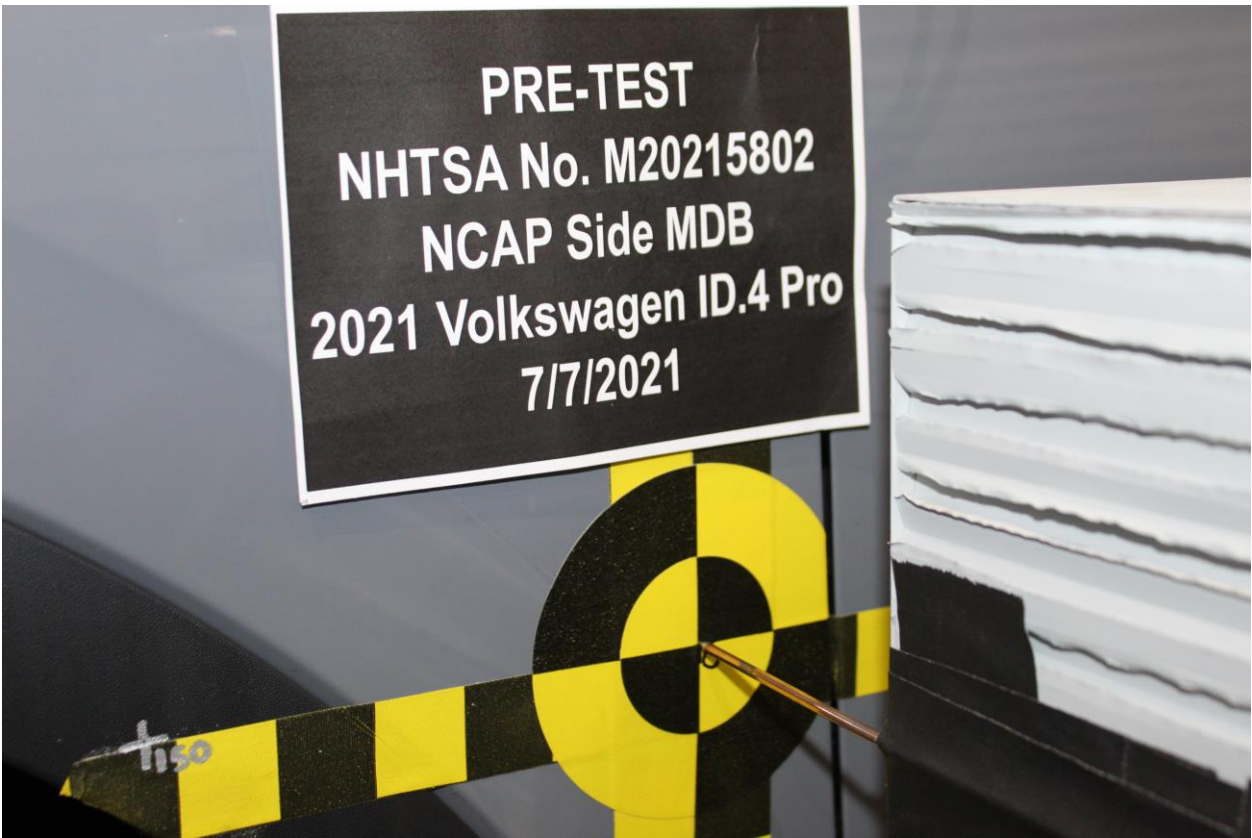
Figure A-19: Pre-Test Close-up View of Impact Point Target

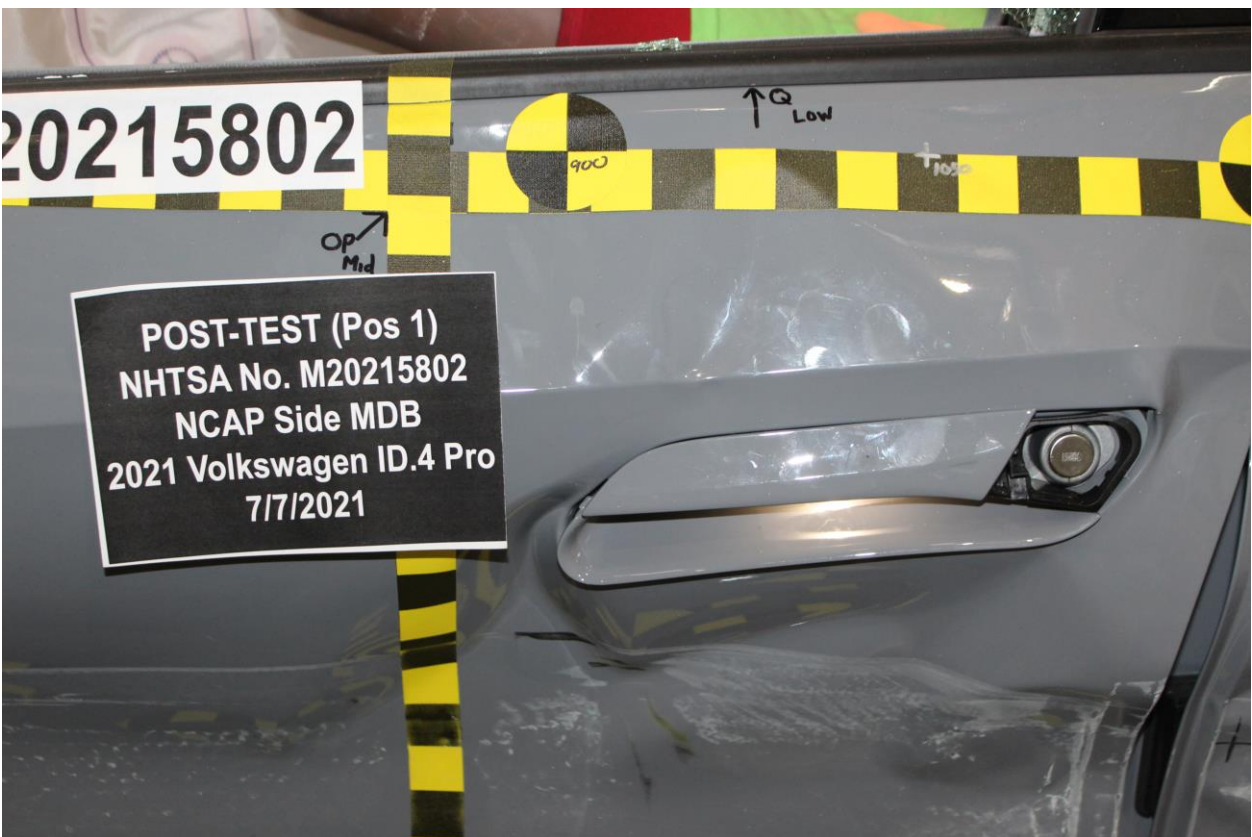
Figure A-22: Post-Test Left Front Door Latch Close-Up

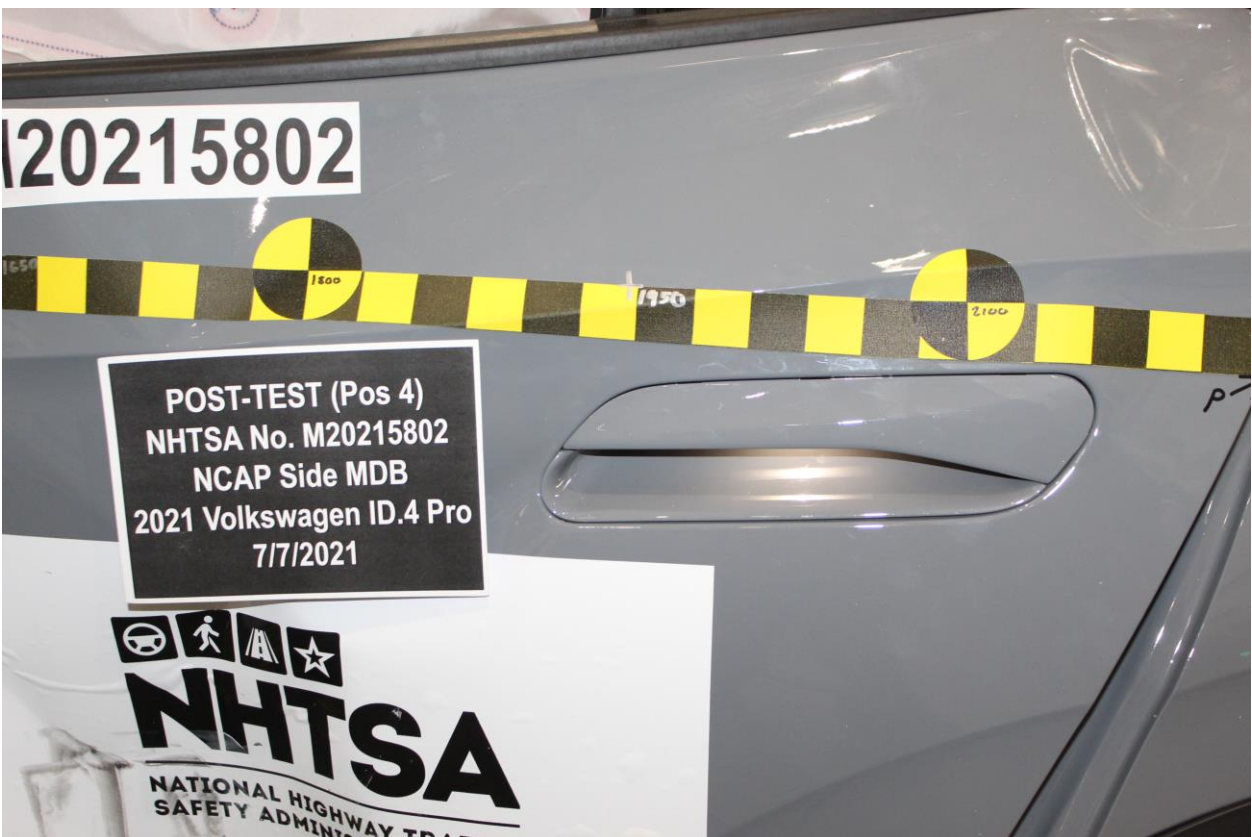
Figure A-24: Post-Test Left Rear Door Latch Close-Up

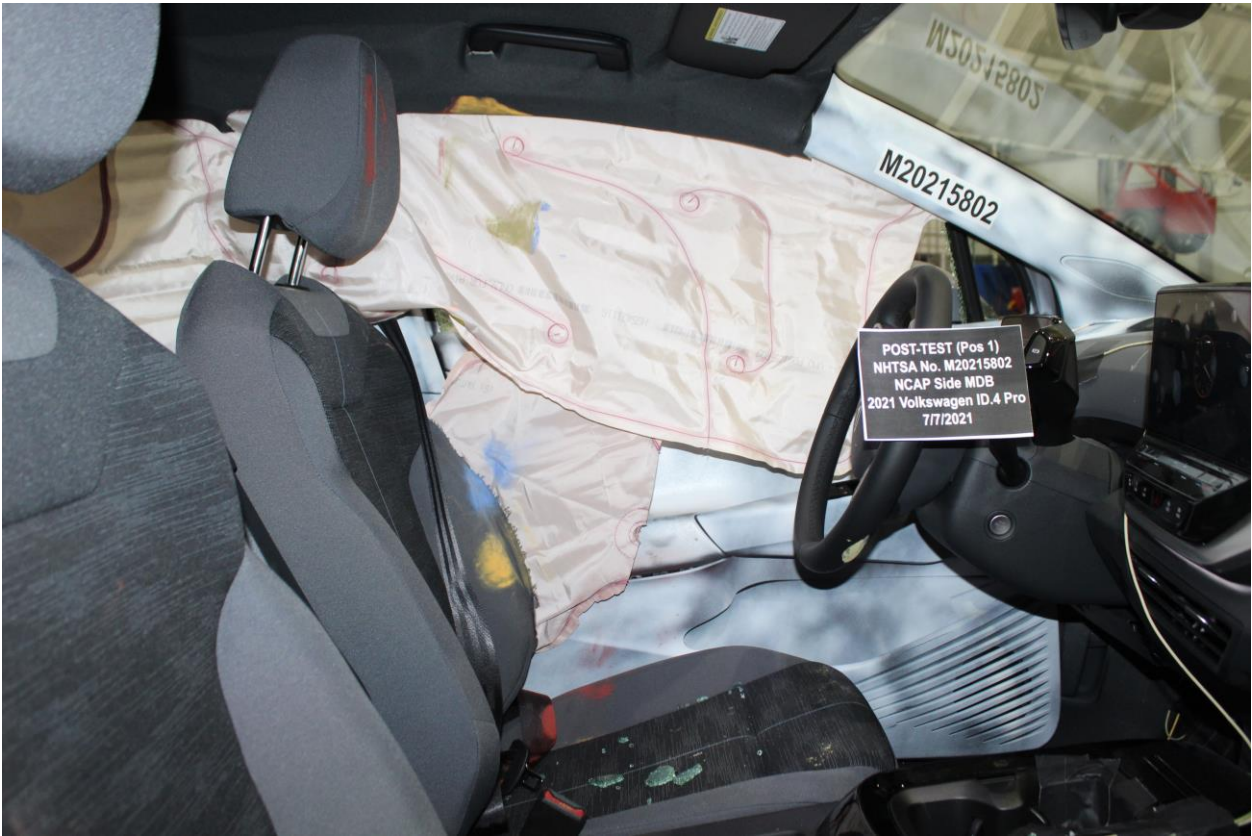
Figure A-47: Post-Test Driver Inner Door Panel View Showing Driver Dummy Contact Locations

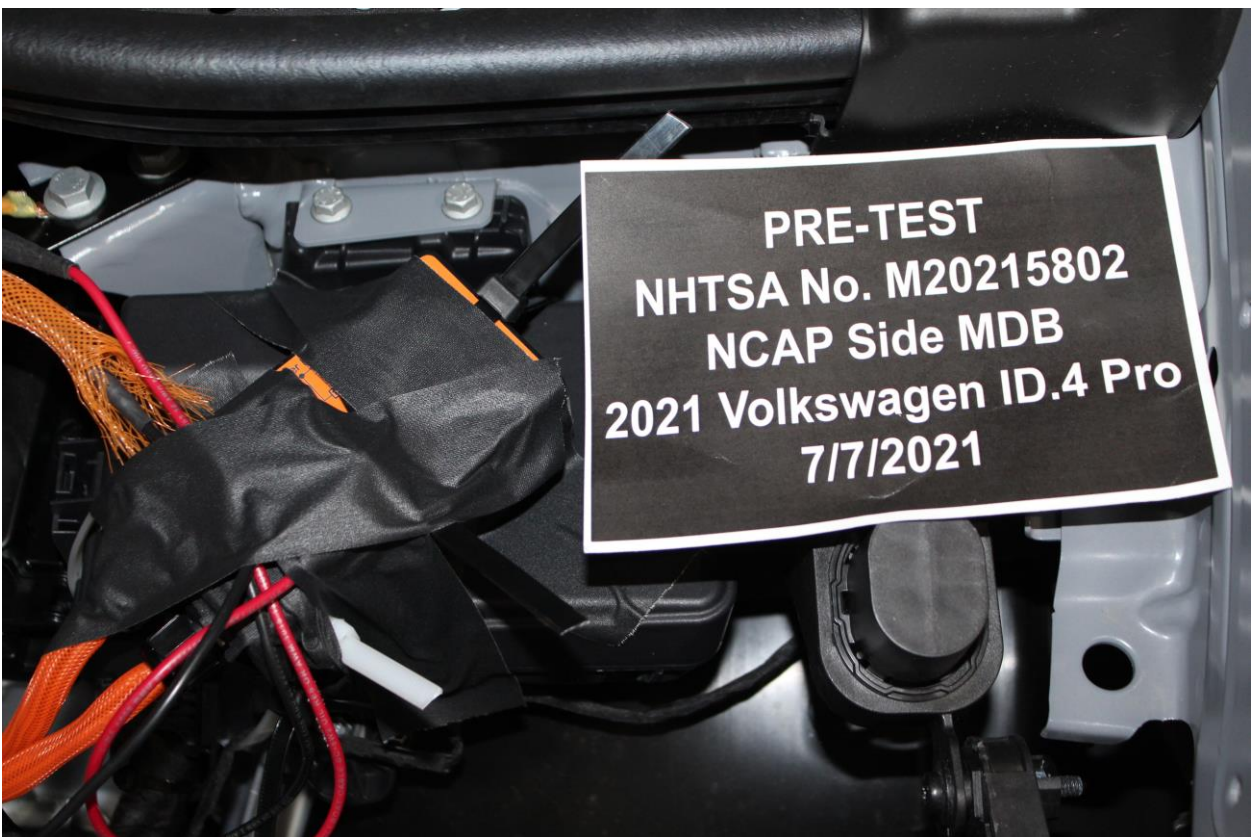
Figure 305-24: Pre-Impact View of Installed Test Interface Port
