Haze Study - 2003 to 2007 Toyota Corolla VOR Replaceable Bulb Headlamp

FINAL INDICANT REPORT

NHTSA Report No. 108-CAN-18-010-I

15. Supplementary Notes		11. Contract or Grant No. DTNH22-14-D-00370L	
16. Abstract The scope of this testing was to compare the performance from aged headlamps with lens haze against the performance from a brand new headlamp with no haze.		13. Type of Report and Period Covered

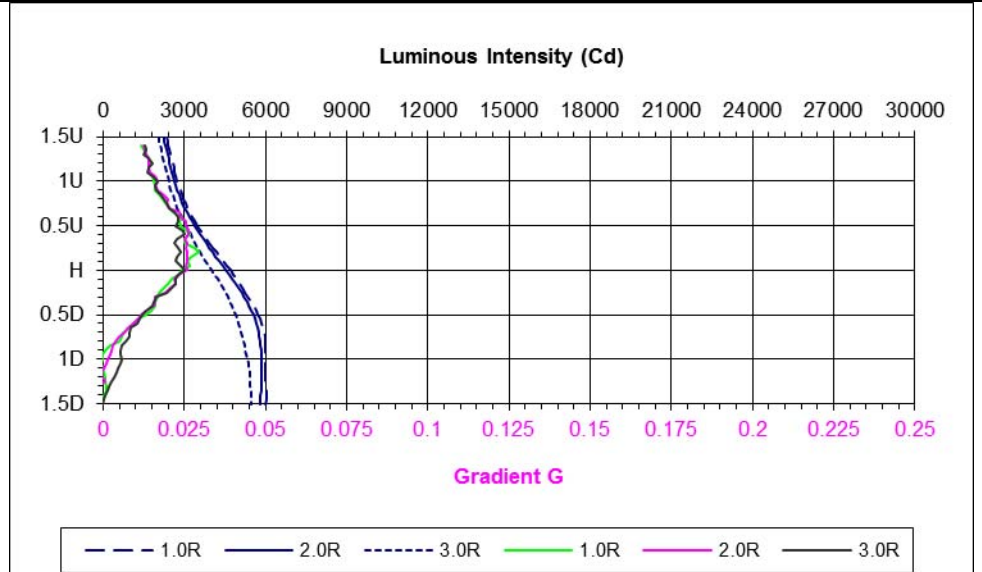
H-LH1 (Haze)

VOR Aim

Maximum Vertical Gradient

Location	Value	Required
0.20U/1.0R	0.029*	> 0.13
0.45U/2.0R	0.026*	
H/3.0R	0.025*

Maximum inclination of cutoff is **NOT** within ±0.2°.

New sample meets S10.18.9 Visual/Optical Aiming cutoff requirements.
 Aged samples do **NOT** meet S10.18.9 Visual/Optical Aiming cutoff requirements.

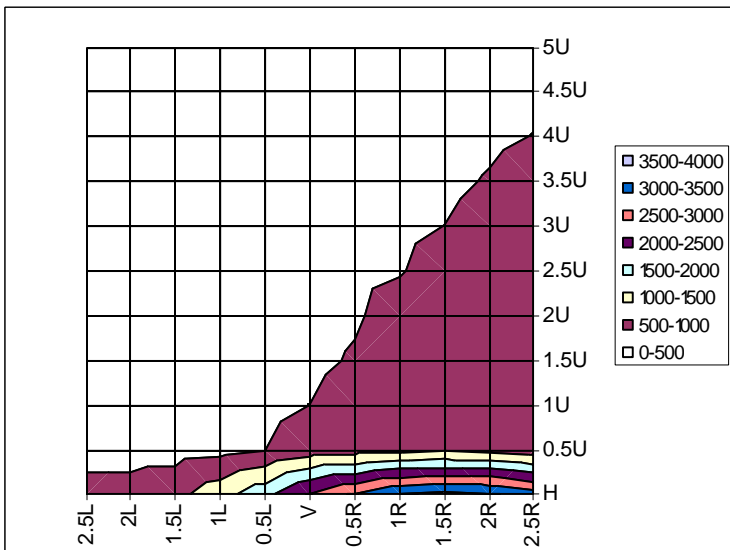
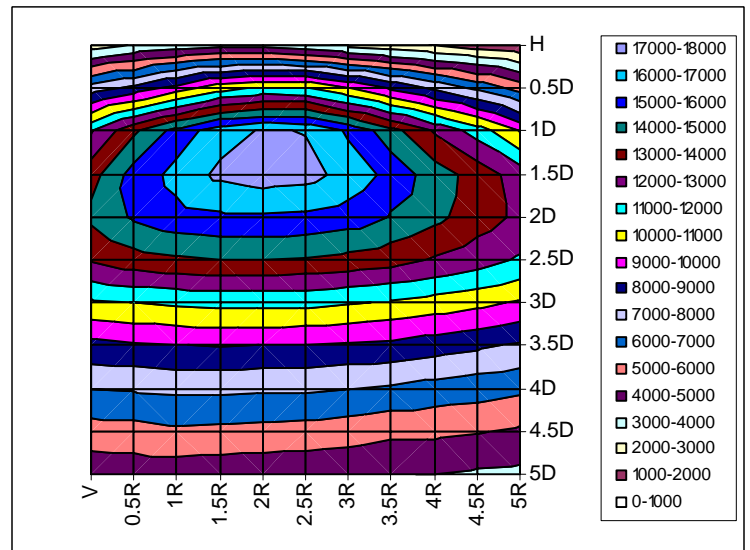
5U to 10D / 20L to 20R / 0.5° increments

Max Intensity: 17505 Cd @ 1.5D / 2.0R
Beam Flux: 350 Lm

5U to H / 2.5L to 2.5R

H to 5D / V to 5R

After aiming, each sample was tested to FMVSS 108 Table XIX Lower Beam requirements and its color measured at 1.5D/2.0R. Then the luminous intensity from 5U to 10D, 20L to 20R was measured in 0.5° increments and compiled into an isoscan plot. Two additional 5° x 5° isoscan sub-plots were provided to highlight key areas in the scan. The luminous intensity in vertical slices from 10U to 10D in 0.1° increments was also measured at the 1L and V horizontal locations.

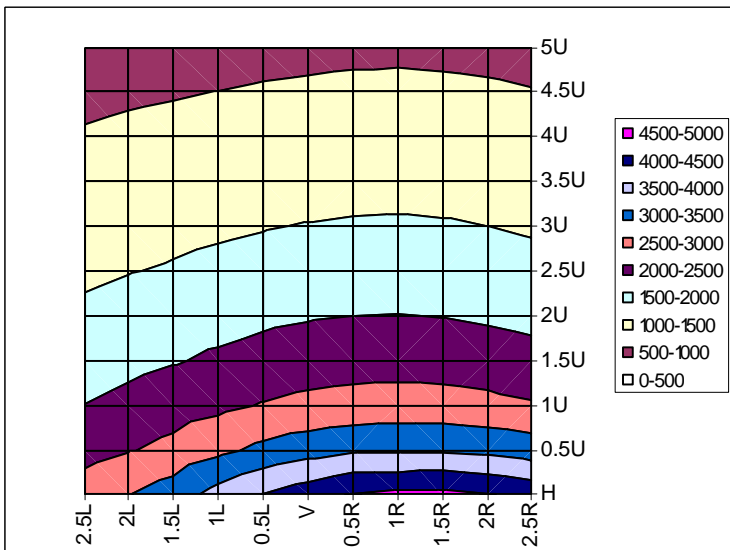
5U to 10D / 20L to 20R / 0.5° increments

Max Intensity: 6065 Cd @ 1.0D / 0.5R
Beam Flux: 236 Lm

5U to H / 2.5L to 2.5R

H to 5D / V to 5R

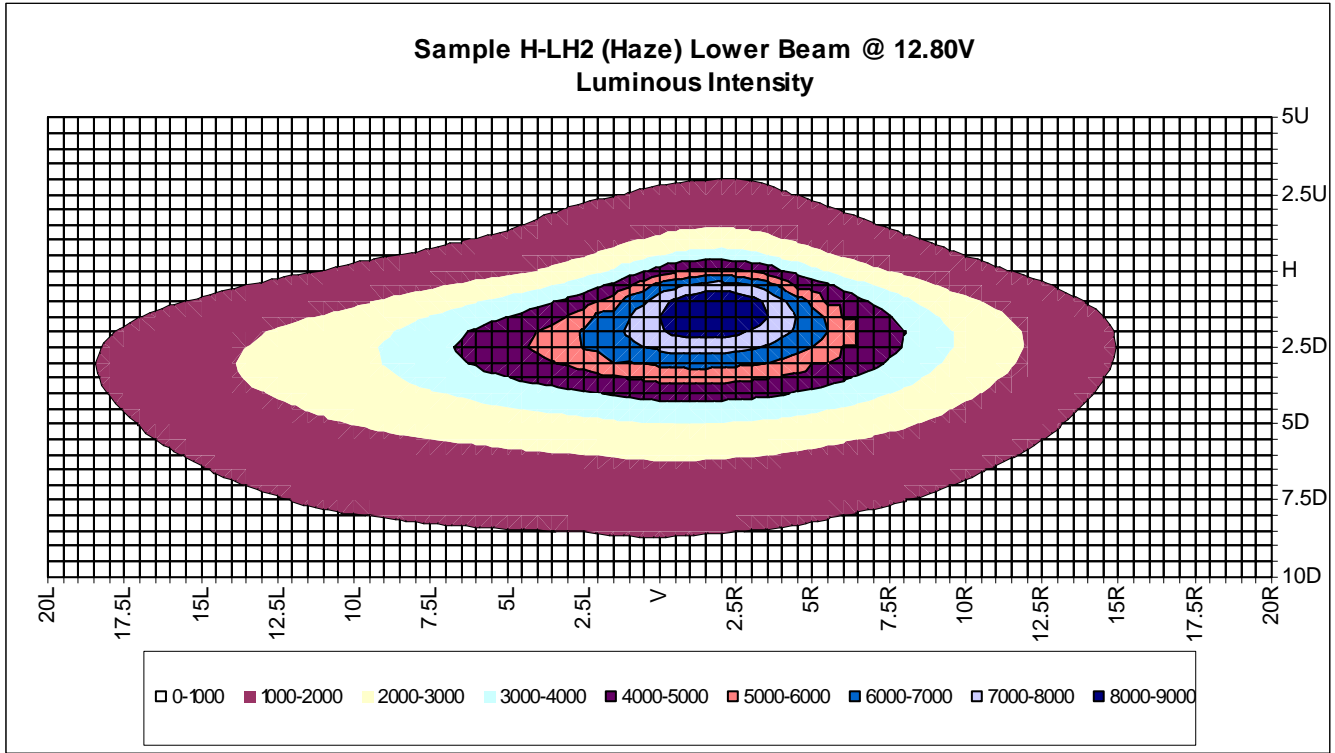
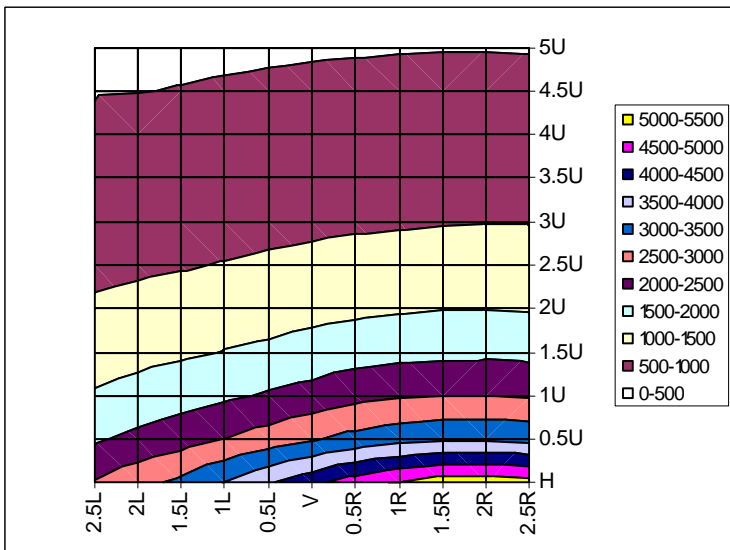
5U to 10D / 20L to 20R / 0.5° increments

5U to H / 2.5L to 2.5R

H to 5D / V to 5R

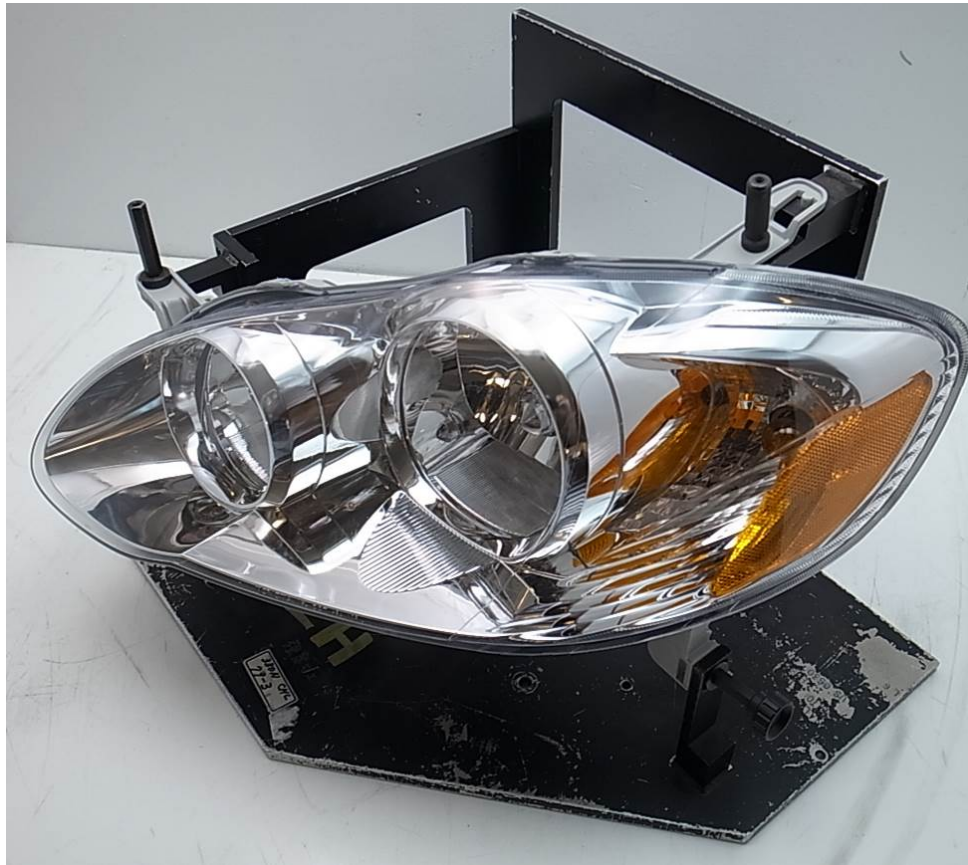
Lamp on Provided Fixture

Samples mounted on headlamp fixture provided by the lamp manufacturer. Headlamp fixture was mounted on level goniometer with Lower Beam light source located at goniometer center of rotation and tilt with fixture markings aligned parallel and perpendicular to detector axis at HV, then adjusted the headlamp aim hardware until the Lower Beam cutoff was located at H/2.0R and balanced from H/1.0R to H/3.0R (VOR aim). If the Lower Beam cutoff was not suitable for aiming photoelectrically (e.g. on lamps with noticeable haze), the test engineer would attempt to aim the beam visually. If the beam was not able to be aimed visually, the Lower Beam maximum was placed at the same approximate vertical location as on the new headlamp.

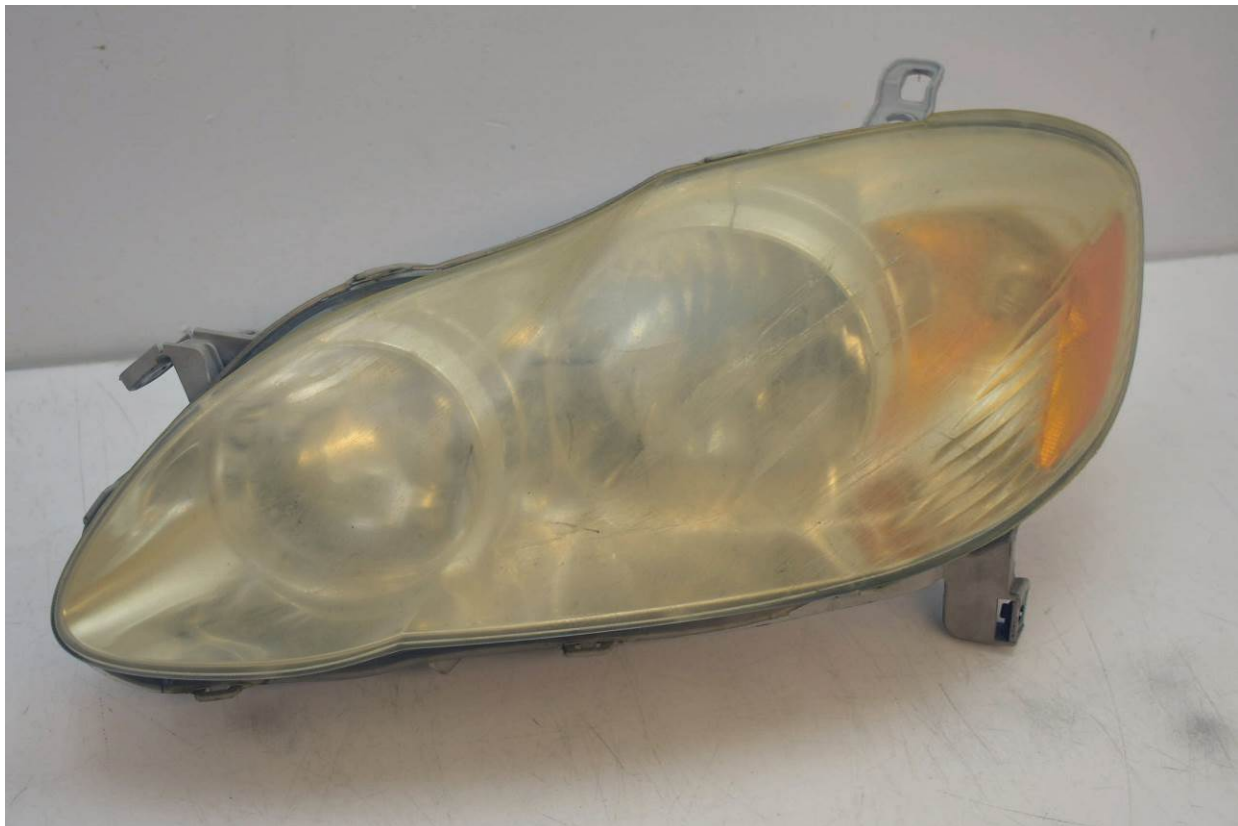
H-LH4 (Not Used) from 2005 Toyota Corolla

Aged lamp H-LH4 was not measured due to a significant scuff mark across the headlamp lens which made it unsuitable for the test program.
