REPORT NUMBER: TWG-CAL-20-05

**NEW CAR ASSESSMENT PROGRAM (NCAP)
SIDE AIRBAG OUT-OF-POSITION TEST**

**GM Korea Company
2020 Buick Encore GX
SUV**

NHTSA NUMBER: M20200101TWG3

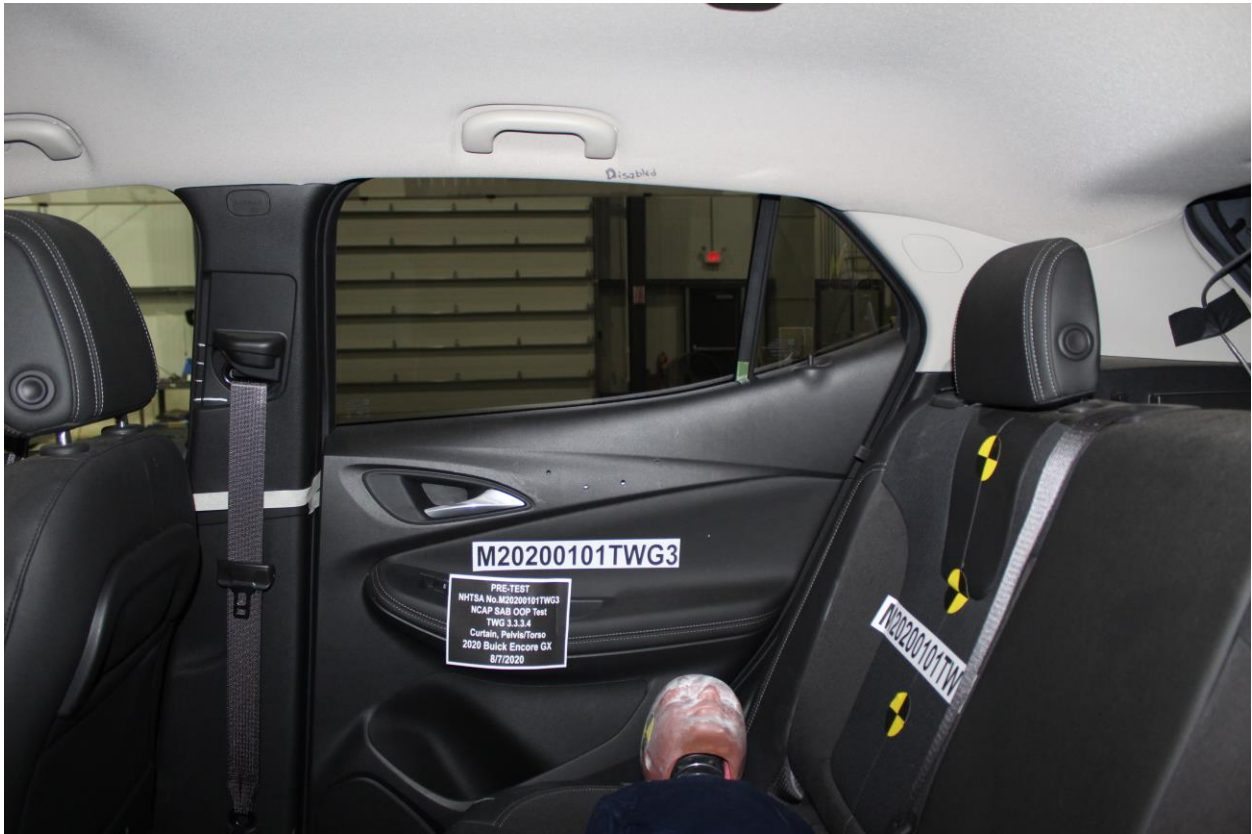
Figure A-5: Pre-Test Vehicle Location of Airbag 1

Seating Position:	P3	Right Rear Seating Position
Test:	3.3.3.4	Seat Mounted – Lying on Seat
Airbag: 1	Curtain	Roof Rail Mounted – Passenger Side
Airbag: 2	Seat/Torso	Rear Passenger Seat Mounted – Outside Seam
Booster Block:	N/A	N/A
Vehicle	Buick	Encore GX SUV
Previous Crash Test	SPNCAP	NCAP Side Pole – NHTSA No. M20200101

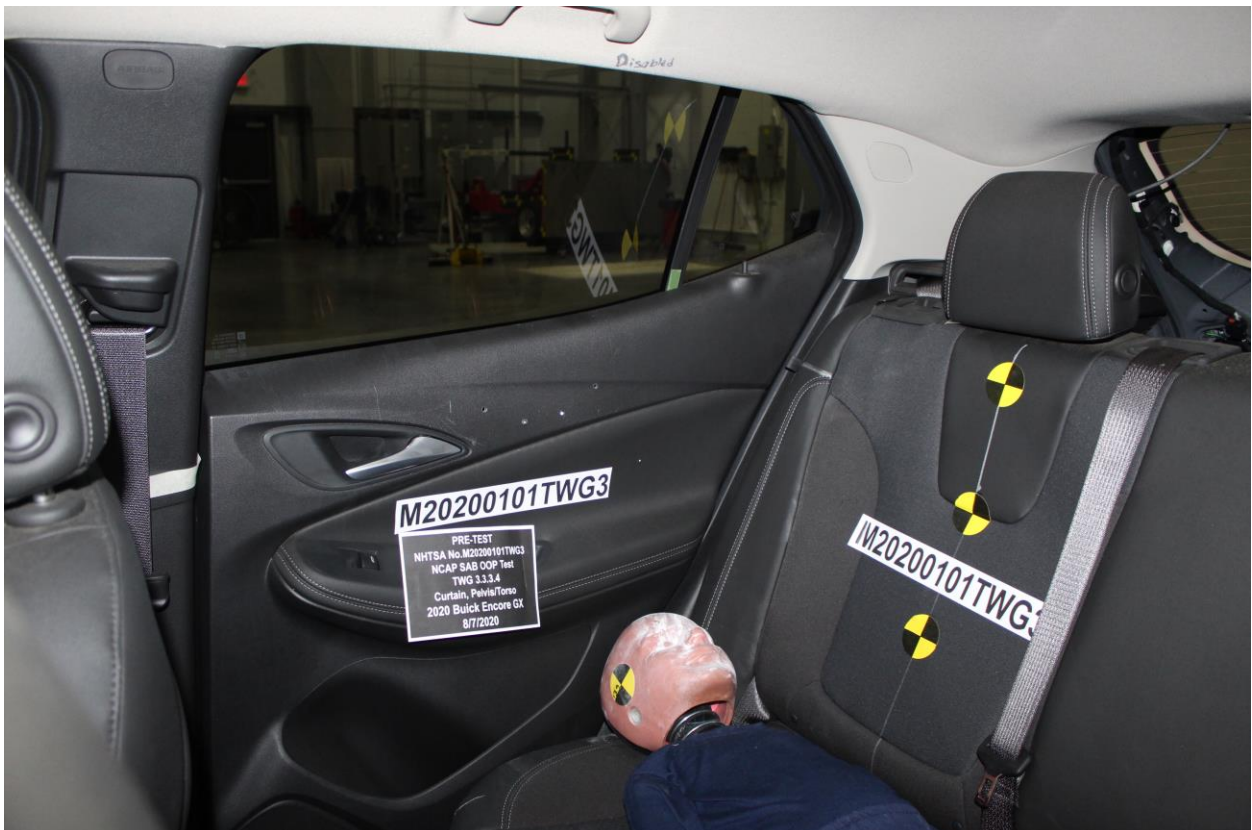
Figure A-6: Pre-Test Vehicle Location of Airbag 2

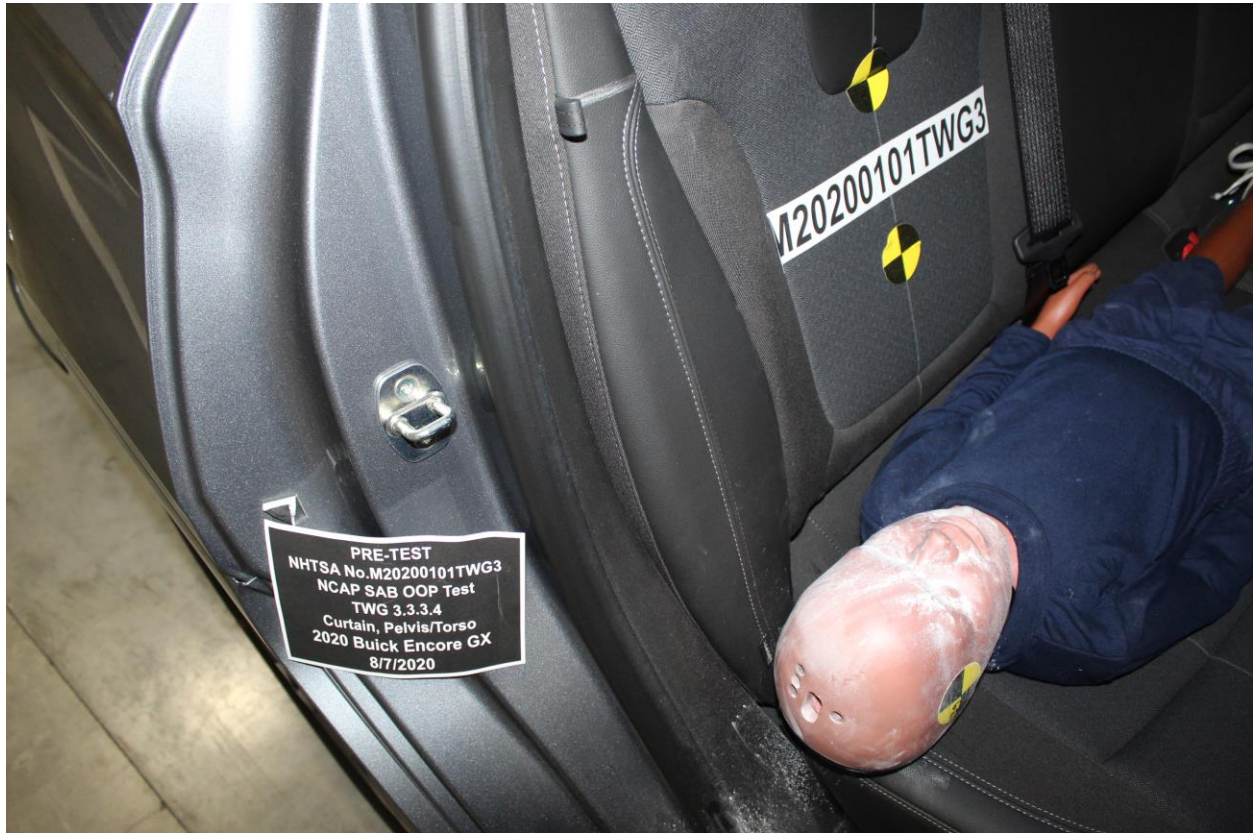
Figure A-7: Pre-Test Vehicle Location of Airbag 3

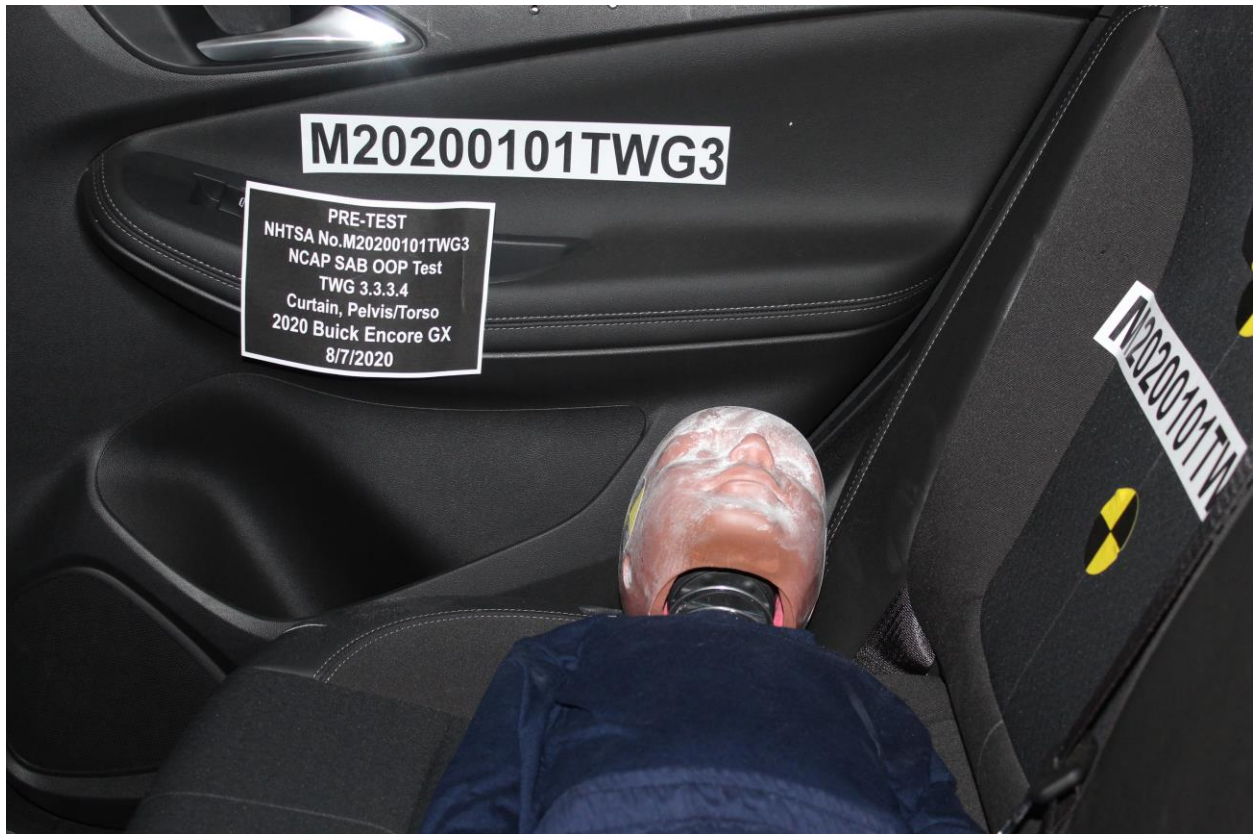
Figure A-11: Pre-Test Dummy Left Side Close-up View

The Hybrid III 3-Year-Old anthropomorphic test device (ATD) was placed in the right rear passenger seat laying face up with head aligned with the vertical centerline of the seat-mounted airbag module. This placement followed the ATD placement instructions in the NCAP Laboratory Test Procedure as well as the Recommended Procedures for Evaluating Occupant Injury Risk from Deploying Side Airbags as prepared by the Side Airbag Out-of-Position Injury Technical Working Group (TWG). This orientation complies with section 3.3.3.4 of the TWG Recommended Procedures for Evaluating Occupant Injury Risk from Deploying Side Airbags as defined by Lund, et al and the Technical Working Group First Revision dated July 2003.

TWG Setup Instructions:	Place the dummy on the seat lying on its back with its arms at its sides so that its rearmost arm contacts the seatback. Slide the dummy outboard until the CG of the head is aligned with the vertical centerline of the airbag module. Should the door/side trim interfere with the placement of the head then adjust the seat to ensure that the test objective is met. If necessary, stabilize the dummy by placing a block of lightweight foam under the dummy's legs.
Actual Setup:	The dummy was placed on the seat lying on its back with its arms at its sides so that its rearmost arm contacted the seatback. The dummy was slid outboard until the top of the head could no longer be moved outboard due to interference with the right rear passenger interior door trim. As a result, the CG of the head was not directly aligned with the vertical centerline of the airbag module.

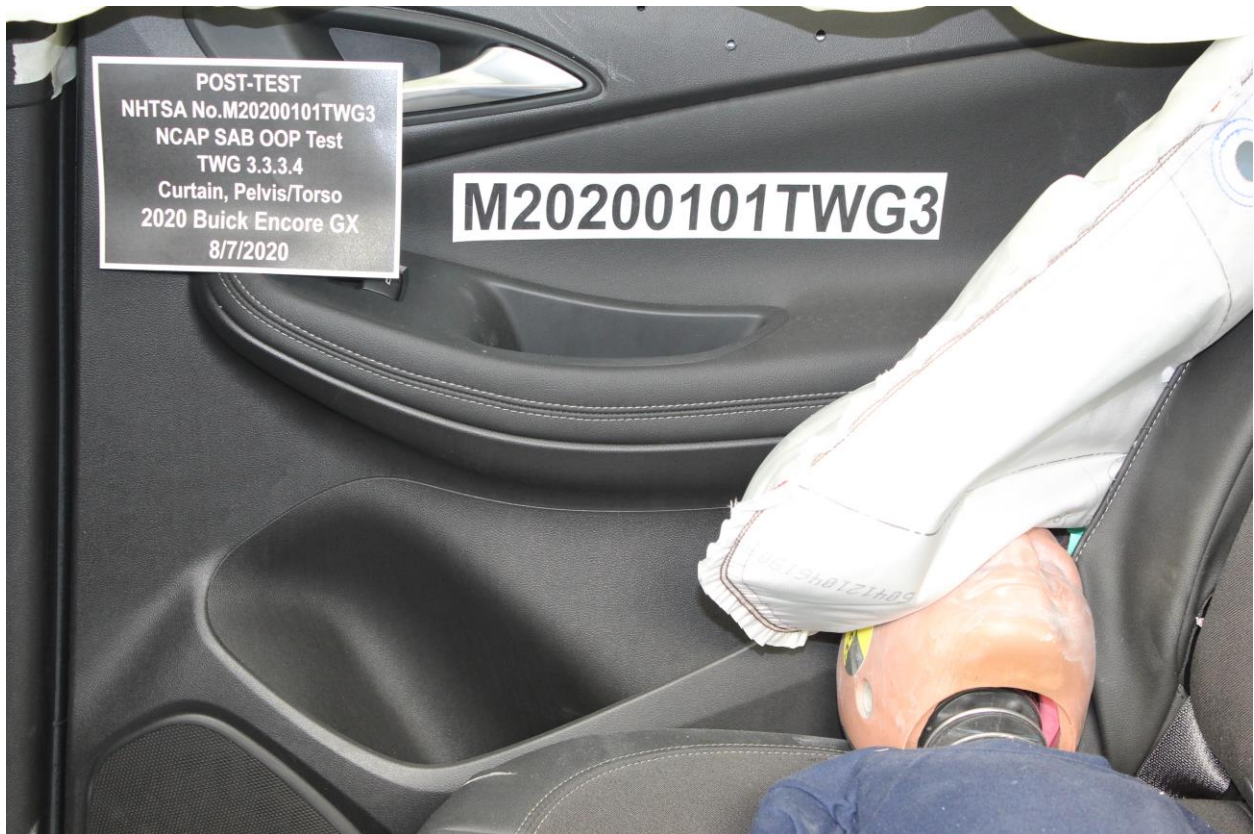
Figure A-12: Post-Test Dummy Left Side Close-up View

Head Contact:	Torso/Pelvis Airbag
Upper Torso Contact:	Right Rear Passenger Seat Pan
Lower Torso Contact:	Right Rear Passenger Seat Pan
Knee Contact:	Center Rear Passenger Seat Pan
Foot Contact:	Left Rear Passenger Seat Pan

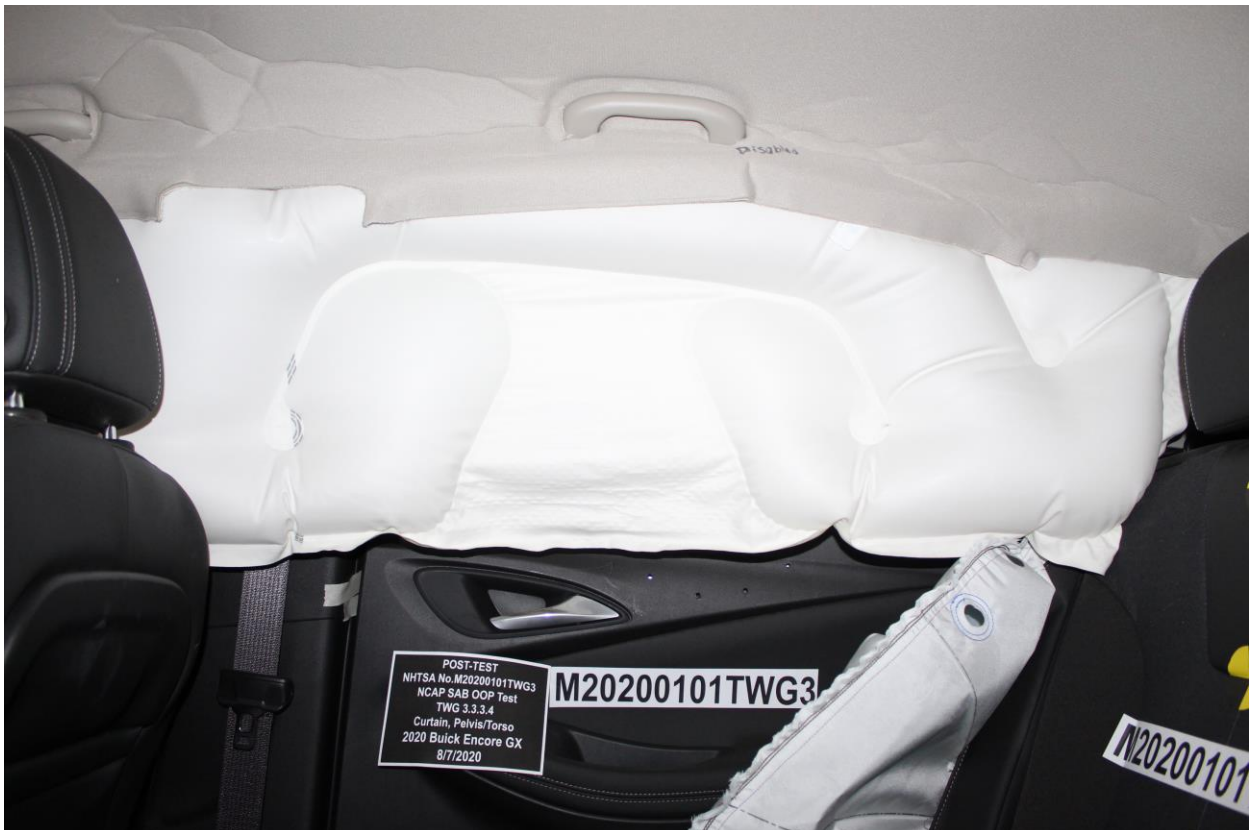
Figure A-26: Post-Test Curtain Air Bag Left Side View

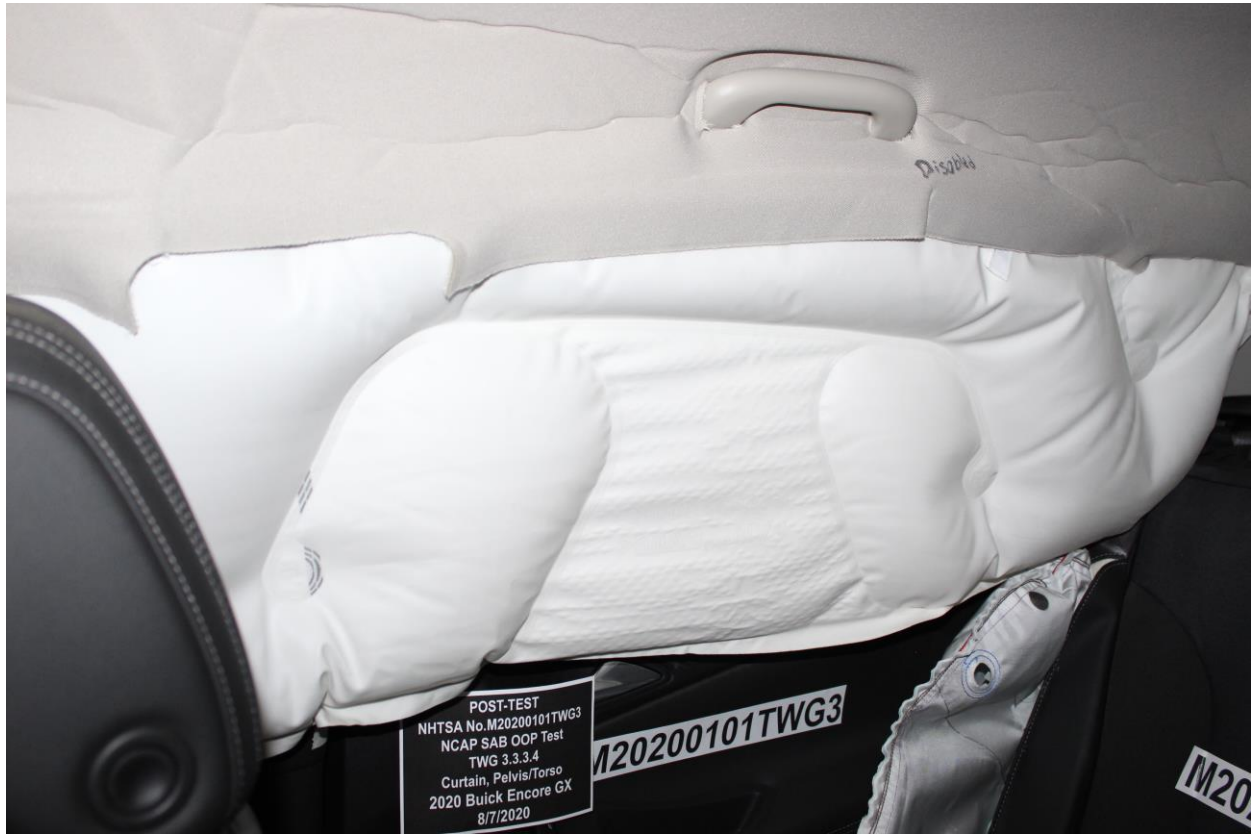
Figure A-27: Post-Test Curtain Air Bag Left ¾ Front View

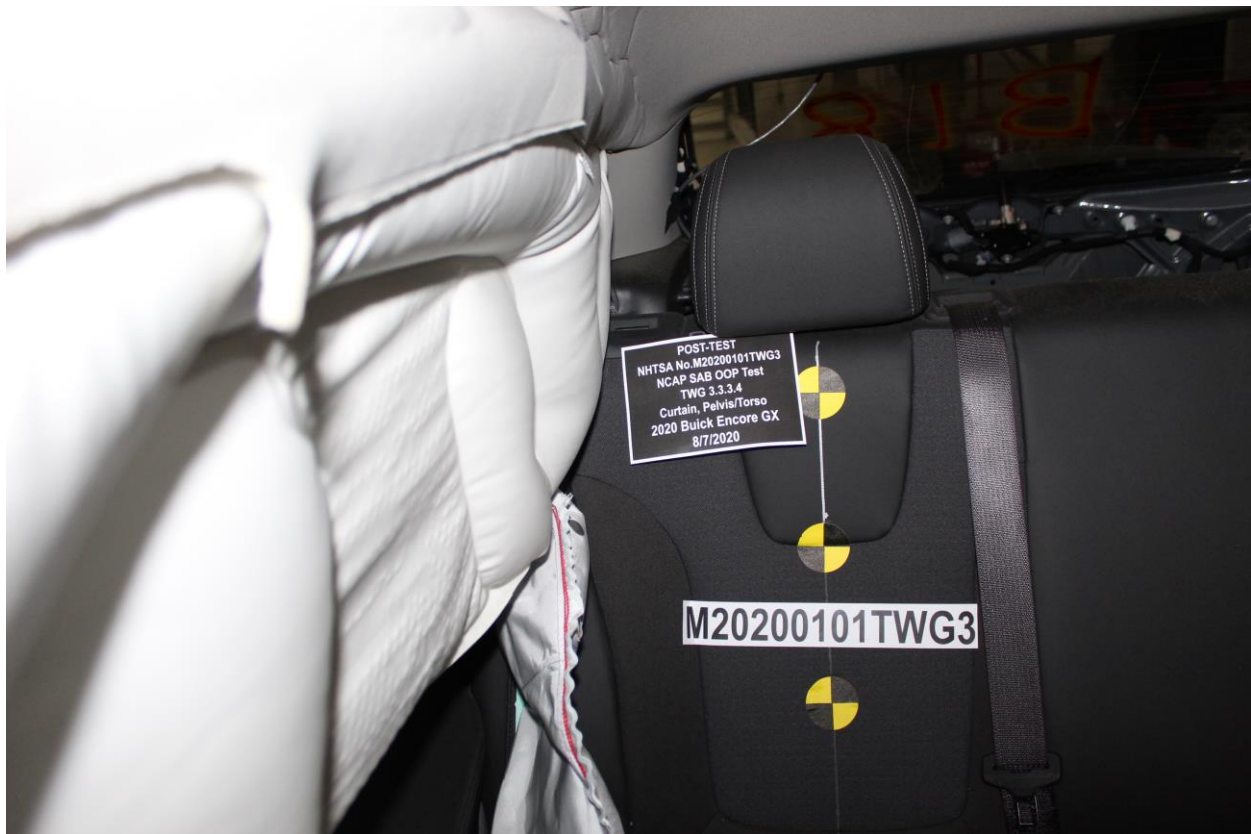
Figure A-28: Post-Test Curtain Air Bag Front View

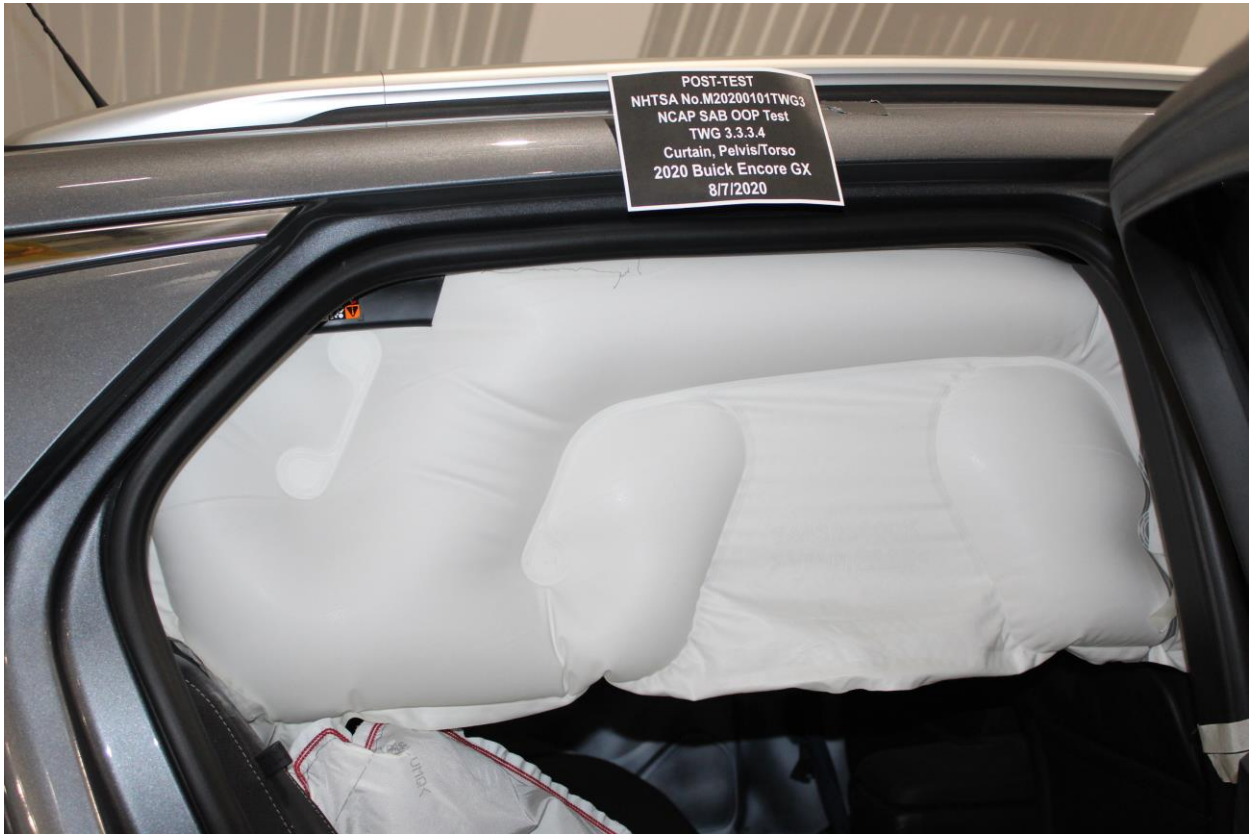
Figure A-29: Post-Test Curtain Air Bag Right Side View (Door Open)
