REPORT NUMBER: TWG-TRC-20-02

NEW CAR ASSESSMENT PROGRAM (NCAP)
Side Airbag Out-of-Position Test

KIA MOTORS CORPORATION
2020 Kia Soul 5-DR SUV

NHTSA NUMBER: M20204214TWG2
TRC TEST NUMBER: 200723-1

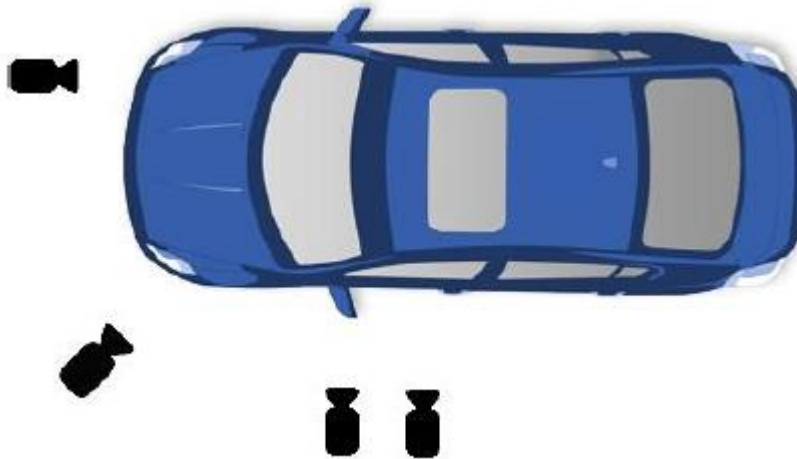
CAMERA SETUP DIAGRAM FOR SAB OOP TESTS

No.	Camera View	Location (mm) ¹			Lens (mm)	Speed (fps)
		X	Y	Z		
1	Left View	-1995	-3111	-1240	25	1000
2	Oblique View	2298	-1324	-1525	25	1000
3	Front View	2293	260	-1404	28	1000
4	Real Time (optional)	-1763	-3040	-1165	Zoom	30

¹ +X forward of vehicle, +Y right of vehicle, +Z into ground

One real-time camera and three high-speed cameras were used to record the air bag deployment event. High speed images were recorded at rates of 1,000 frames per second. Cameras were placed relative to the position 2 and were positioned to capture the deployment event from the side, the front, and the oblique views.

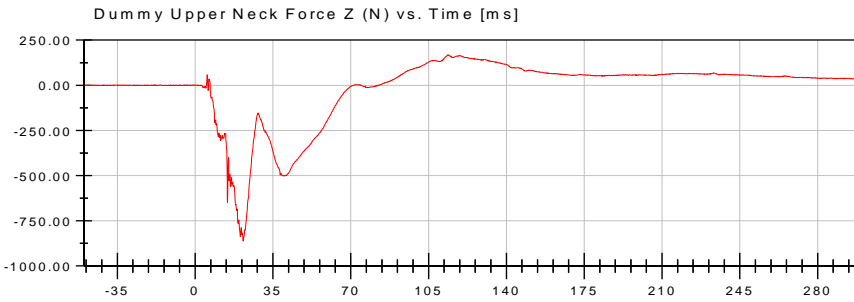
168.72 N at 113.76 ms

-861.71 N at 21.60 ms

CFC_1000

Injury Criteria	Value	Time (ms)
Upper Neck NTF	0.08	164.56
Upper Neck NTE	0.23	71.20
Upper Neck NCF	0.33	14.56
Upper Neck NCE	0.56	39.28
Peak Tension	168.7	113.76
Peak Compression	-861.7	21.60

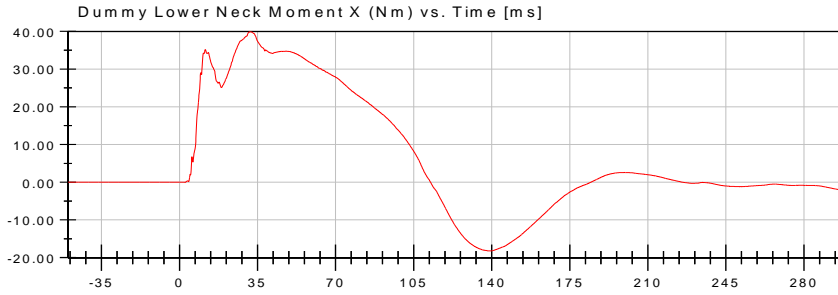
39.88 Nm at 31.76 ms

-18.20 Nm at 139.76 ms

CFC_600

Channel	Unit	CFC	Maximum	Time (ms)	Minimum	Time (ms)
Head X	G	1000	23.84	14.32	-2.61	7.76
Head Y	G	1000	42.00	15.04	-61.82	14.72
Head Z	G	1000	44.12	14.48	-9.20	11.12
Head Resultant	G	1000	66.22	14.72		
Head Red X	G	1000	23.72	14.32	-3.03	7.12
Head Red Y	G	1000	42.09	15.04	-62.61	14.72
Head Red Z	G	1000	44.25	14.48	-9.19	11.12
Head Red Resultant	G	1000	67.10	14.72		
Upper Neck X	N	1000	122.67	13.52	-191.17	21.68
Upper Neck Y	N	1000	303.69	14.96	-60.85	138.48
Upper Neck Z	N	1000	168.72	113.76	-861.71	21.60
Upper Neck Resultant	N	1000	912.99	21.60		
Upper Neck X	Nm	600	15.27	21.20	-18.05	10.48
Upper Neck Y	Nm	600	14.66	13.60	-15.65	35.04
Upper Neck Z	Nm	600	9.35	135.68	-13.45	59.60
Upper Neck Resultant	Nm	600	22.20	11.60		
Lower Neck X	N	1000	324.23	14.32	-215.53	51.84
Lower Neck Y	N	1000	398.38	10.56	-95.40	40.64
Lower Neck Z	N	1000	165.60	113.52	-839.96	22.16
Lower Neck Resultant	N	1000	846.97	22.16		
Lower Neck X	Nm	600	39.88	31.76	-18.20	139.76

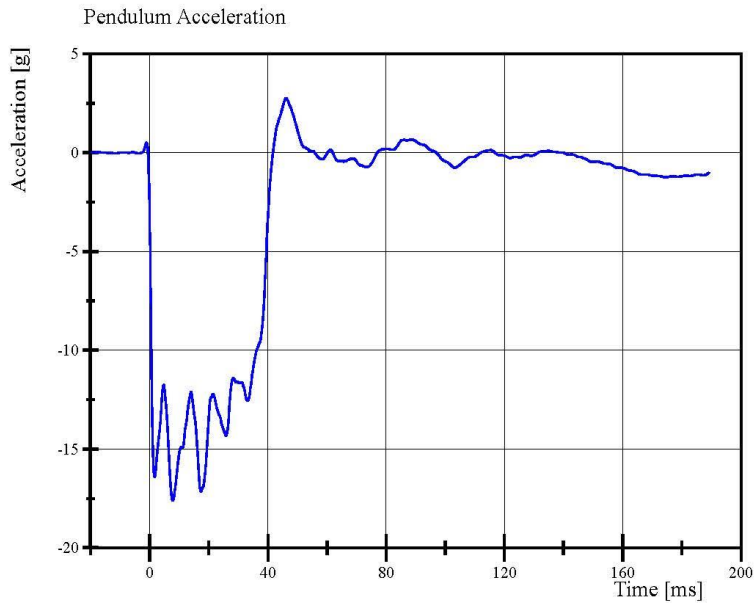
Filter Class: CFC_180
Max: 2.8 g at 46.2 ms
Min: -17.6 g at 7.8 ms

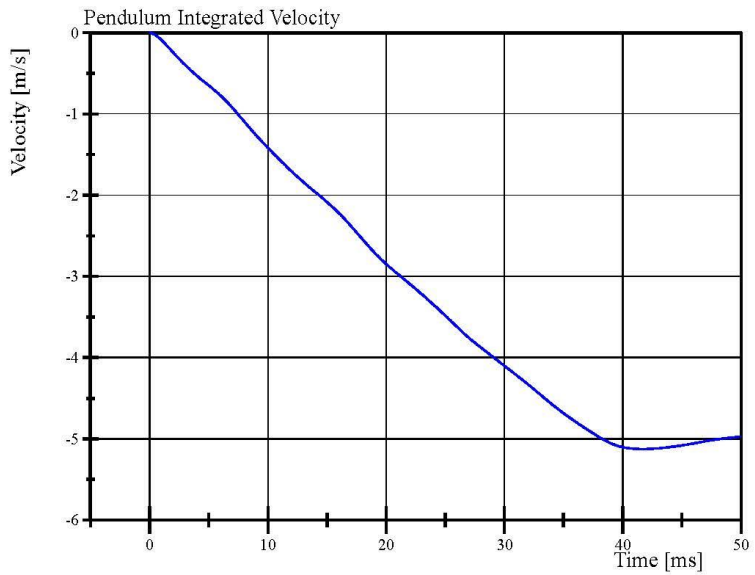
Filter Class: CFC_180
Max: 0.0 m/s at 0.0 ms
Min: -5.1 m/s at 41.7 ms

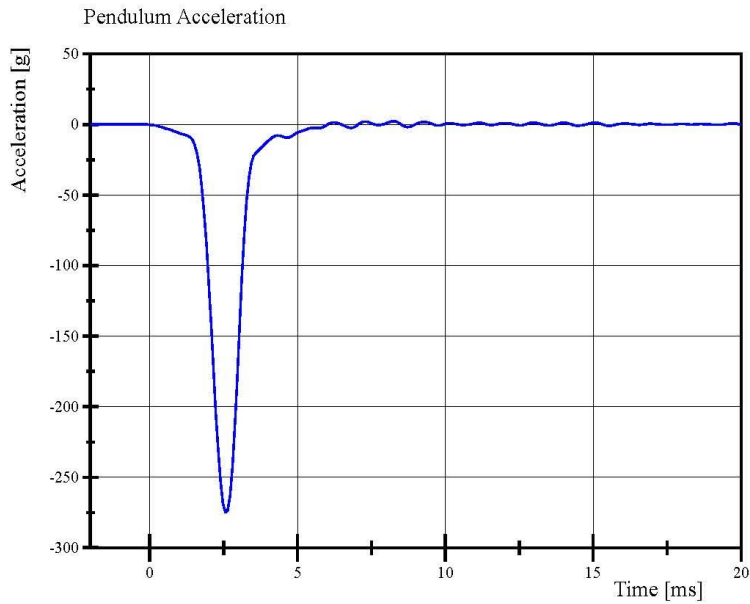
Right Knee Femur Response Test
HIII 6YO Serial No. 182 Certification No. 4-1
Test Date: 7/16/2020

Filter Class: CFC_600
Max: 2.5 g at 8.2 ms
Min: -275.0 g at 2.6 ms

Test Parameter	Specification	Test Results	Pass
Temperature	18.9 - 25.6 °C	20.8 °C	Yes
Relative Humidity	10 - 70 %	60 %	Yes
Probe Velocity	2.07 - 2.13 m/s	2.109 m/s	Yes
Peak Femur Force	(-2,000) - (-3,000) N	-2,211.1 N	Yes

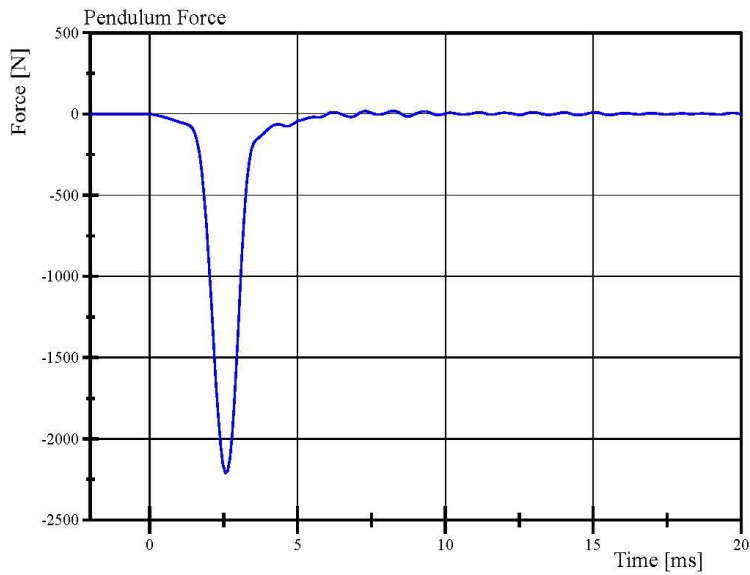
Filter Class: CFC_600
Max: 19.7 N at 8.2 ms
Min: -2,211.1 N at 2.6 ms
