**Final Report Number: NCAP-TRC-21-002**

**New Car Assessment Program (NCAP)  
Frontal Barrier Impact Test**

**FCA US LLC  
2021 Dodge Durango  
NHTSA Number: M20210300**

**FINAL REPORT**

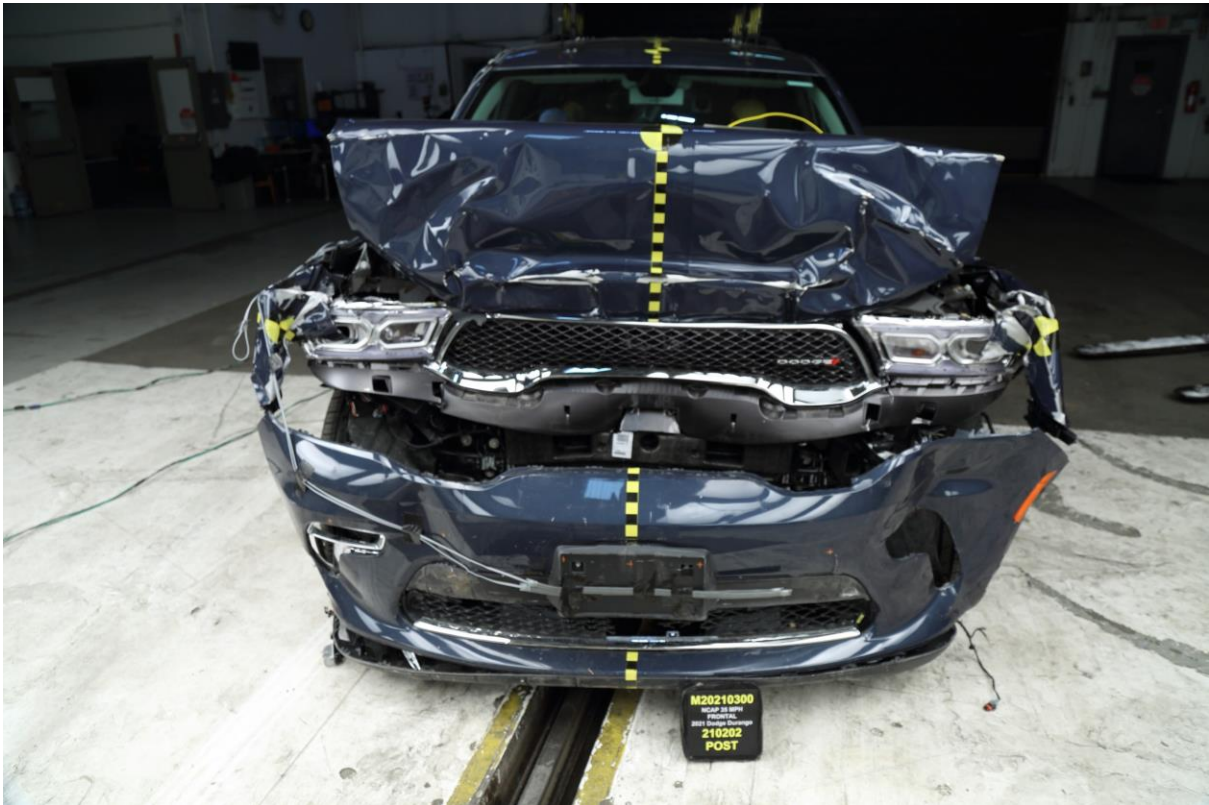
**009 Post-Test Front View of Test Vehicle**
