REPORT NUMBER: NCAP-CAL-21-005

NEW CAR ASSESSMENT PROGRAM (NCAP) FRONTAL BARRIER IMPACT TEST

General Motors Corporation 2021 Buick Envision Preferred Five Door SUV

NHTSA No: M20210100

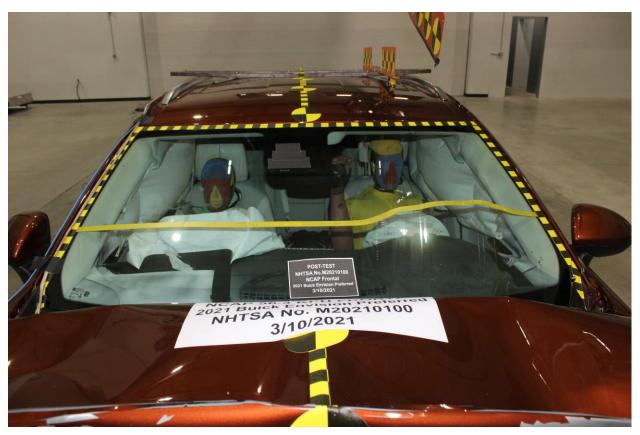
Figure A-19: Post-Test Windshield View

There was 100 percent windshield retention and no intrusion into the protected zone of the windshield during the event. There was a total of 0.0 grams of stoddard solvent leakage after the event or during any phase of the static rollover. The maximum static crush of the vehicle was 457 mm and both driver and passenger side doors remained closed during the impact event and were operable after the impact.
