**REPORT NUMBER: NCAP-MGA-22-003**

**NEW CAR ASSESSMENT PROGRAM (NCAP)  
Frontal Barrier Impact Test**

**HONDA OF AMERICA MFG., INC.  
2022 Acura MDX SH-AWD 5-Door SUV  
NHTSA No.: O20225300**

**FINAL REPORT**

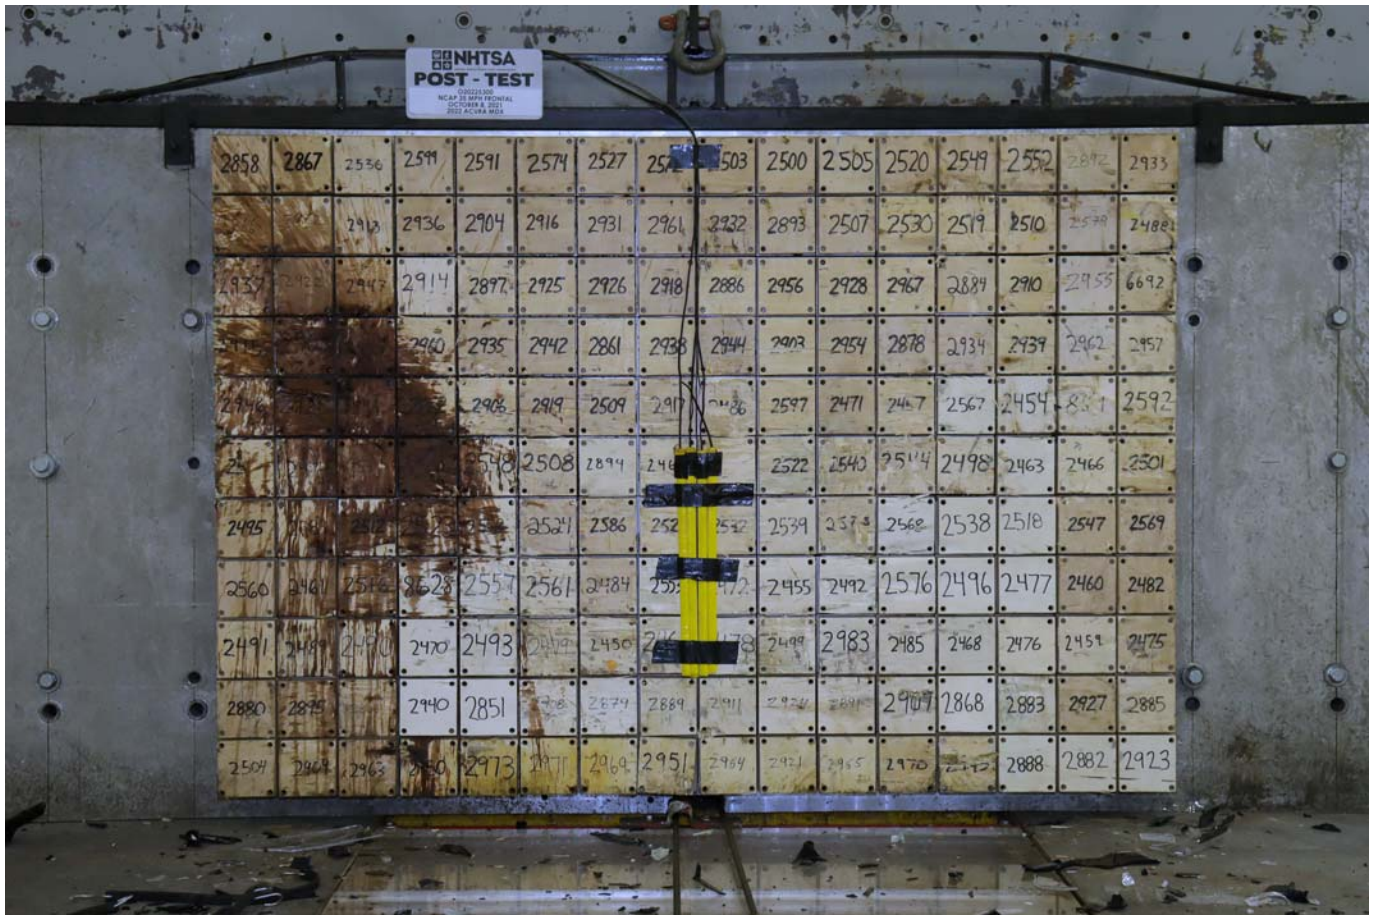
Photo No. 003 - Post-Test Load Cell Wall

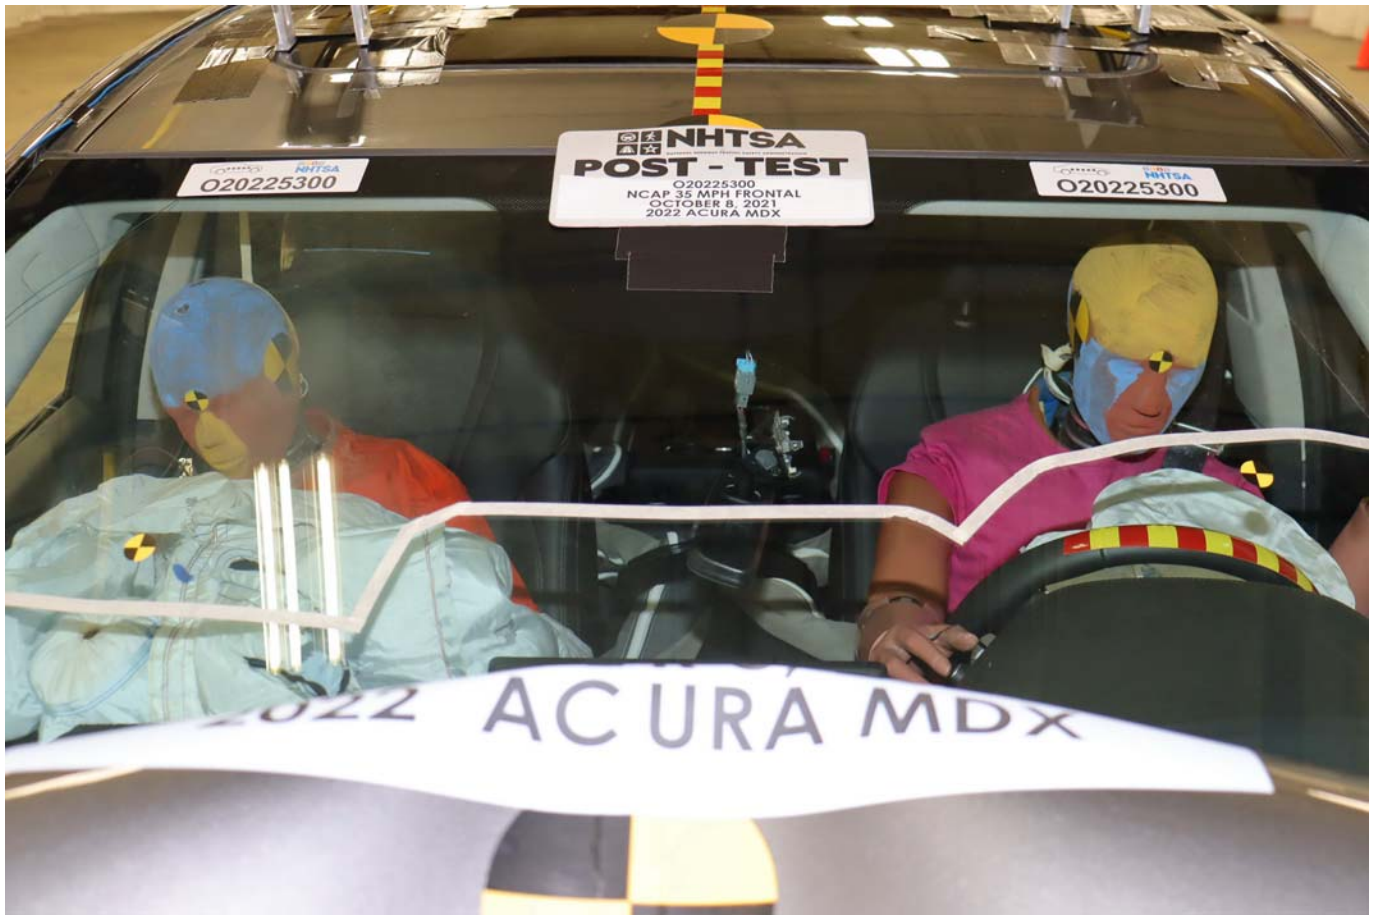
Photo No. 019 - Post-Test Windshield View

There was 100 percent windshield retention and no intrusion into the protected zone of the windshield during the event. There was no Stoddard Solvent leakage after the event or during any phase of the static rollover.

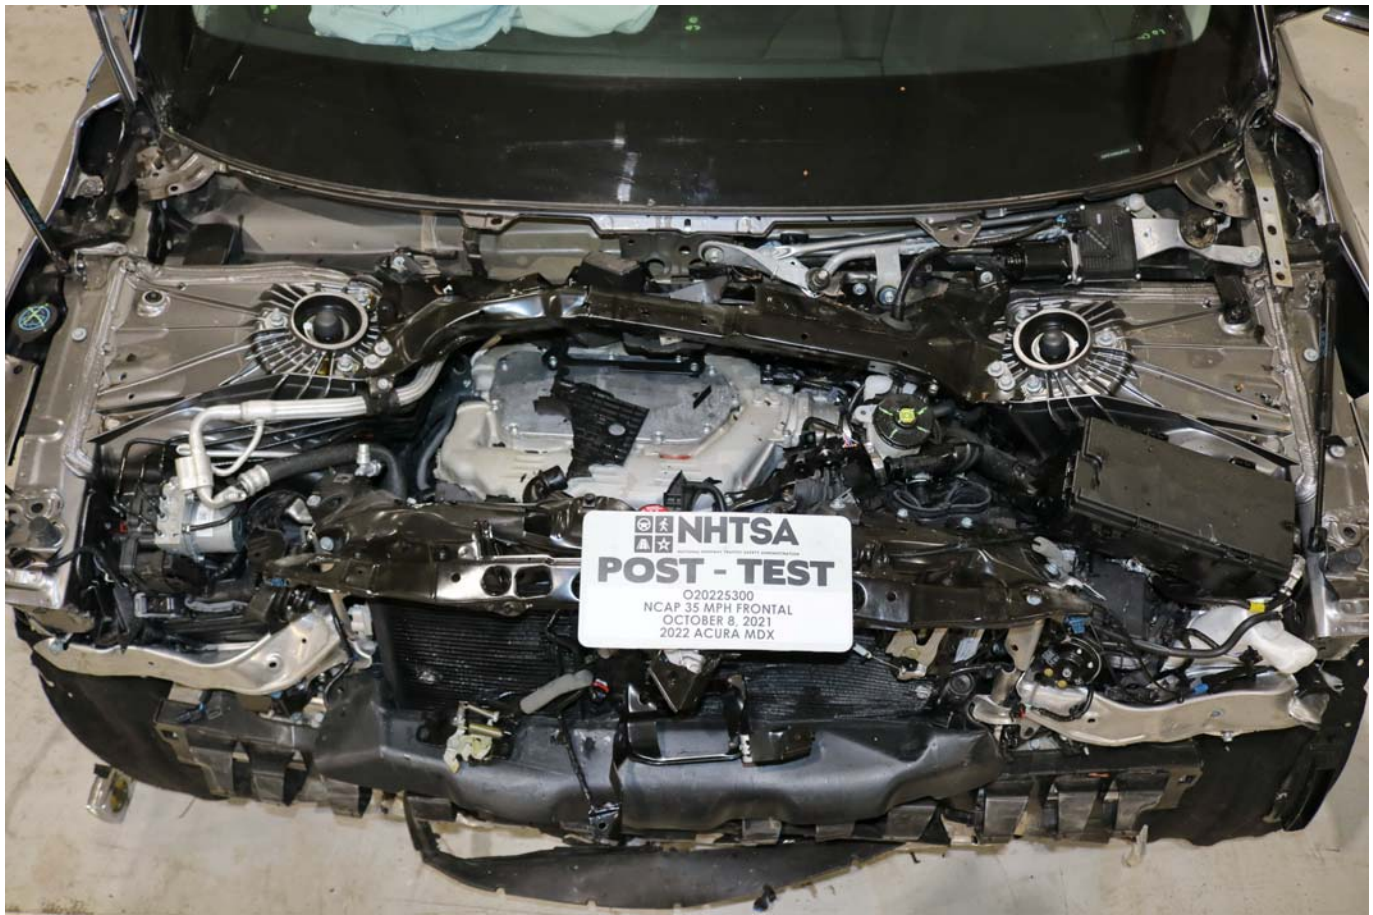
Photo No. 021 - Post-Test Engine Compartment View

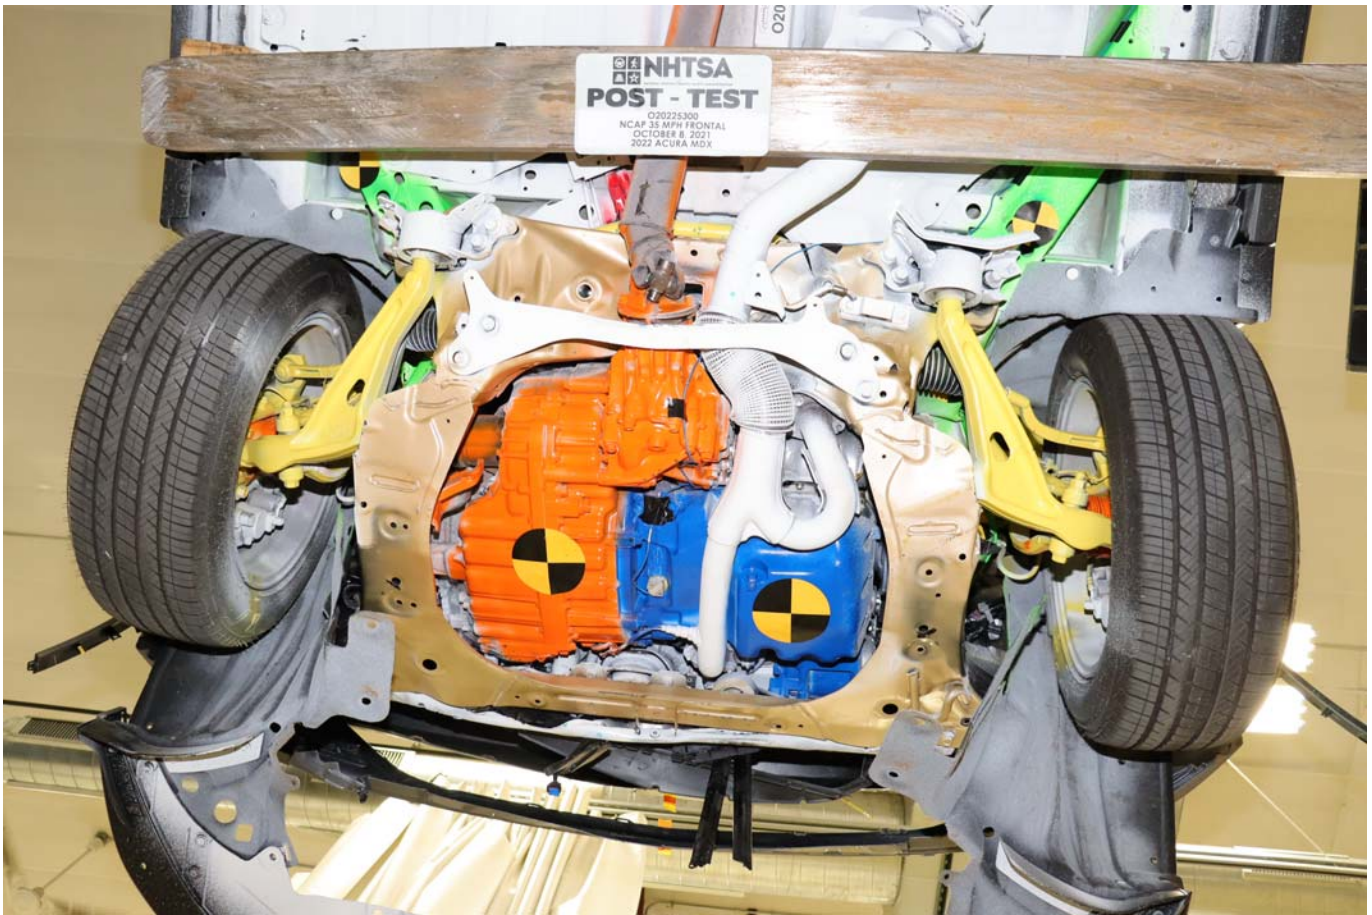
Photo No. 025 - Post-Test Front Underbody View

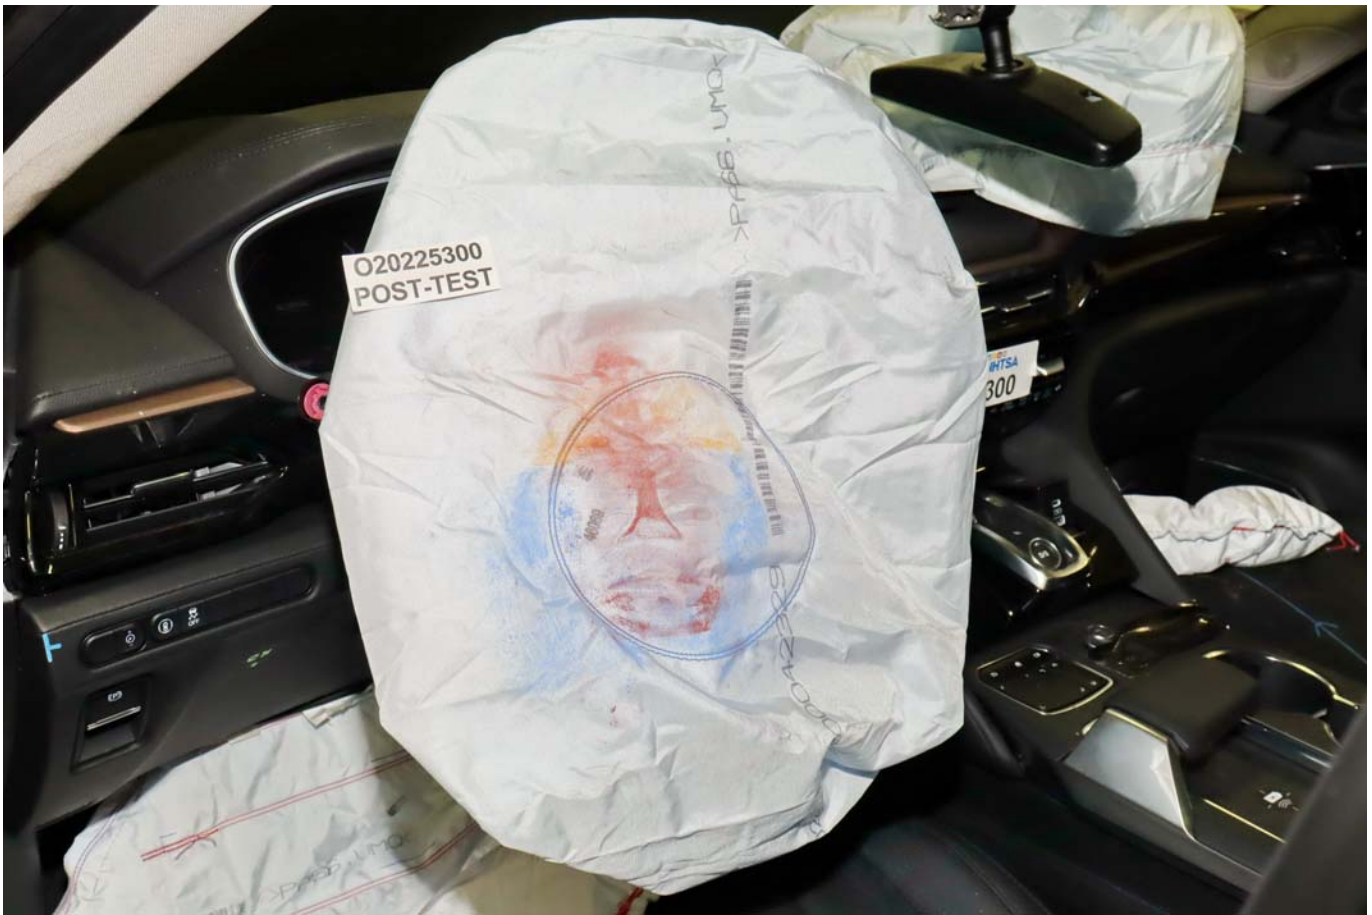
Photo No. 049 - Post-Test Driver Dummy Contact with Airbag

The driver's visible contact points were as follows: The driver's head contacted the airbag. The driver's head also contacted the headrest. The driver's knees contacted the knee airbag.

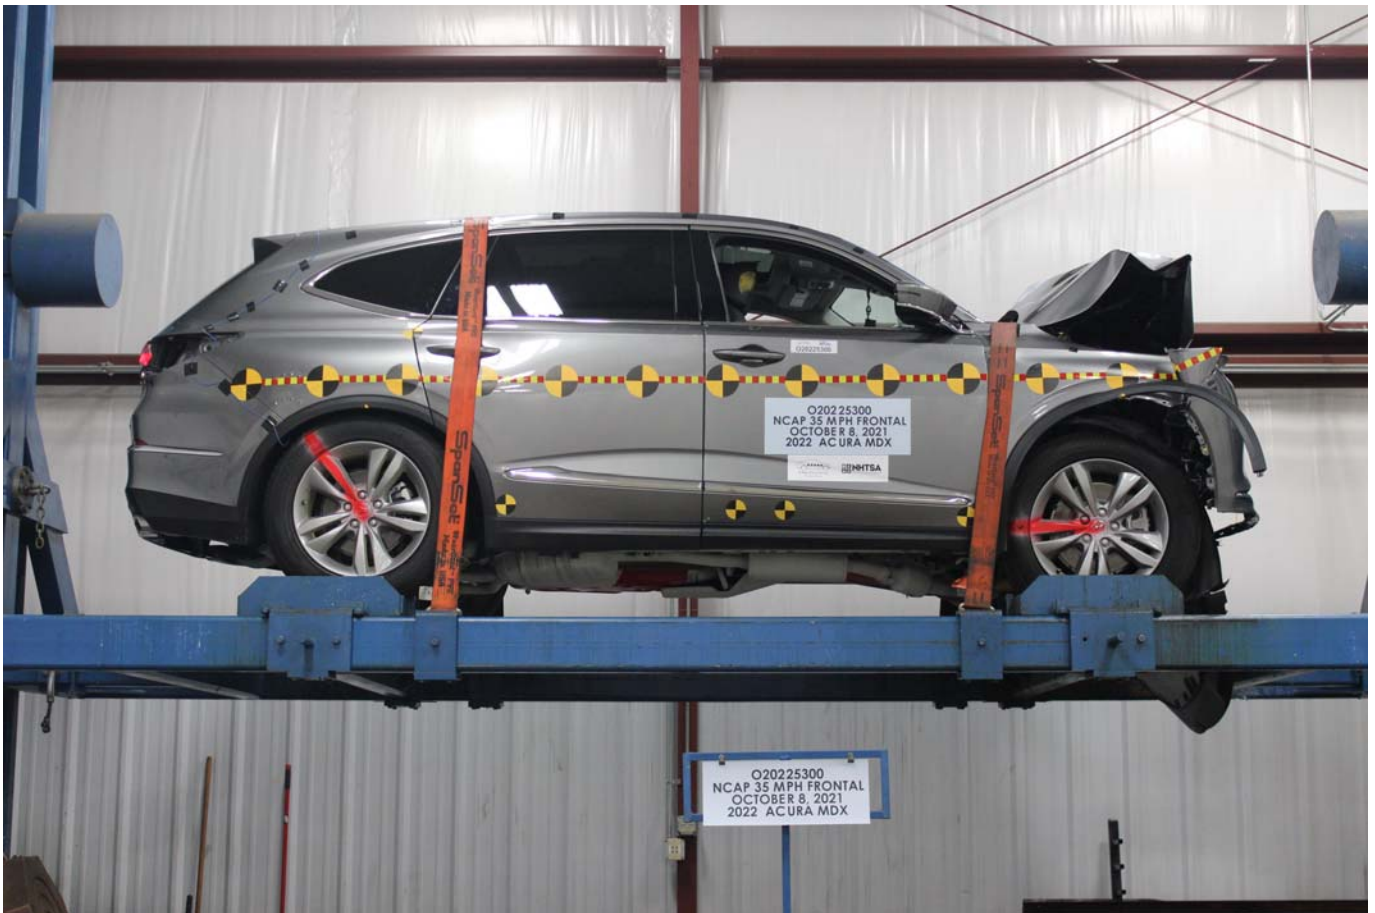
Photo No. 077 - Vehicle at 0 Degrees on Static Rollover Device

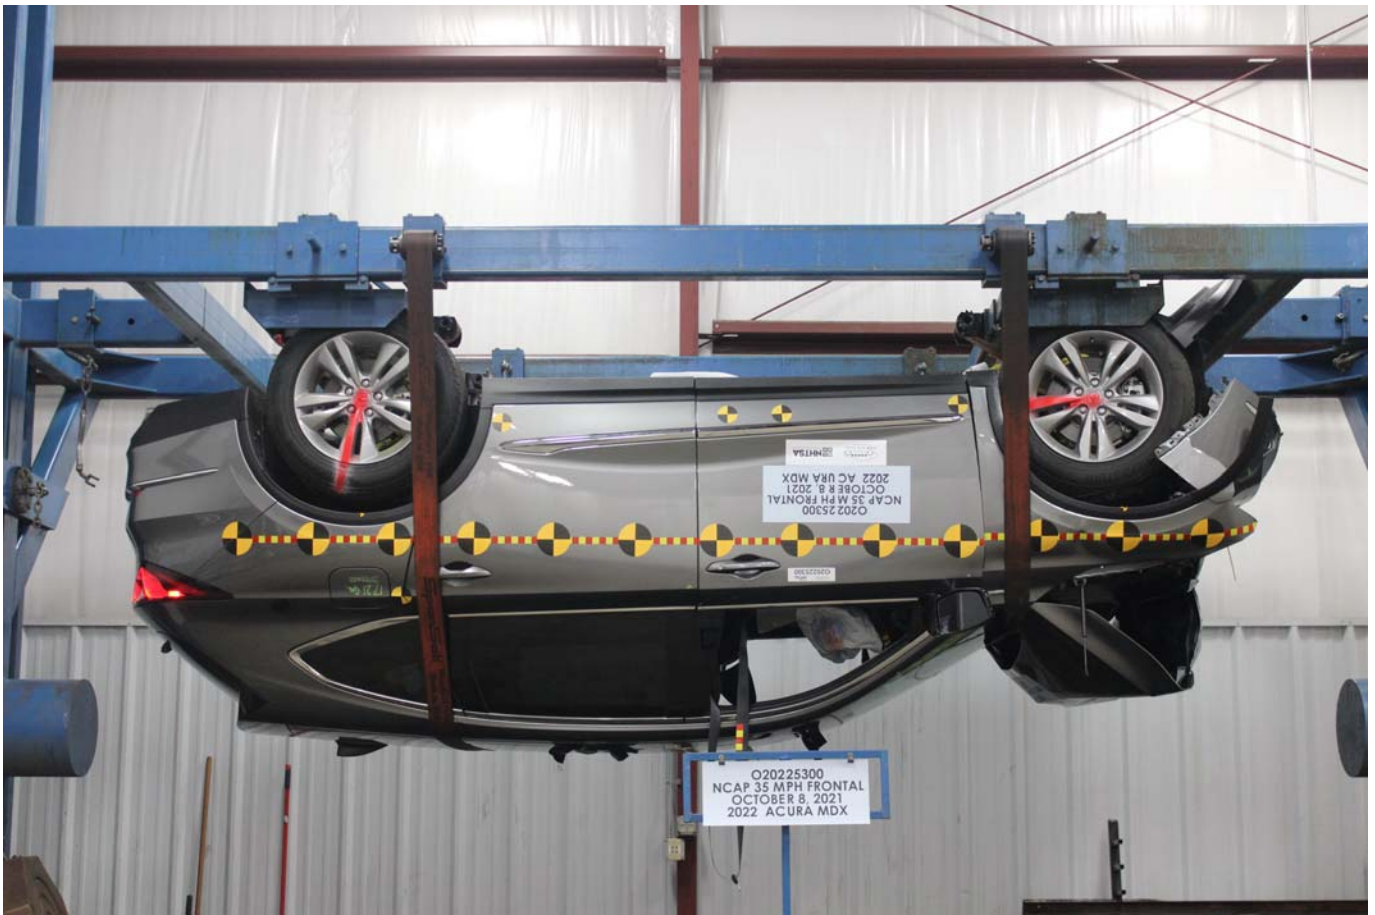
Photo No. 079 - Vehicle at 180 Degrees on Static Rollover Device

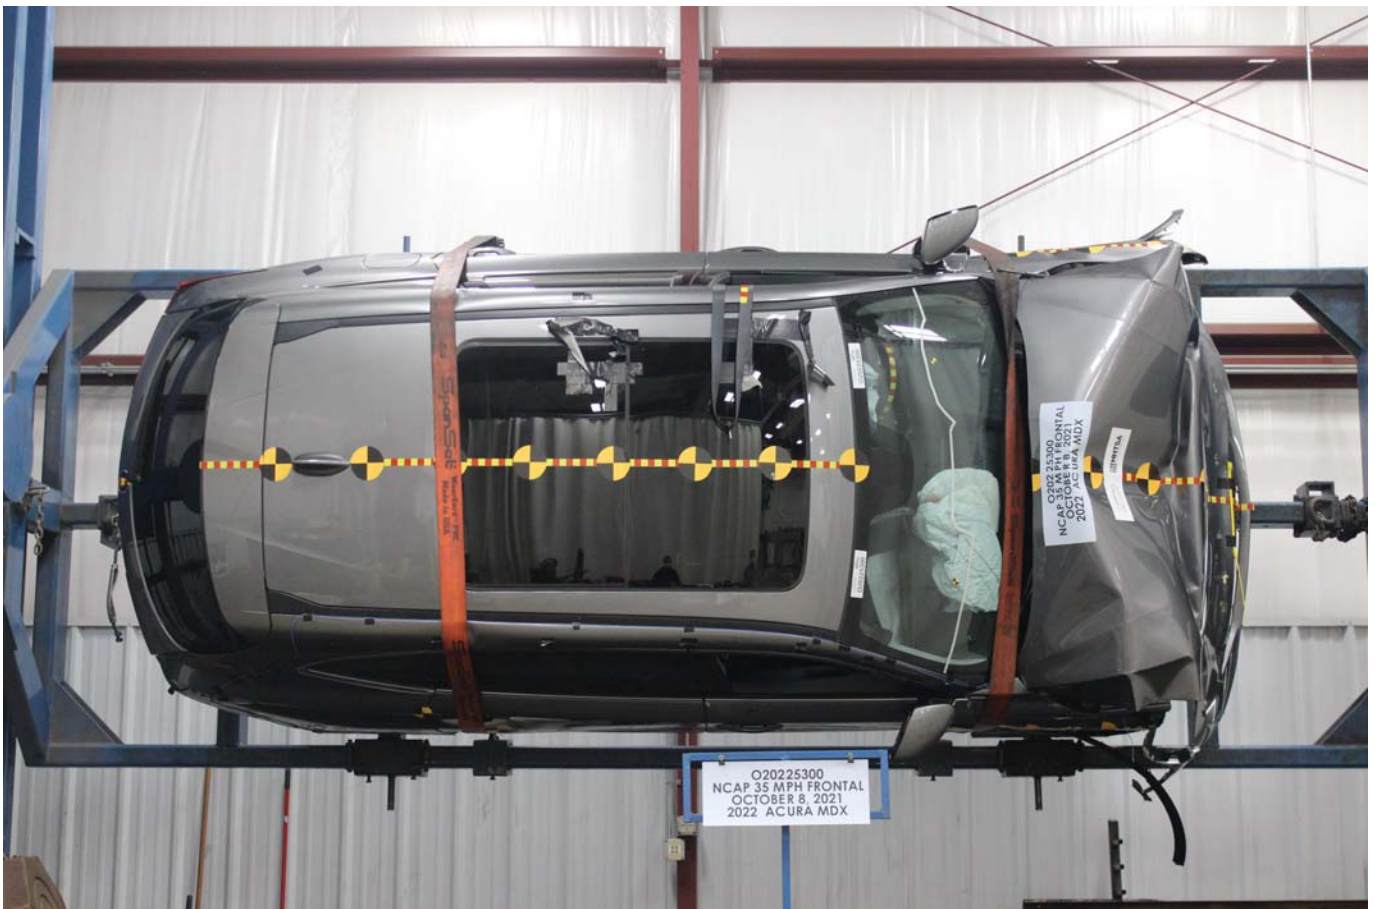
Photo No. 080 - Vehicle at 270 Degrees on Static Rollover Device

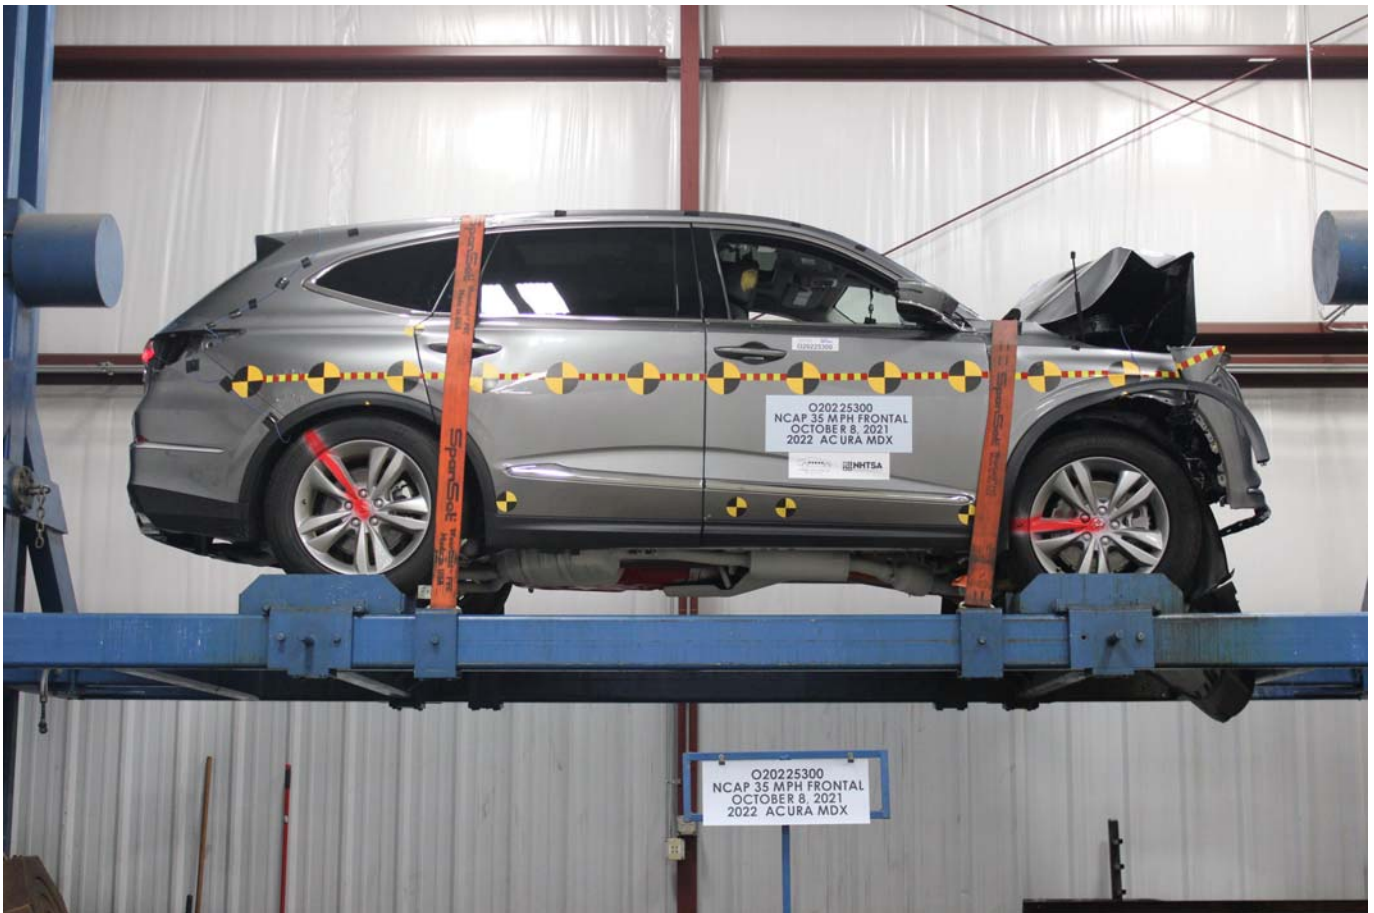
Photo No. 081 - Vehicle at 360 Degrees on Static Rollover Device

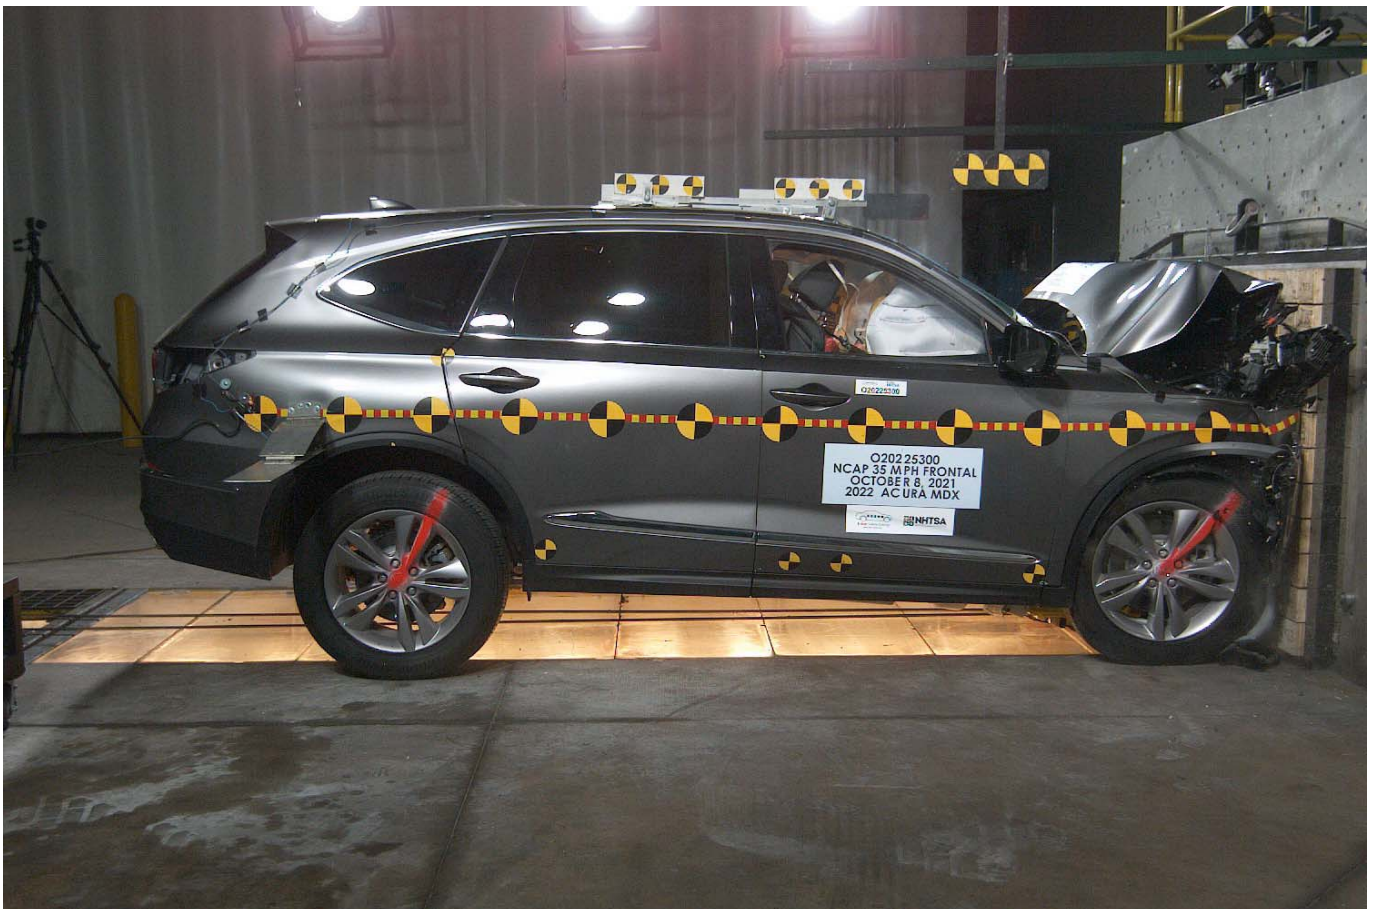
Photo No. 082 - 2022 Acura MDX SH-AWD 5-Door SUV Frontal Impact Event

A load cell barrier consisting of 176 load cells was impacted by a 2022 Acura MDX SH-AWD 5-Door SUV at a velocity of 56.03 km/h. The test was performed at MGA Research Corporation on October 8, 2021. Pre-test and post-test photographs of the vehicle and dummies can be found in Appendix A.
