NEW CAR ASSESSMENT PROGRAM LANE DEPARTURE WARNING CONFIRMATION TEST NCAP-DRI-LDW-22-08

2022 Mitsubishi Outlander SE 2.5S-AWC

1. Report No.	Government Accession No.	Recipient's Catalog No.		
NCAP-DRI-LDW-22-08				
4. Title and Subtitle		5. Report Date		
Draft Report of Lane Departure Warning	Confirmation Test of a 2022 Mitsubishi	1/20/2022		
Outlander SE 2.5S-AWC.		6. Performing Organization Code		
		DRI

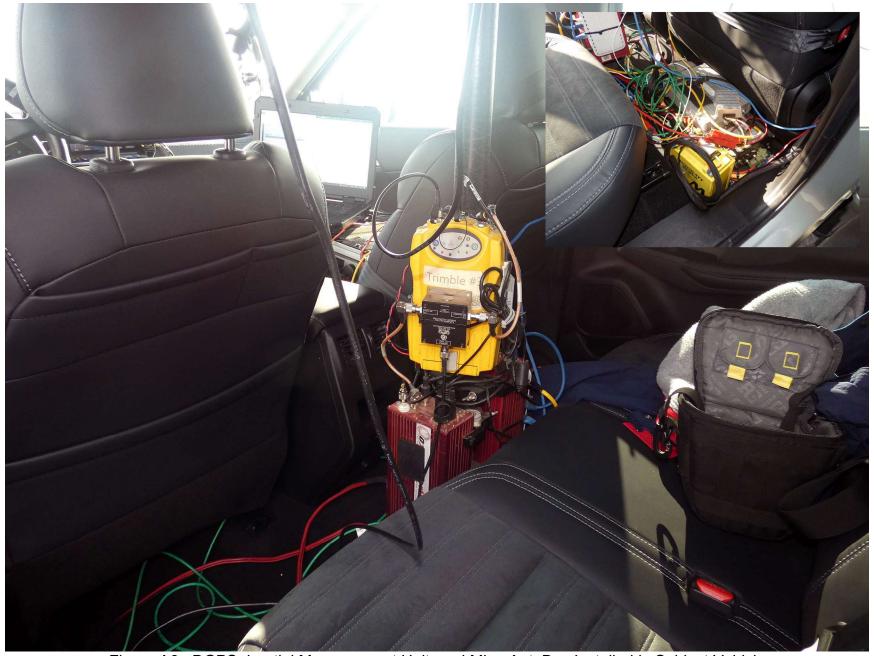
Figure A6. DGPS, Inertial Measurement Unit, and MicroAutoBox Installed in Subject Vehicle

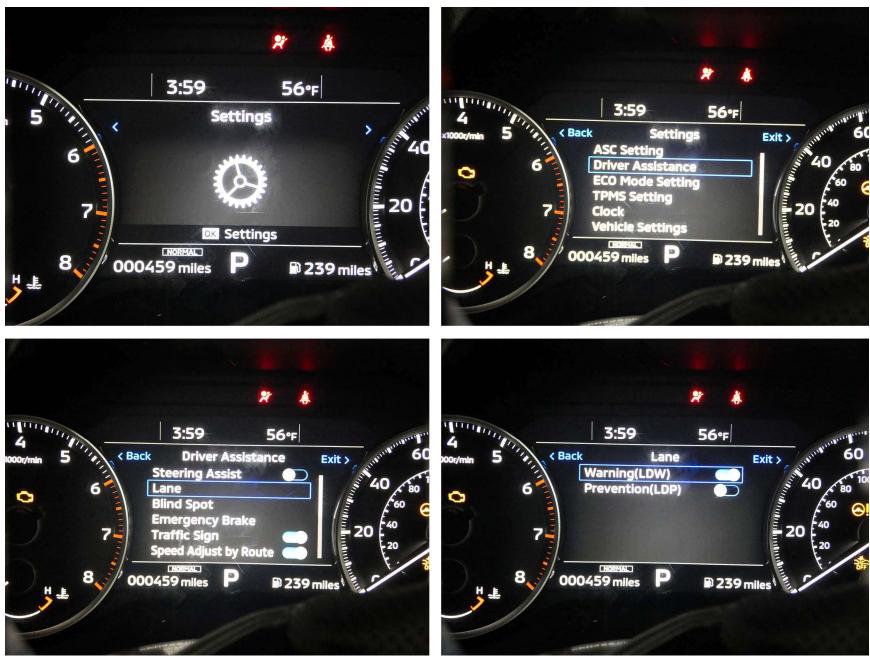
Figure A10. LDW System Menus

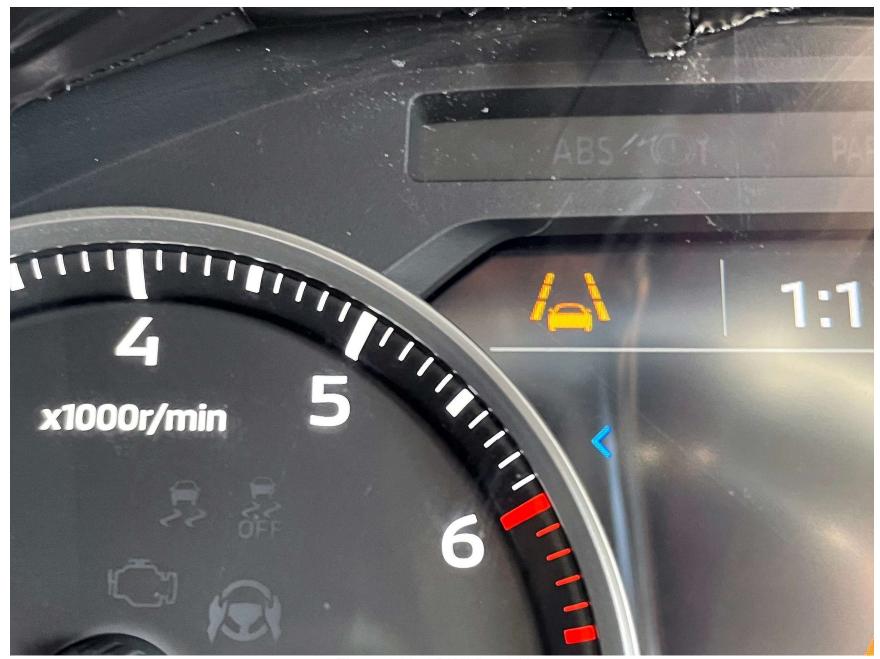
Figure A11. LDW Visual Alert

When the vehicle approaches either the left or the right side of the traveling lane, a haptic warning is given to the driver via a vibration felt in the steering wheel whose primary frequency is approximately 37 Hz. Additionally, a visual alert flashes to alert the driver. The visual alert is provided in the upper left-hand corner of the instrument panel and is an image of a vehicle crossing over a lane line as seen from above.
