**NEW CAR ASSESSMENT PROGRAM
LANE DEPARTURE WARNING CONFIRMATION TEST
NCAP-DRI-LDW-22-10**

2022 Subaru Forester Premium/NFF

1. Report No. NCAP-DRI-LDW-22-10	2. Government Accession No.	3. Recipient's Catalog No.	
4. Title and Subtitle Draft Report of Lane Departure Warning Confirmation Test of a 2022 Subaru Forester Premium/NFF.		5. Report Date

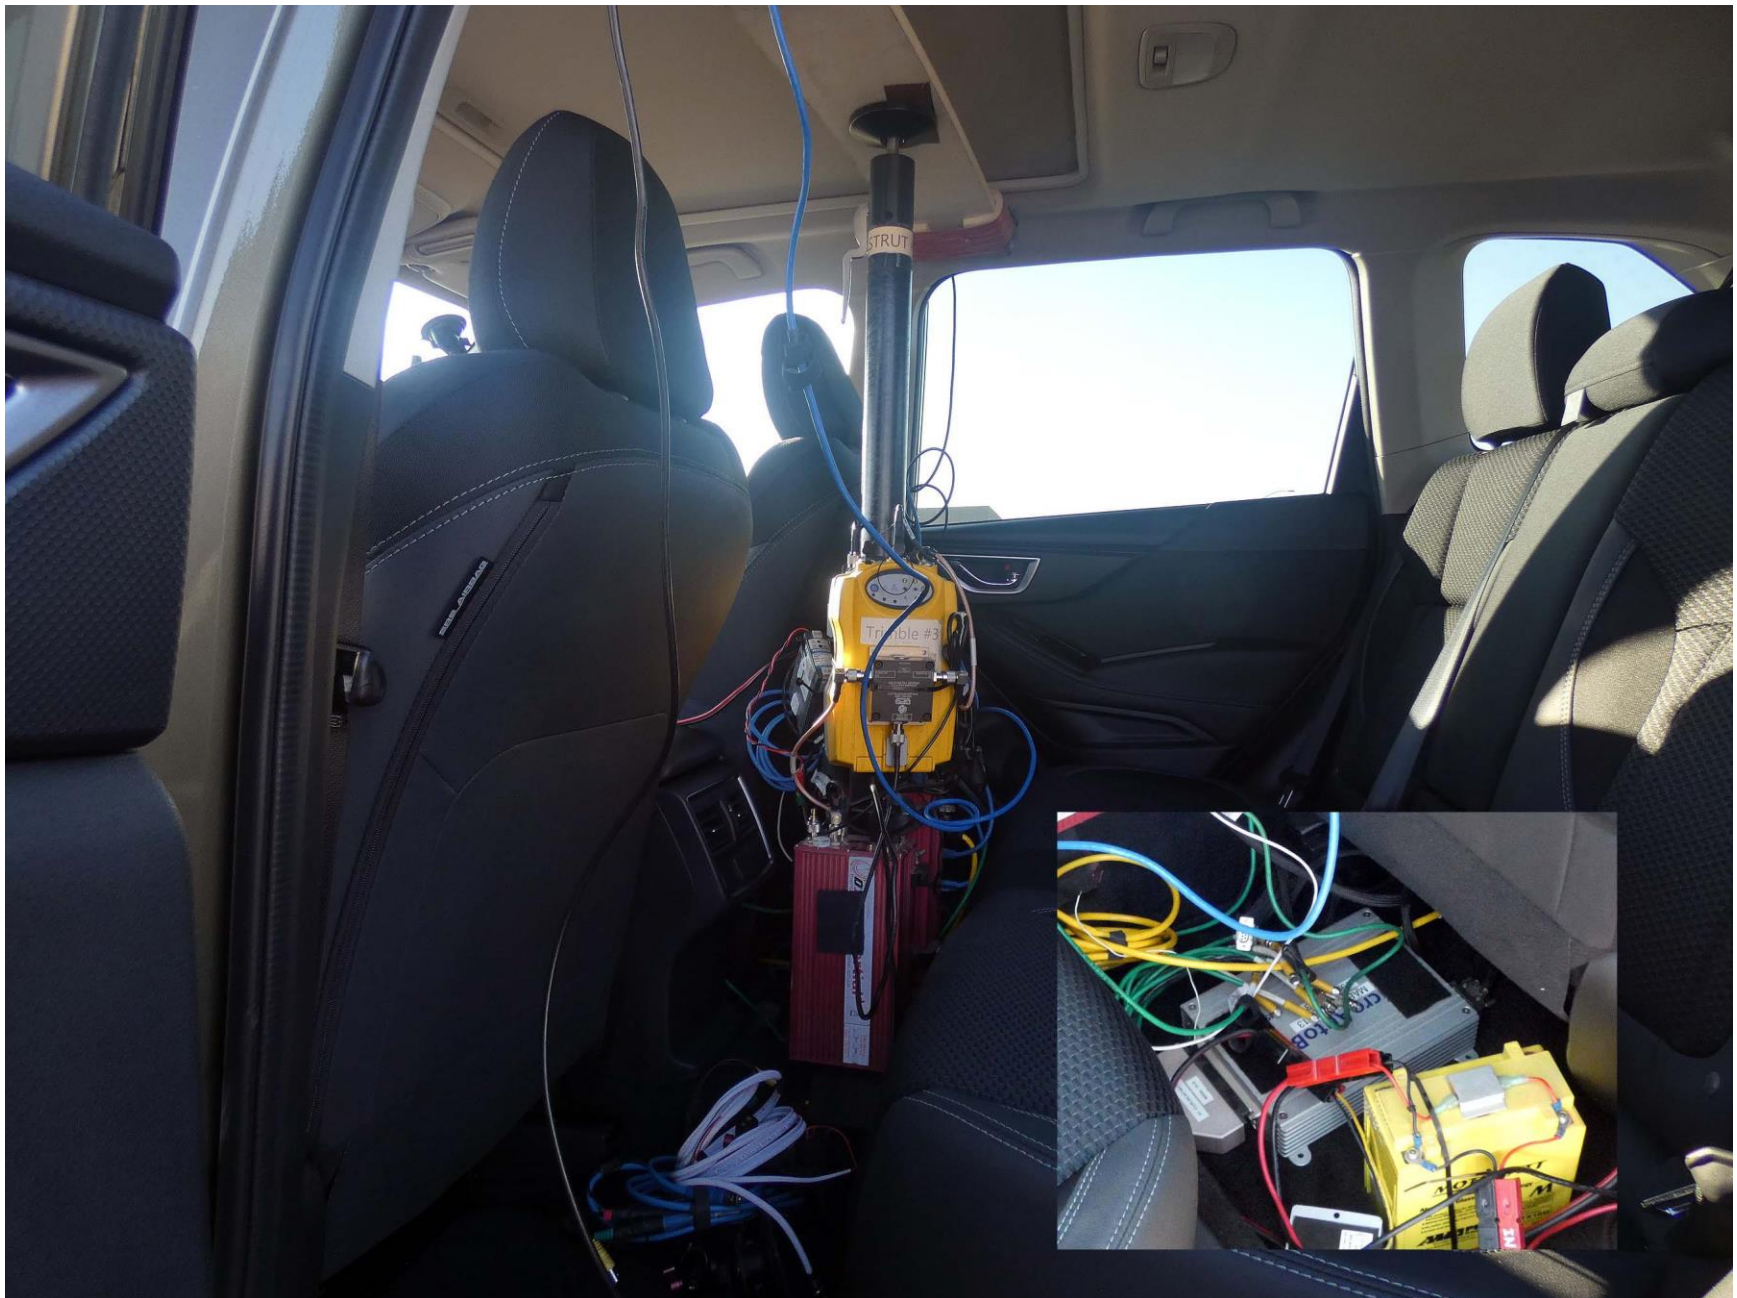
Figure A6. DGPS, Inertial Measurement Unit, and MicroAutoBox Installed in Subject Vehicle

Table 2 lists the sensors, signal conditioning, and data acquisition equipment used for these tests.

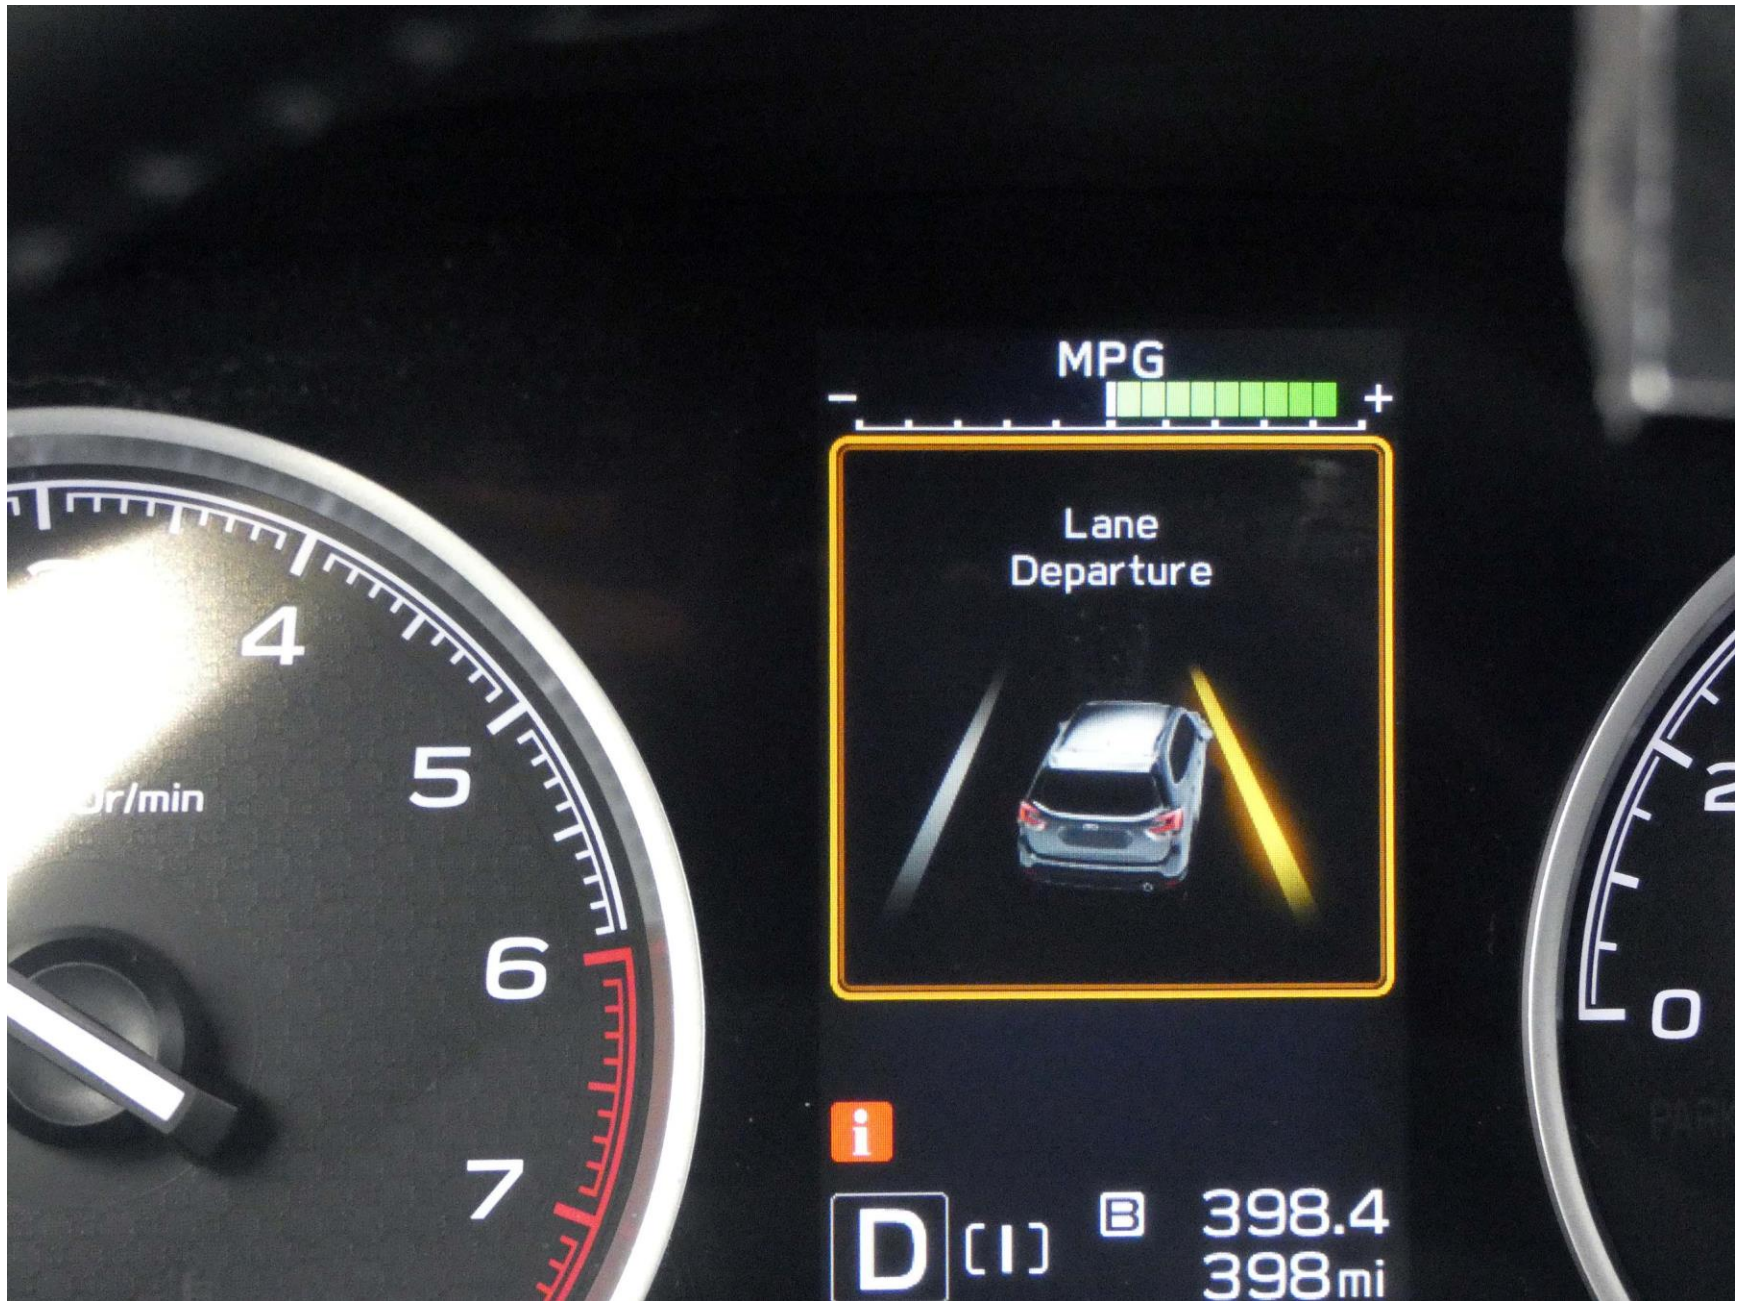
Figure A9. LDW Visual Alert

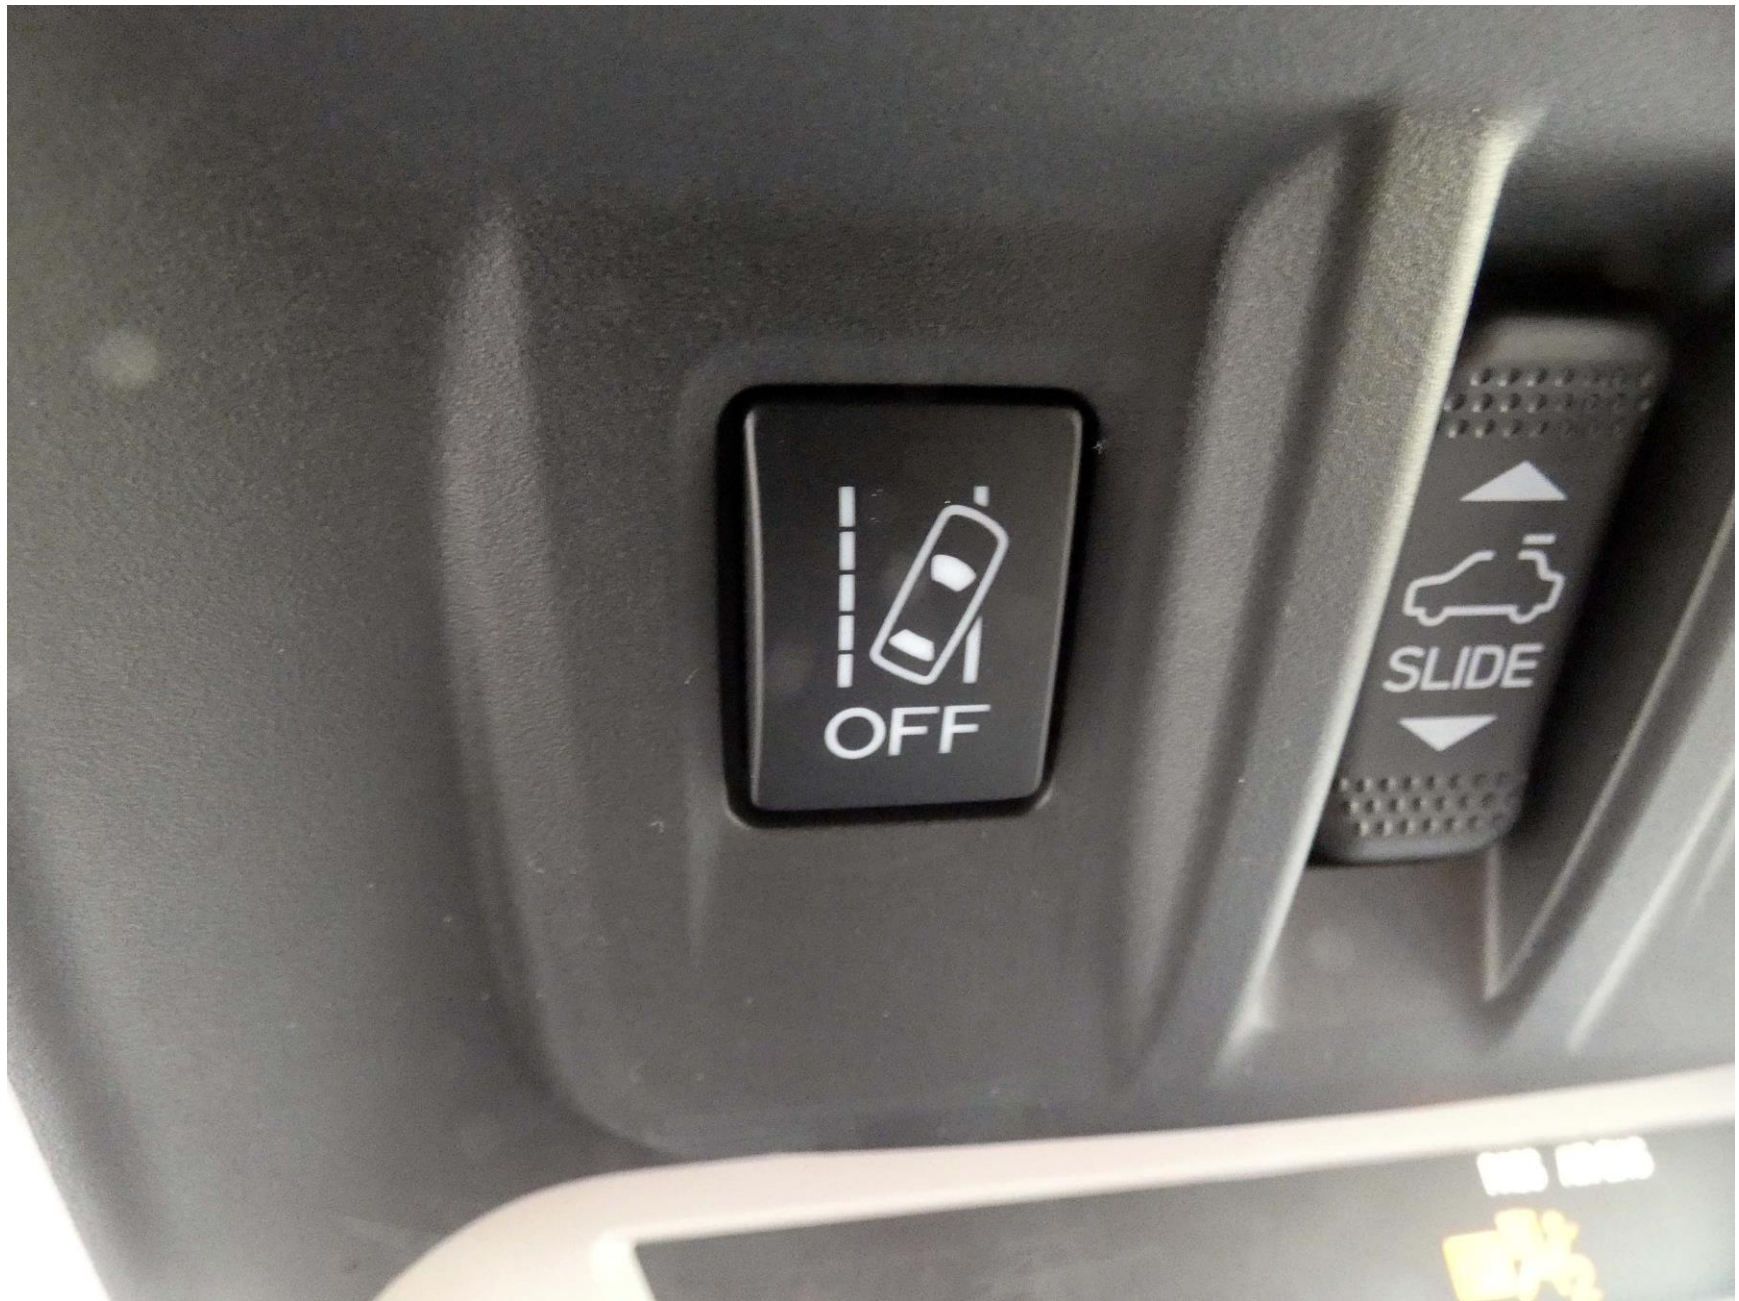
Figure A10. LDW On/Off Switch
