**NEW CAR ASSESSMENT PROGRAM
CRASH IMMINENT BRAKING SYSTEM CONFIRMATION TEST
NCAP-DRI-CIB-22-14**

2022 Subaru Forester Premium/NFF

DYNAMIC RESEARCH, INC.

Draft Report

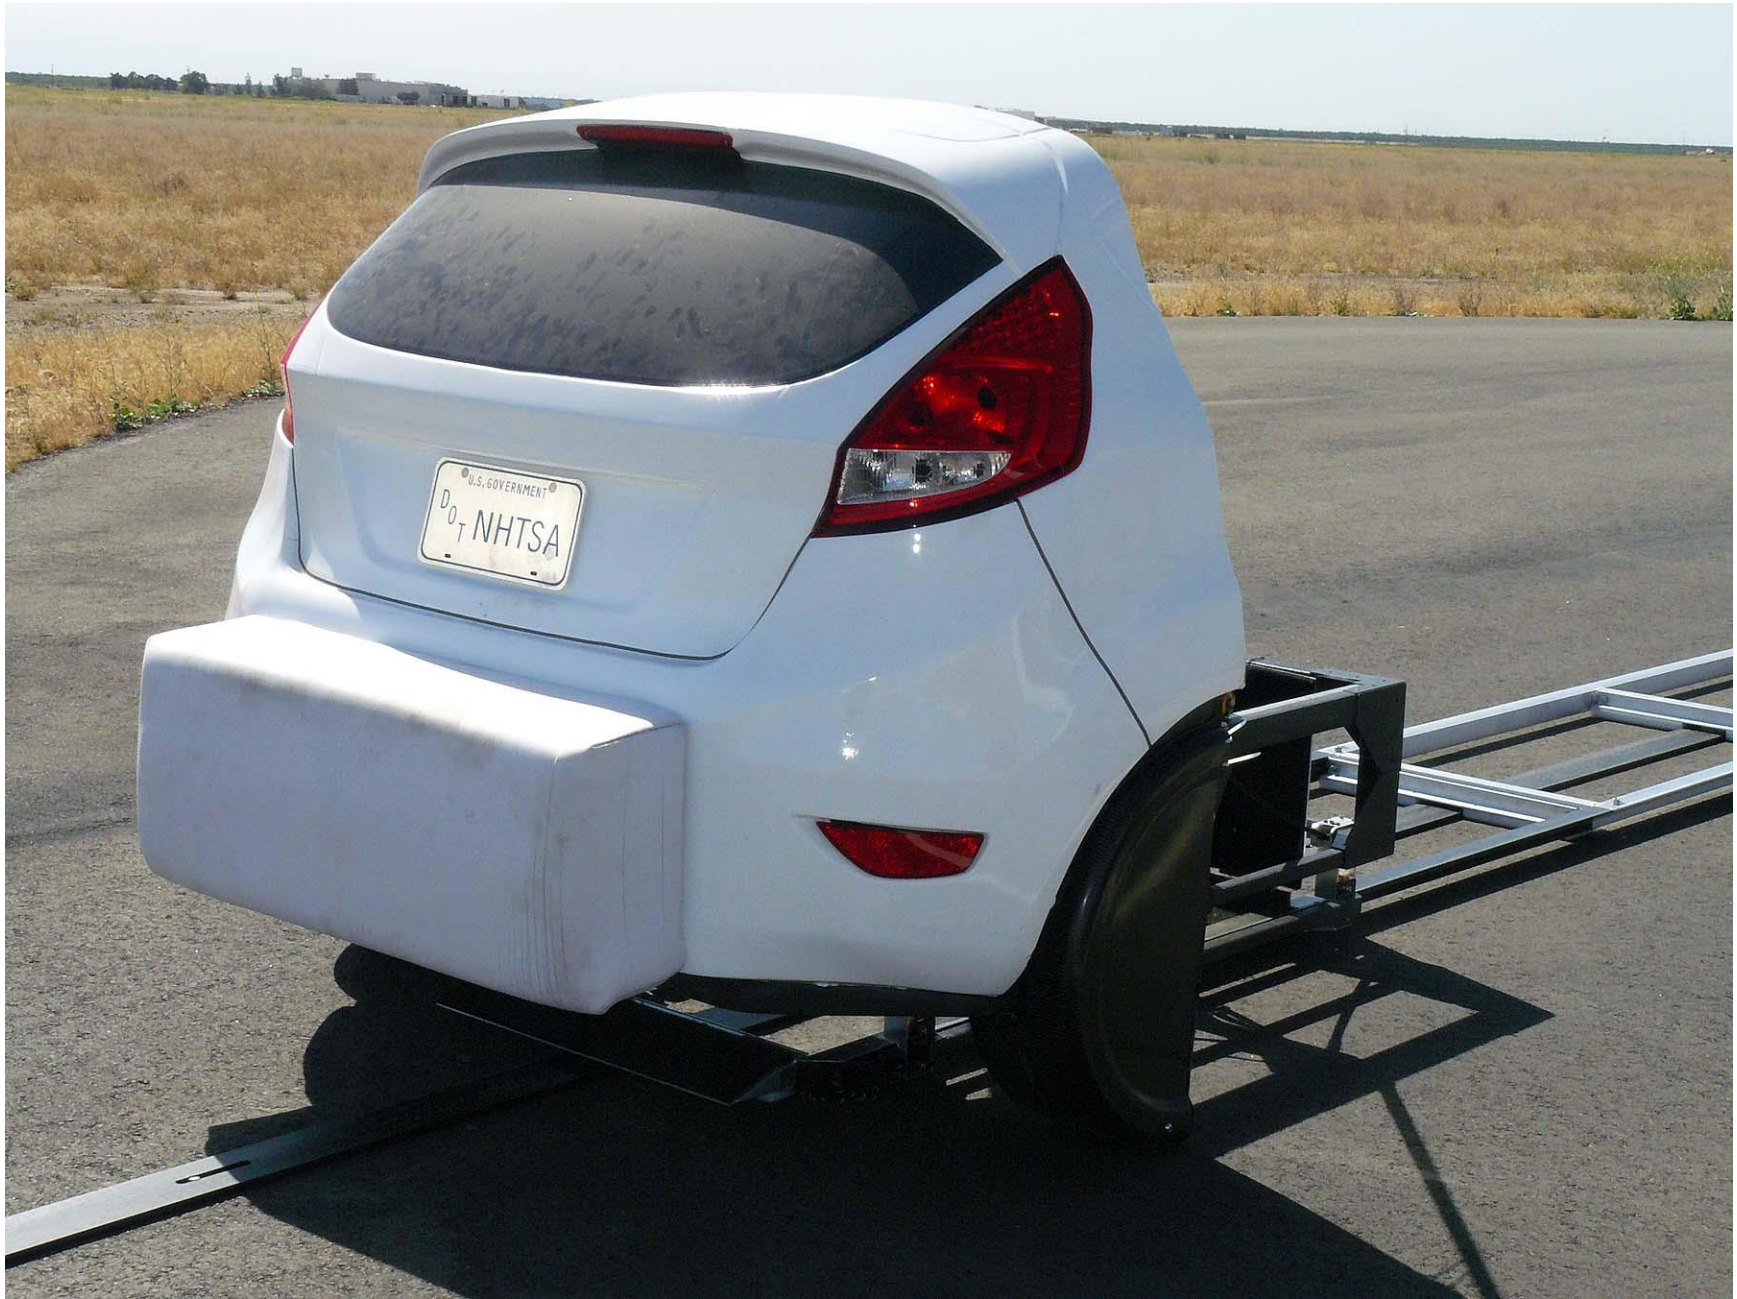
Figure A6. Rear View of Principal Other Vehicle (SSV)

CIB testing requires a POV that realistically represents typical vehicles, does not suffer damage or cause damage to a test vehicle in the event of collision, and can be accurately positioned and moved during the tests. The tests reported herein made use of the NHTSA developed Strikeable Surrogate Vehicle (SSV).

- Provide an accurate representation of a real vehicle to CIB sensors, including cameras and radar.
- Be resistant to damage and inflict little or no damage to the SV as a result of repeated SV-to-POV impacts.

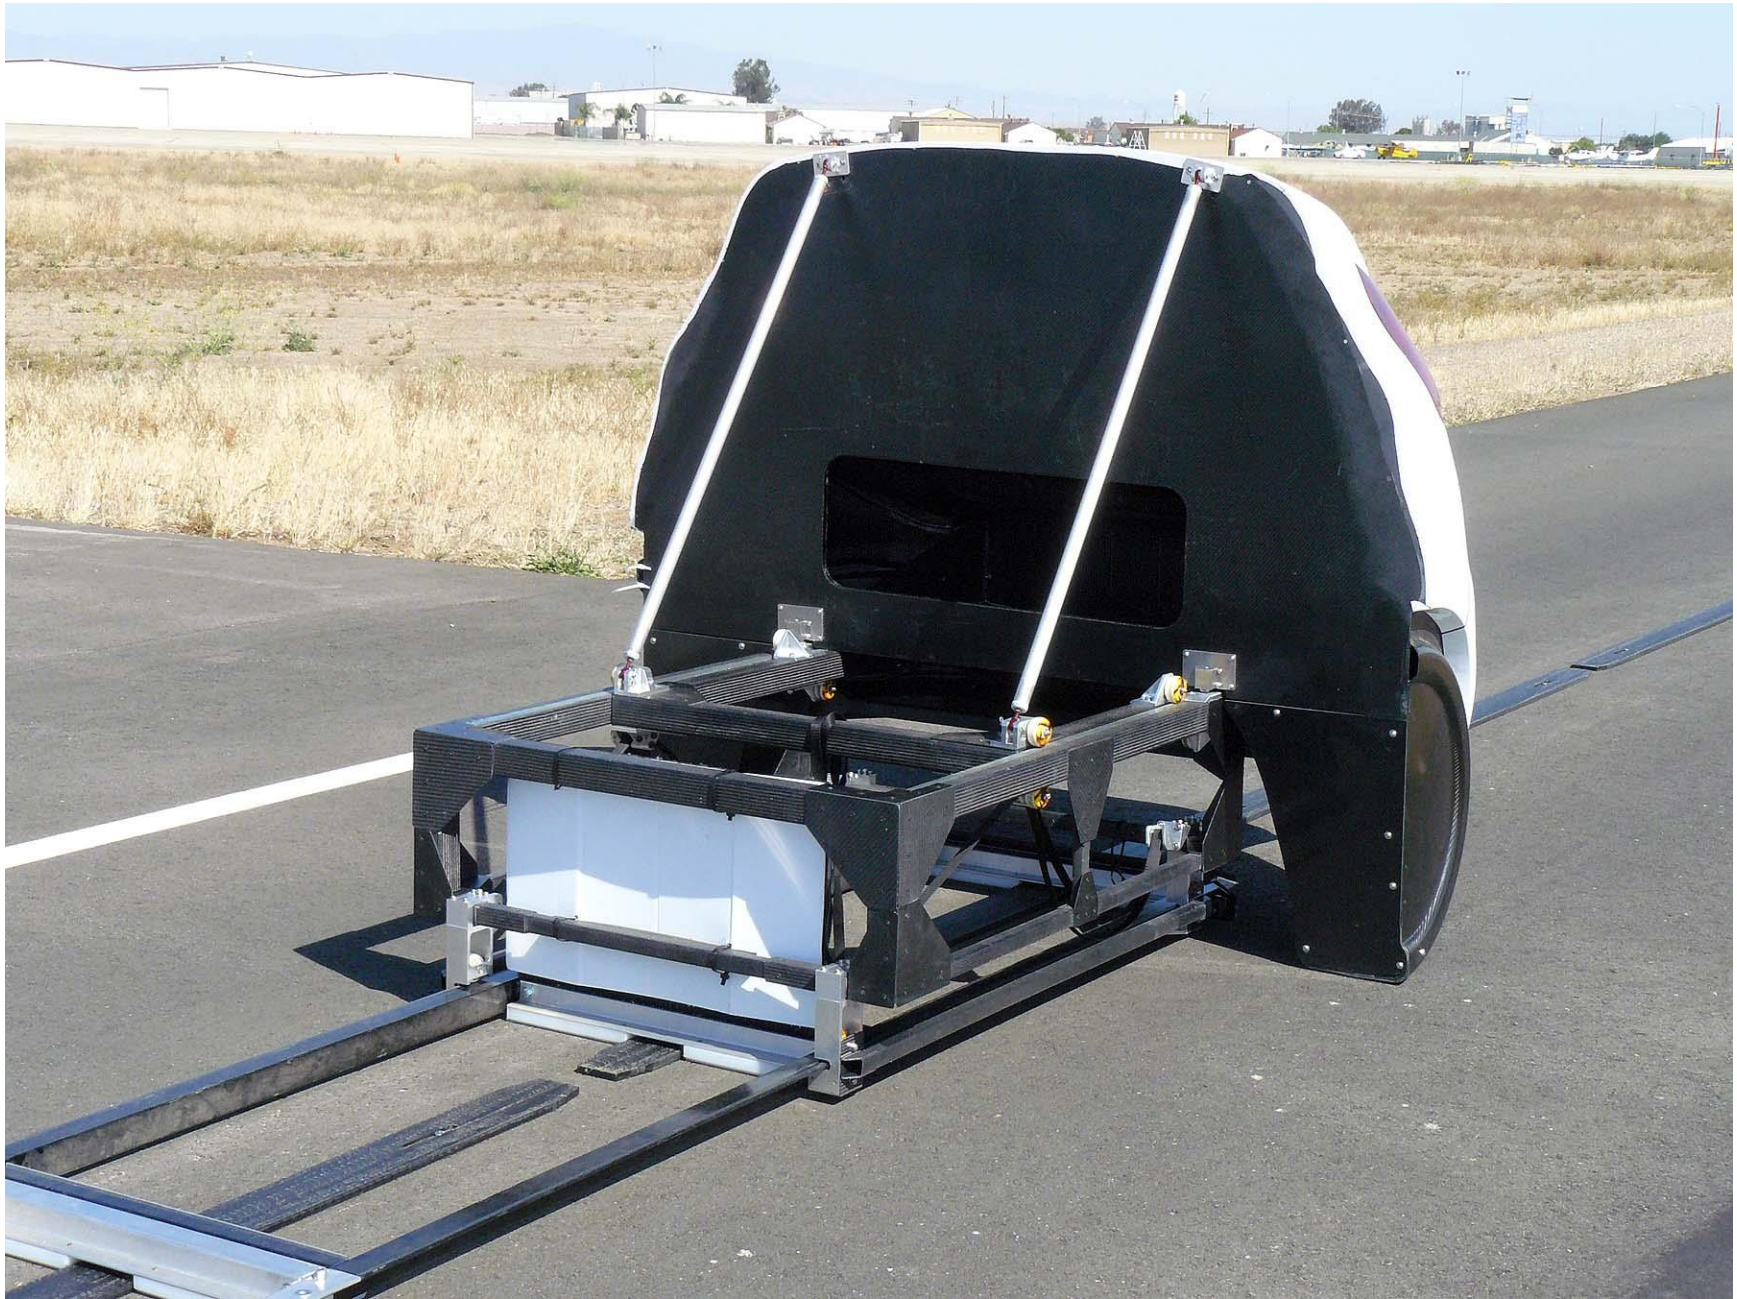
Figure A7. Load Frame/Slider of SSV

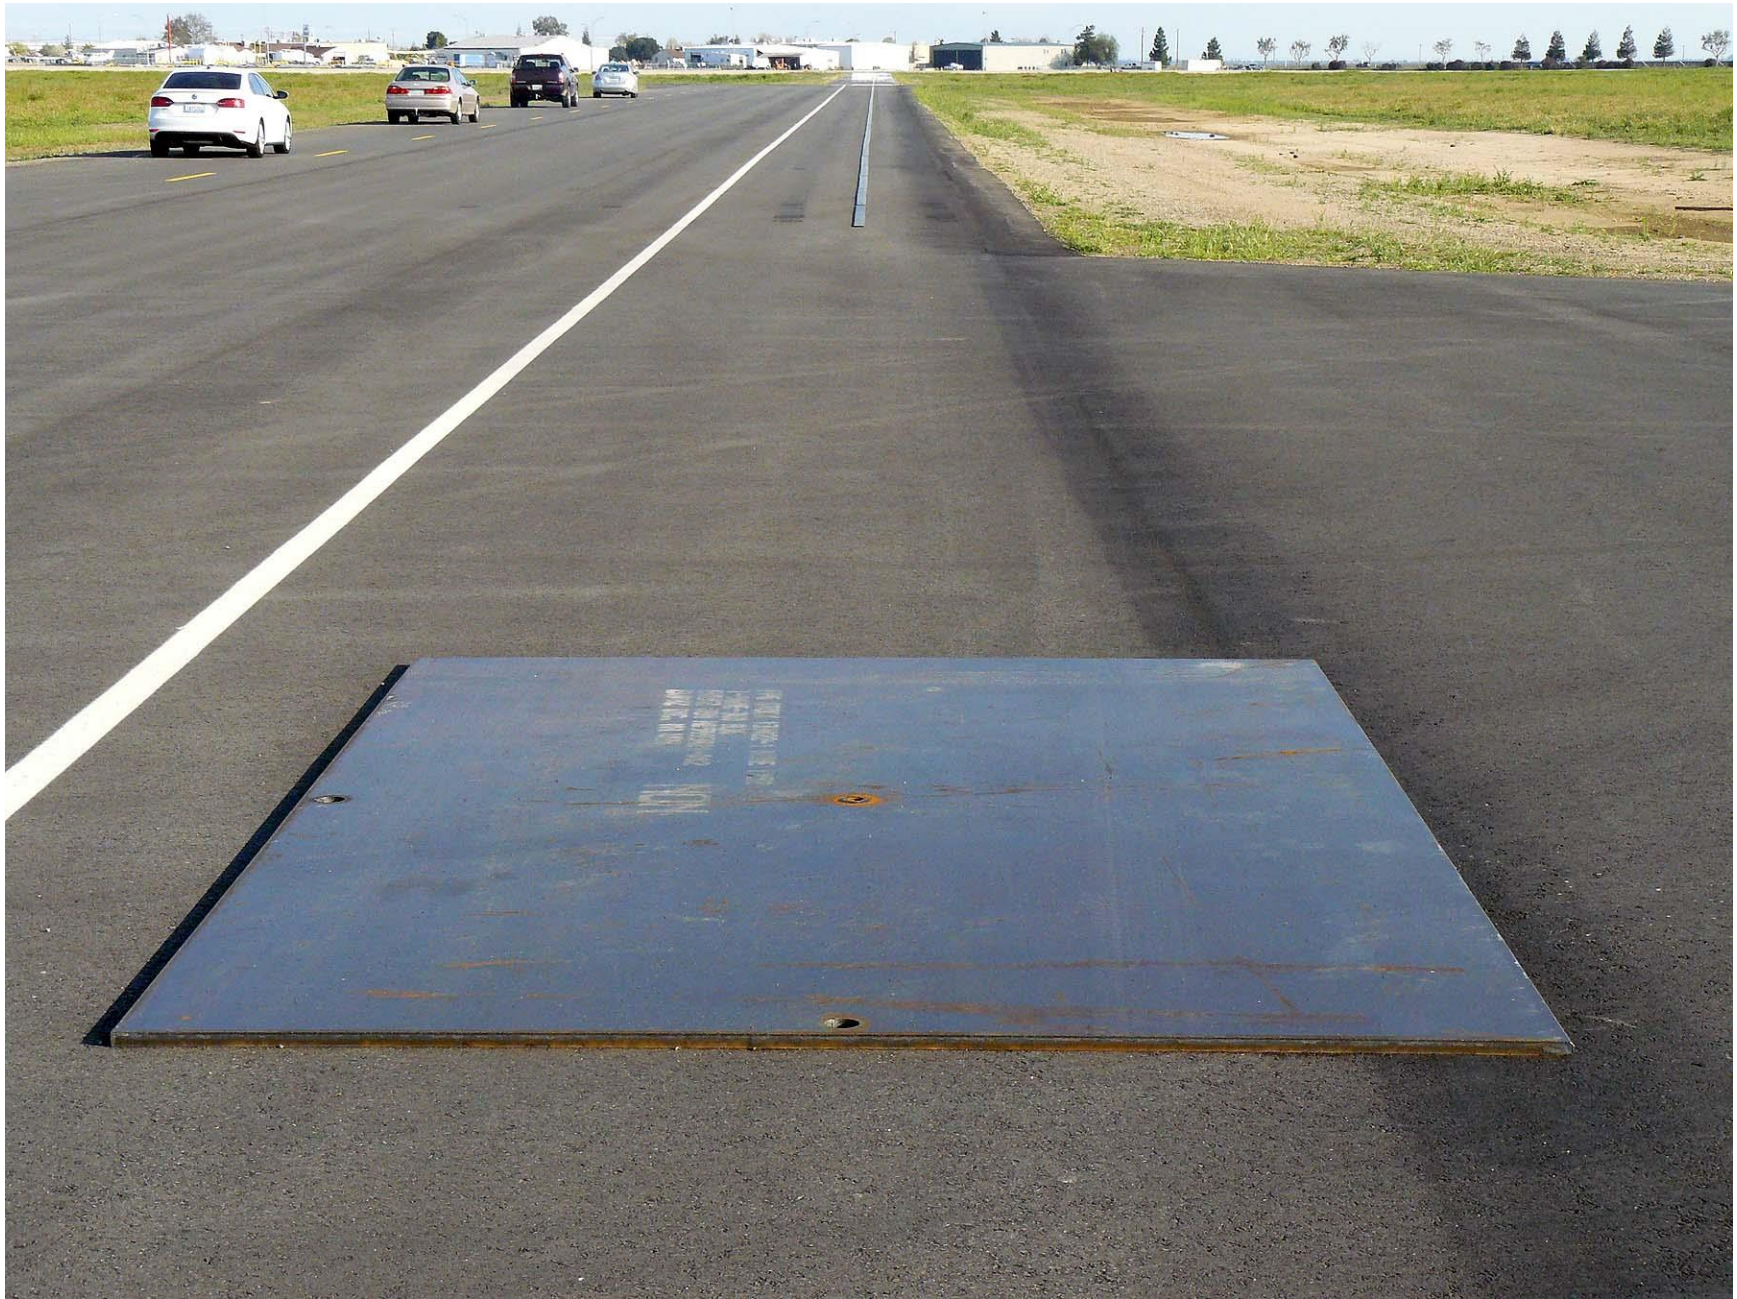
Figure A9. Steel Trench Plate

The false positive suppression test series evaluates the ability of a CIB system to differentiate a steel trench plate (STP) from an object presenting a genuine safety risk to the SV. Although the STP is large and metallic, it is designed to be driven over without risk of injury to the driver or damage to the SV. Therefore, in this scenario, the automatic braking available from CIB is not necessary and should be suppressed. The test condition is nearly equivalent to that previously defined for Test 1, the stopped POV condition, but

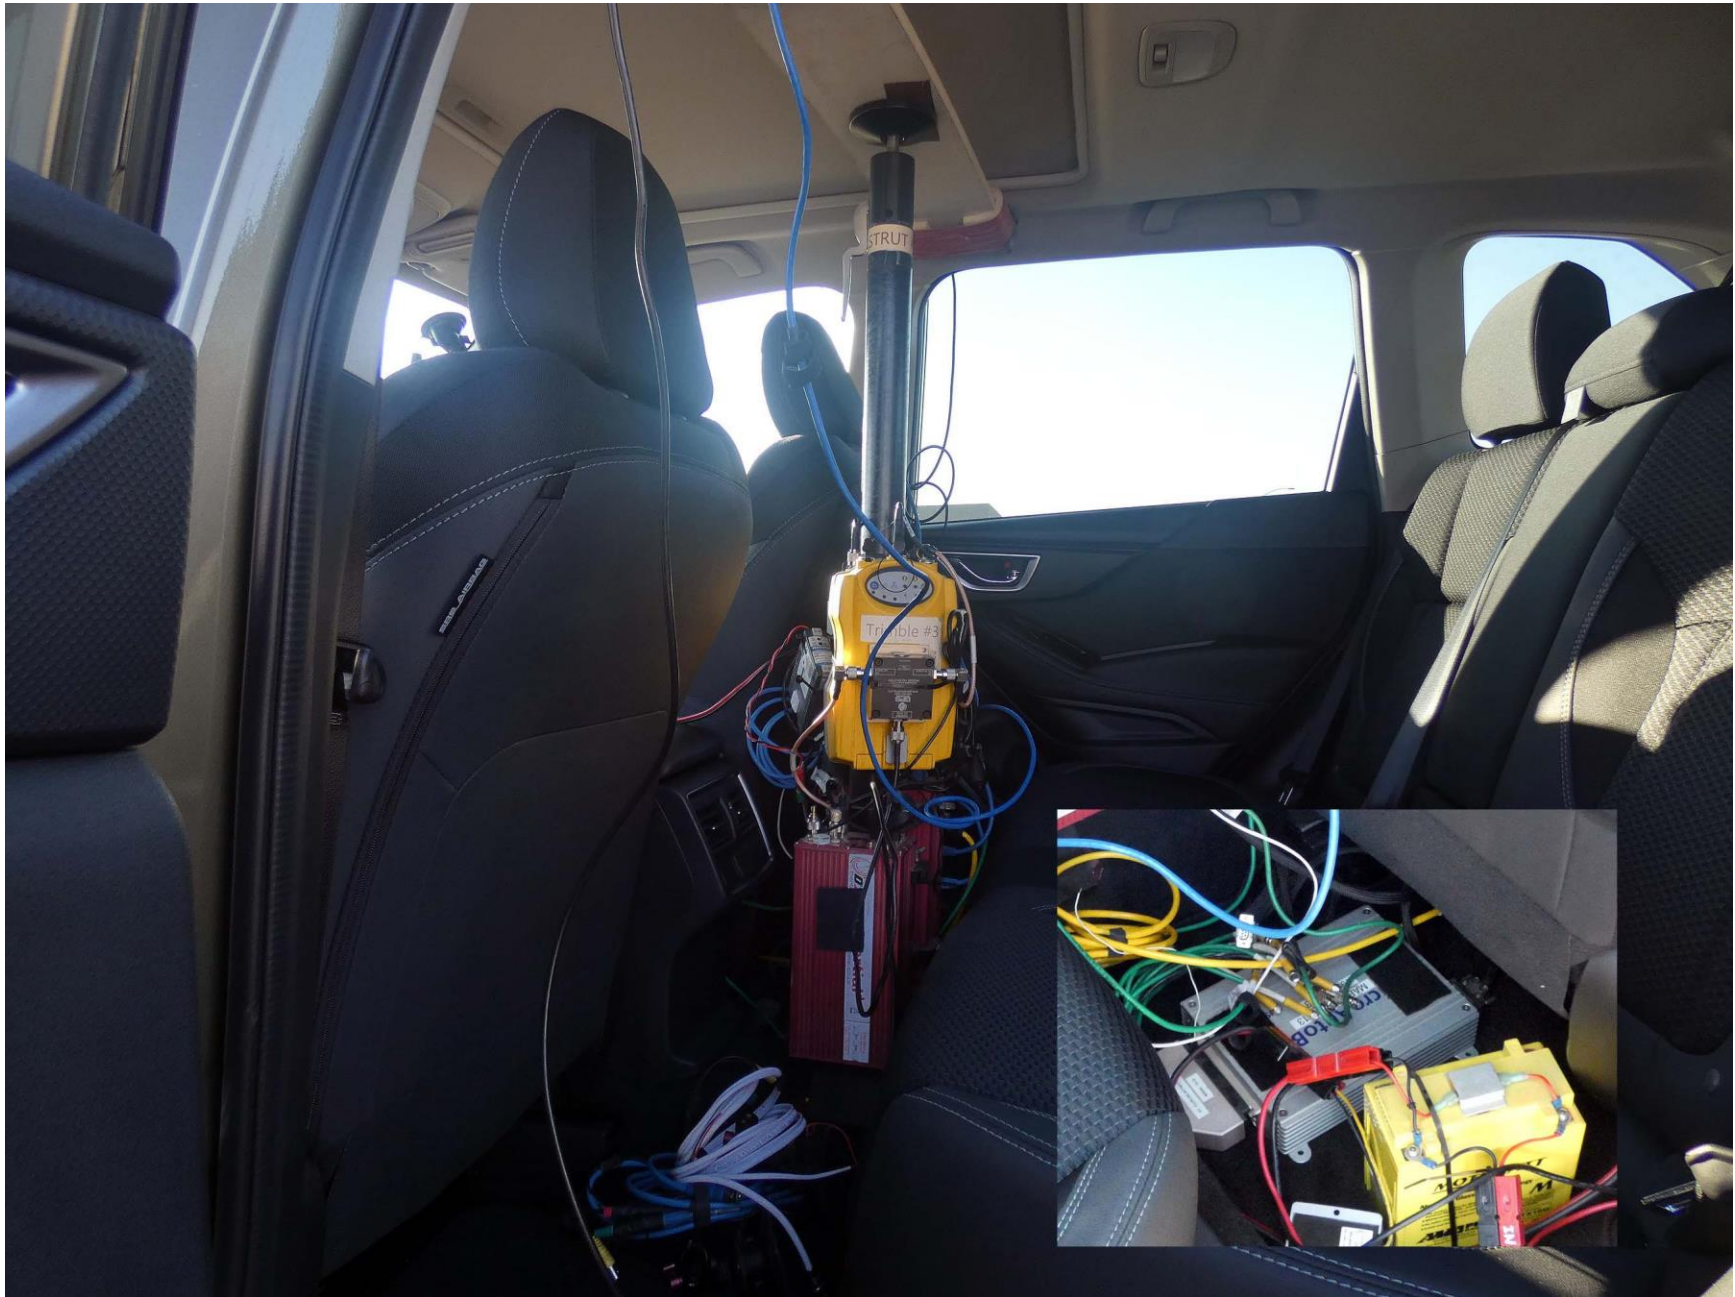
Figure A10. DGPS, Inertial Measurement Unit, and MicroAutoBox Installed in Subject Vehicle

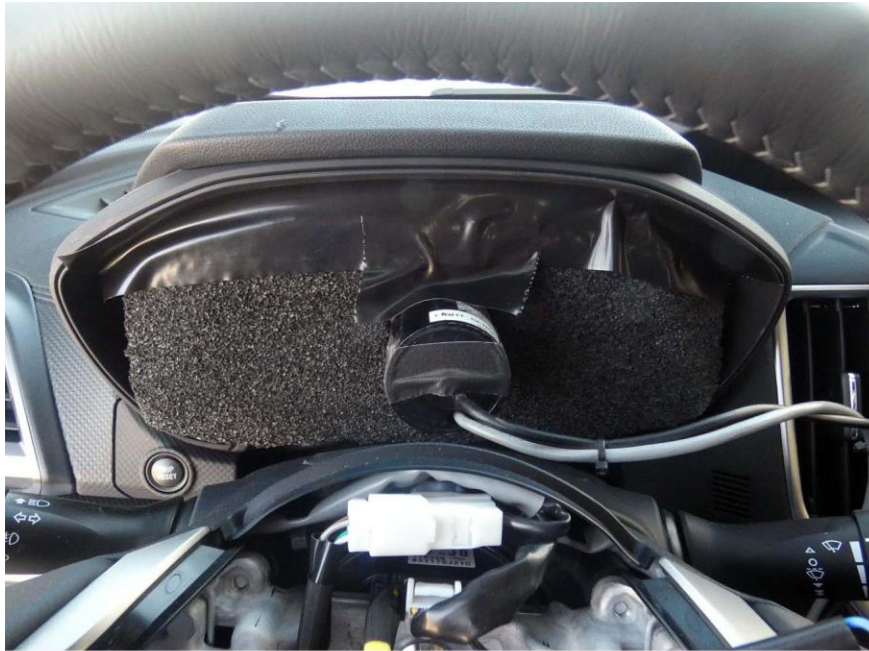
Figure A11. Sensor for Detecting Auditory and Visual Alerts

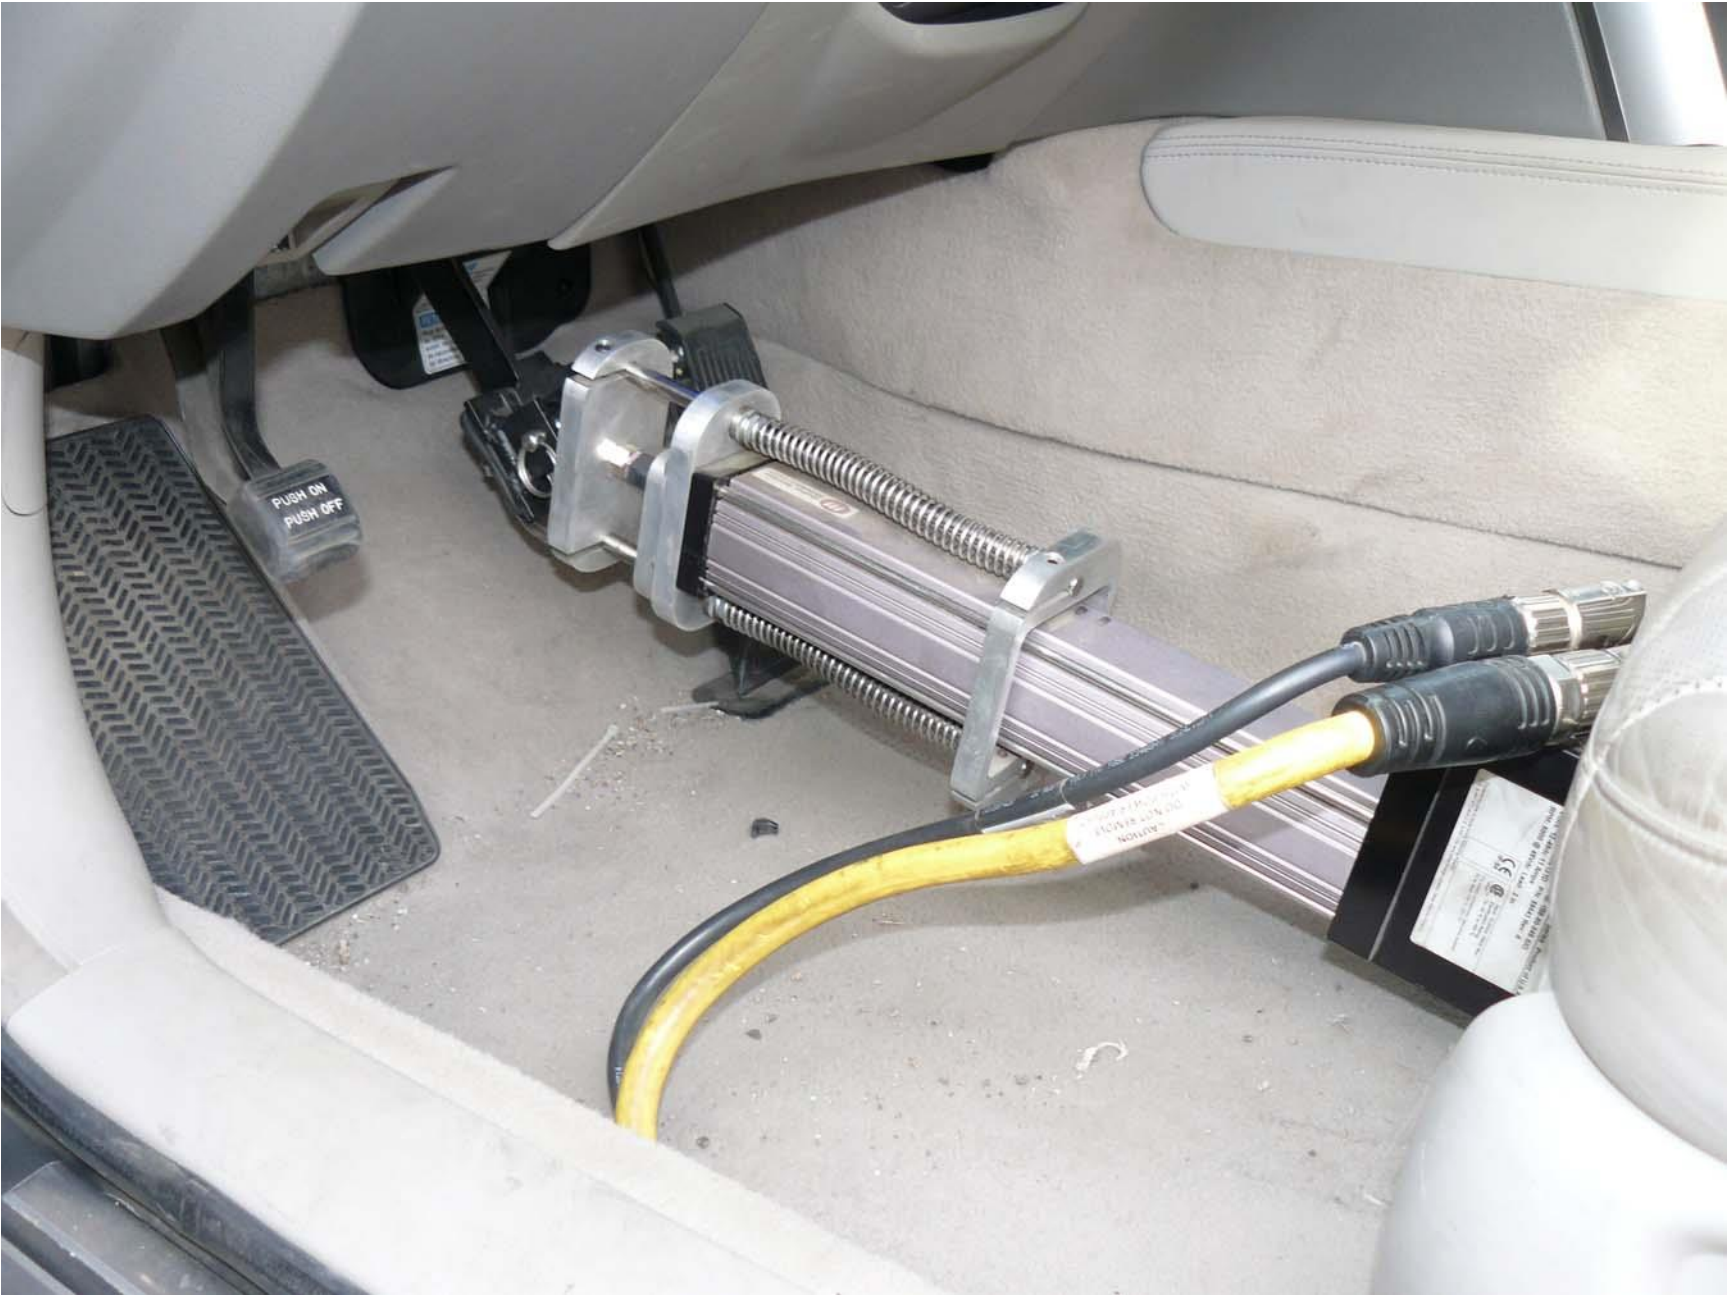
Figure A13. Brake Actuator Installed in POV System

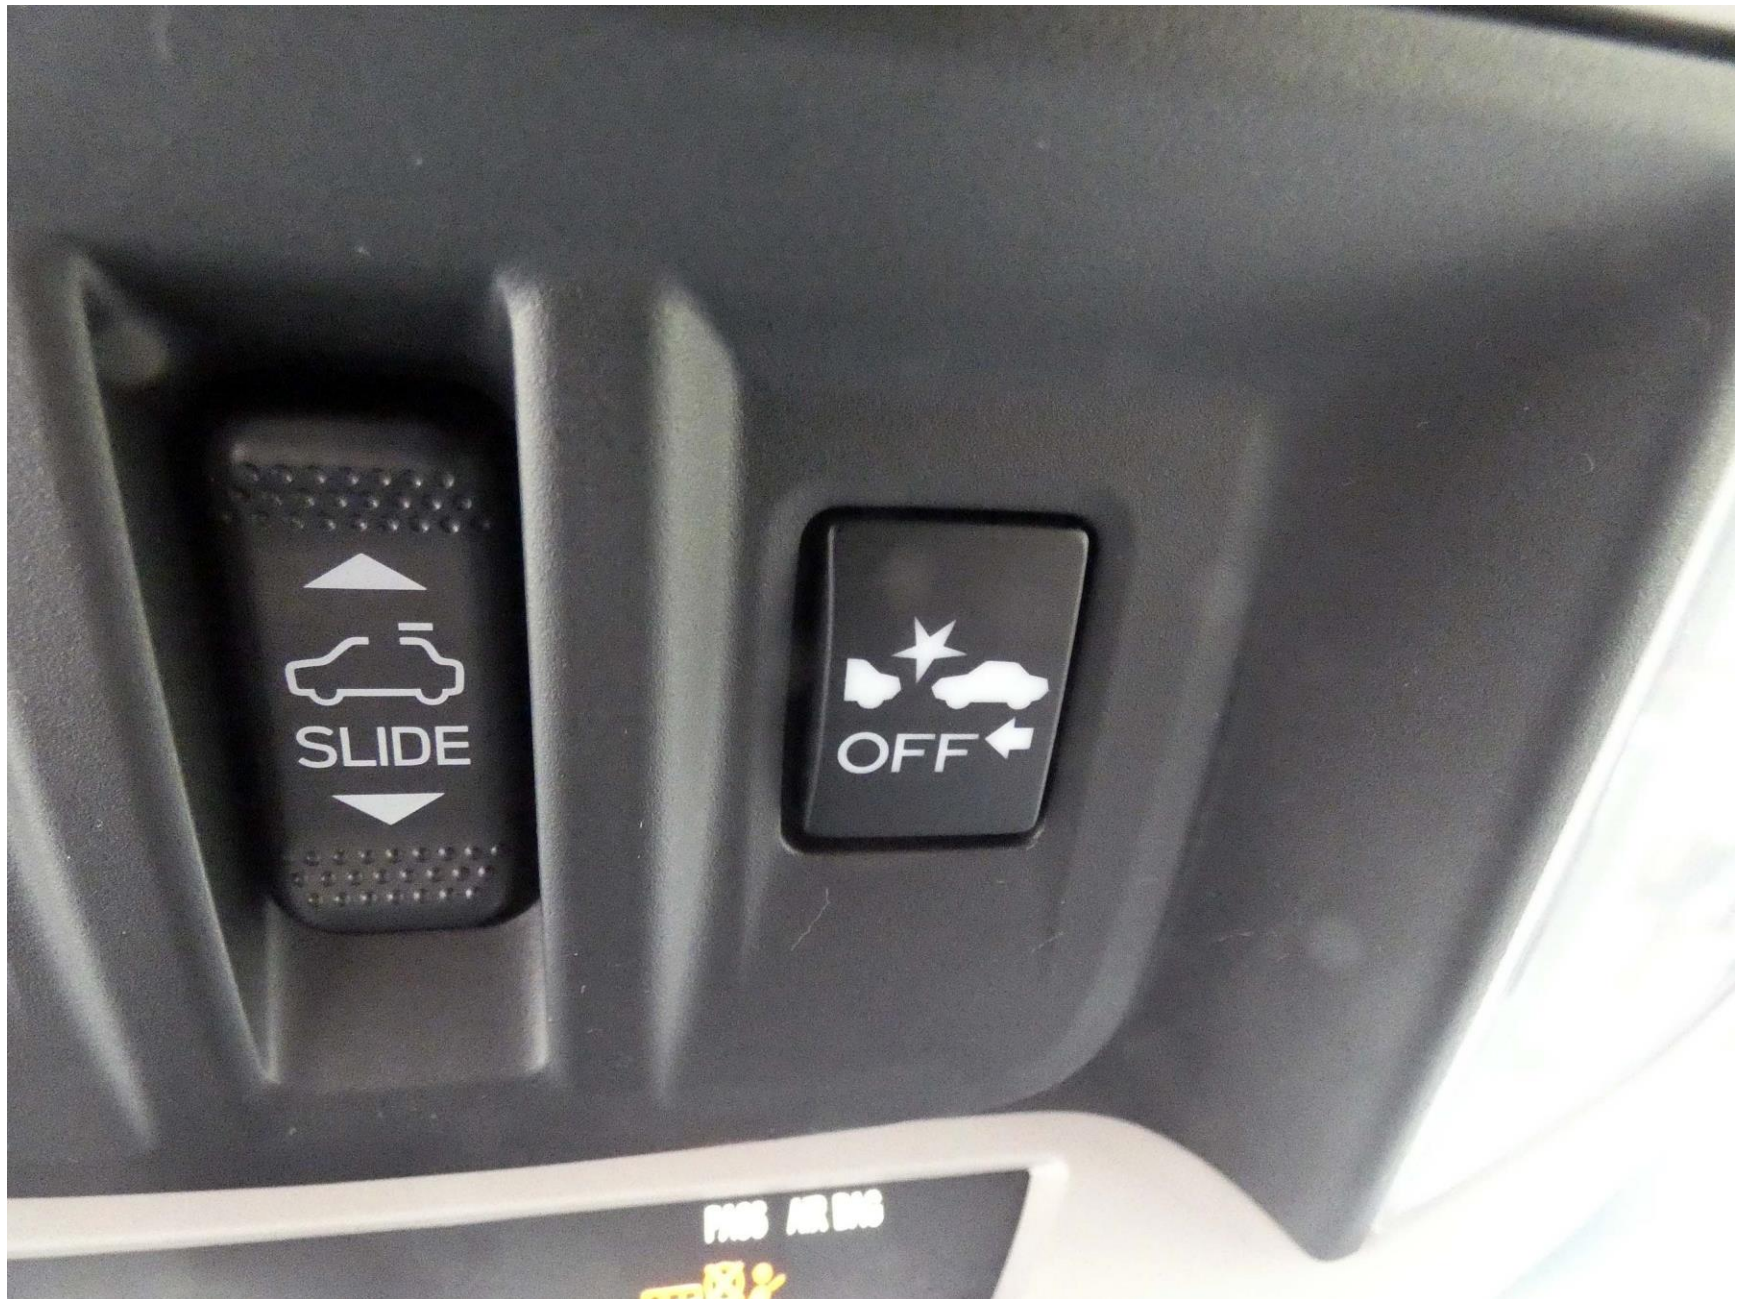
Figure A14. AEB On/Off Switch Control

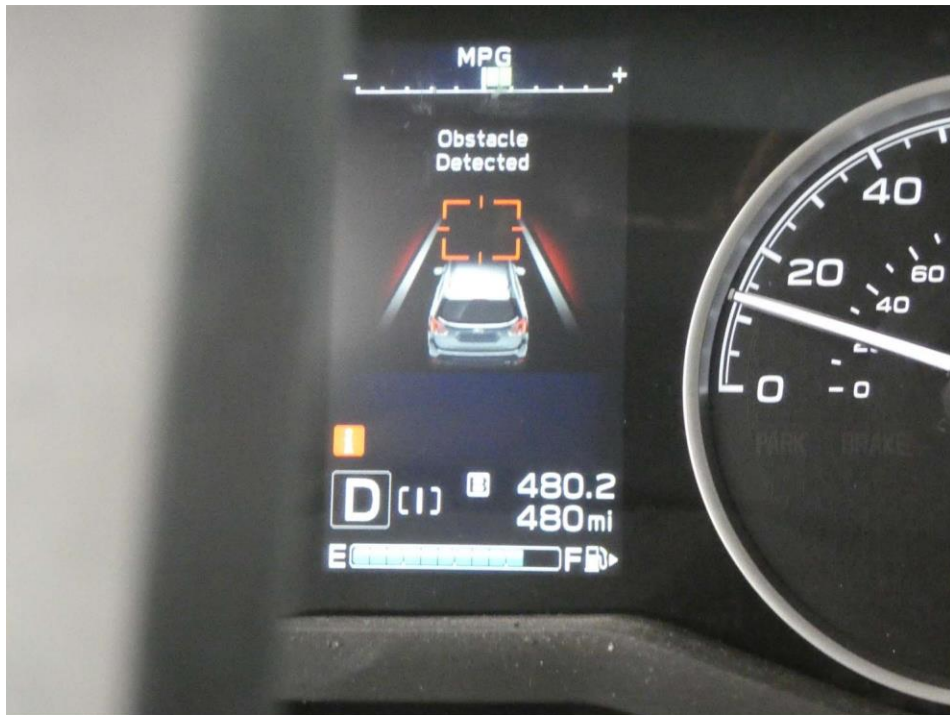
Figure A15. Visual Alert
