**BLIND SPOT INTERVENTION SYSTEM CONFIRMATION TEST  
NCAP-DRI-BSI-20-01**

**2019 Audi A6 55 TFSI (3.0T) quattro**

**DYNAMIC RESEARCH, INC.**

**Final Report**

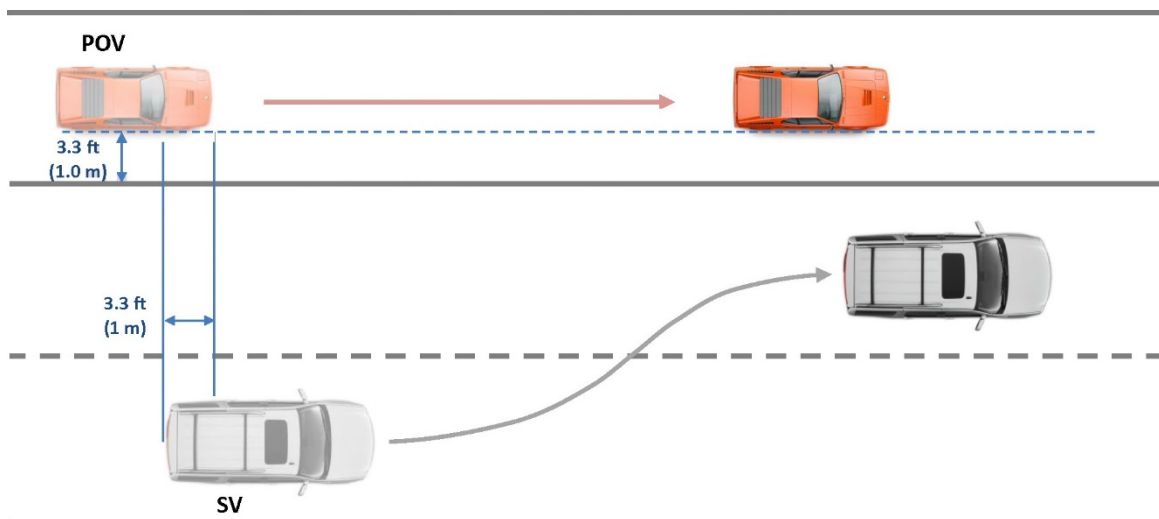
The SV Lane Change with Constant Headway, False Positive (SVLC\_Constant\_HW\_FP) test assesses whether or not a BSI system detects and responds to a non-threatening POV during a single lane change. In this scenario, the POV is two lanes away from the SV, adjacent to the SV blind spot, and traveling with constant headway. This test scenario is depicted in Figure 5. In this scenario the test begins with the POV in the second lane to the left of the SV. After both vehicles have reached their designated speeds and headway overlap, the SV driver engages the left turn signal indicator and initiates a single lane change maneuver into the lane between the initial SV and POV travel lanes. Specific details of the lane change method depended on the automation level as summarized in Table 3a and 3b.

This test scenario was performed in two parts comprised of “baseline” and “evaluation” trials, with SV automation level 0, 1, 2, or 3 depending on the highest SAE automation level available on the SV. The main difference between the baseline and evaluation trials is that evaluation trials were performed with the POV present and the baseline trials were performed without the POV. The BSI system was expected to not respond any differently to the presence of the POV compared to a similar baseline test trial without the POV.

Figure 5. Lane Change with Constant Headway, False Positive Test Scenario

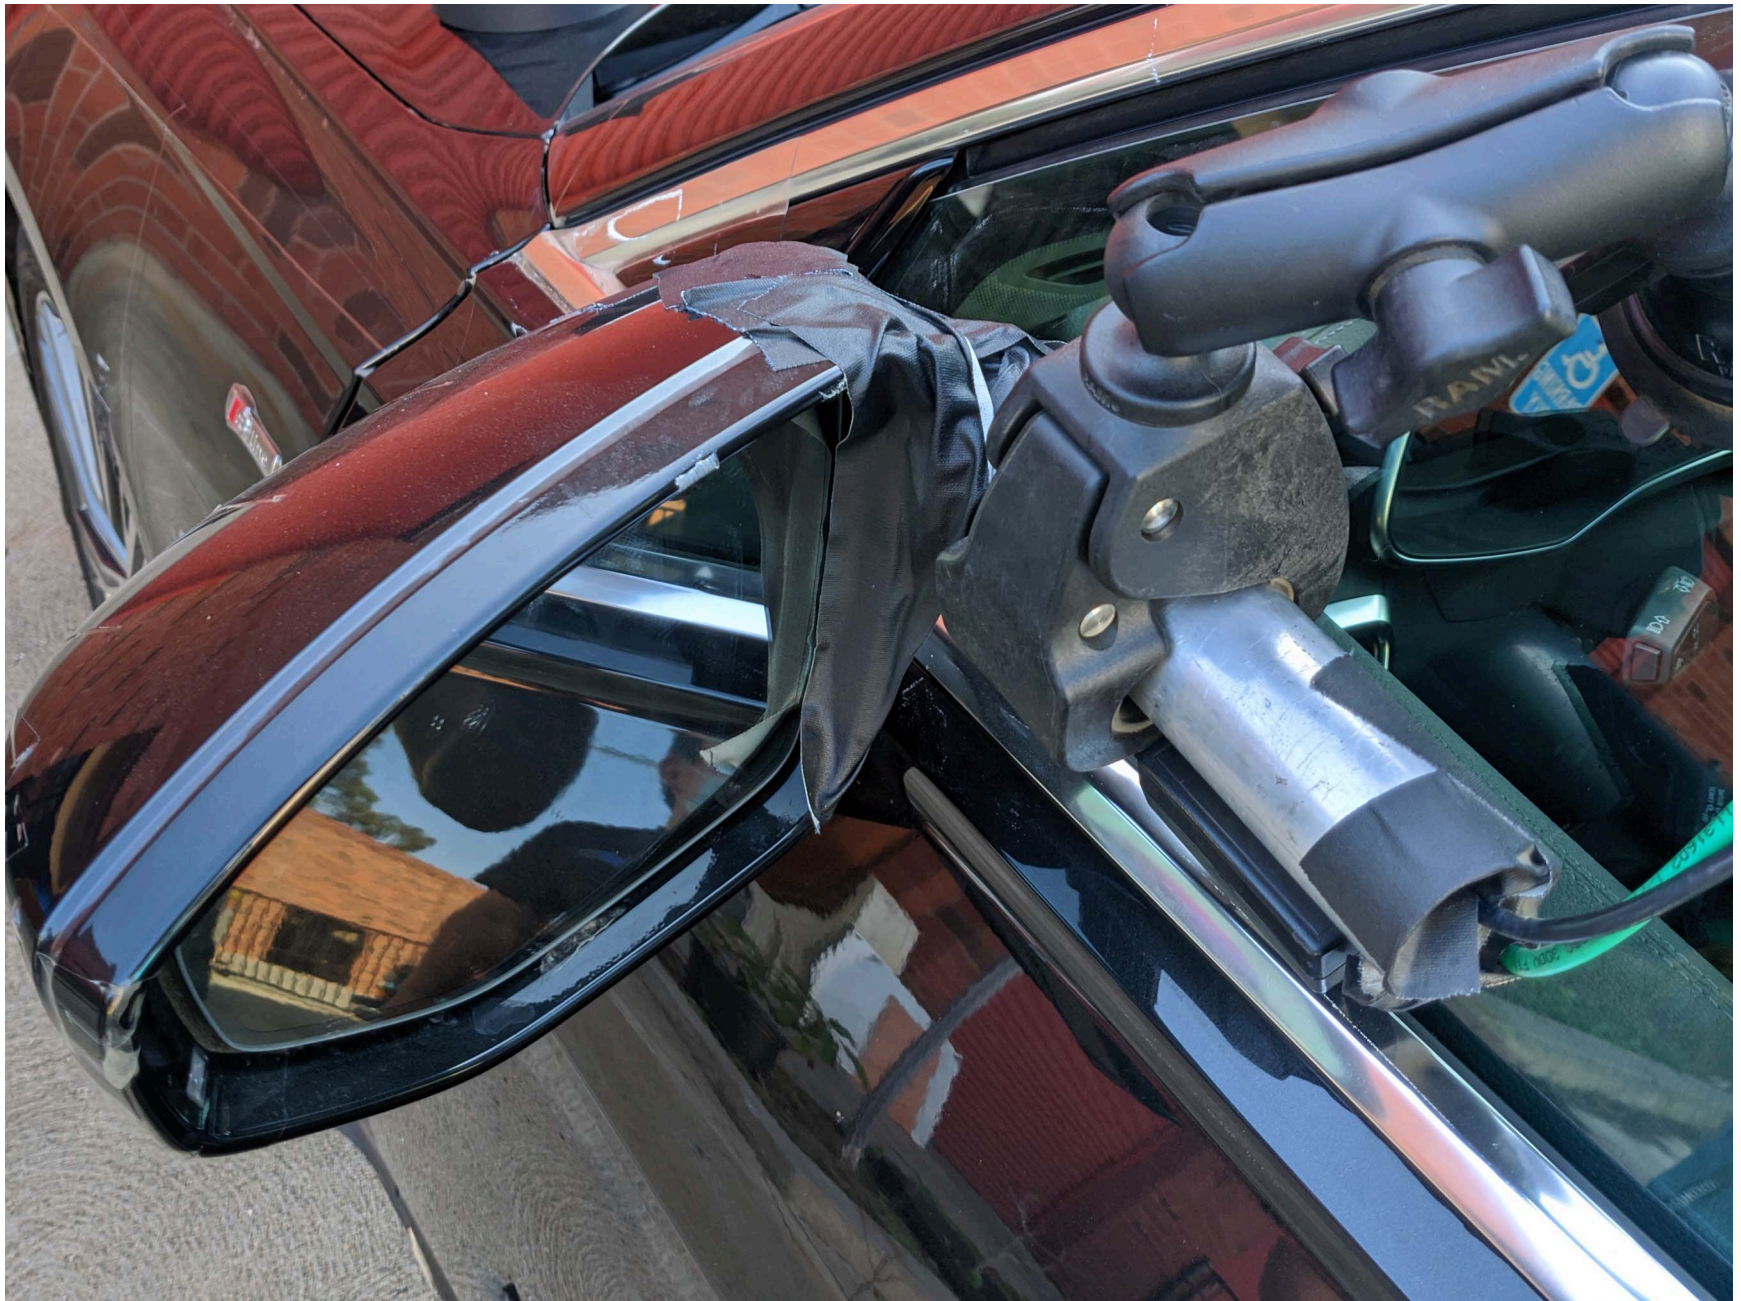
Figure A10. Sensor for Detecting Visual Alerts

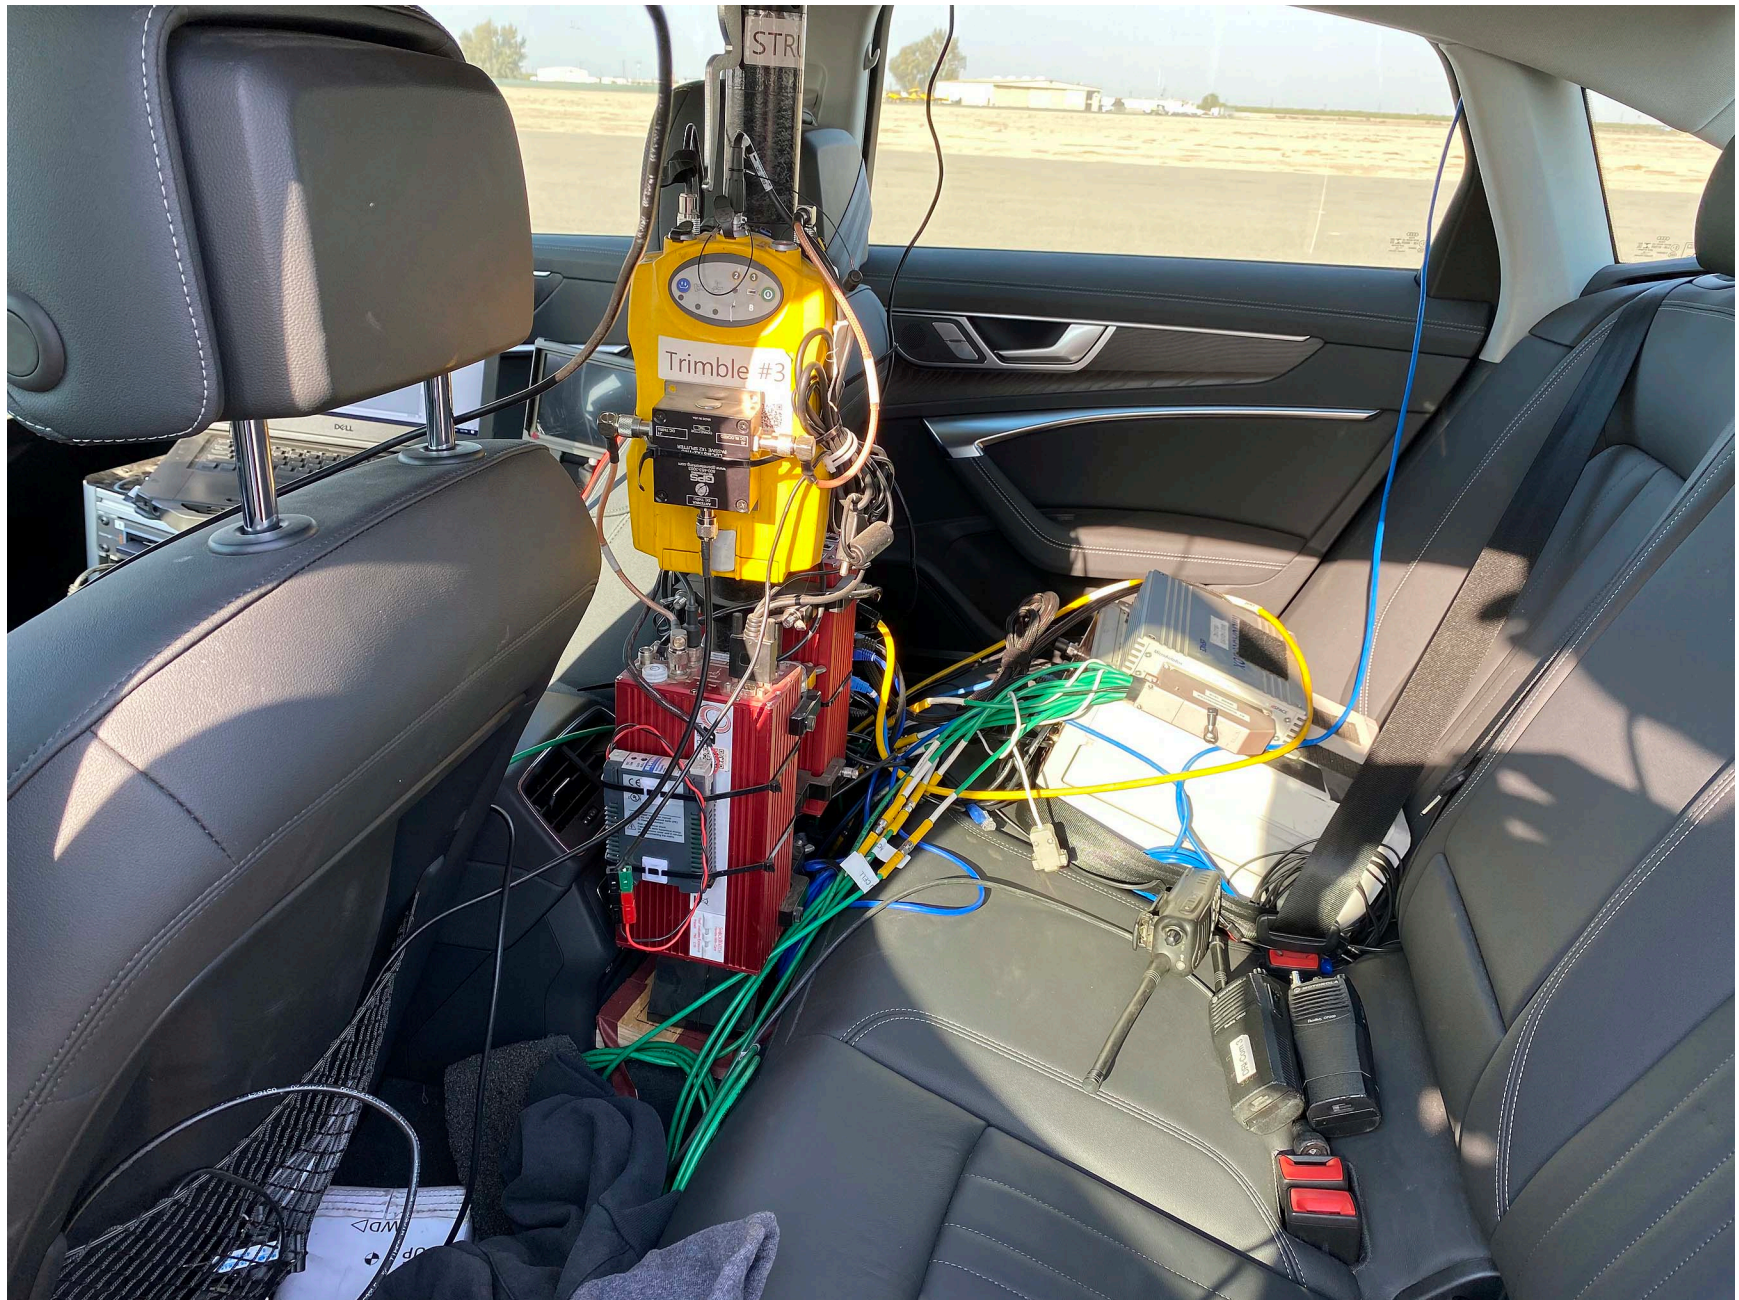
Figure A11. DGPS, Inertial Measurement Unit, and MicroAutoBox Installed in Subject Vehicle

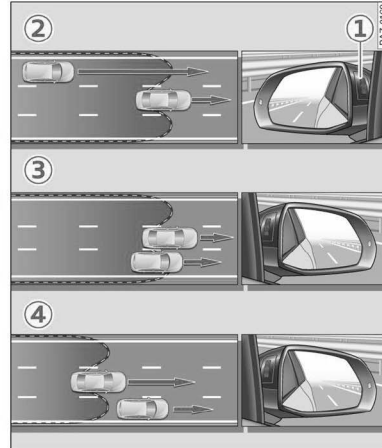
Fig. 116 Diagram: driving situations and displays in the exterior mirror (example)
