**BLIND SPOT INTERVENTION SYSTEM CONFIRMATION TEST  
NCAP-DRI-BSI-20-02**

**2020 Audi Q5 45 TFSI quattro**

**DYNAMIC RESEARCH, INC.**

**Final Report**

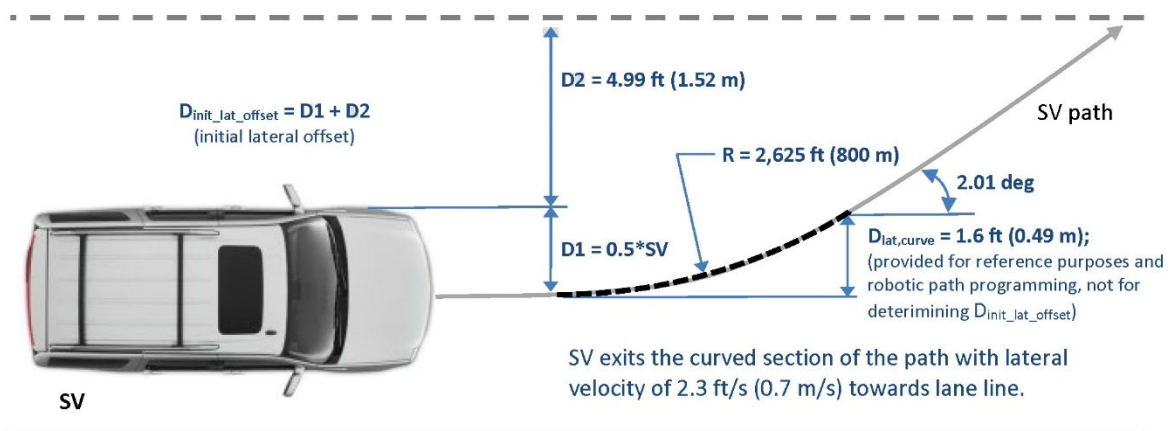
Figure 2. Input Parameters Used to Define the SV Path During the SV Level 0 and 1 Lane Change with Constant Headway Scenario

The tests with SV automated vehicle level 0 or 1 were performed with manual steering input from a robotic steering controller. The SV and POV began in their respective travel lanes with their longitudinal axes oriented parallel to the roadway edge. The initial SV path was offset in the lane as shown in Figure 2 . Both vehicles then accelerated to an initial speed of 45 mph (72.4 km/h). This speed and specified headway overlap between the front-most point of the POV and the rear-most point of the SV were maintained throughout the test. The headway overlap is specified with the front bumper of the POV located  $1.0 \pm 0.5$  m ( $3.3 \pm 1.6$  ft) ahead of the rear of the SV (therefore the specified headway distance is a negative value indicating longitudinal overlap).

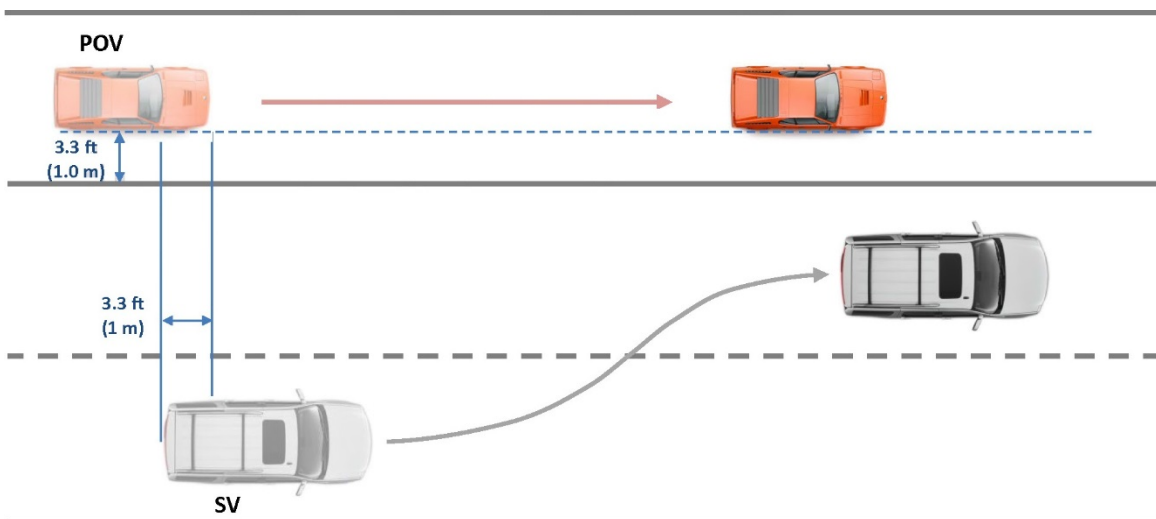
Figure 5. Lane Change with Constant Headway, False Positive Test Scenario

The SV Lane Change with Constant Headway, False Positive (SVLC\_Constant\_HW\_FP) test assesses whether or not a BSI system detects and responds to a non-threatening POV during a single lane change. In this scenario, the POV is two lanes away from the SV, adjacent to the SV blind spot, and traveling with constant headway. This test scenario is depicted in Figure 5. In this scenario the test begins with the POV in the second lane to the left of the SV. After both vehicles have reached their designated speeds and headway overlap, the SV driver engages the left turn signal indicator and initiates a single lane change maneuver into the lane between the initial SV and POV travel lanes. Specific details of the lane change method depended on the automation level as summarized in Table 3a and 3b.

This test scenario was performed in two parts comprised of “baseline” and “evaluation” trials, with SV automation level 0, 1, 2, or 3 depending on the highest SAE automation level available on the SV. The main difference between the baseline and evaluation trials is that evaluation trials were performed with the POV present and the baseline trials were performed without the POV. The BSI system was expected to not respond any differently to the presence of the POV compared to a similar baseline test trial without the POV.

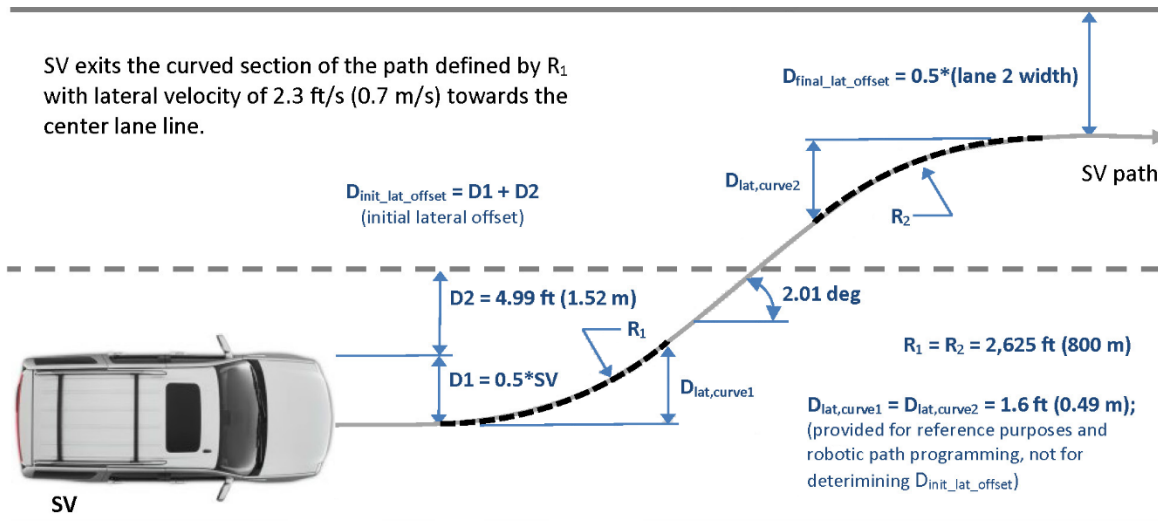
Figure 6. Input Parameters used to define the SV path during the SV Lane Change with Constant Headway, False Positive Scenario

- There were 7 evaluation trials with the POV, as specified in Table 3b. The SV and POV were both driven at the initial speed of 45 mph (72.4 km/h) and established the initial longitudinal and lateral formation shown in Figure 5. The SV speed was achieved either manually or with the cruise control enabled and initialized. After maintaining the initial formation shown in Figure 5 for 3 seconds, the SV driver engaged the left turn signal indicator and initiated the single lane change into the left adjacent lane. No BSI system interventions were expected in the evaluation trial because a single lane change should not result in a collision with the POV.

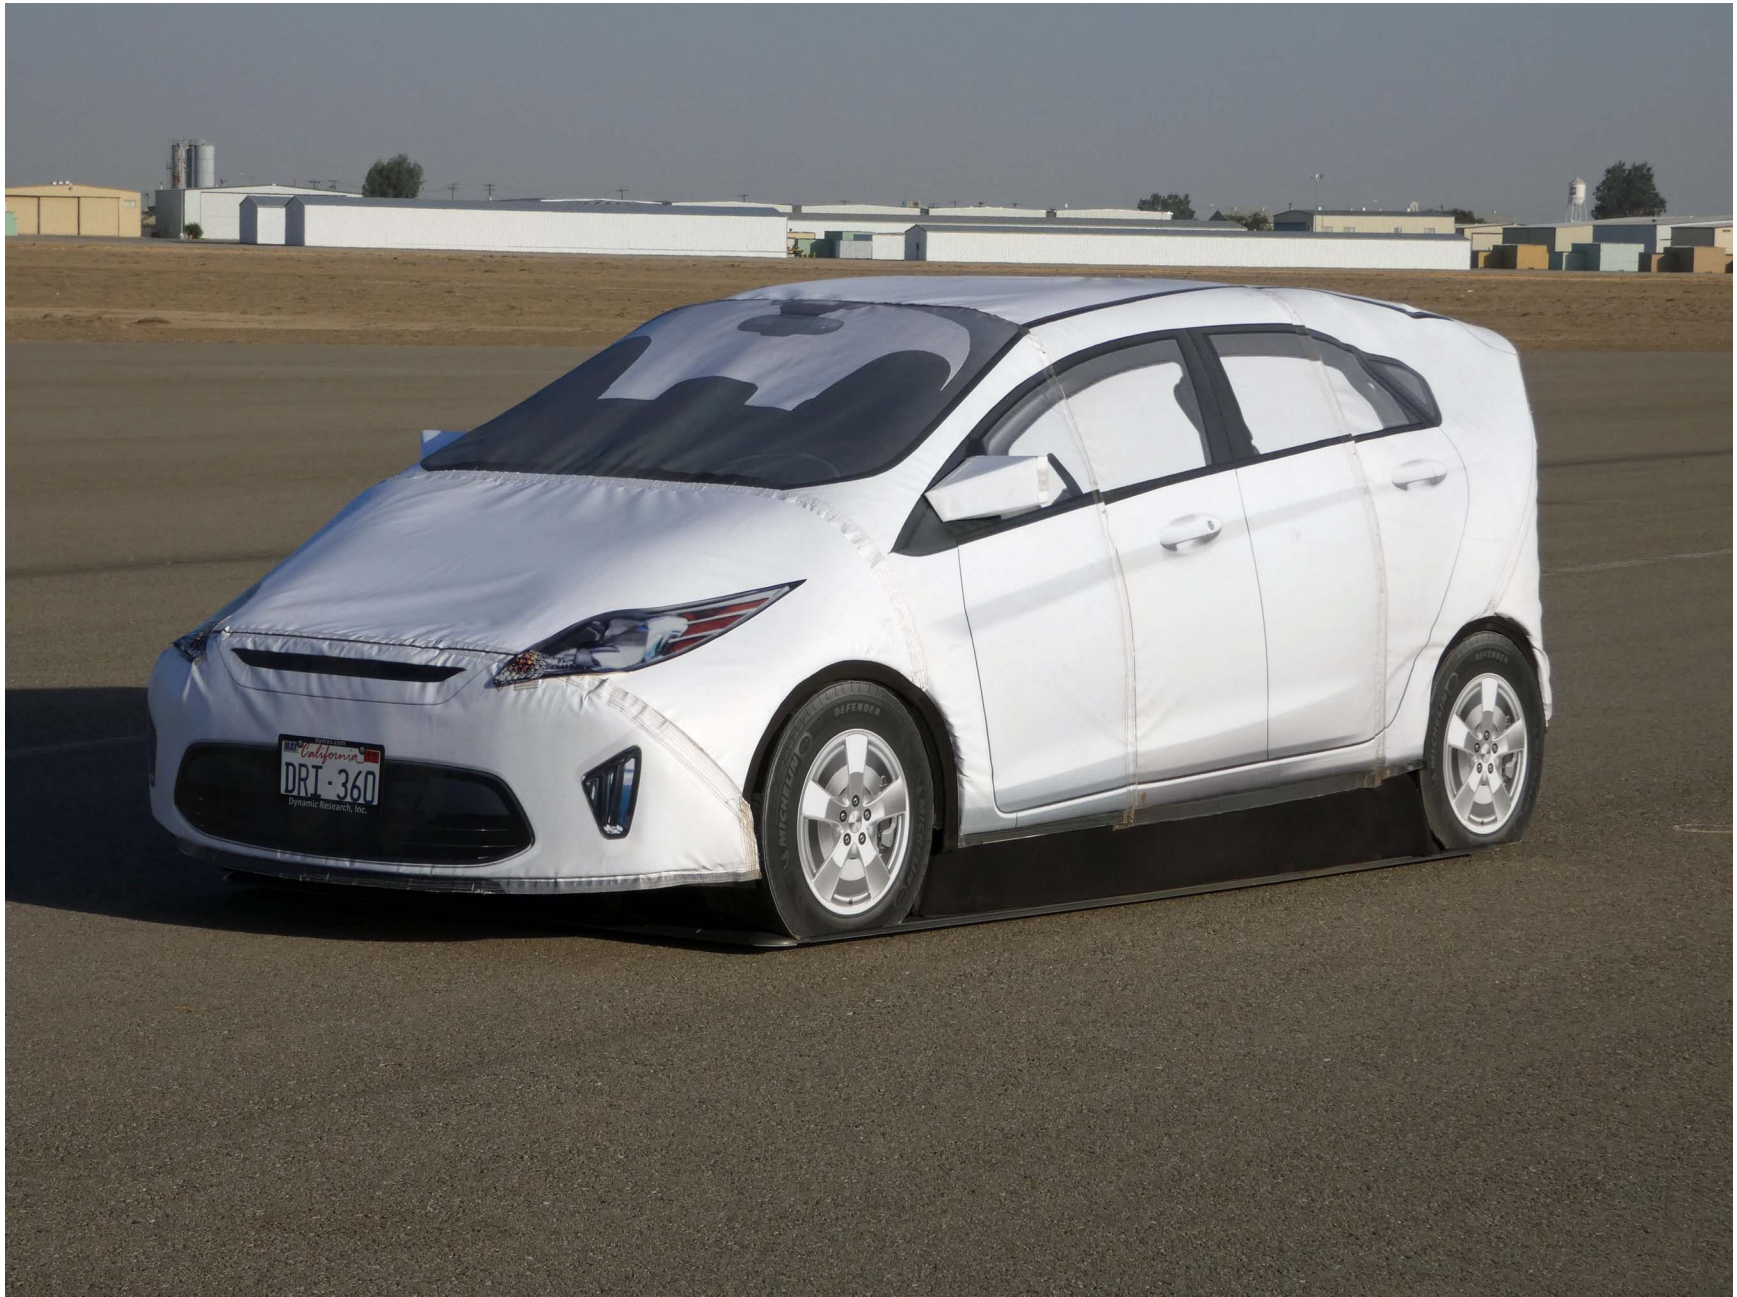
Figure A6. Front View of Principal Other Vehicle - GVT (Tests 1 and 2)

Operationally, the GVT body is attached to LPRV using Velcro hook and loop fasteners. The GVT and LPRV are designed to separate if the GVT is struck by the SV. The GVT/LPRV system is shown in Figures A6 and A7 in Appendix A and a detailed description can be found in the NHTSA report: “A Test Track Comparison of the Global Vehicle Target (GVT) and NHTSA’s Strikeable Surrogate Vehicle (SSV)”.<sup>3</sup>

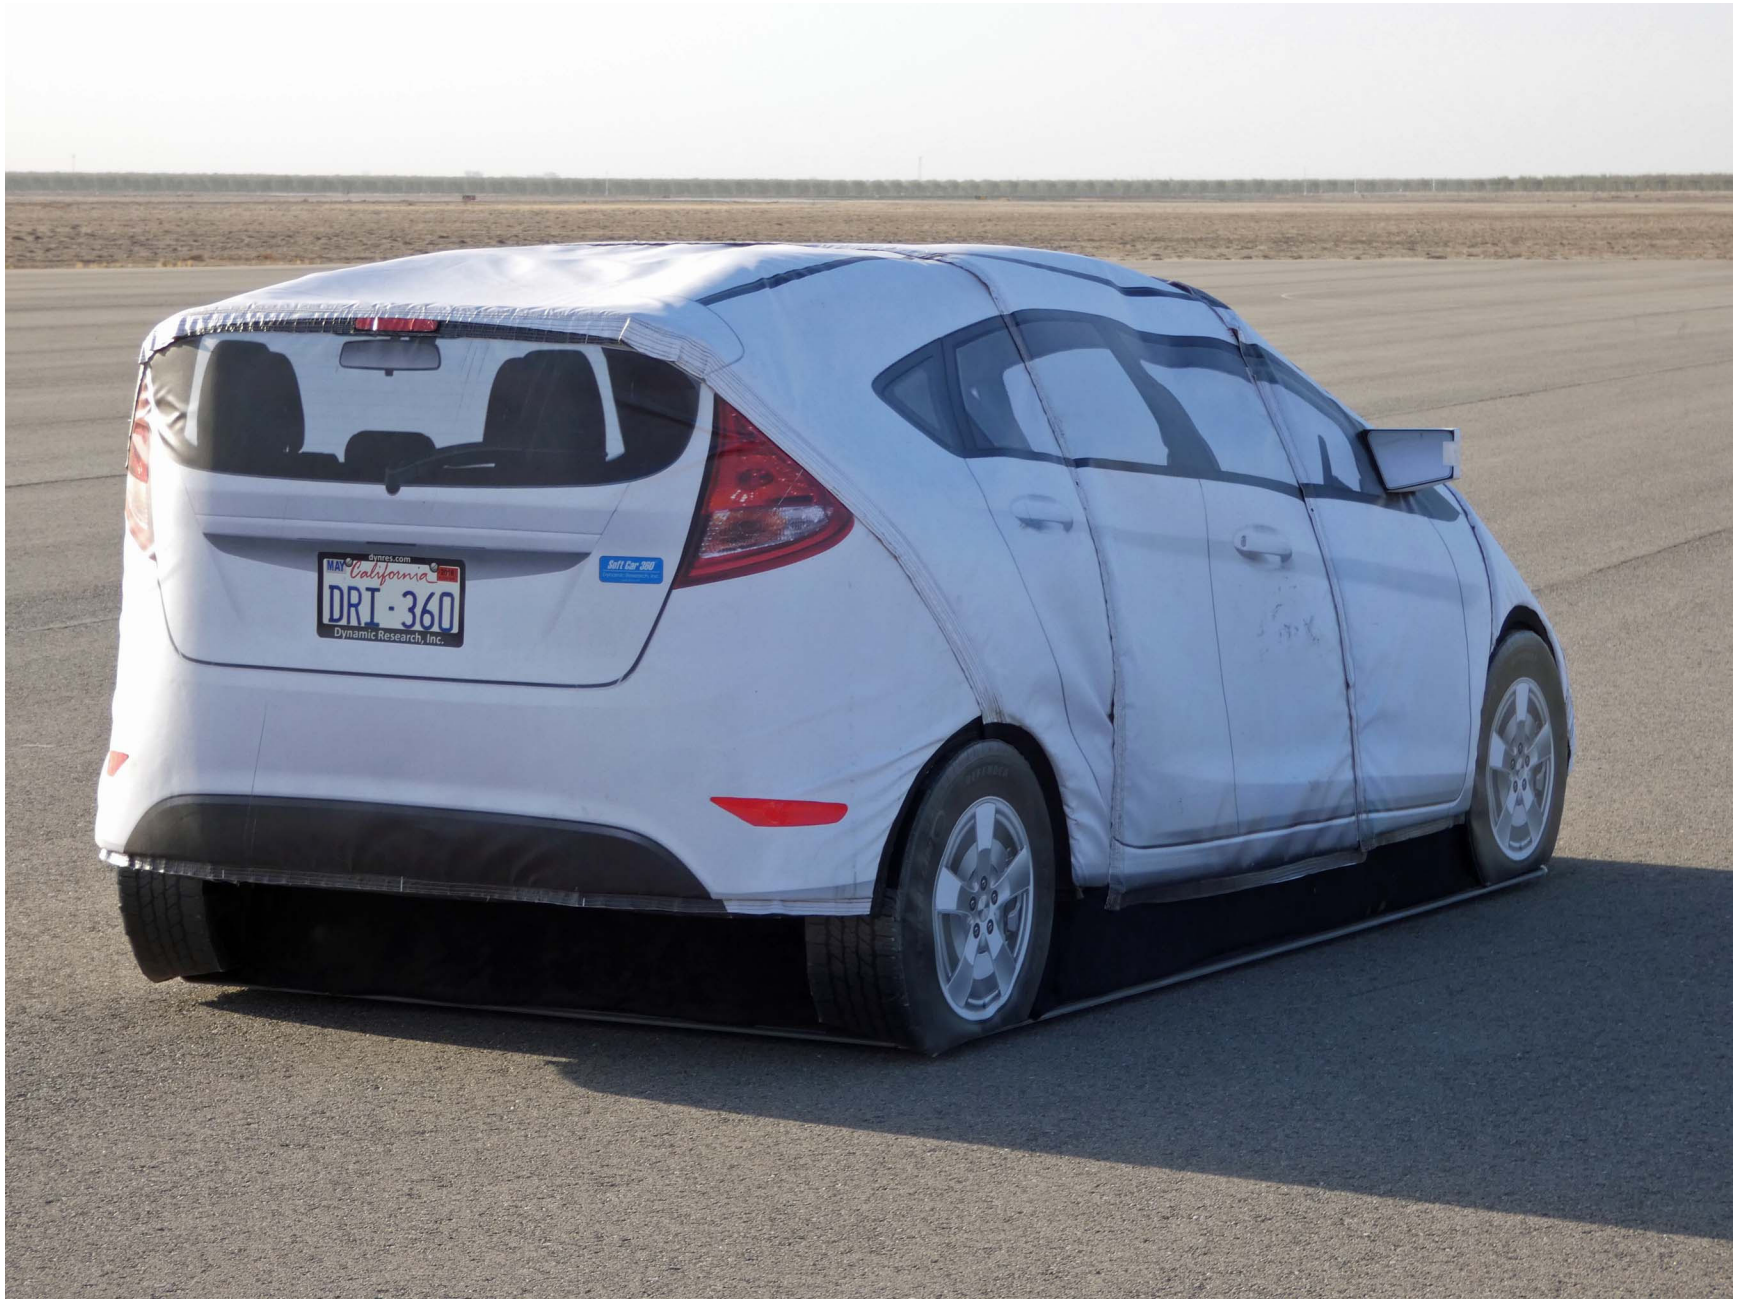
Figure A7. Rear View of Principal Other Vehicle - GVT (Tests 1 and 2)

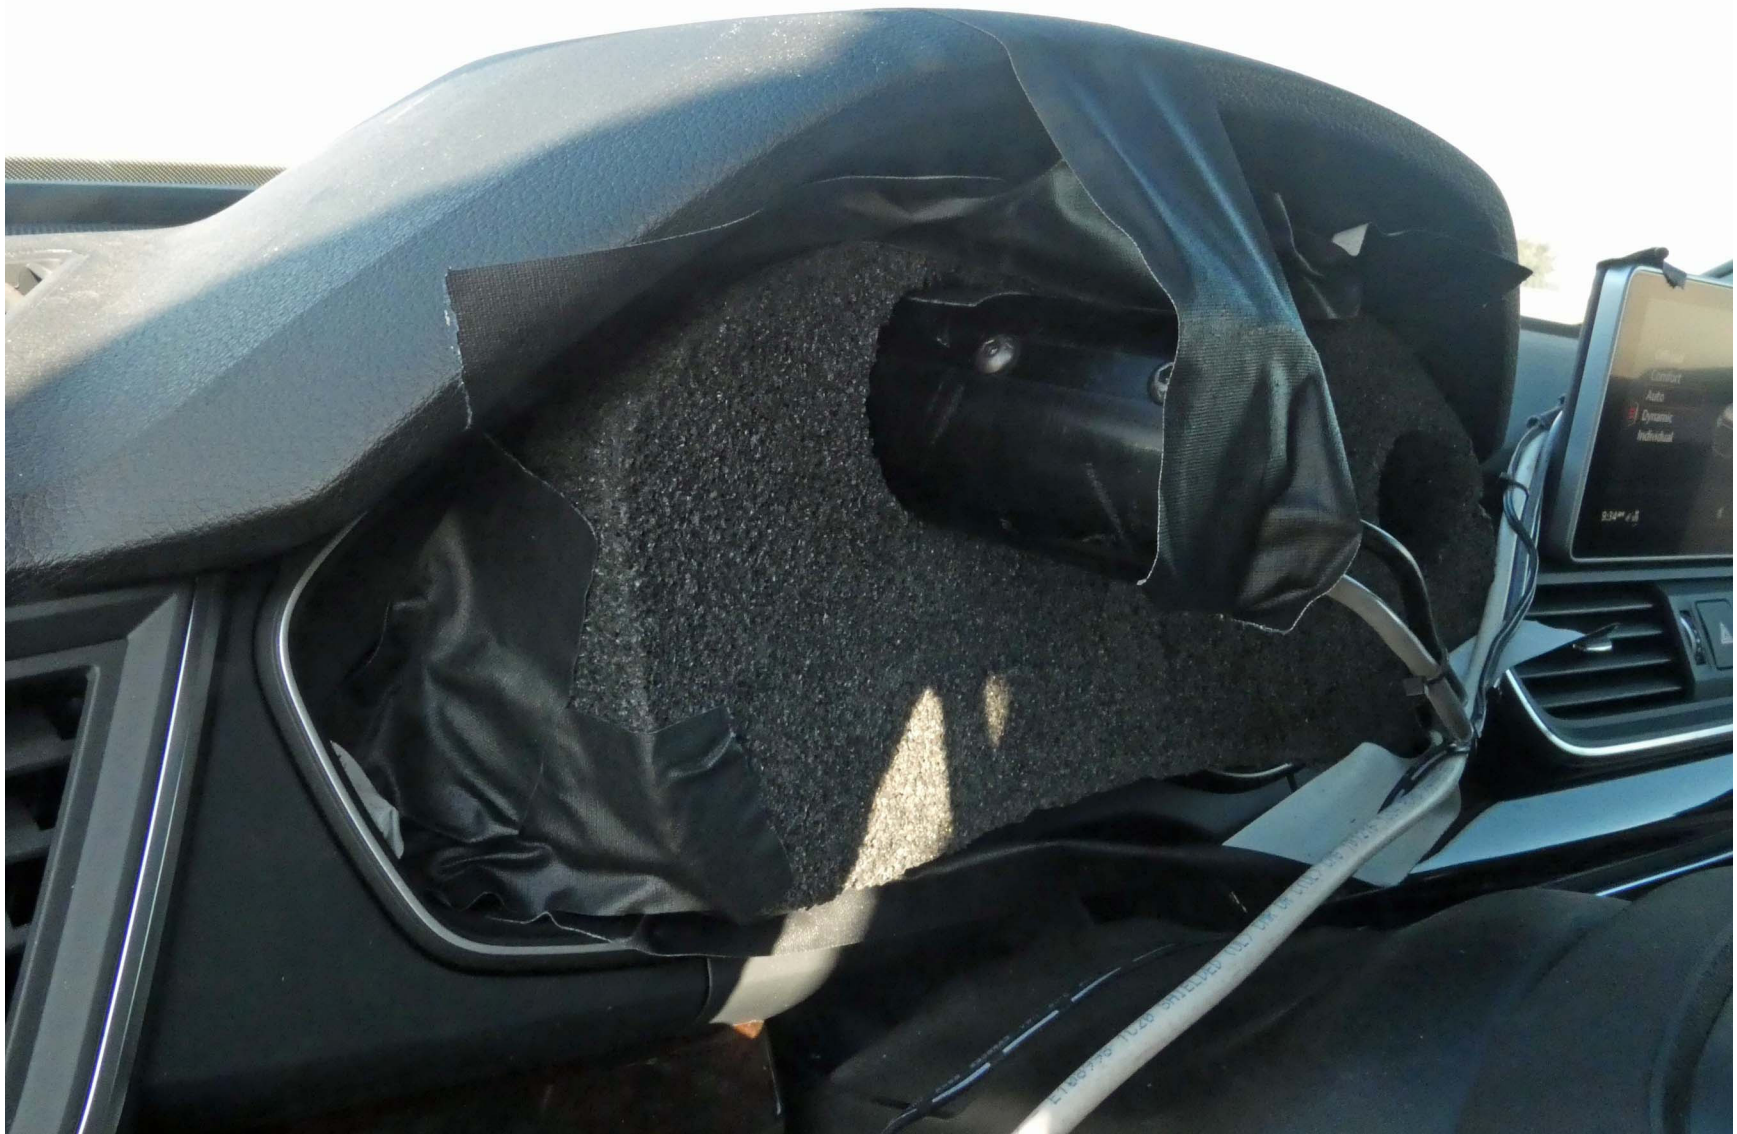
Figure A10. Sensor for Detecting Visual Alerts

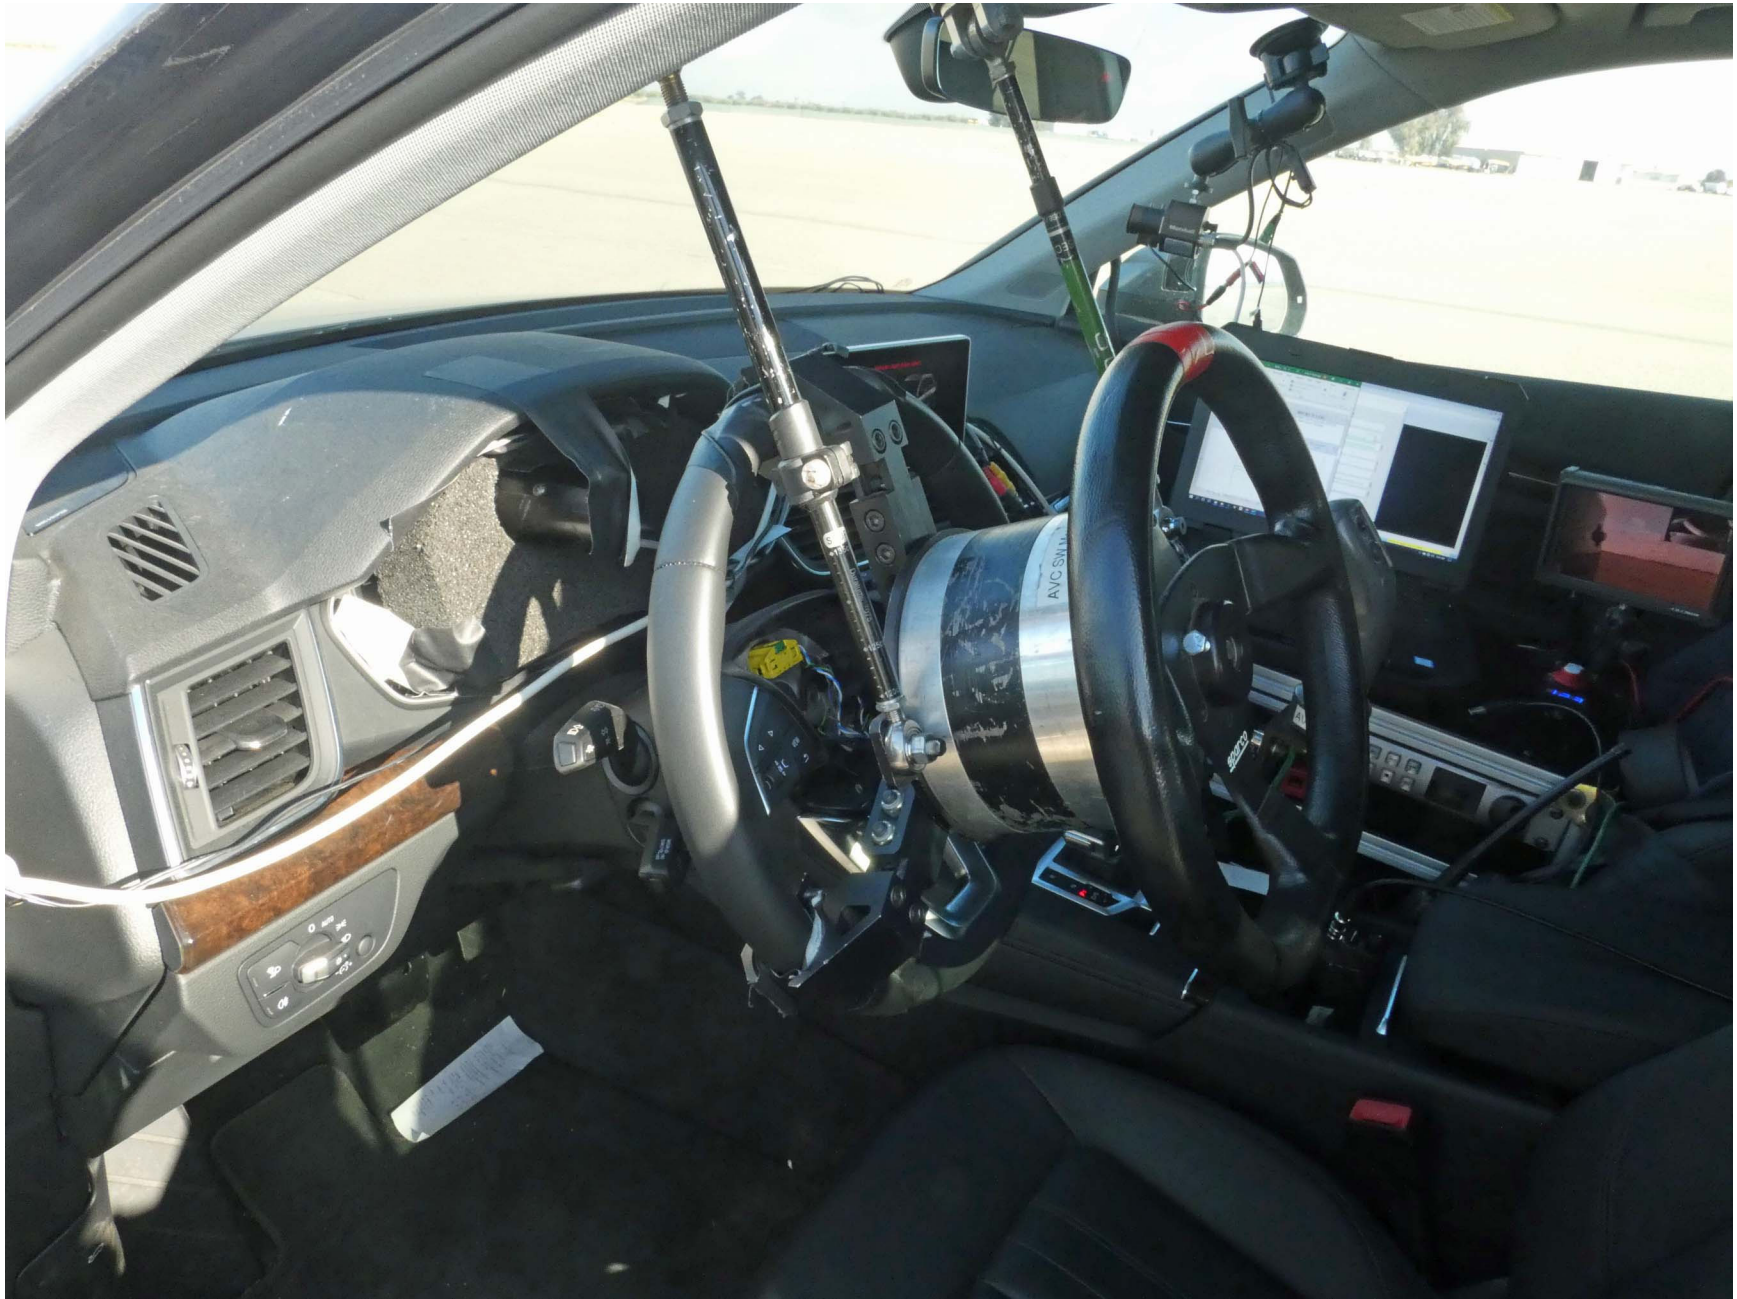
Figure A12. Computer and Steering Controller Installed in Subject Vehicle

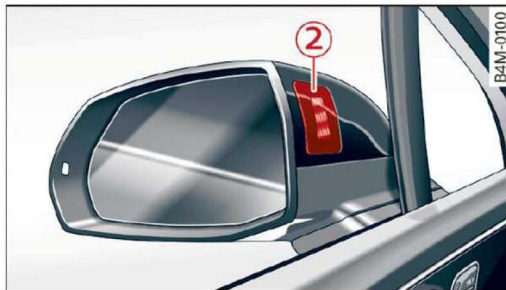
Fig. 129 Indicator on the exterior mirror

Side assist (lane change assist) helps you monitor your blind spot and traffic behind your vehicle. Within the limits of the system, it warns you about vehicles that are approaching or traveling in the same direction as your vehicle within sensor range ① ⇒ *fig. 128*. If a lane change is classified as critical, the display ② in the exterior mirror turns on ⇒ *fig. 129*.

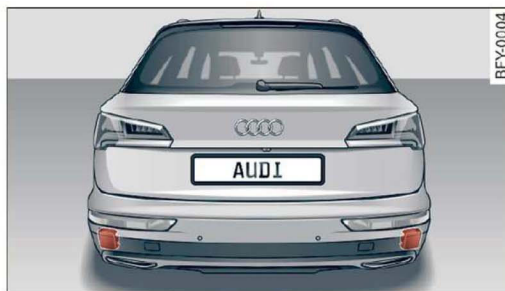
Fig. 131 Rear of the vehicle: sensor locations

The sensors can be displaced by impacts or damage to the bumper, wheel housing and underbody. This can impair the system. Have an authorized Audi dealer or authorized Audi Service Facility check their function.
