**BLIND SPOT INTERVENTION SYSTEM CONFIRMATION TEST  
NCAP-DRI-BSI-20-06**

**2020 Land Rover Range Rover Sport HSE**

**DYNAMIC RESEARCH, INC.**

**Final Report**

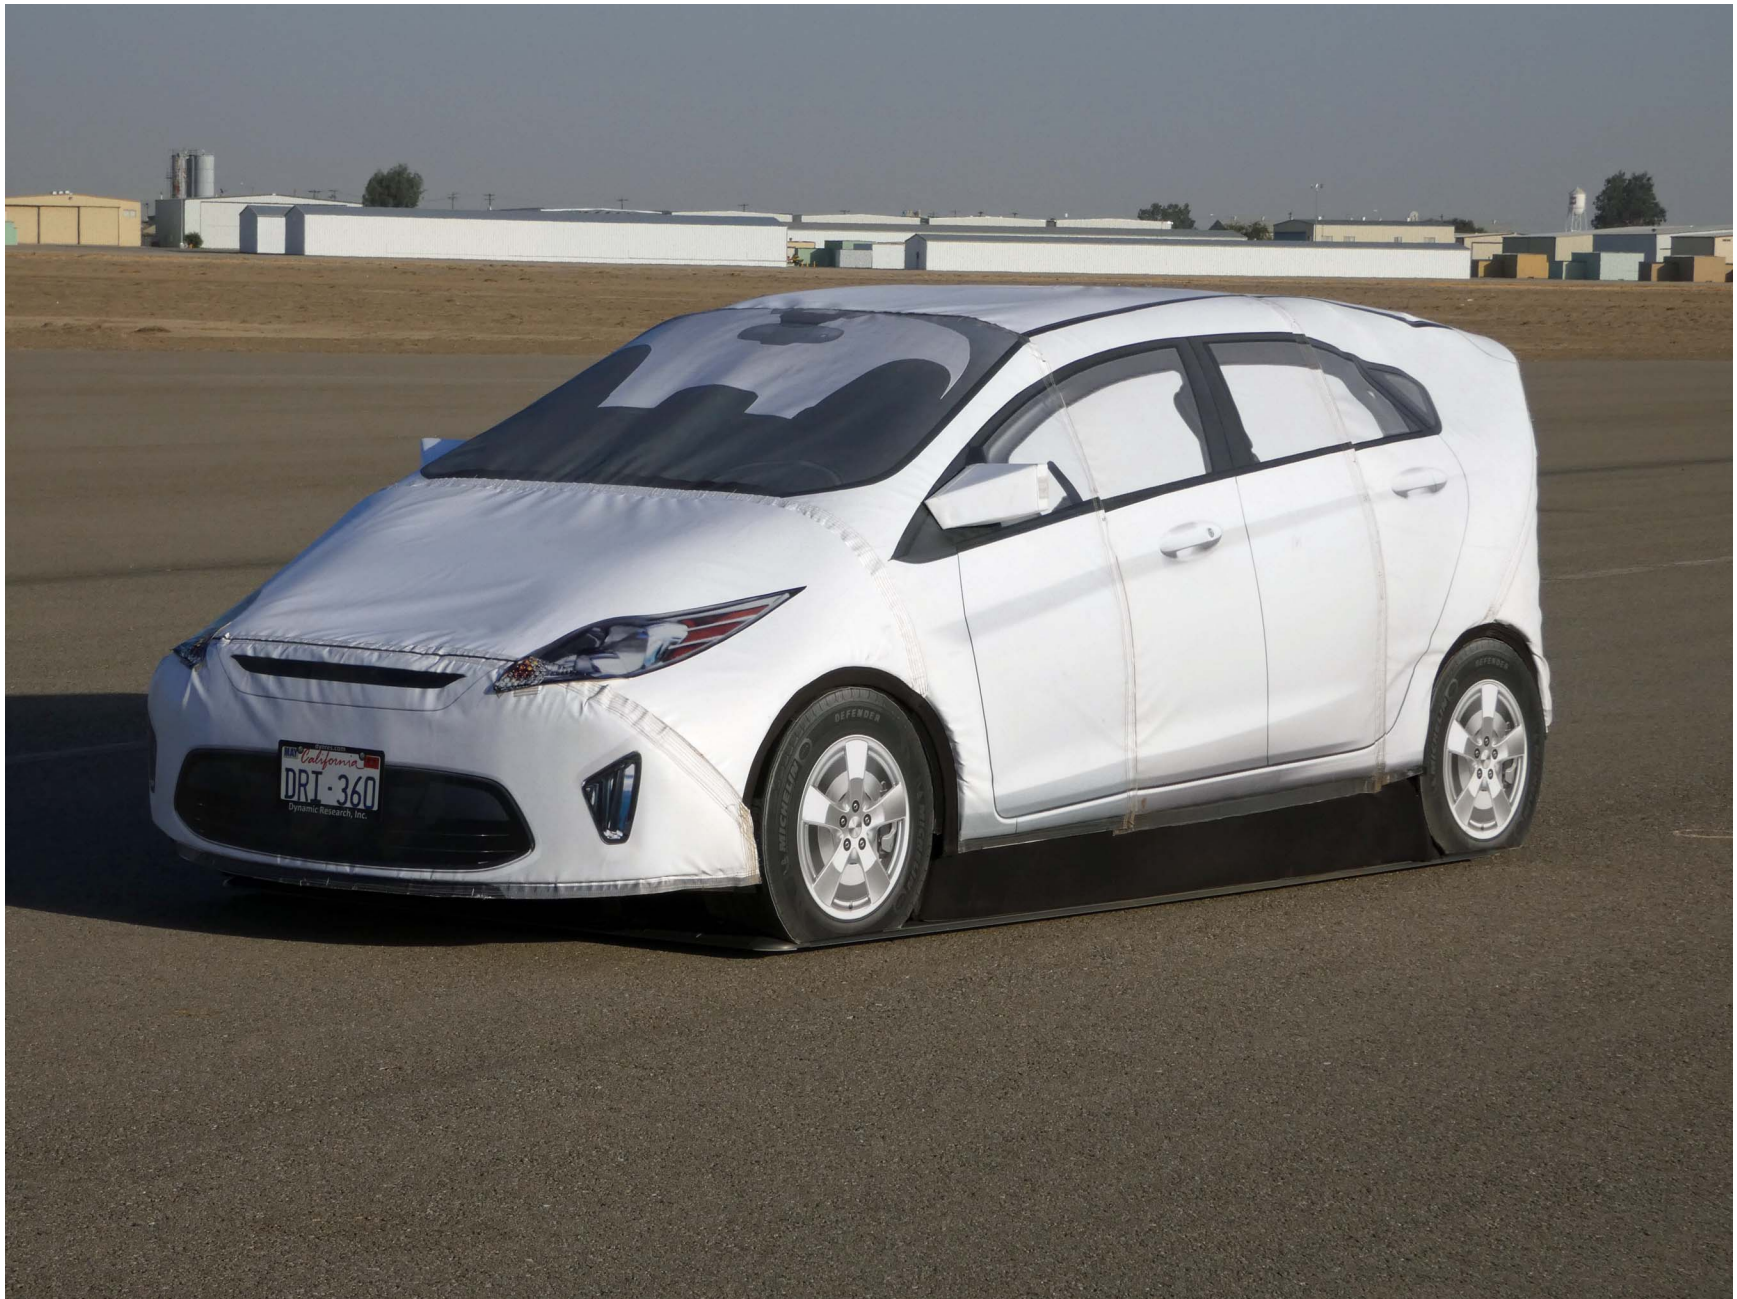
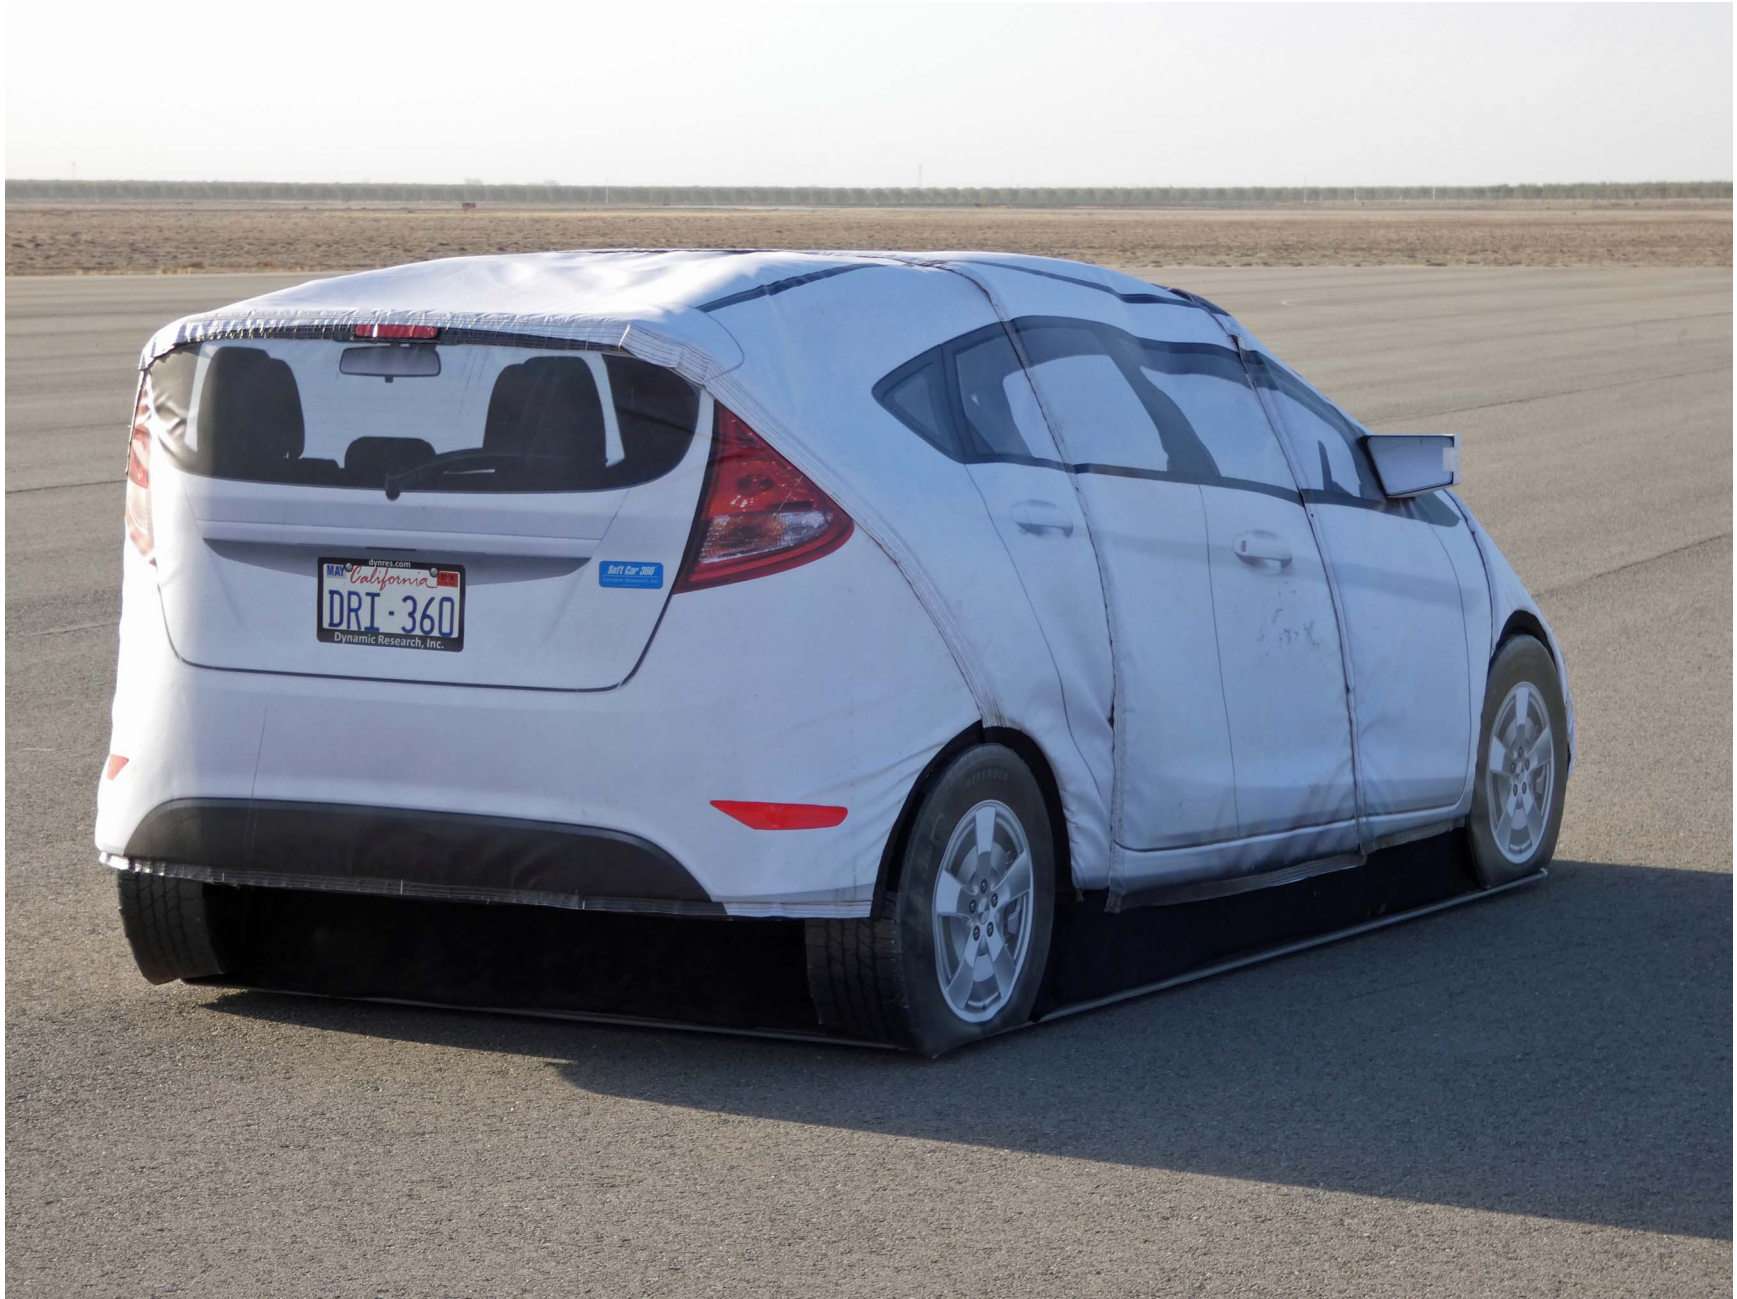
Figure A6. Front View of Principal Other Vehicle - GVT (Tests 1 and 2)

Figure A7. Rear View of Principal Other Vehicle - GVT (Tests 1 and 2)

Operationally, the GVT body is attached to LPRV using Velcro hook and loop fasteners. The GVT and LPRV are designed to separate if the GVT is struck by the SV. The GVT/LPRV system is shown in Figures A6 and A7 in Appendix A and a detailed description can be found in the NHTSA report: “A Test Track Comparison of the Global Vehicle Target (GVT) and NHTSA’s Strikeable Surrogate Vehicle (SSV)”.<sup>3</sup>

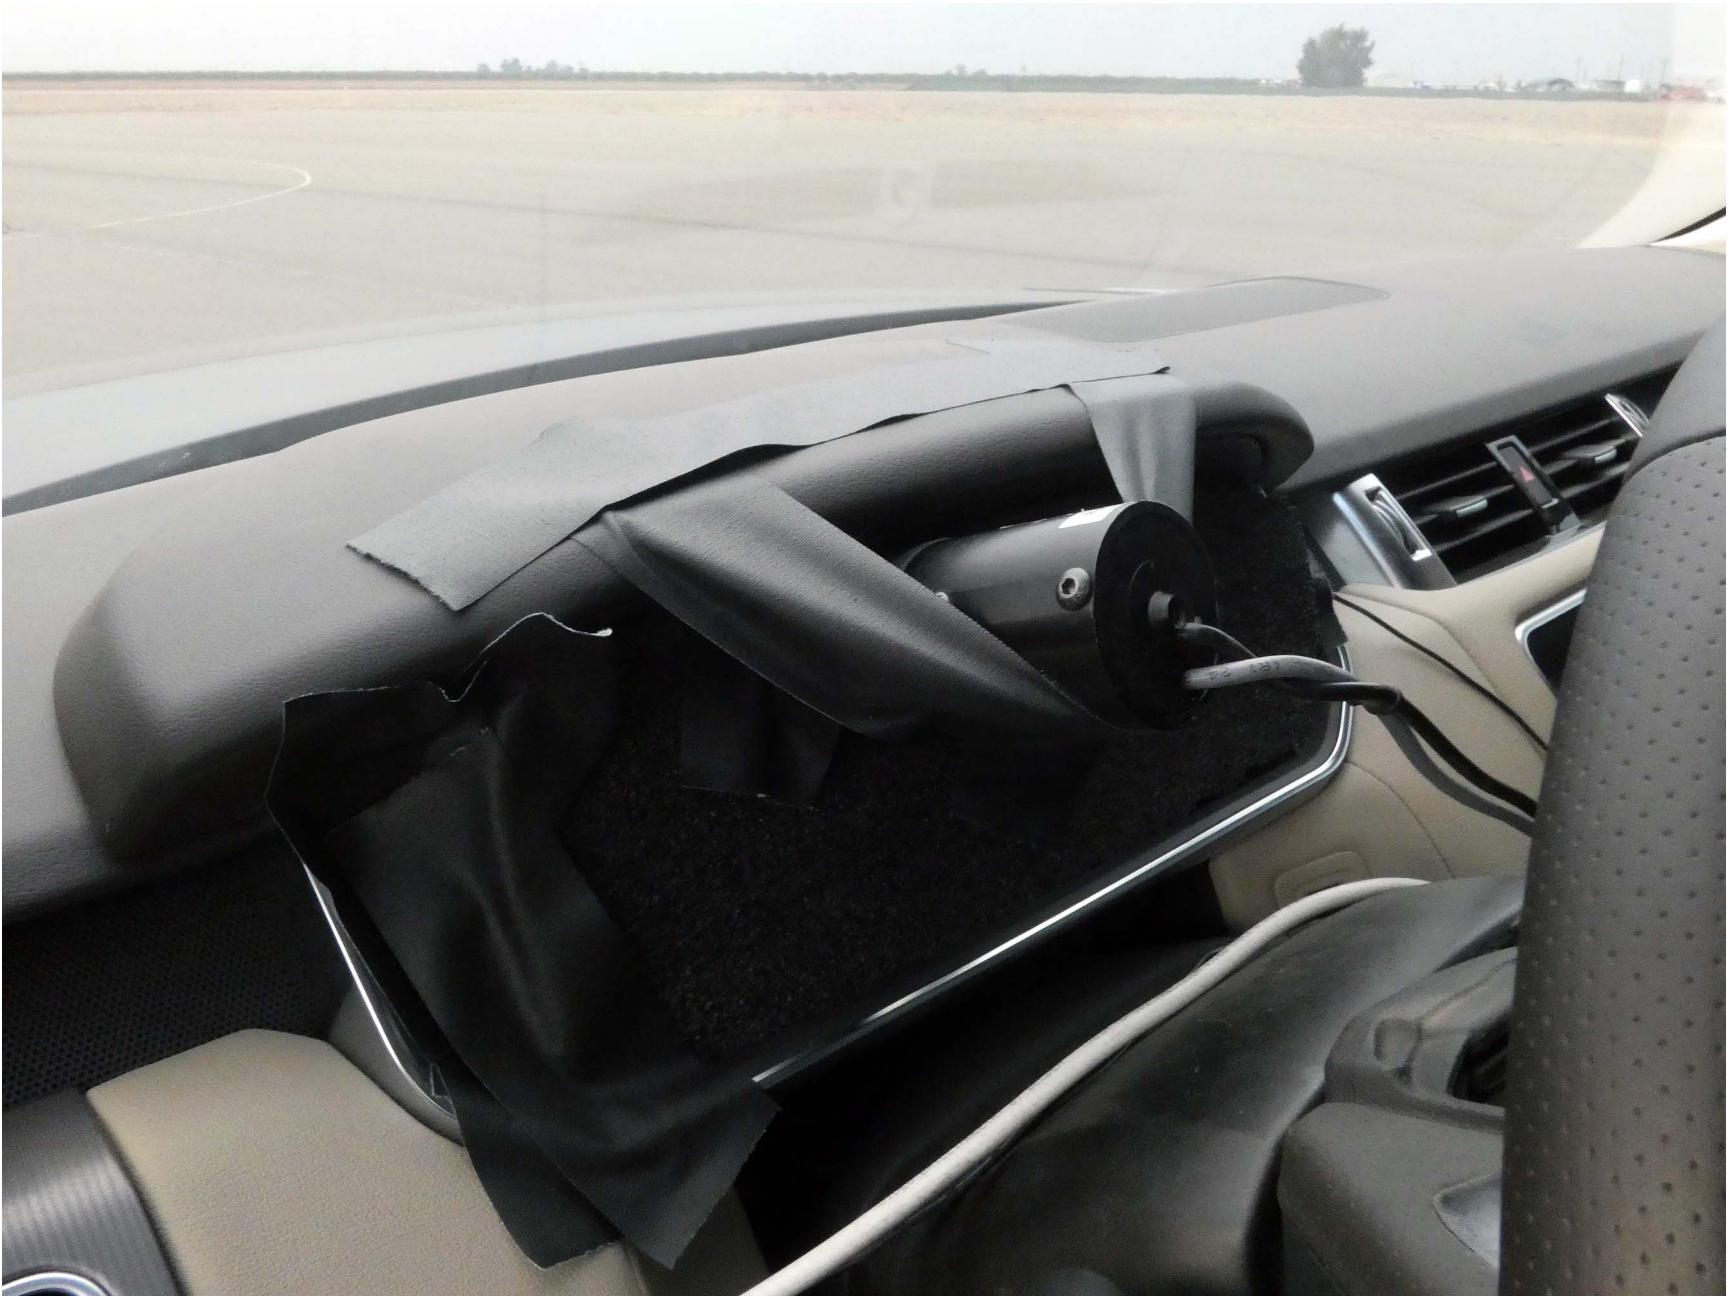
Figure A10. Sensor for Detecting Visual Alerts

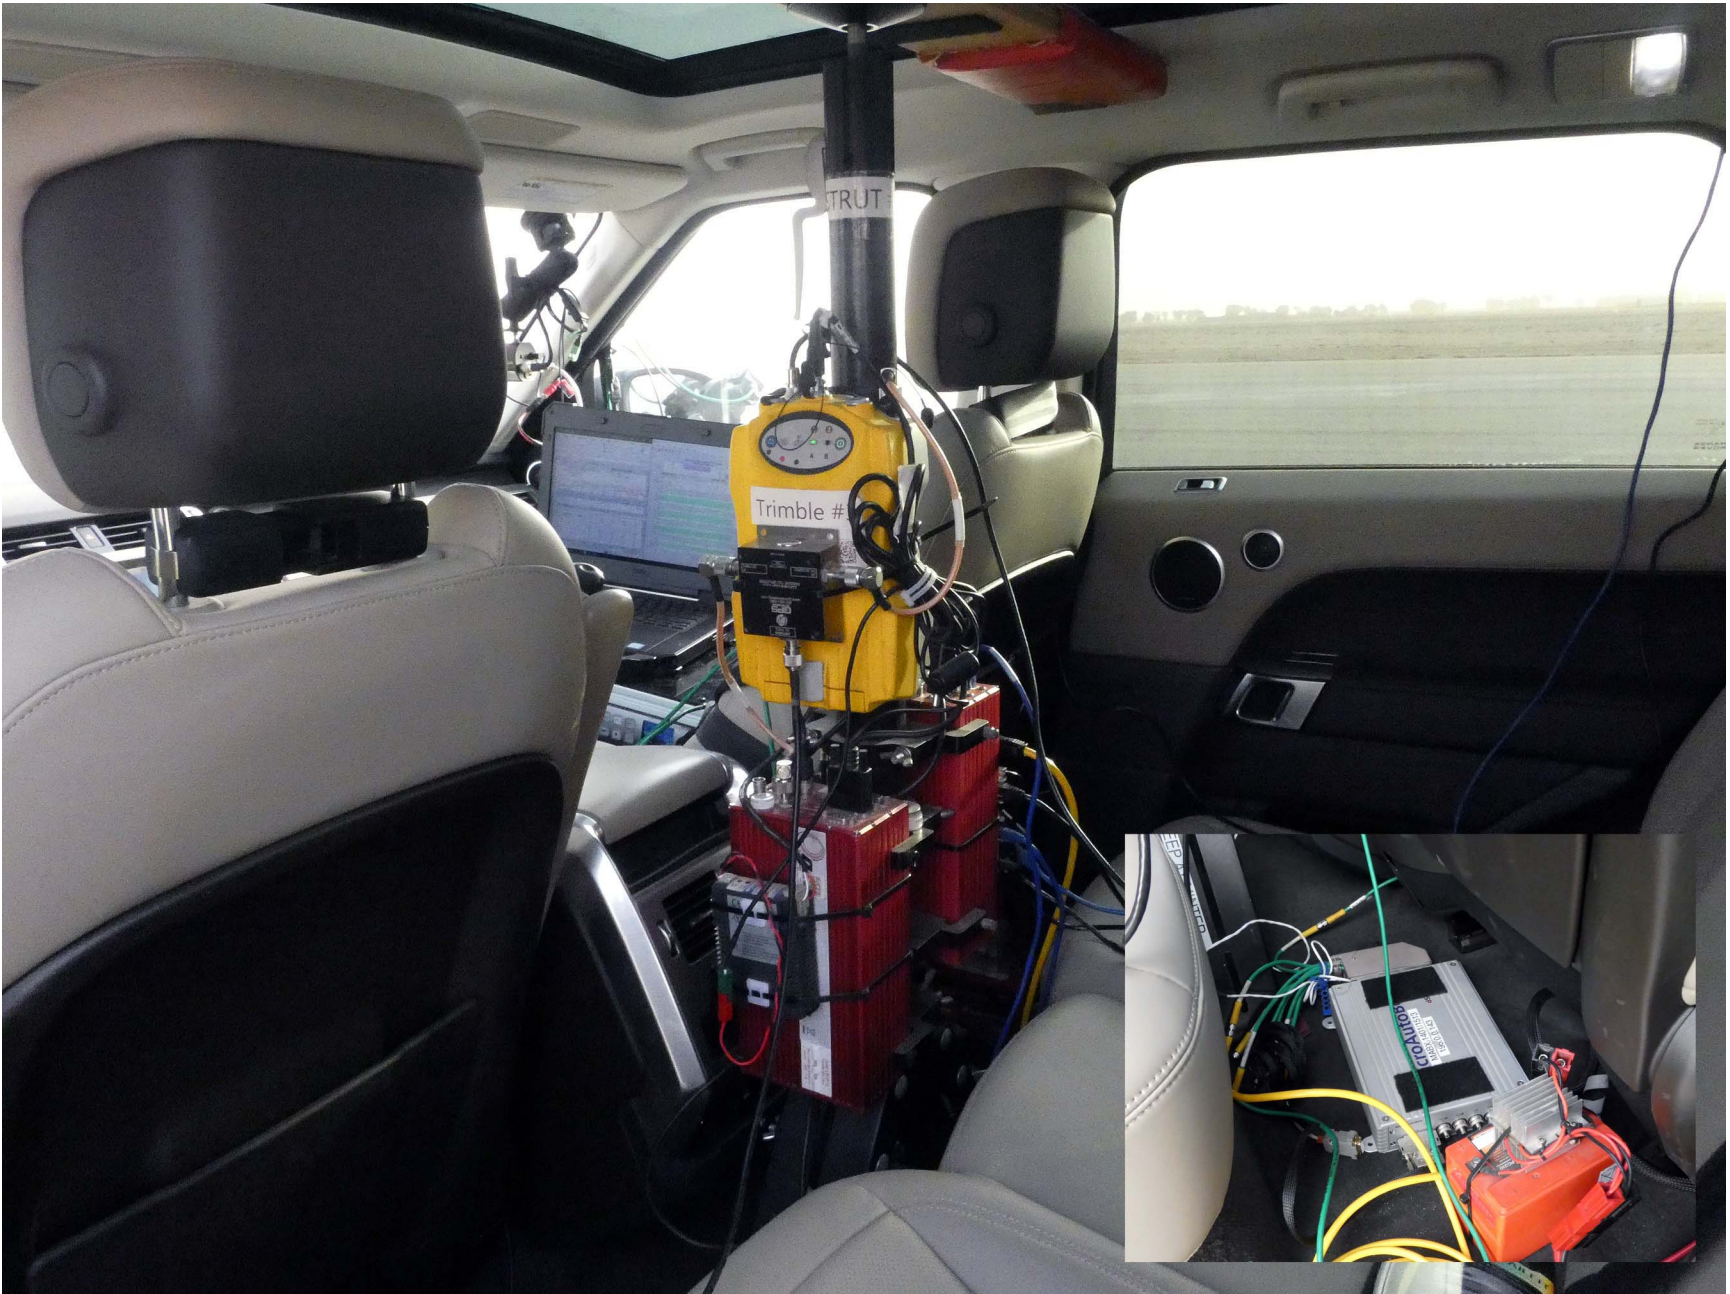
Figure A11. DGPS, Inertial Measurement Unit, and MicroAutoBox Installed in Subject Vehicle

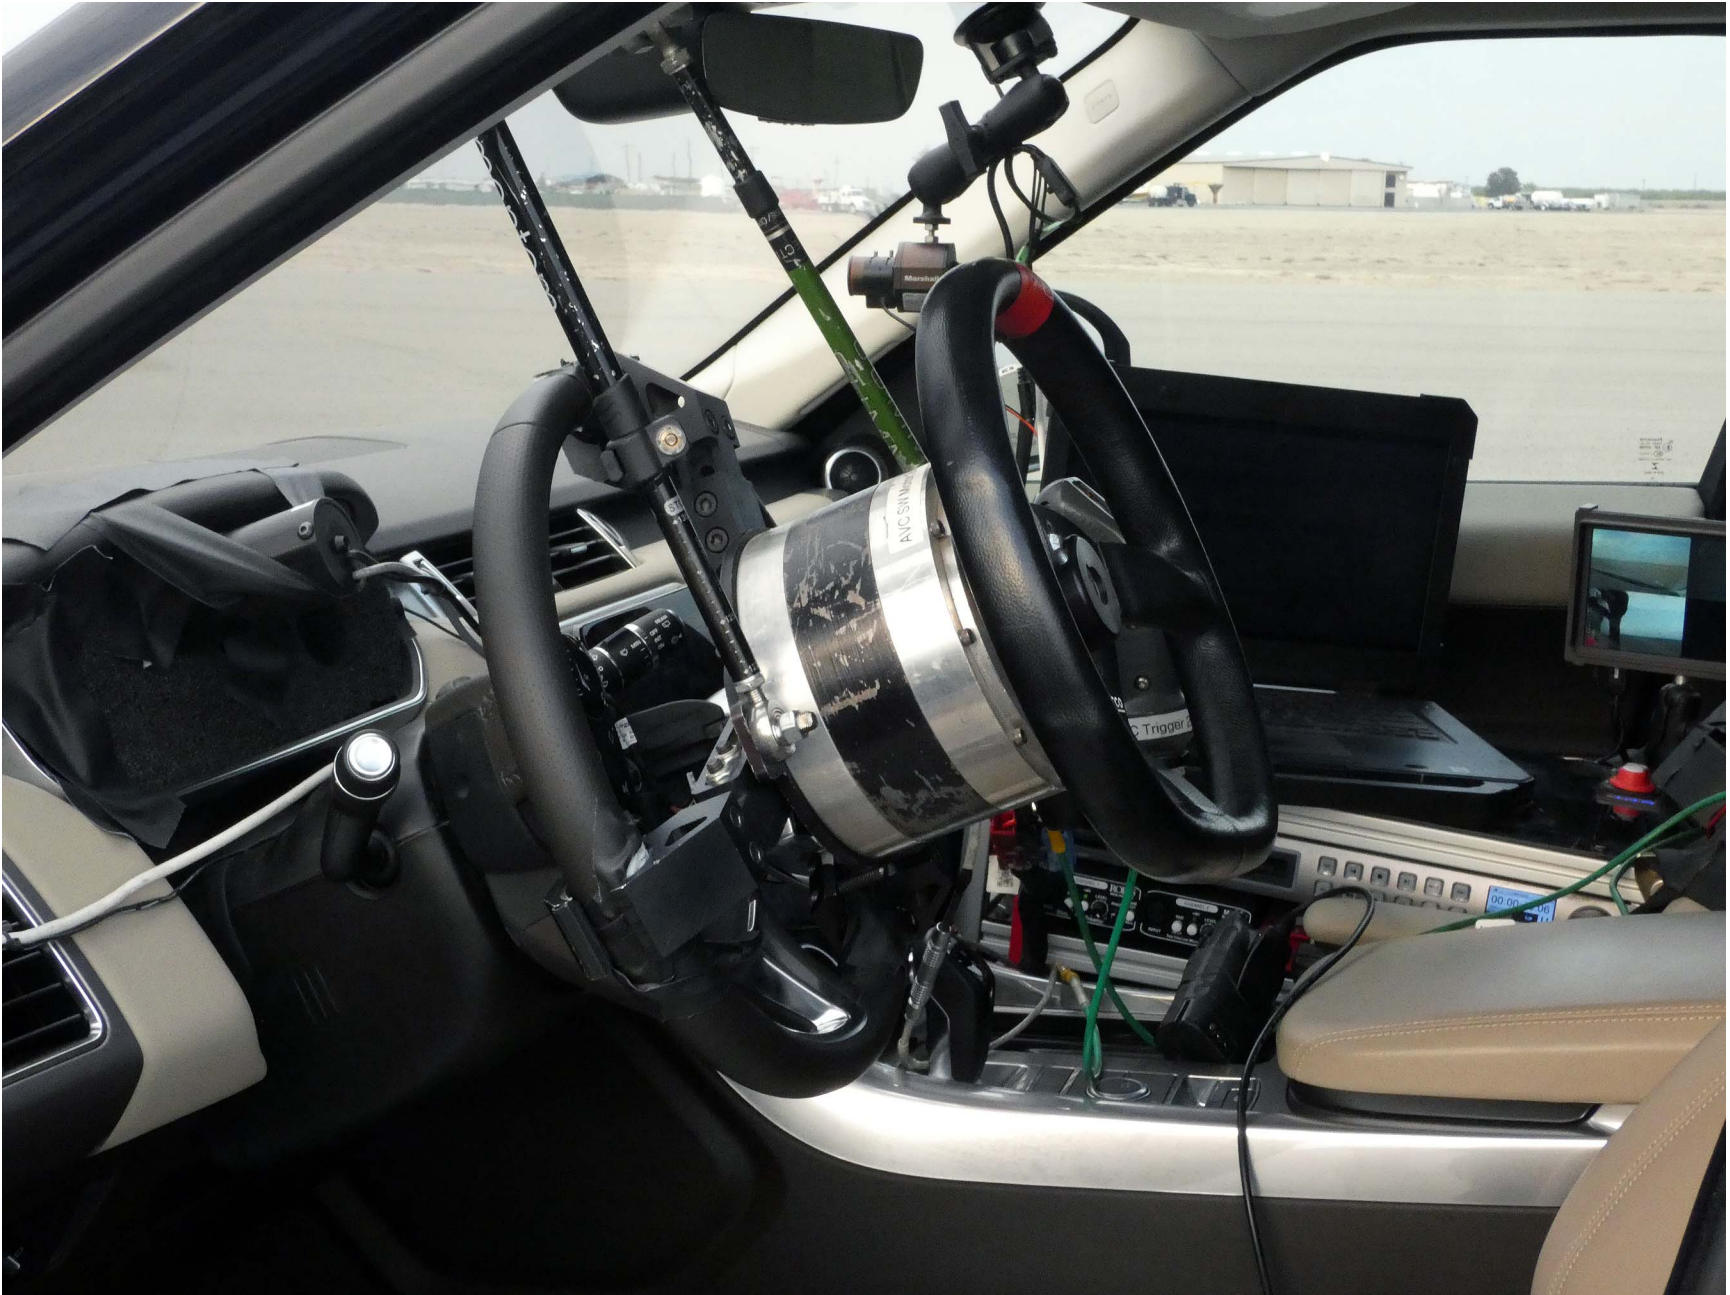
Figure A12. Computer and Steering Controller Installed in Subject Vehicle

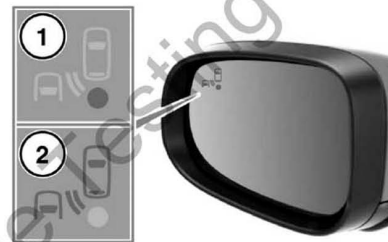
The blind spot monitor system monitors an area adjacent to, and approximately 28 ft (8.5 m) behind, the vehicle. When the system detects an overtaking vehicle, the amber warning icon (1):

- Flashes if the relevant turn signal is being used.
- Illuminates continuously if the relevant turn signal is not being used.
- Extinguishes when the system no longer detects a vehicle in the monitored area.

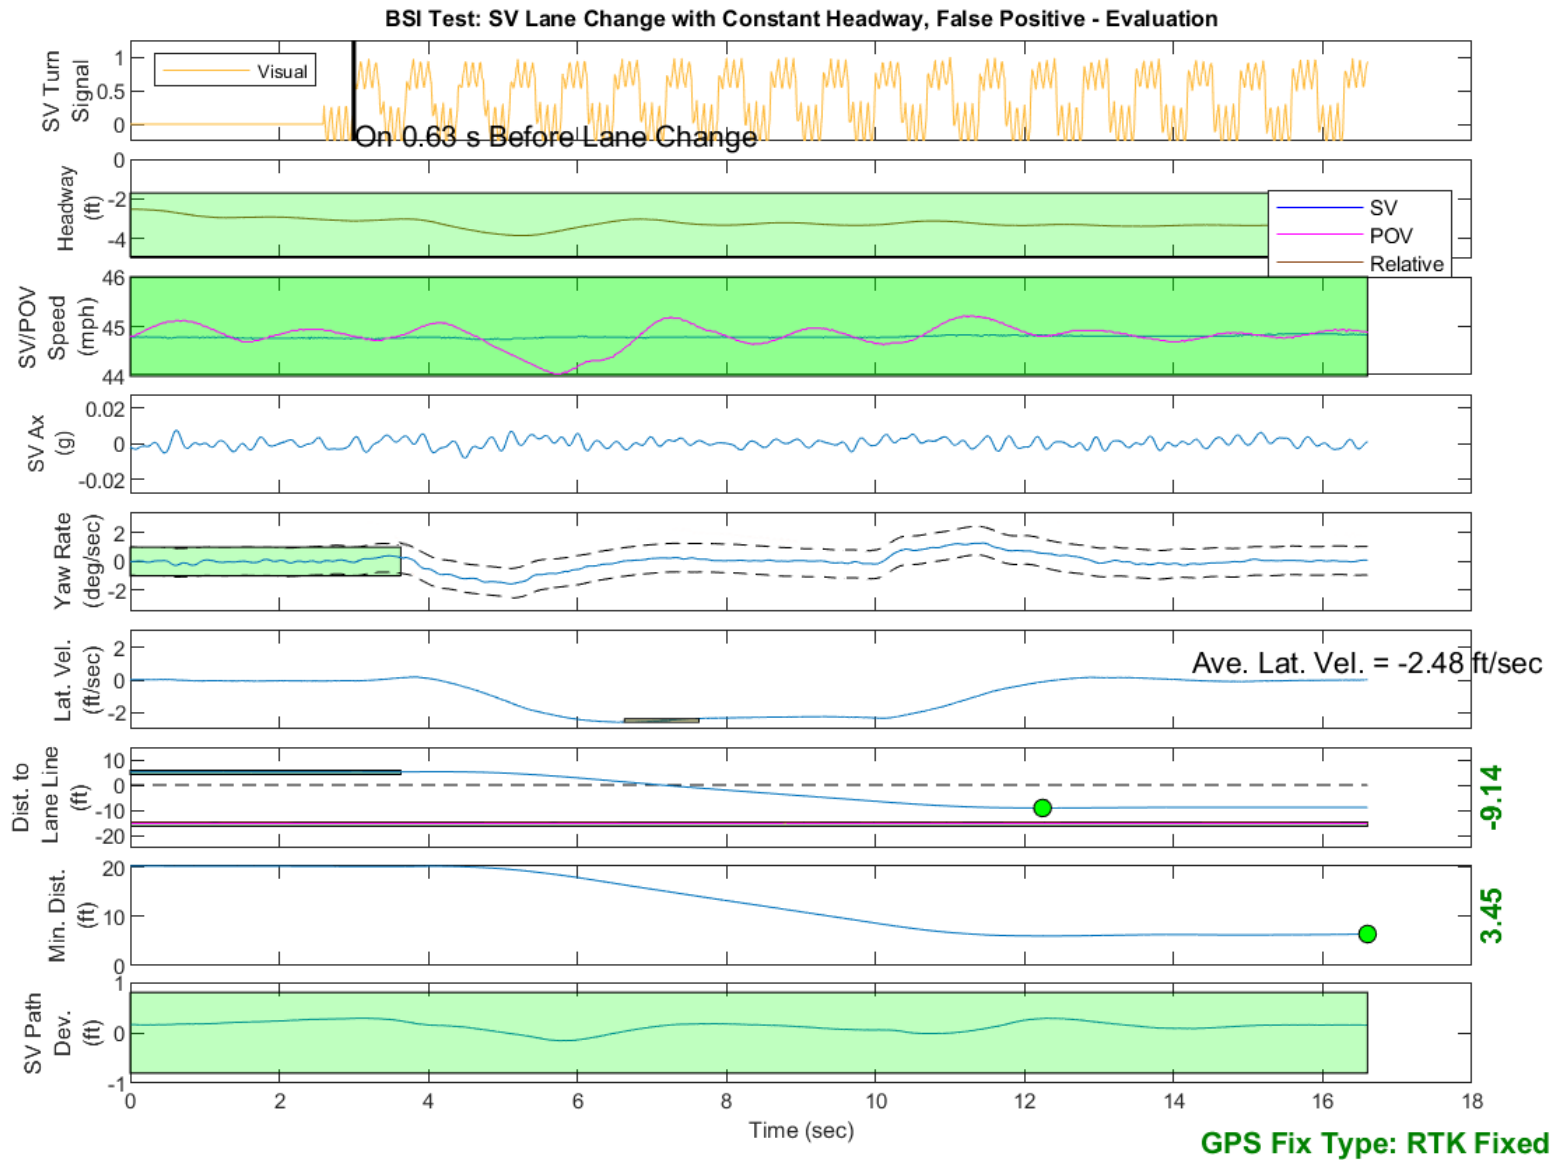
Figure D1. Example Time History for False Positive Evaluation, Passing

Examples of time history plots for each test type (including passing, failing, and invalid runs) are shown in Figures D1 through D3. Time history data plots for the tests of the vehicle under consideration herein are provided beginning with Figure D4.

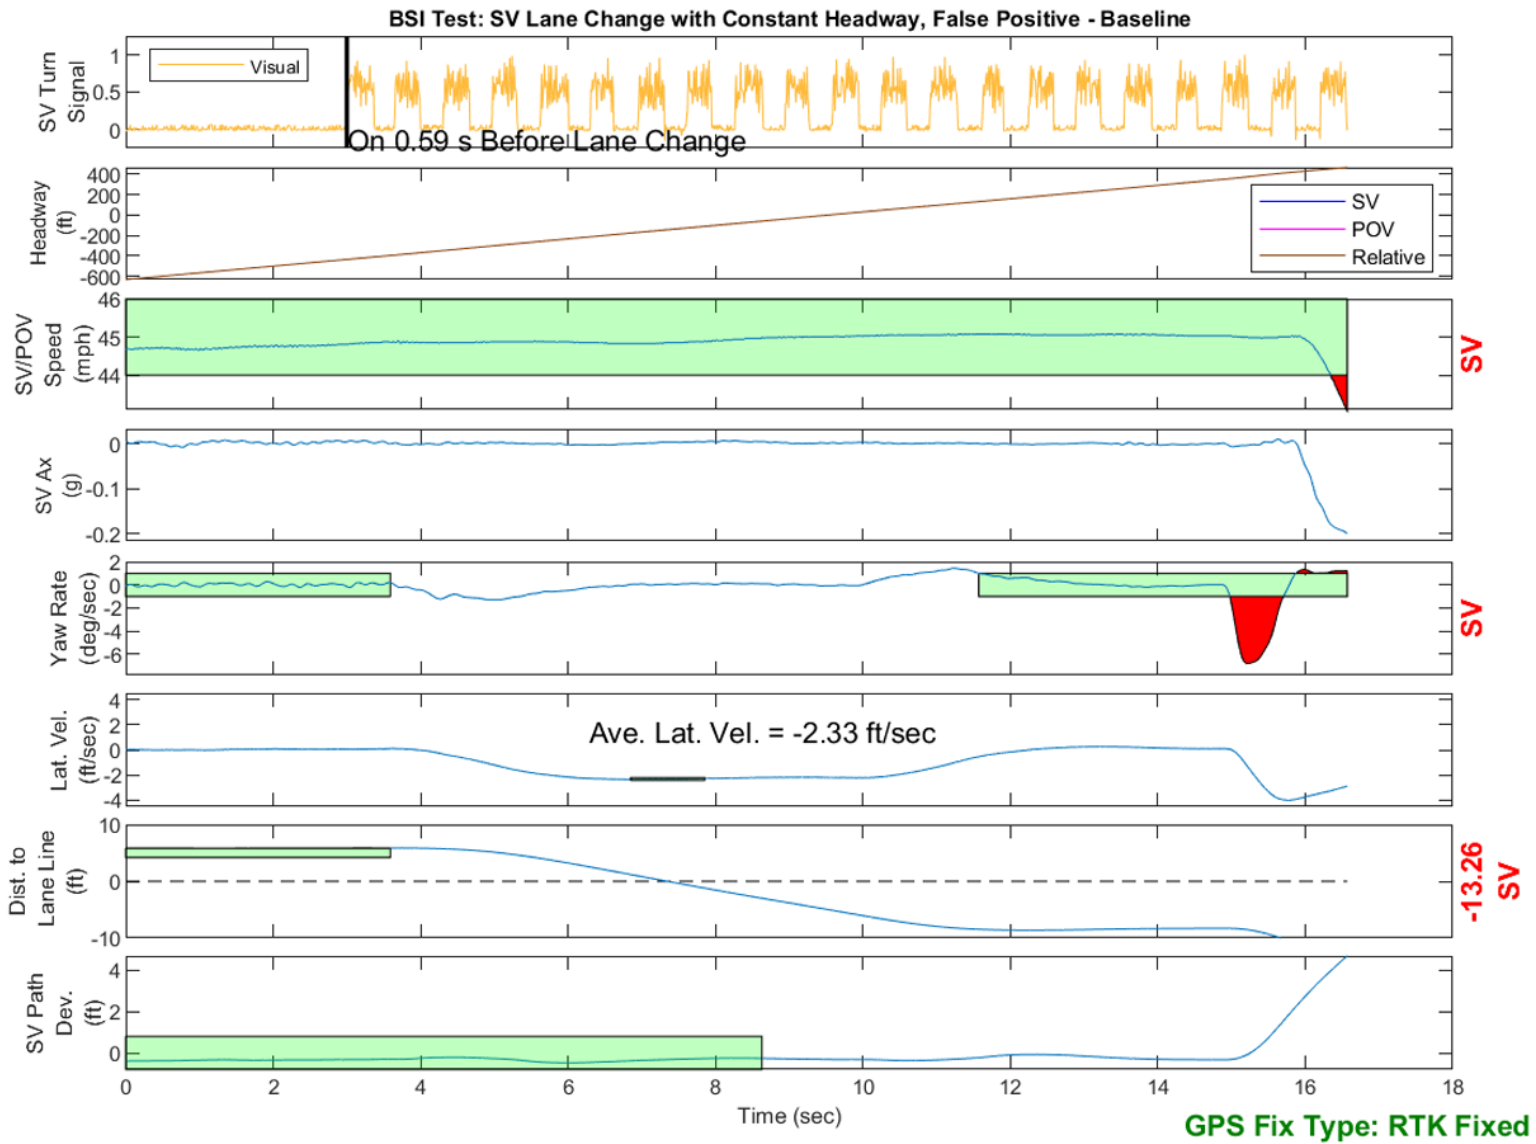
Figure D3. Example Time History for Subject Vehicle with Constant Headway Test, Invalid POV Speed Criteria
