**BLIND SPOT INTERVENTION SYSTEM CONFIRMATION TEST
NCAP-DRI-BSI-20-07**

2020 Mercedes-Benz GLC 300 4Matic SUV

DYNAMIC RESEARCH, INC.

Final Report

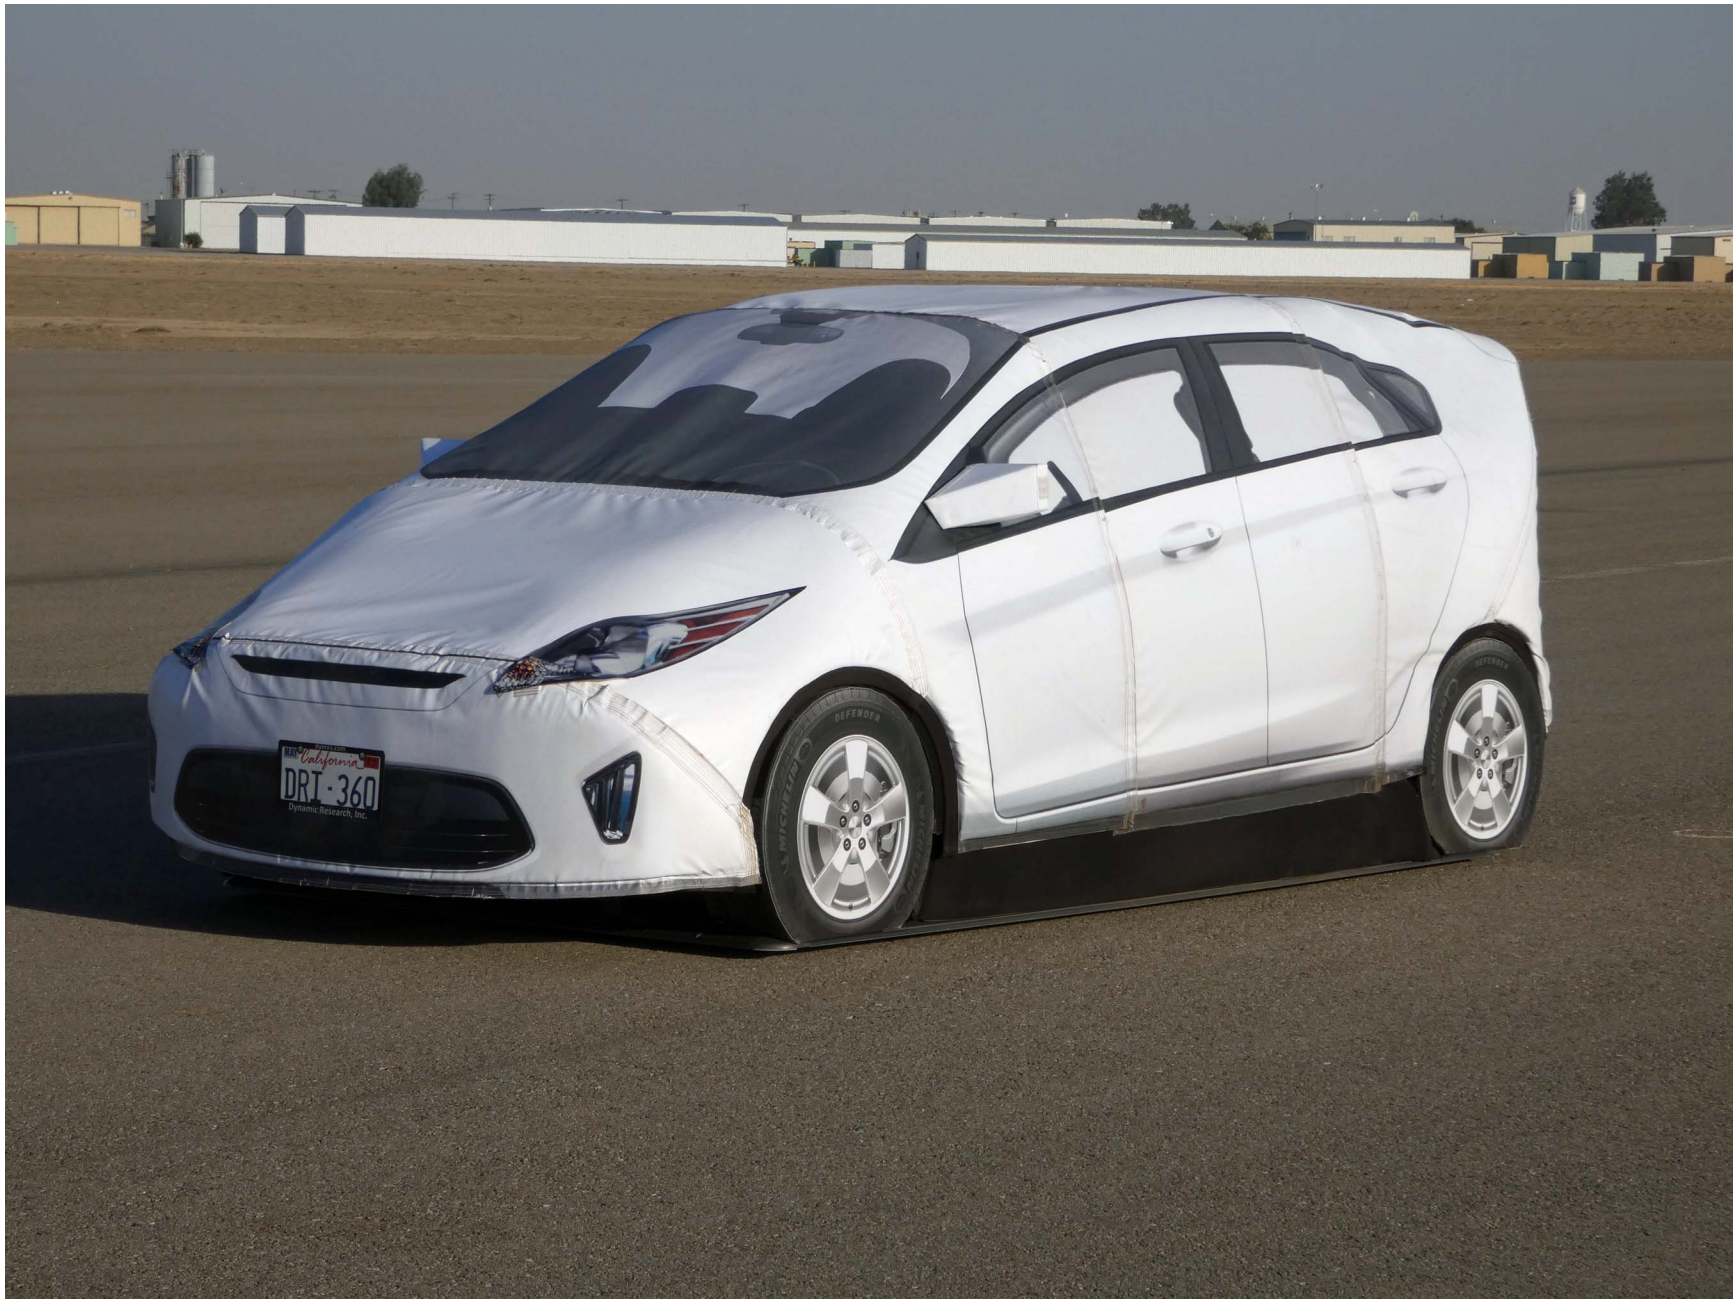
Figure A6. Front View of Principal Other Vehicle - GVT (Tests 1 and 2)

Operationally, the GVT body is attached to LPRV using Velcro hook and loop fasteners. The GVT and LPRV are designed to separate if the GVT is struck by the SV. The GVT/LPRV system is shown in Figures A6 and A7 in Appendix A and a detailed description can be found in the NHTSA report: “A Test Track Comparison of the Global Vehicle Target (GVT) and NHTSA’s Strikeable Surrogate Vehicle (SSV)”.³

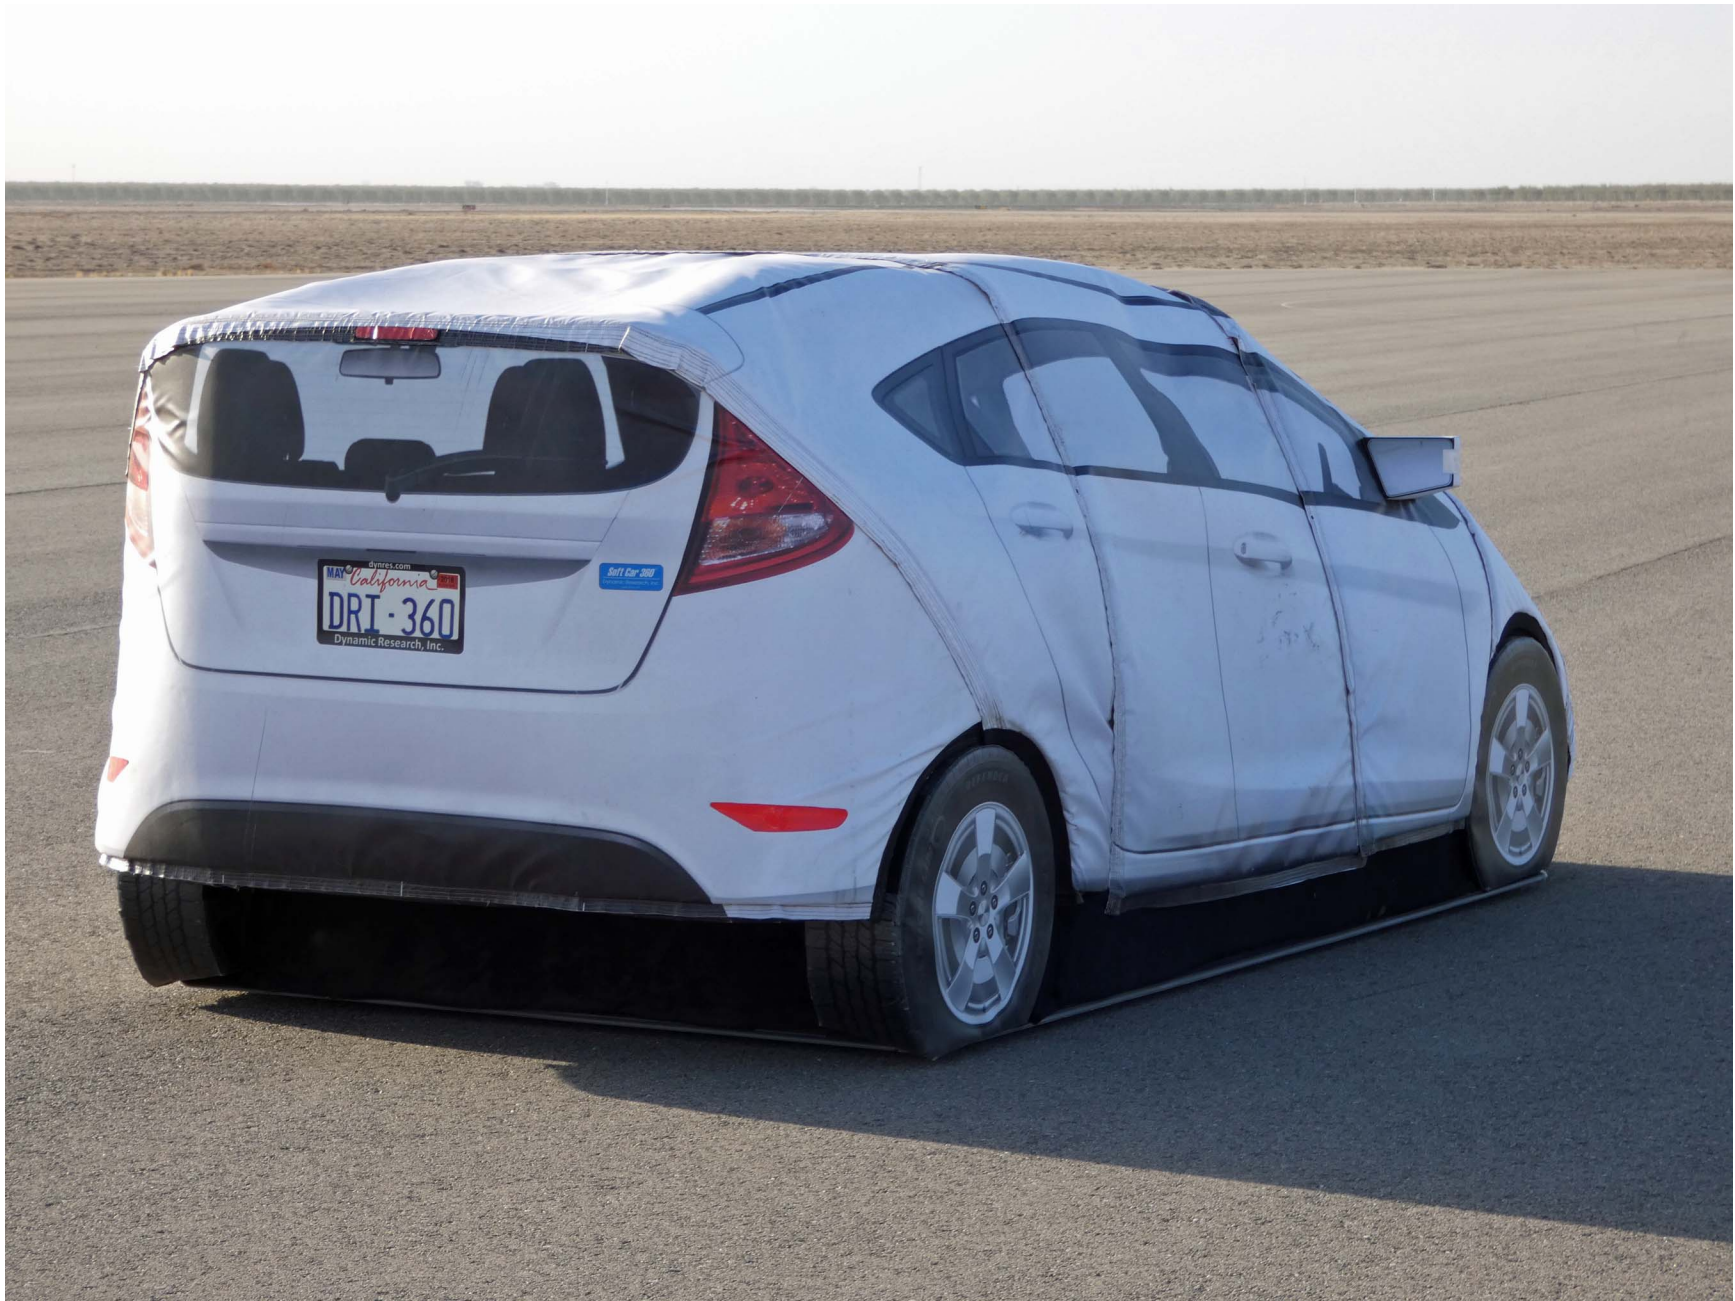
Figure A7. Rear View of Principal Other Vehicle - GVT (Tests 1 and 2)

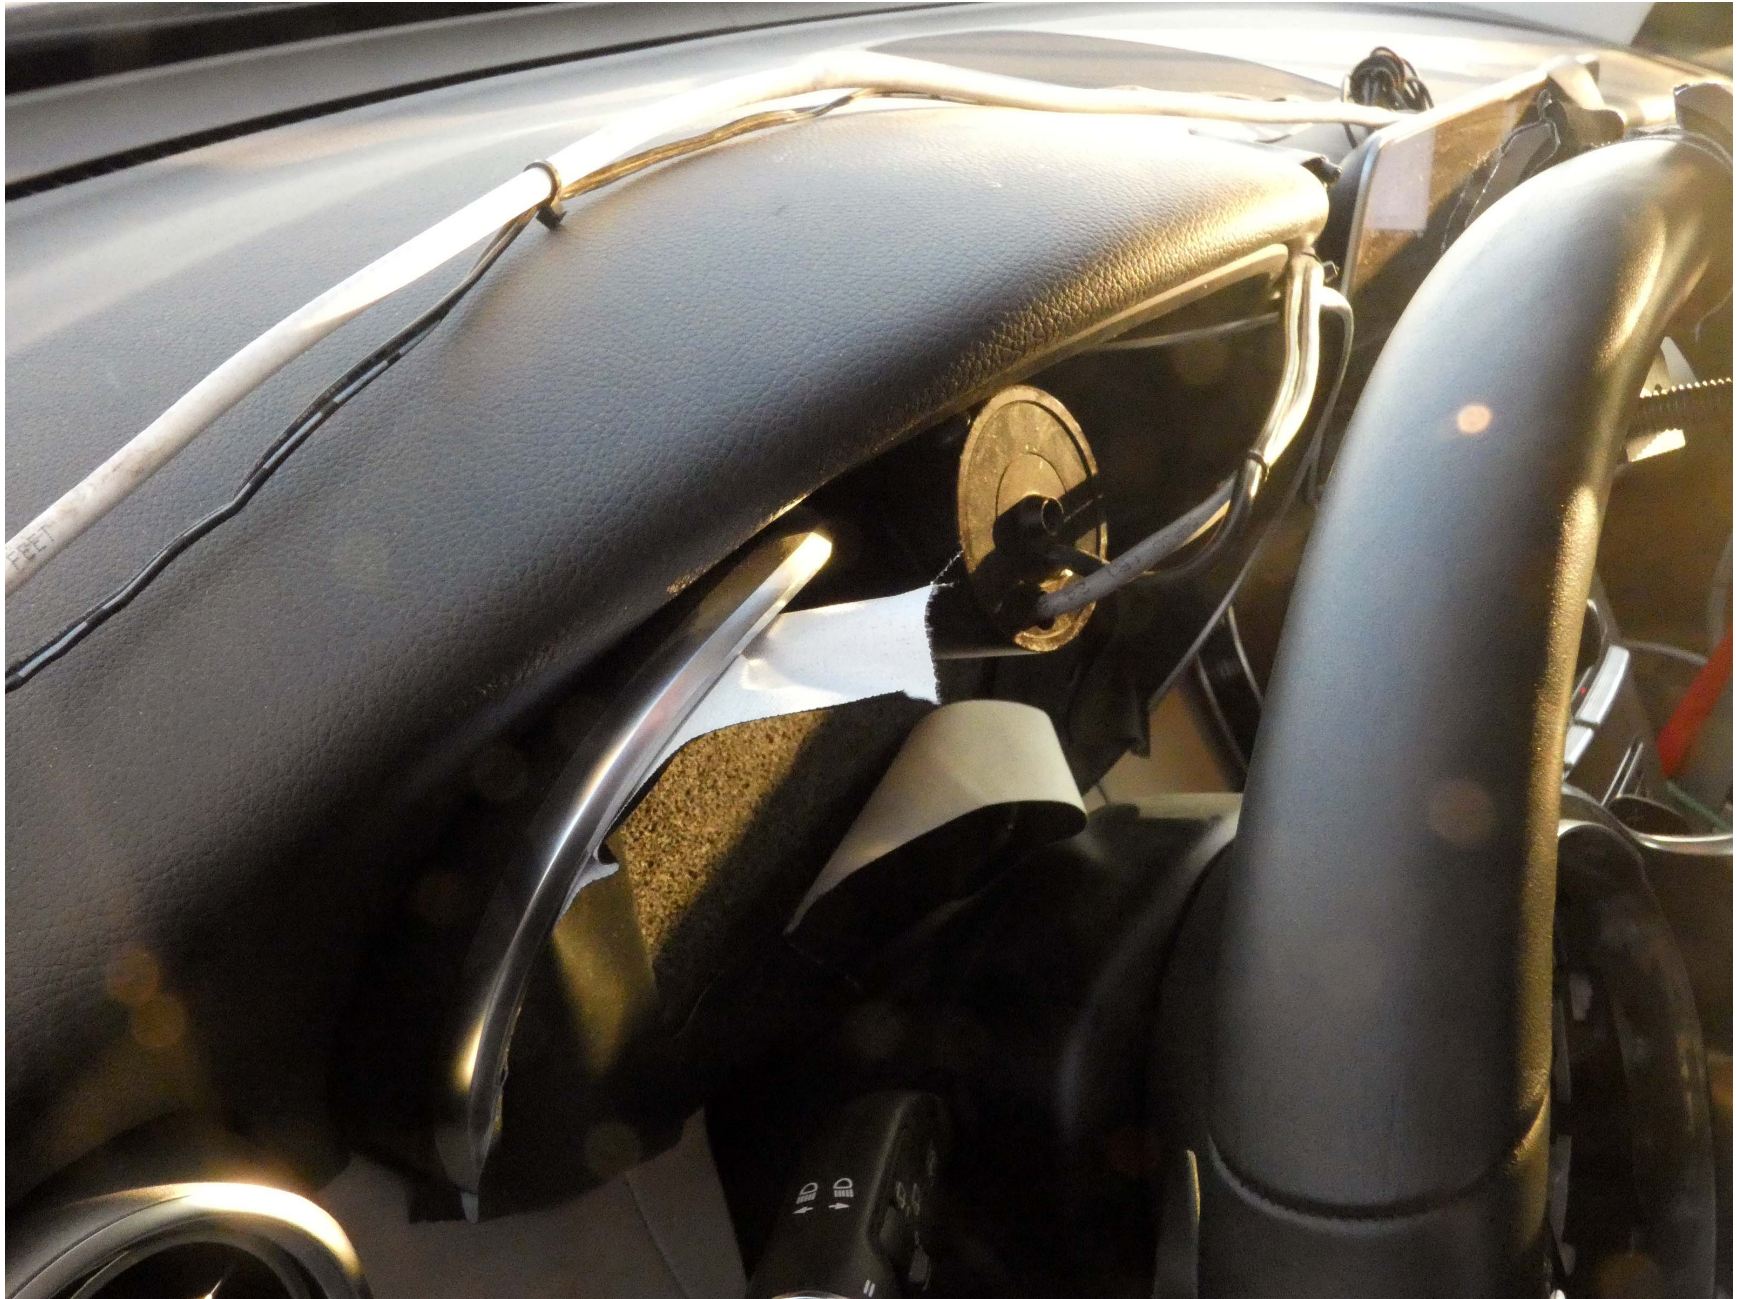
Figure A10. Sensor for Detecting Visual Alerts

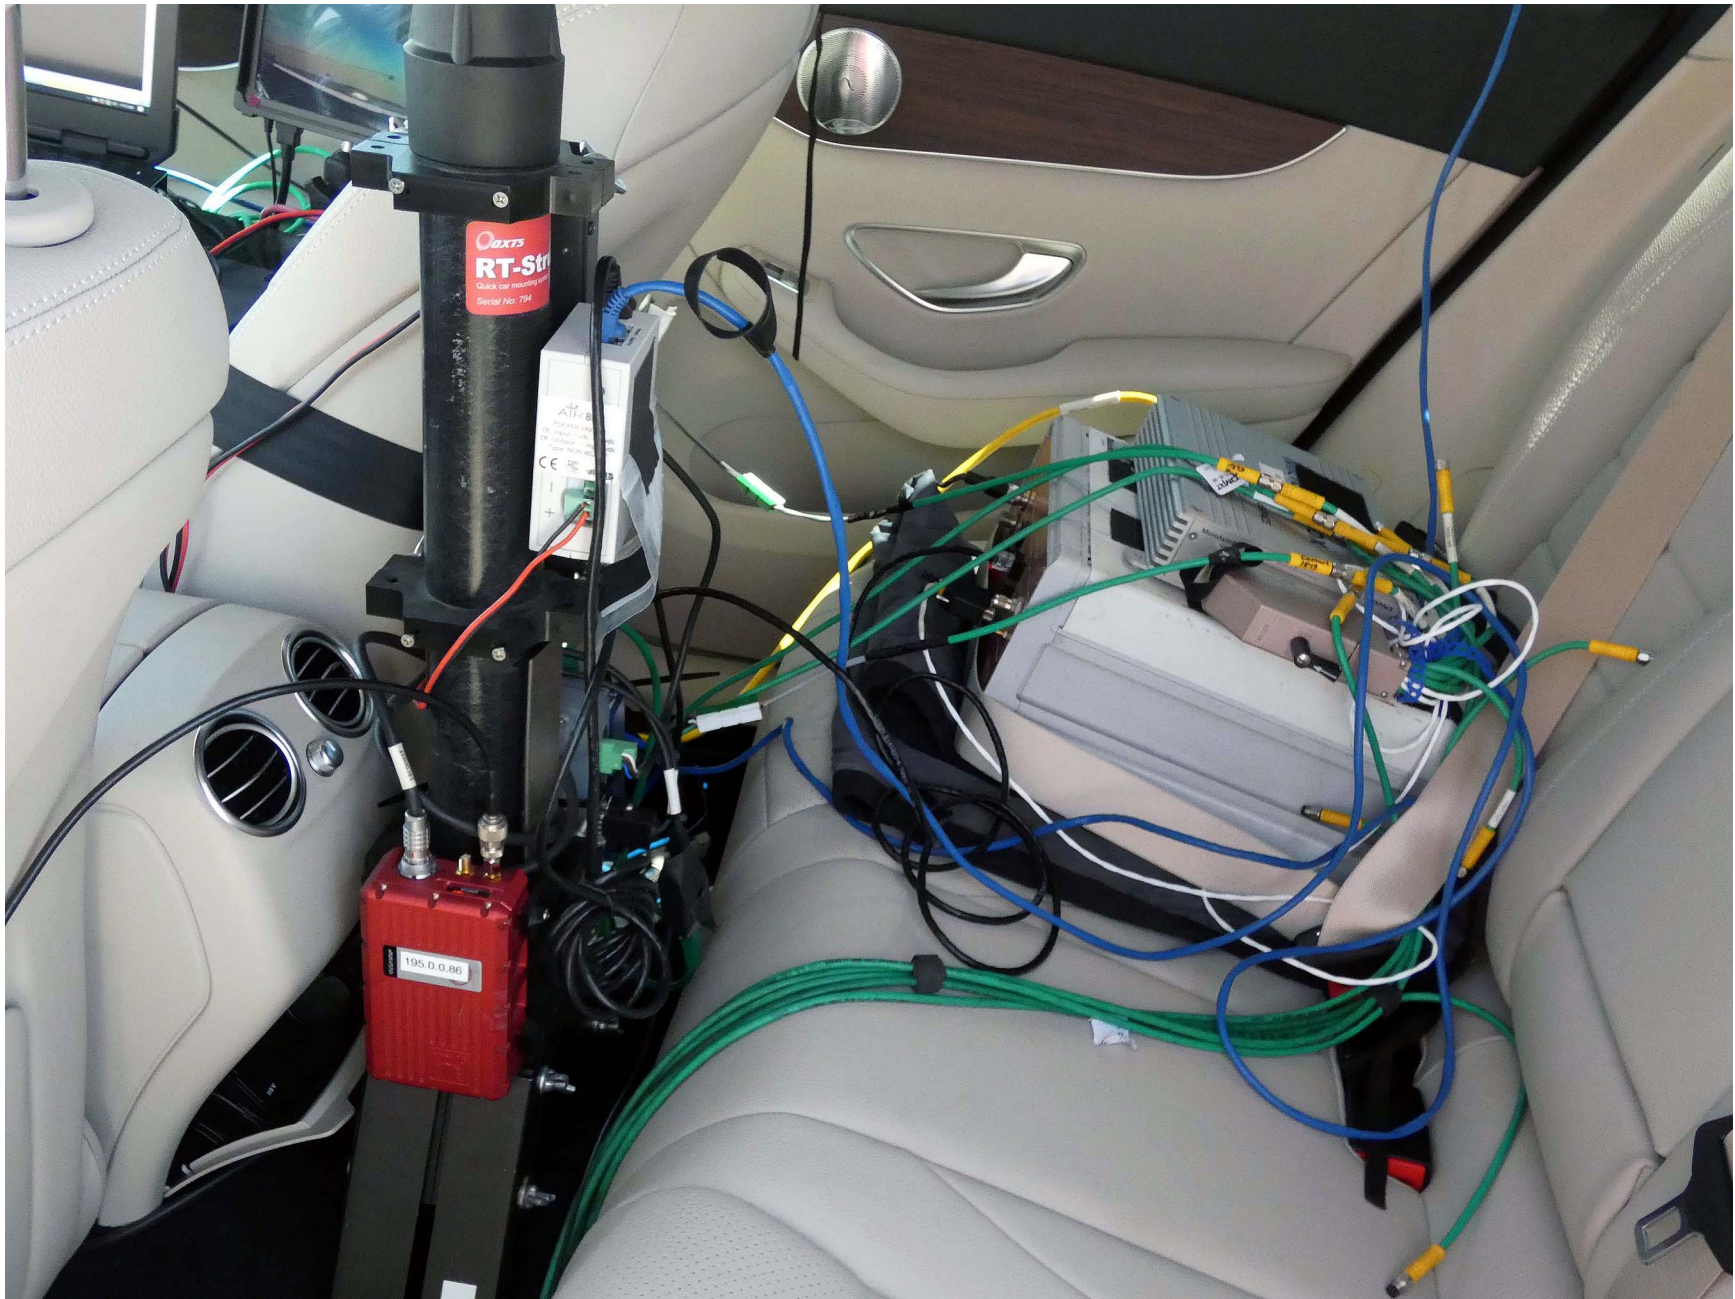
Figure A11. DGPS, Inertial Measurement Unit, and MicroAutoBox Installed in Subject Vehicle

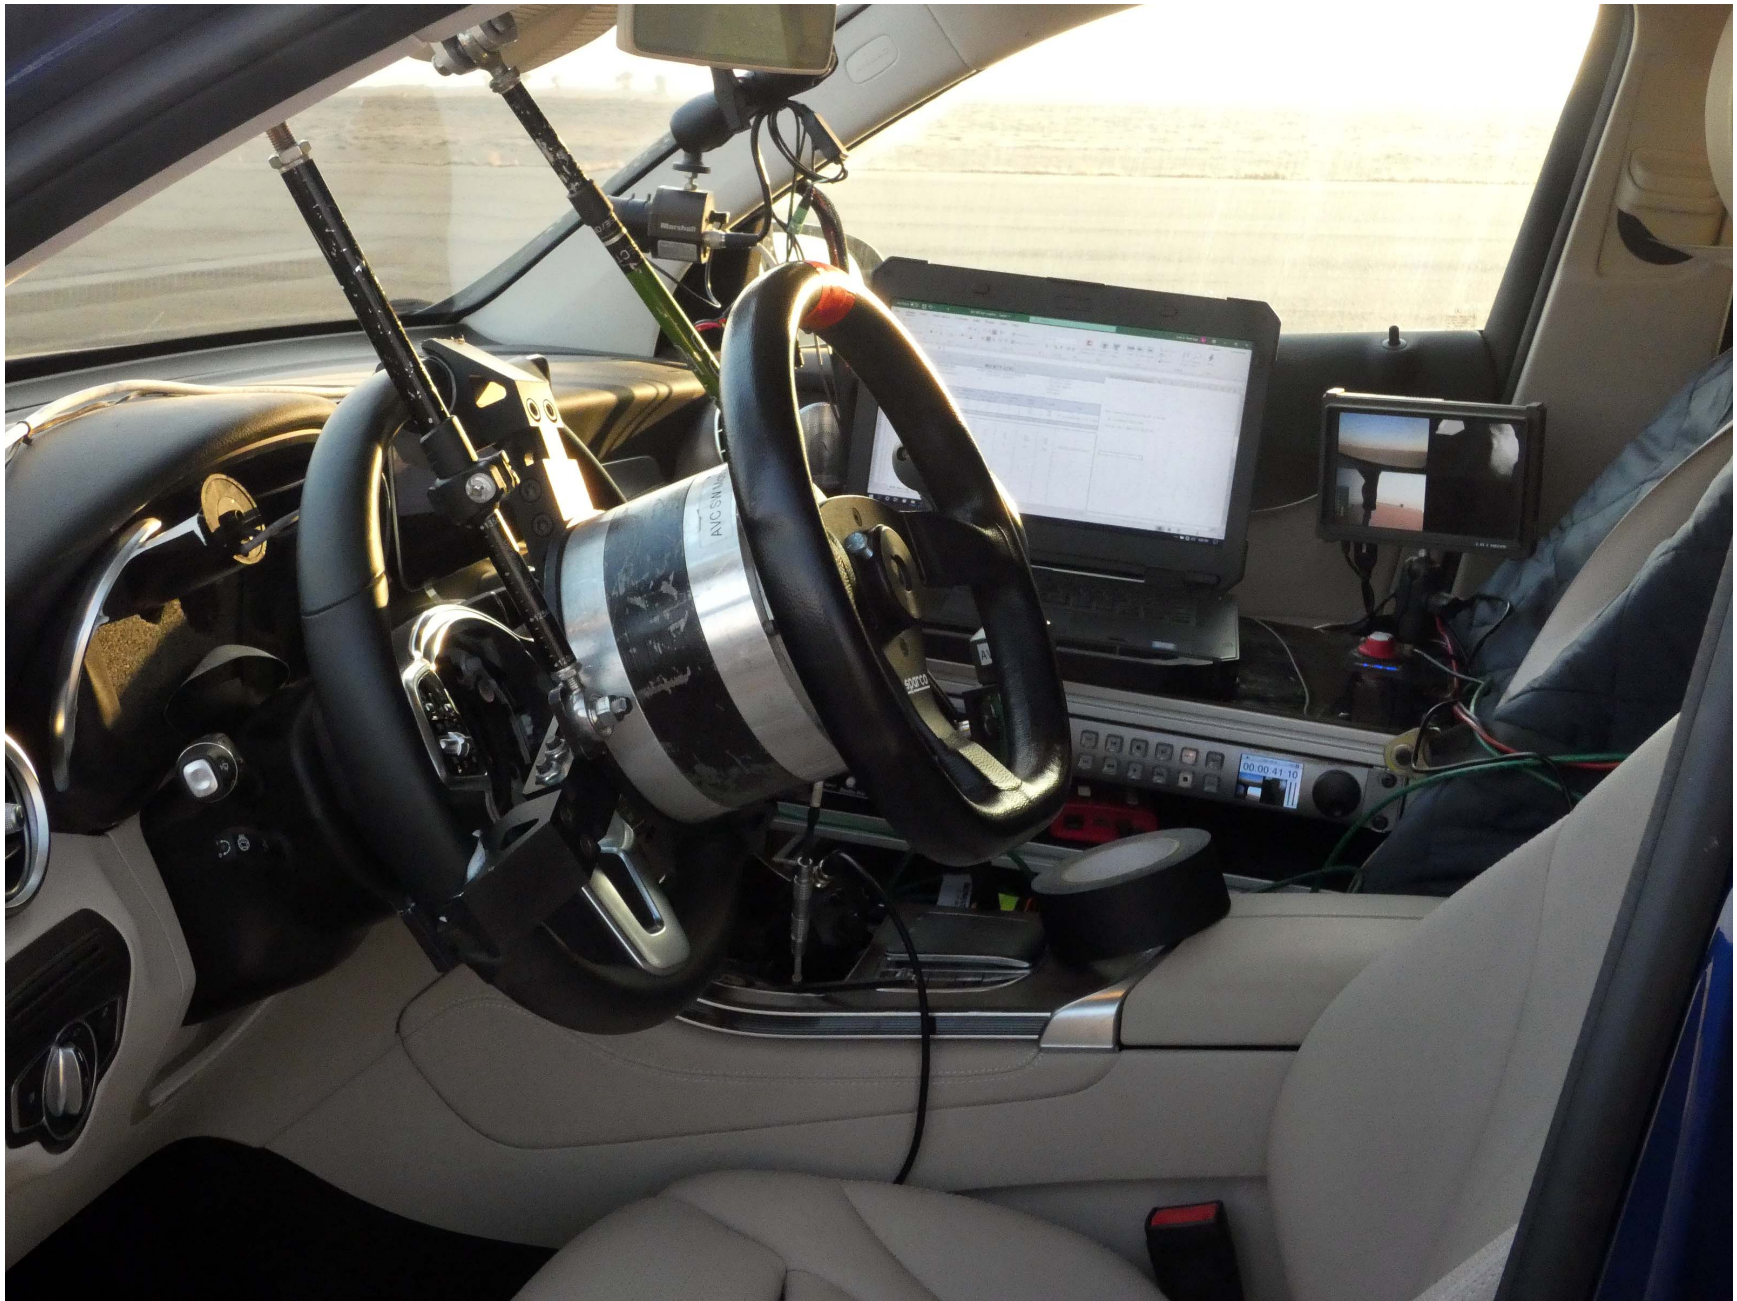
Figure A12. Computer and Steering Controller Installed in Subject Vehicle
