**BLIND SPOT INTERVENTION SYSTEM CONFIRMATION TEST
NCAP-DRI-BSI-20-08**

2020 Nissan Leaf SV

Final Report

1. Report No. NCAP-DRI-BSI-20-08	2. Government Accession No.	3. Recipient's Catalog No.	
4. Title and Subtitle Final Report of Blind Spot Intervention System Testing of a 2020 Nissan Leaf SV.		5. Report Date 29 October 2020

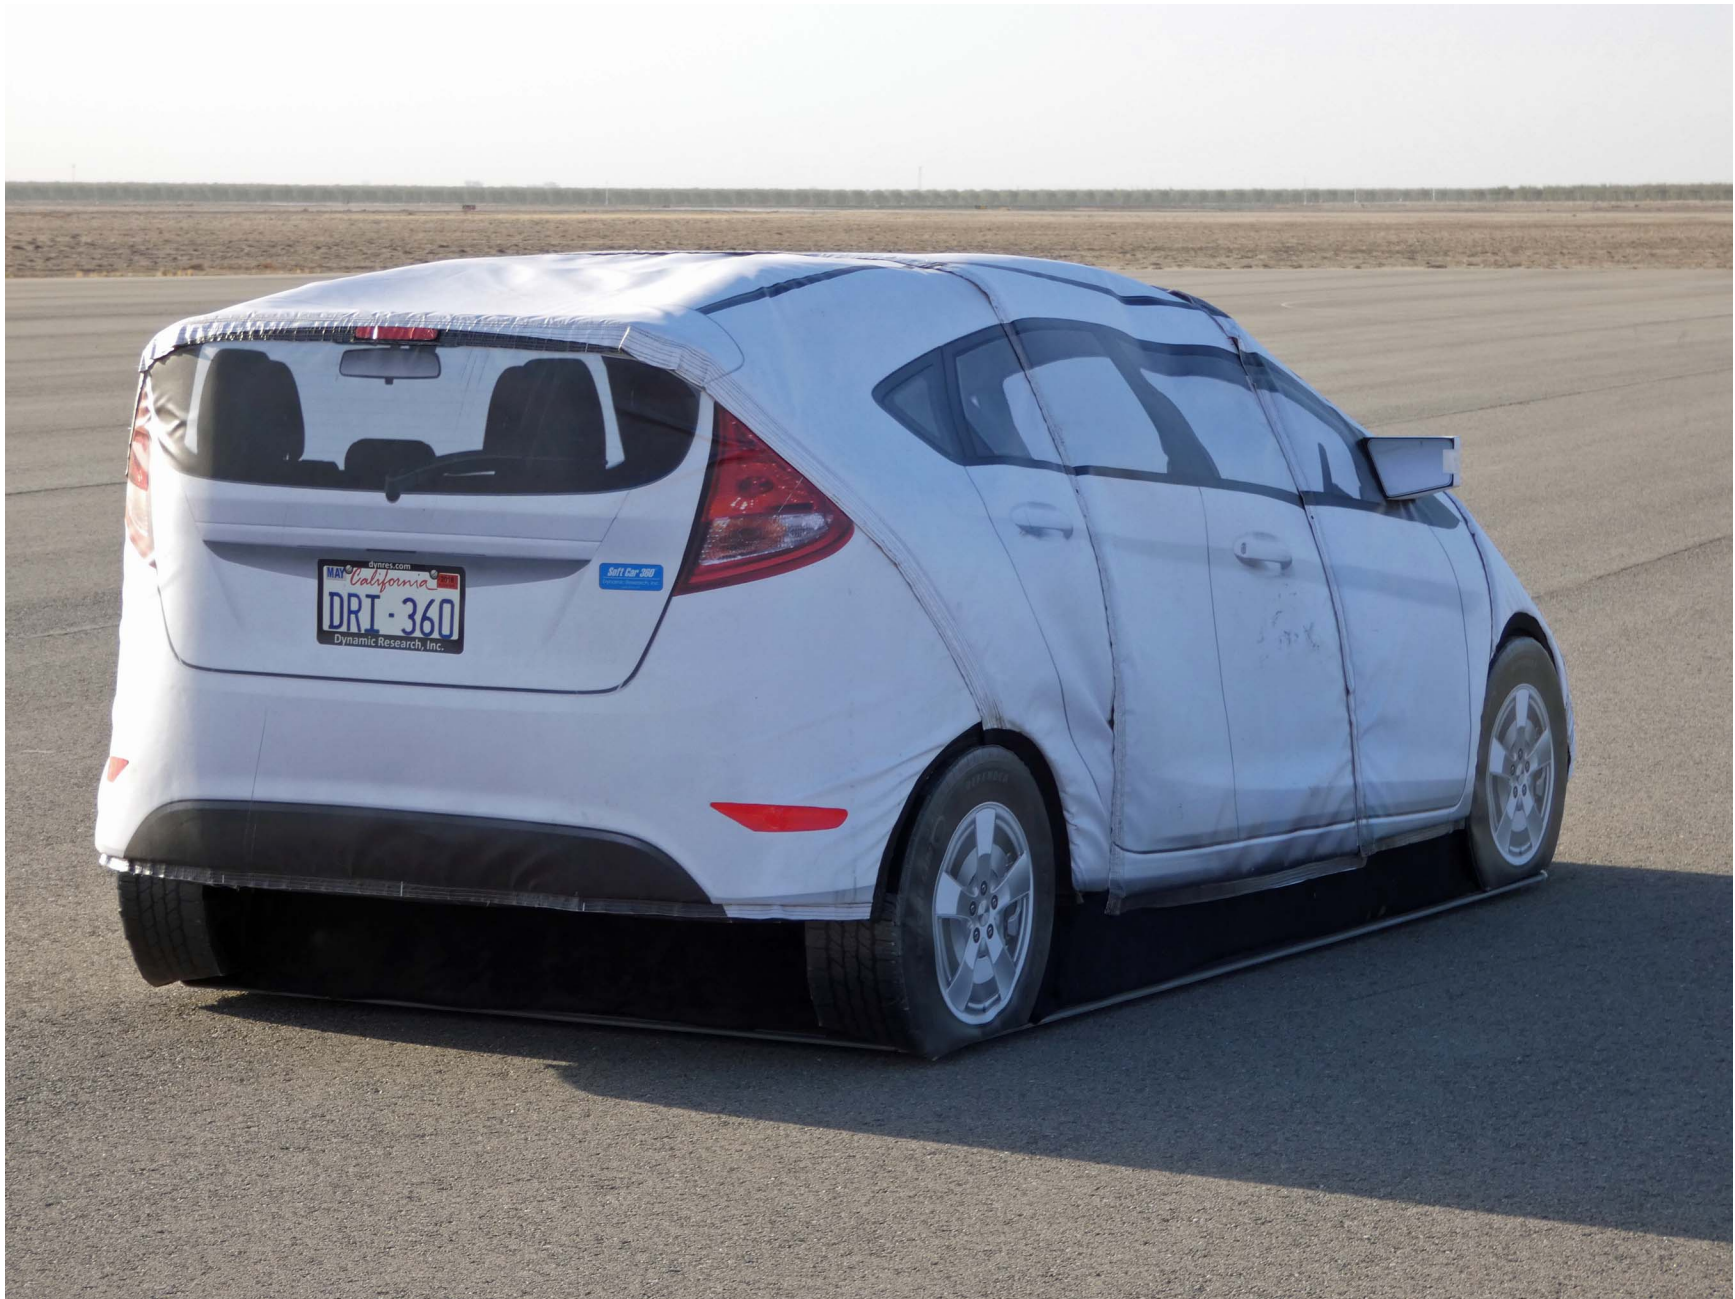
Figure A7. Rear View of Principal Other Vehicle - GVT (Tests 1 and 2)

Operationally, the GVT body is attached to LPRV using Velcro hook and loop fasteners. The GVT and LPRV are designed to separate if the GVT is struck by the SV. The GVT/LPRV system is shown in Figures A6 and A7 in Appendix A and a detailed description can be found in the NHTSA report: “A Test Track Comparison of the Global Vehicle Target (GVT) and NHTSA’s Strikeable Surrogate Vehicle (SSV)”.³

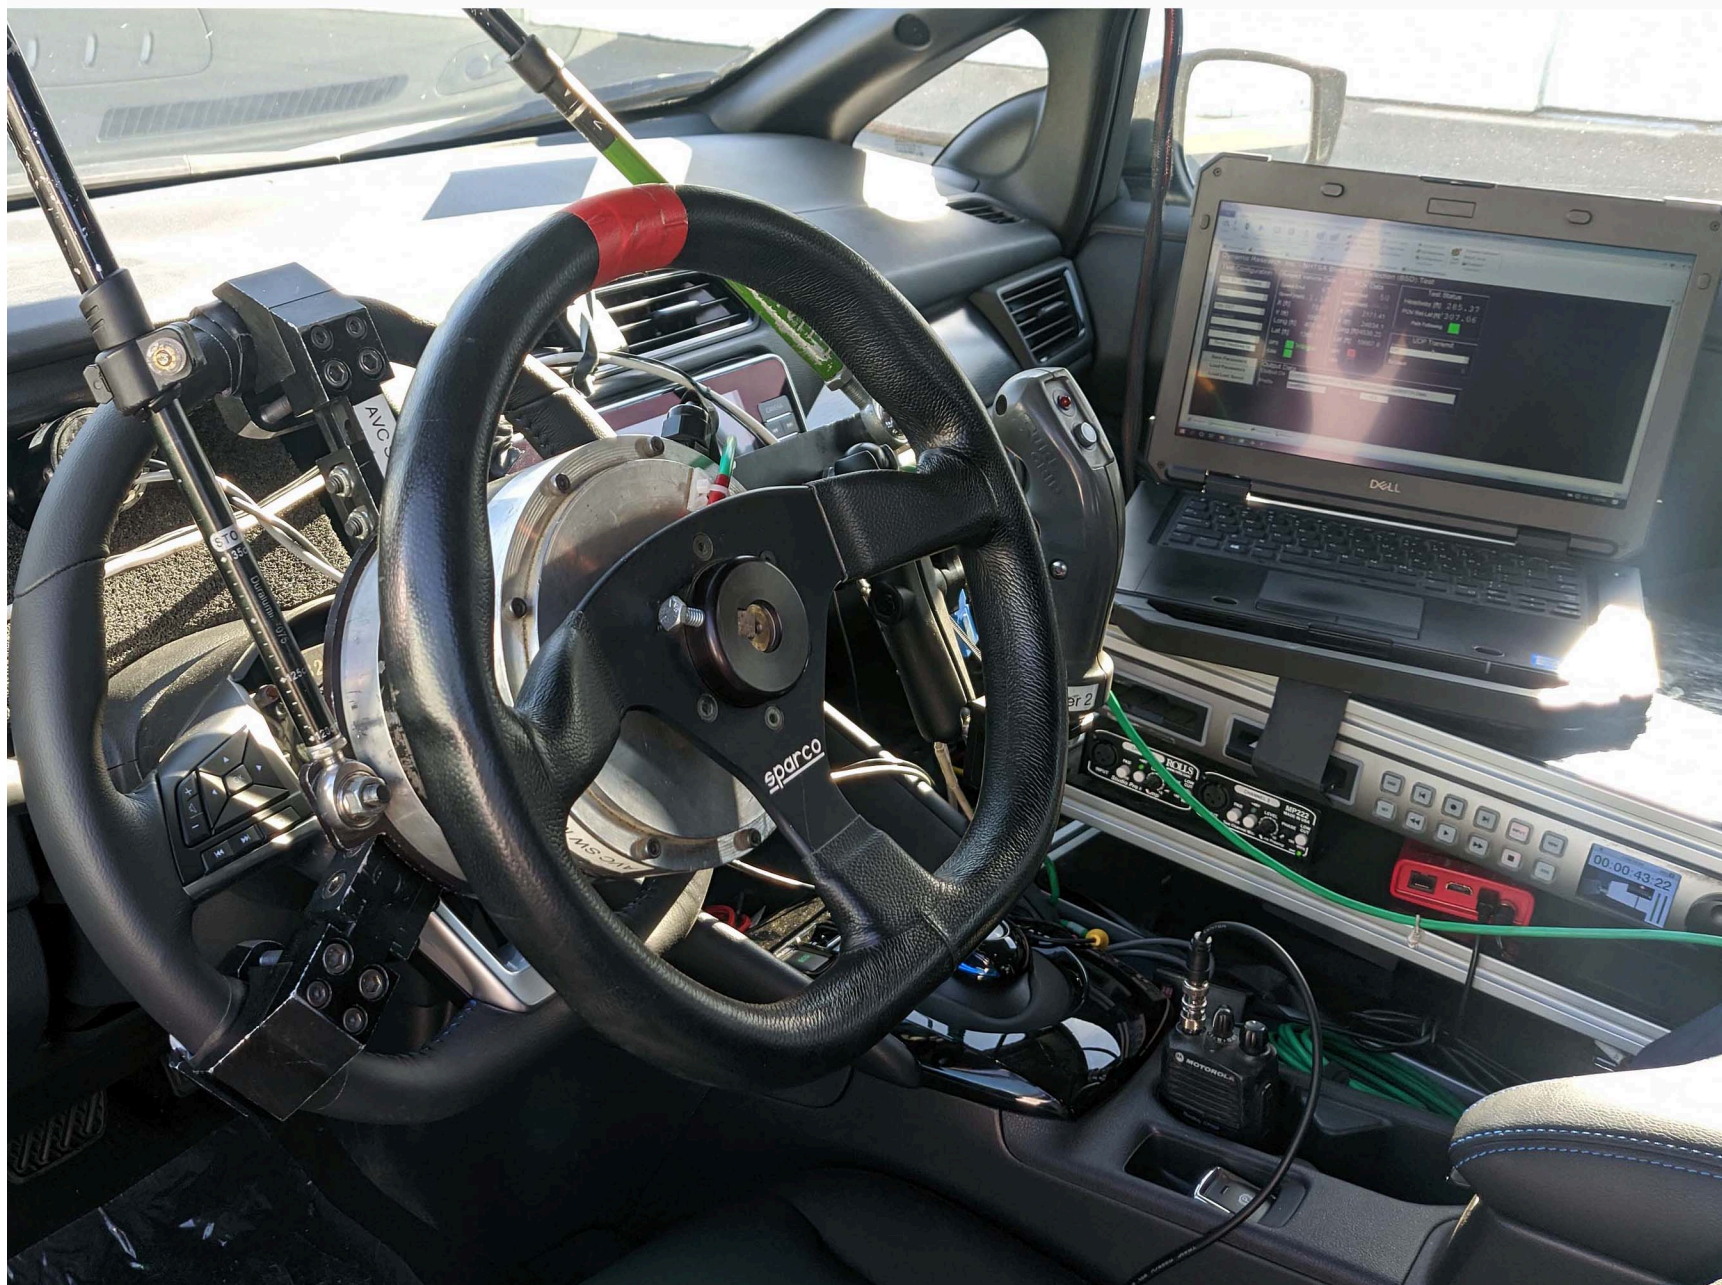
Figure A10. Computer and Steering Controller Installed in Subject Vehicle

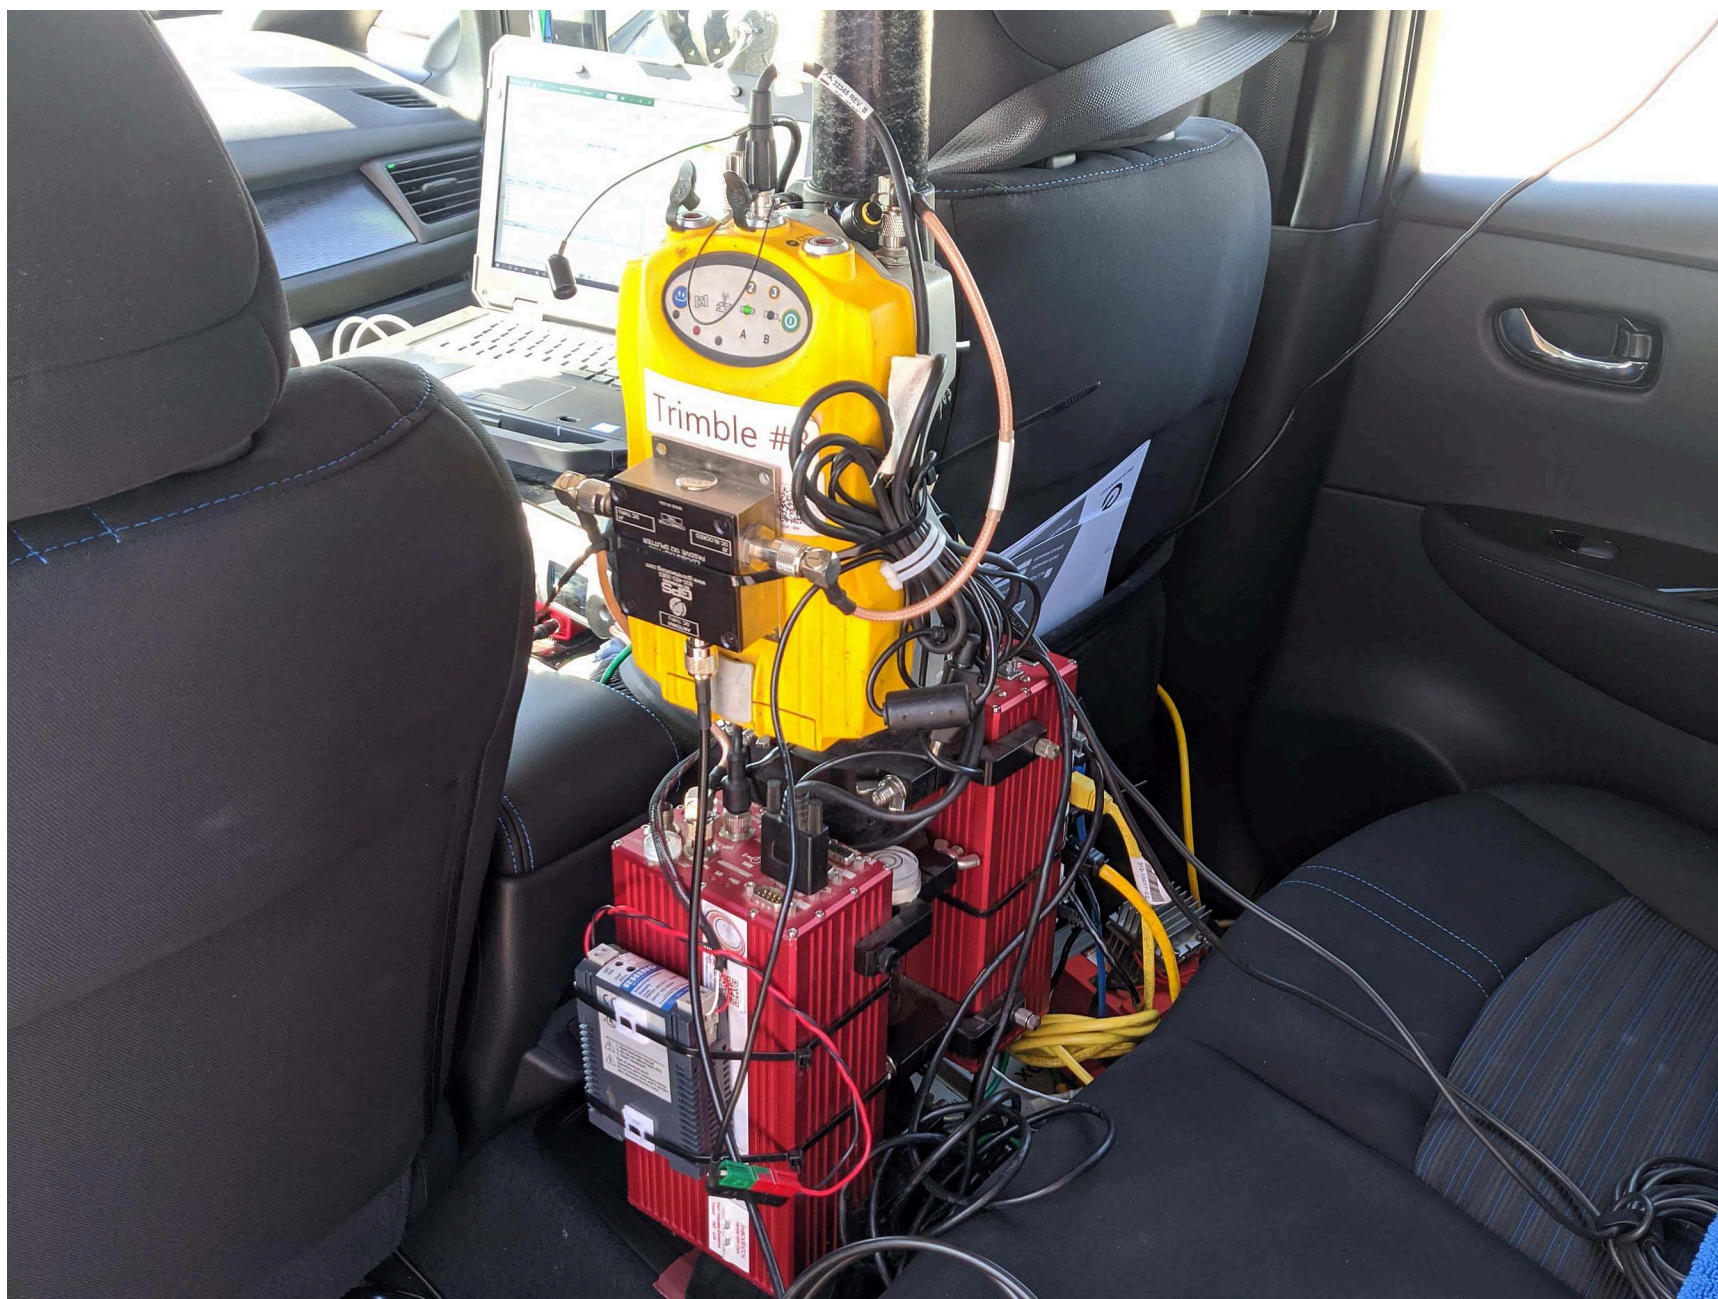
Figure A11. DGPS, Inertial Measurement Unit, and MicroAutoBox Installed in Subject Vehicle

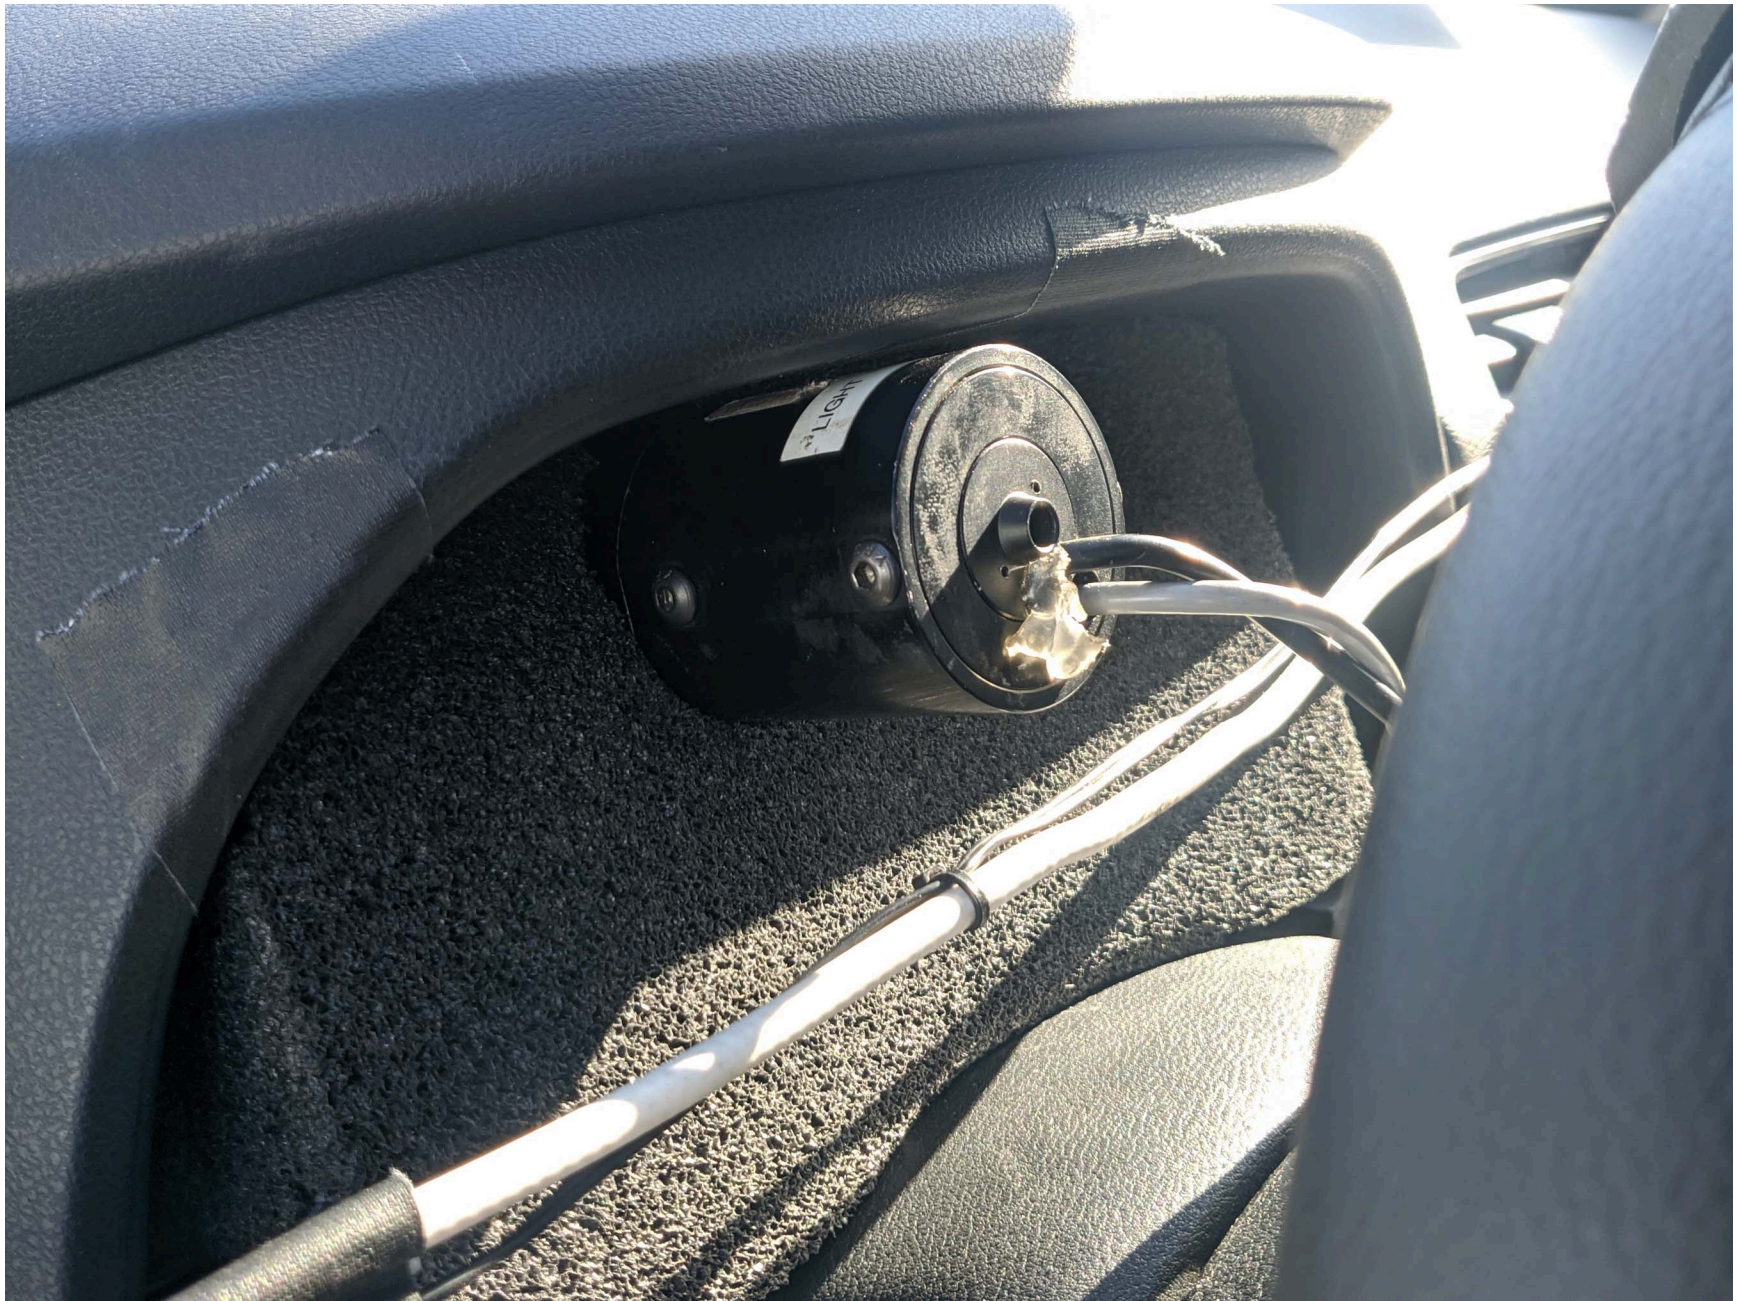
Figure A12. Sensor for Detecting Visual Alerts

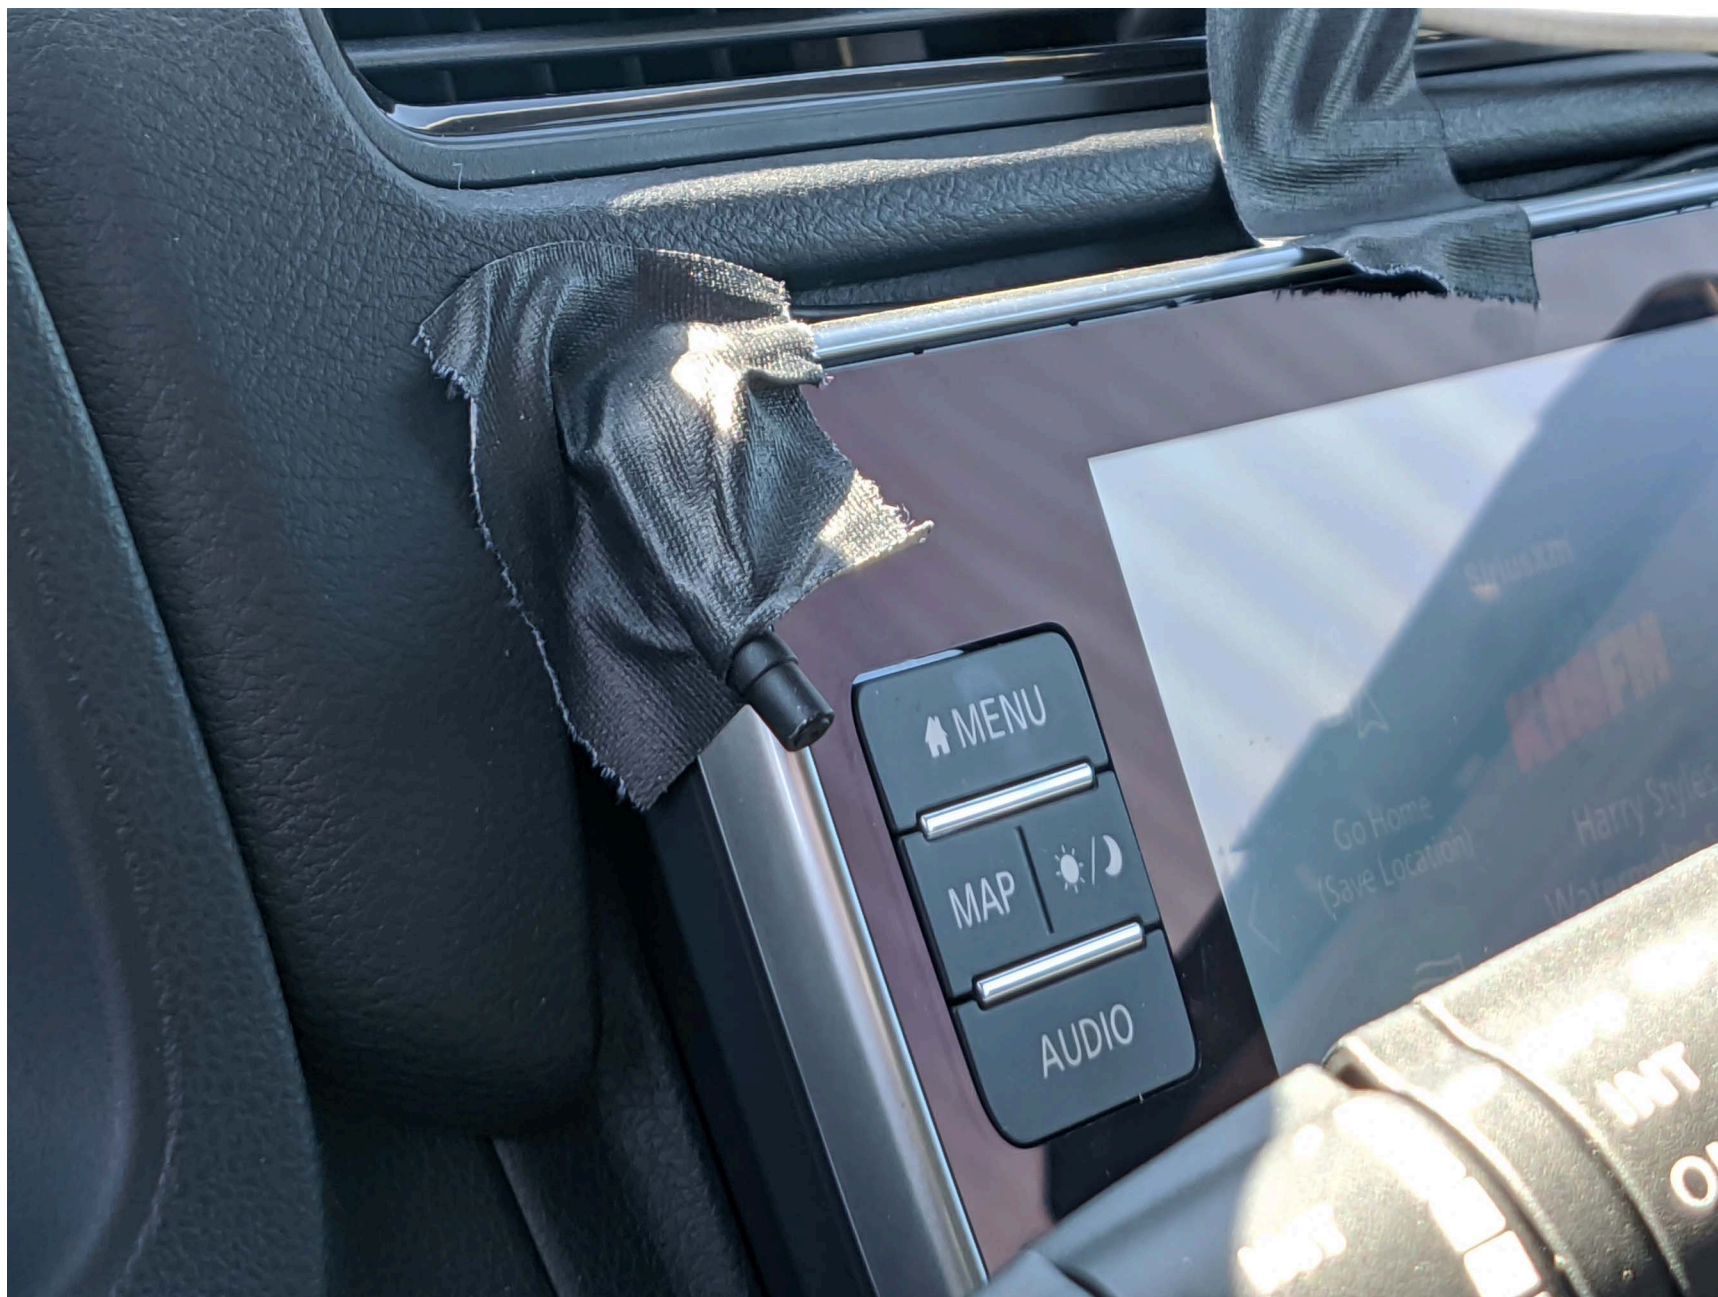
Figure A13. Sensor for Detecting Auditory Alerts
