**BLIND SPOT INTERVENTION SYSTEM CONFIRMATION TEST  
NCAP-DRI-BSI-20-09**

**2020 Volkswagen Jetta 1.4T SEL**

**DYNAMIC RESEARCH, INC.**

**Final Report**

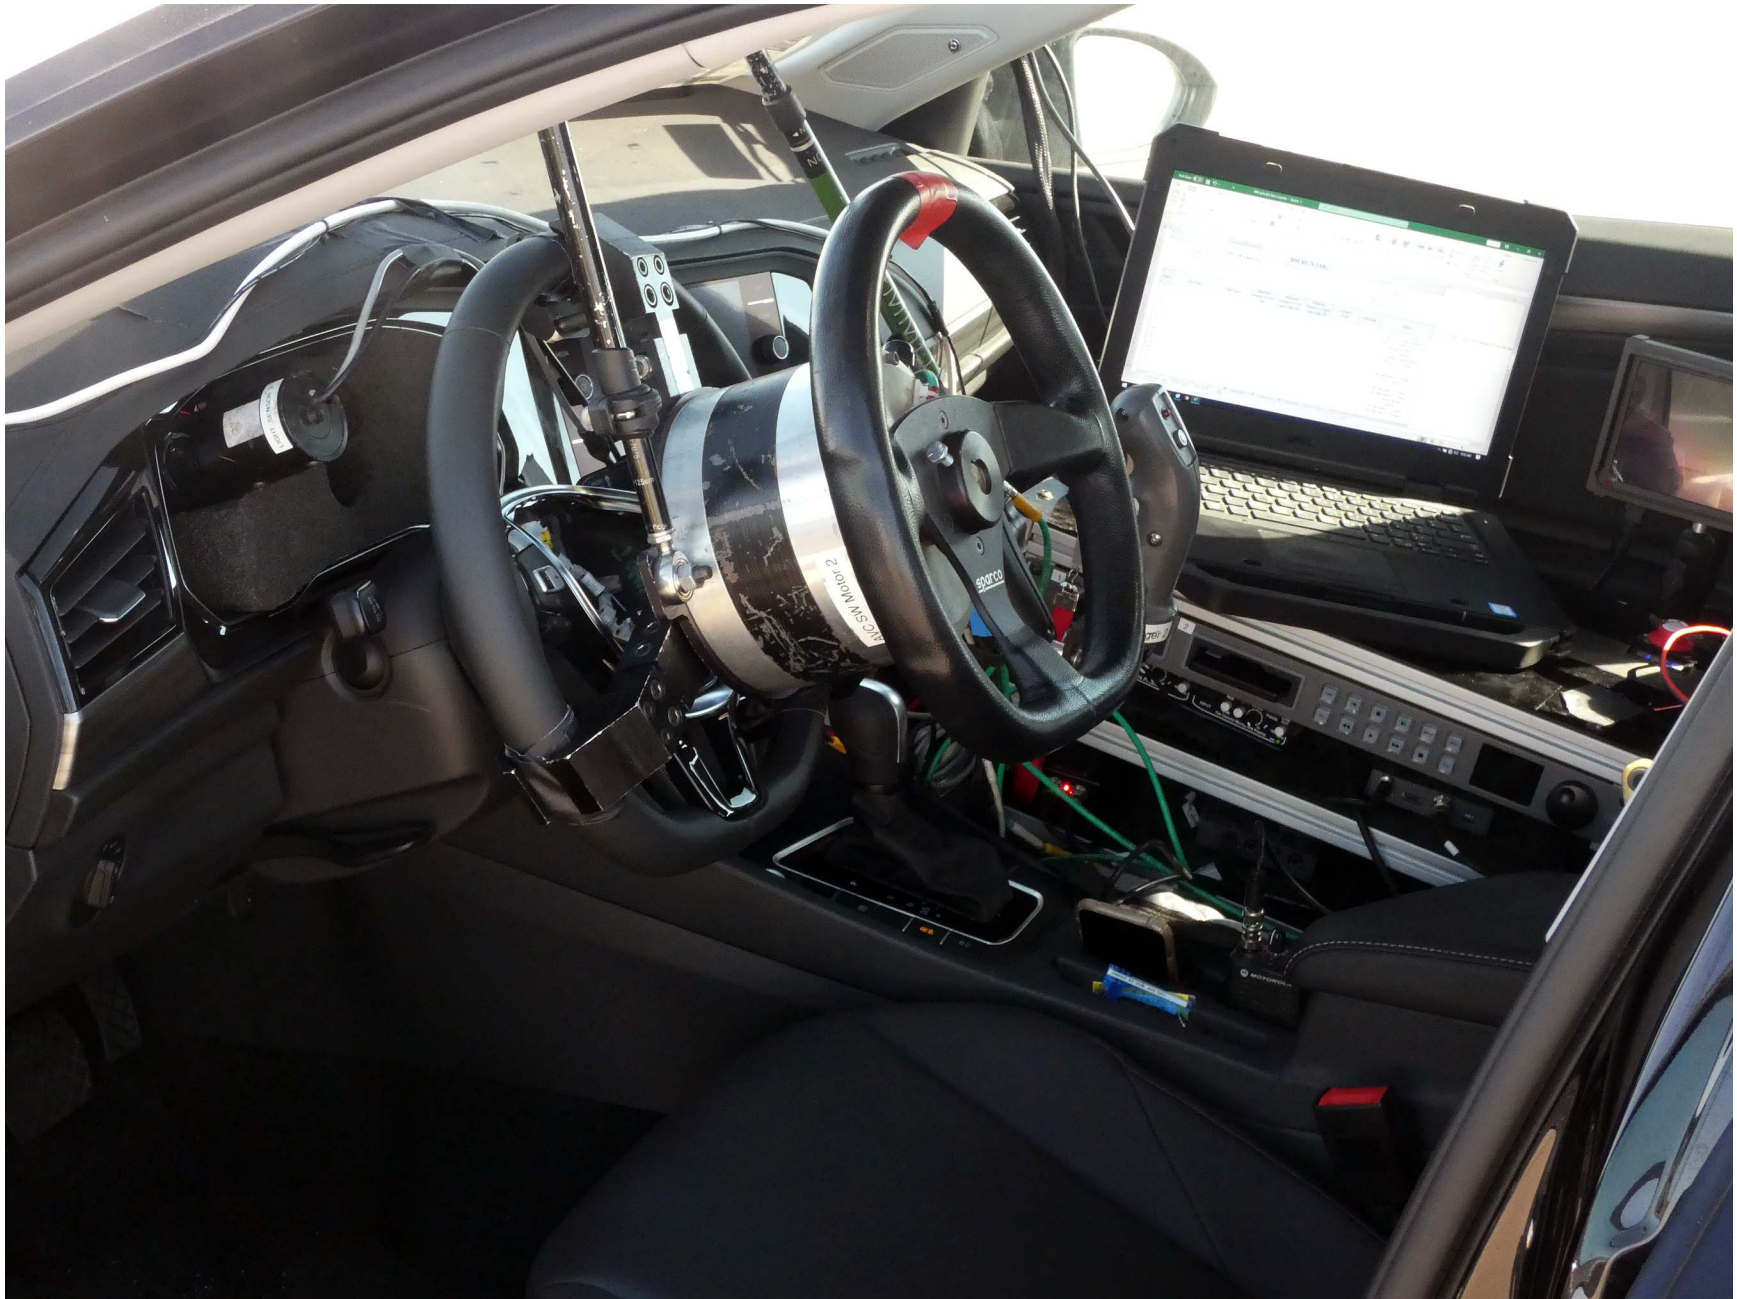
Figure A10. Computer and Steering Controller Installed in Subject Vehicle

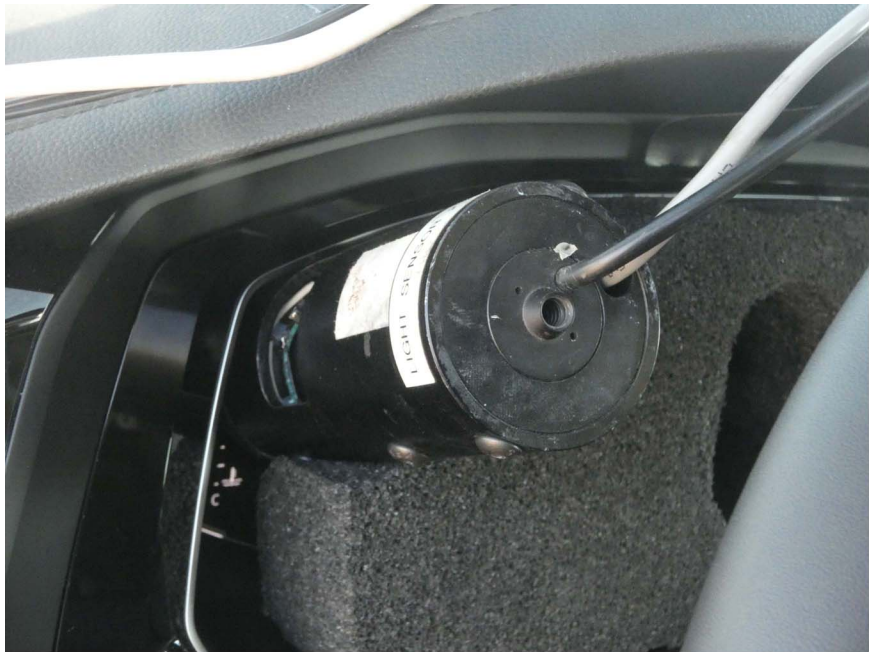
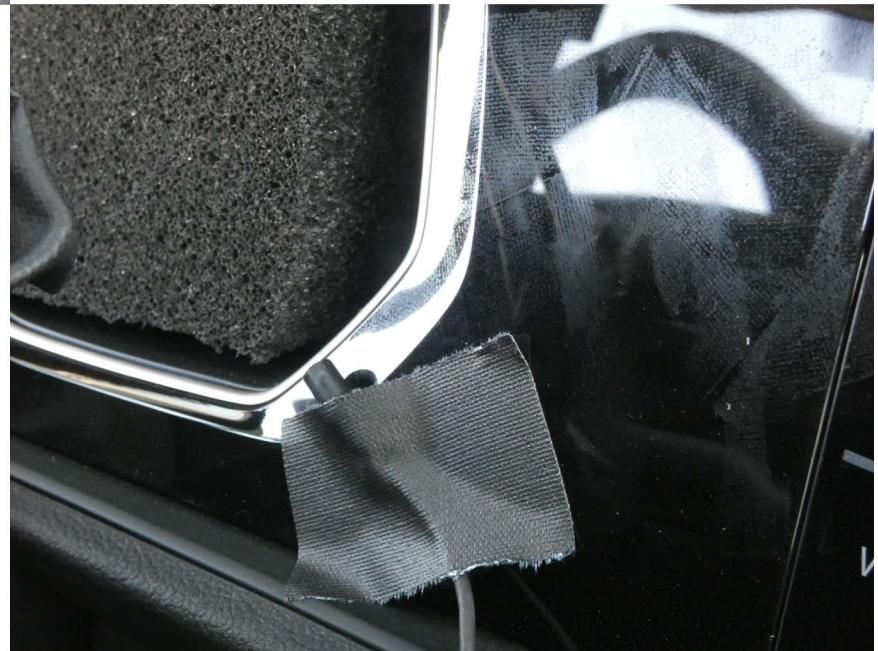
Figure A12. Sensors for Detecting Visual and Auditory Alerts

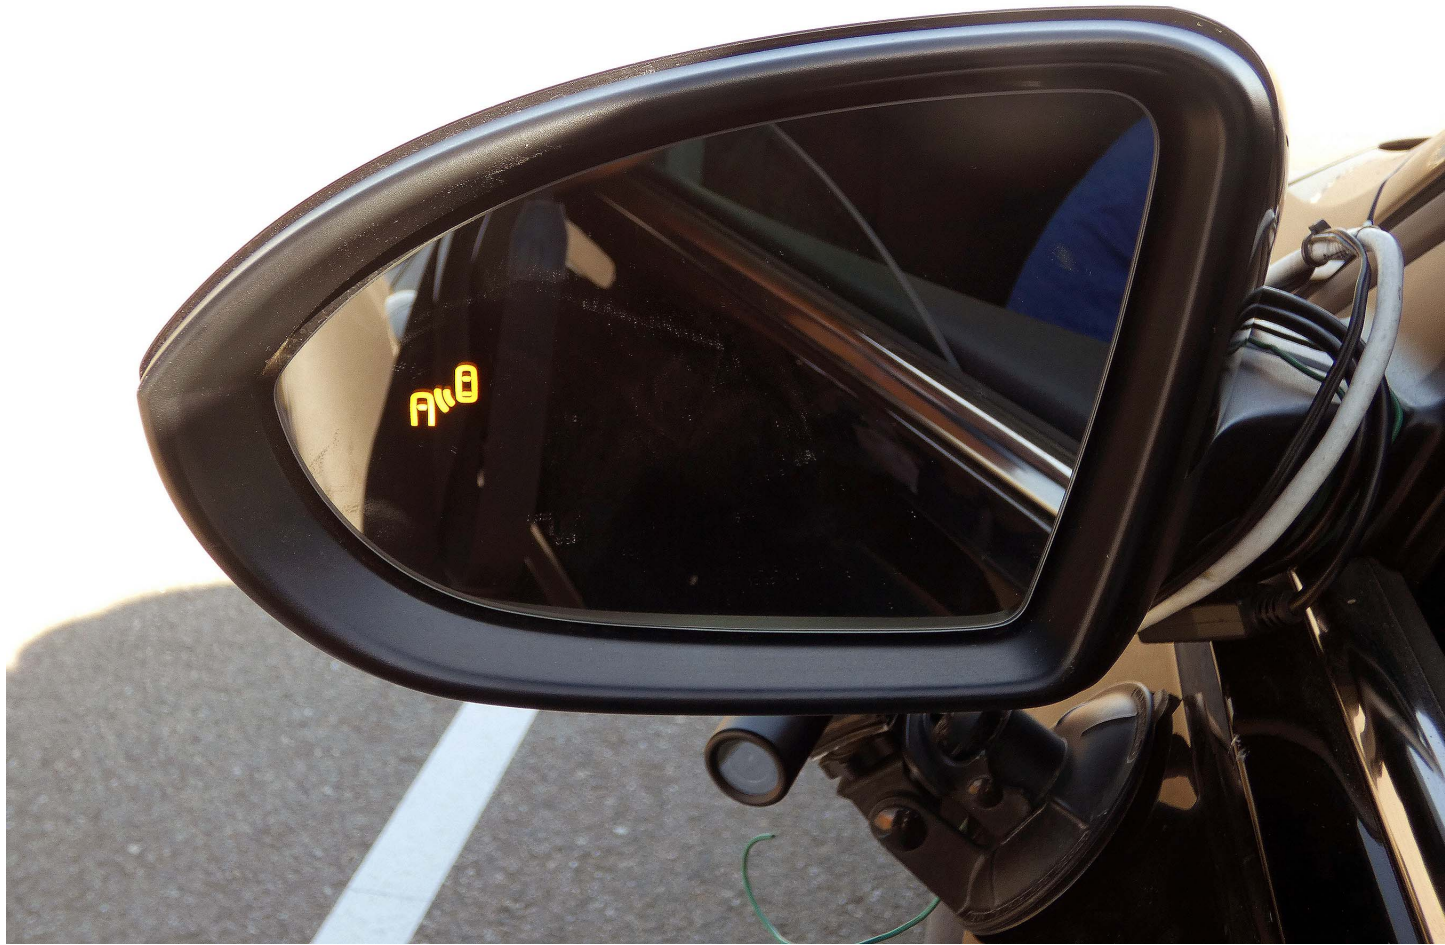
Figure A16. Visual Alert
