**BLIND SPOT INTERVENTION SYSTEM CONFIRMATION TEST  
NCAP-DRI-BSI-20-10-1**

**2020 Volvo S60 T6 AWD Momentum**

**DYNAMIC RESEARCH, INC.**

**Final Report**

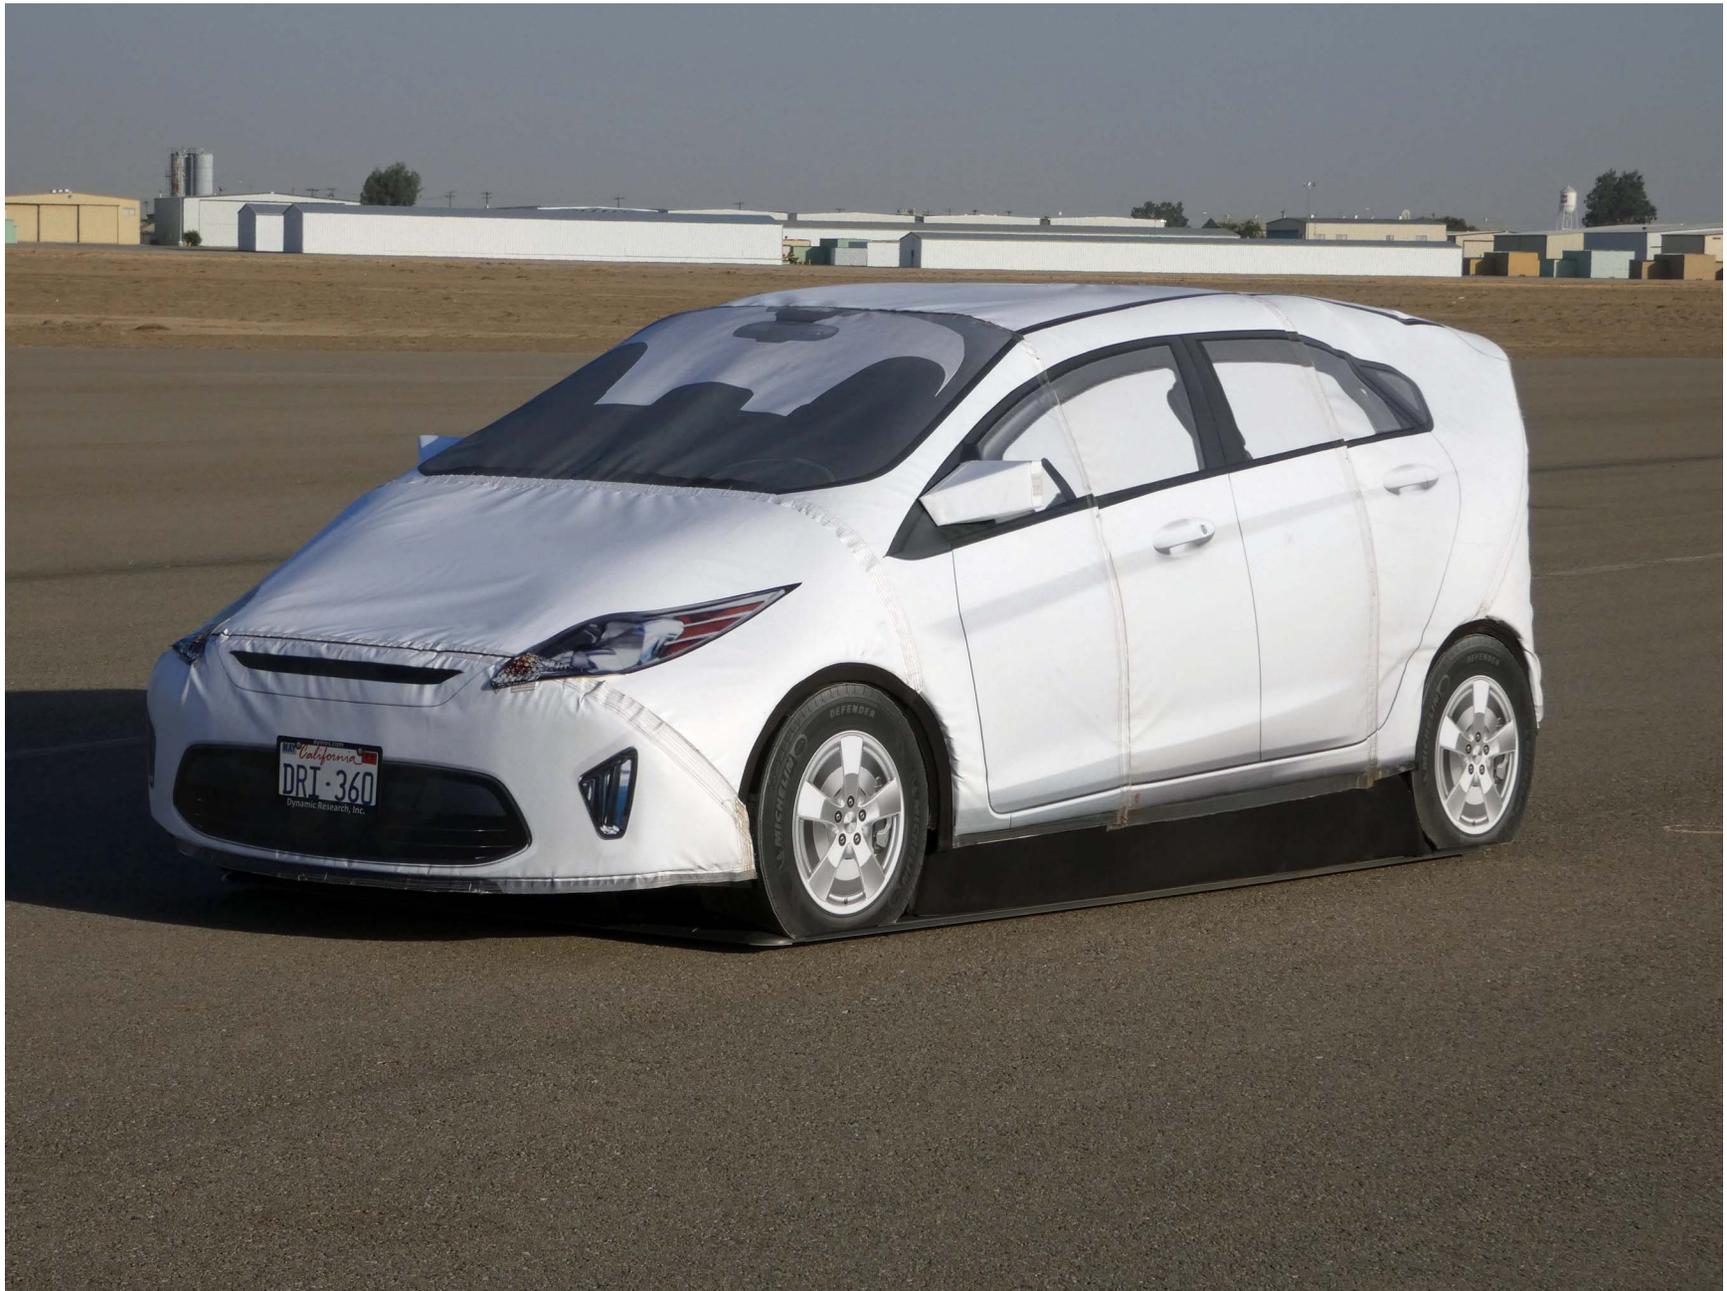
Figure A6. Front View of Principal Other Vehicle - GVT (Tests 1 and 2)

Operationally, the GVT body is attached to LPRV using Velcro hook and loop fasteners. The GVT and LPRV are designed to separate if the GVT is struck by the SV. The GVT/LPRV system is shown in Figures A6 and A7 in Appendix A and a detailed description can be found in the NHTSA report: “A Test Track Comparison of the Global Vehicle Target (GVT) and NHTSA’s Strikeable Surrogate Vehicle (SSV)”.<sup>3</sup>

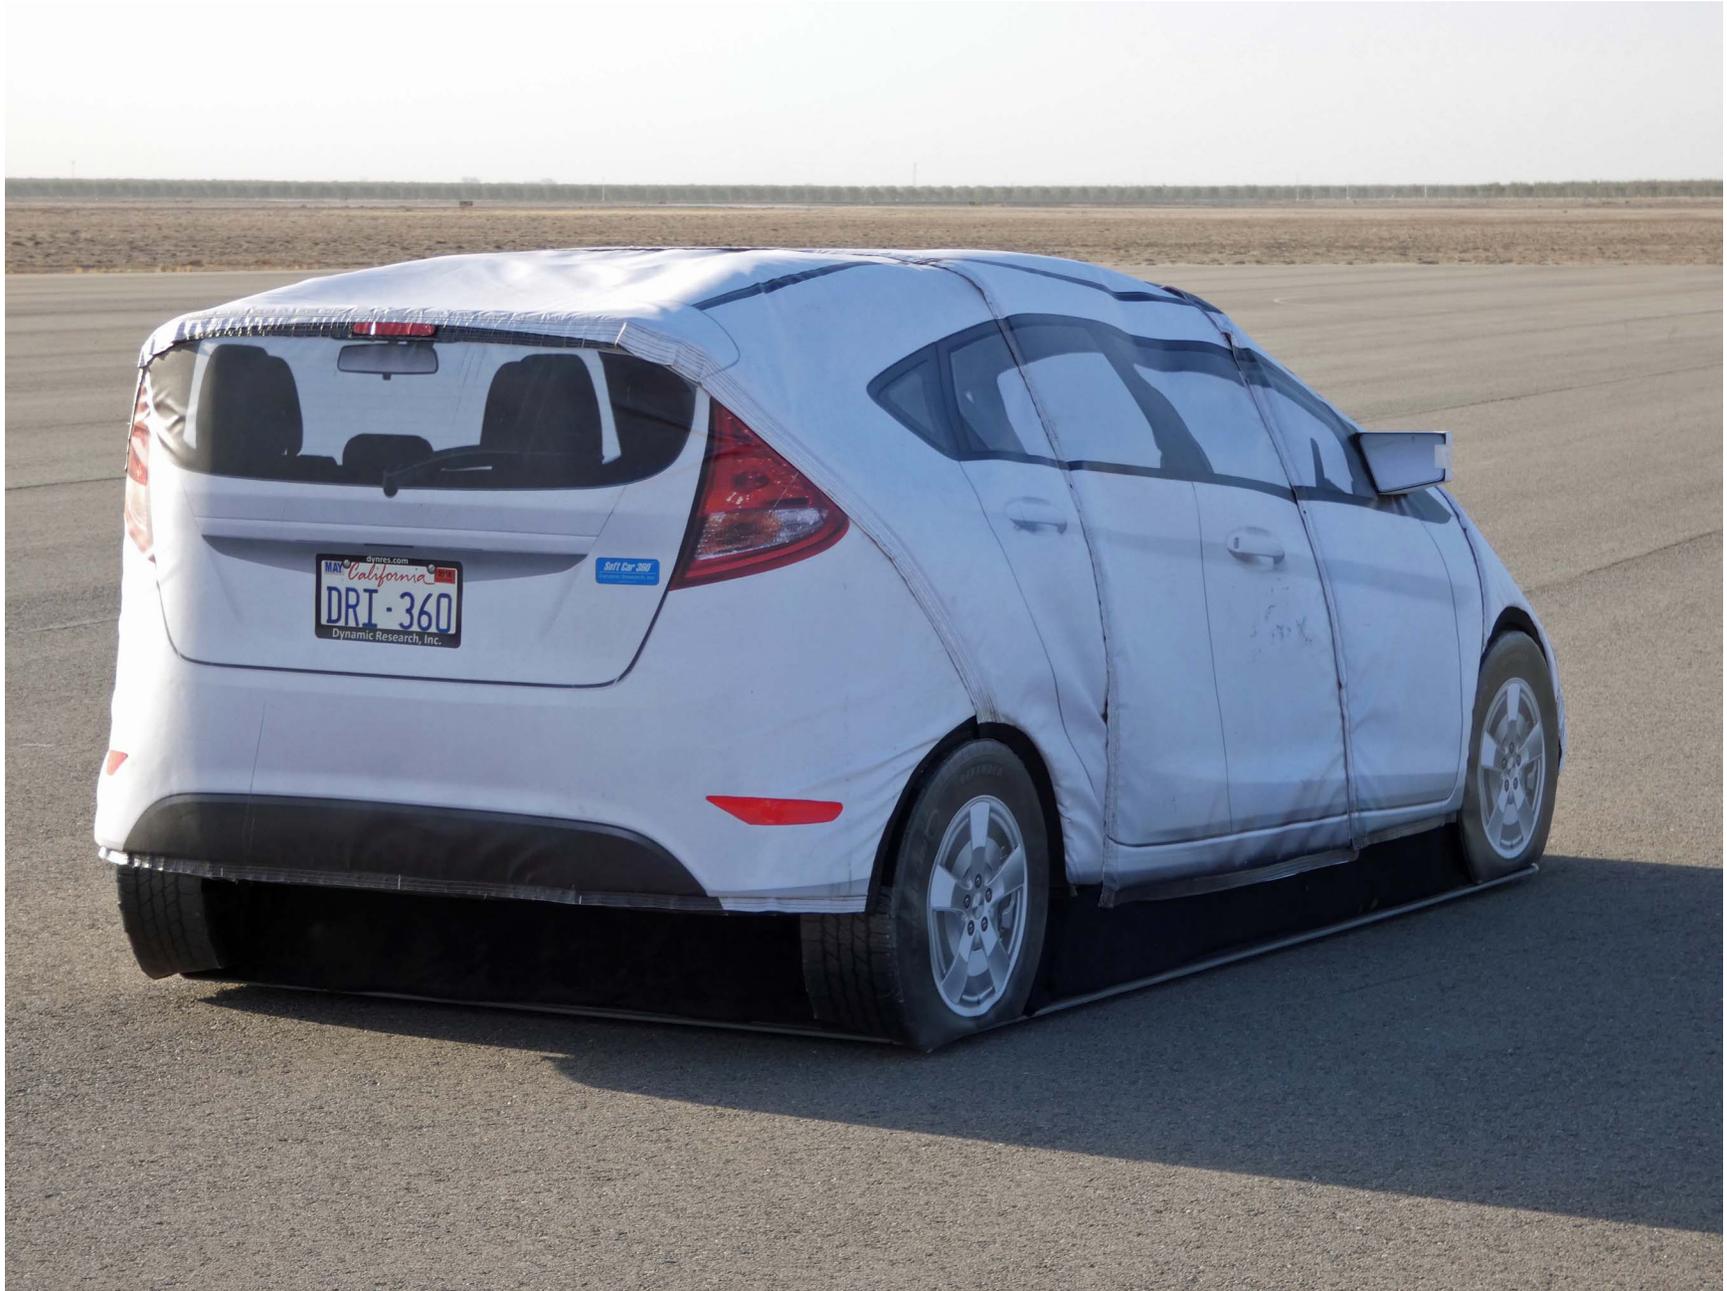
Figure A7. Rear View of Principal Other Vehicle - GVT (Tests 1 and 2)

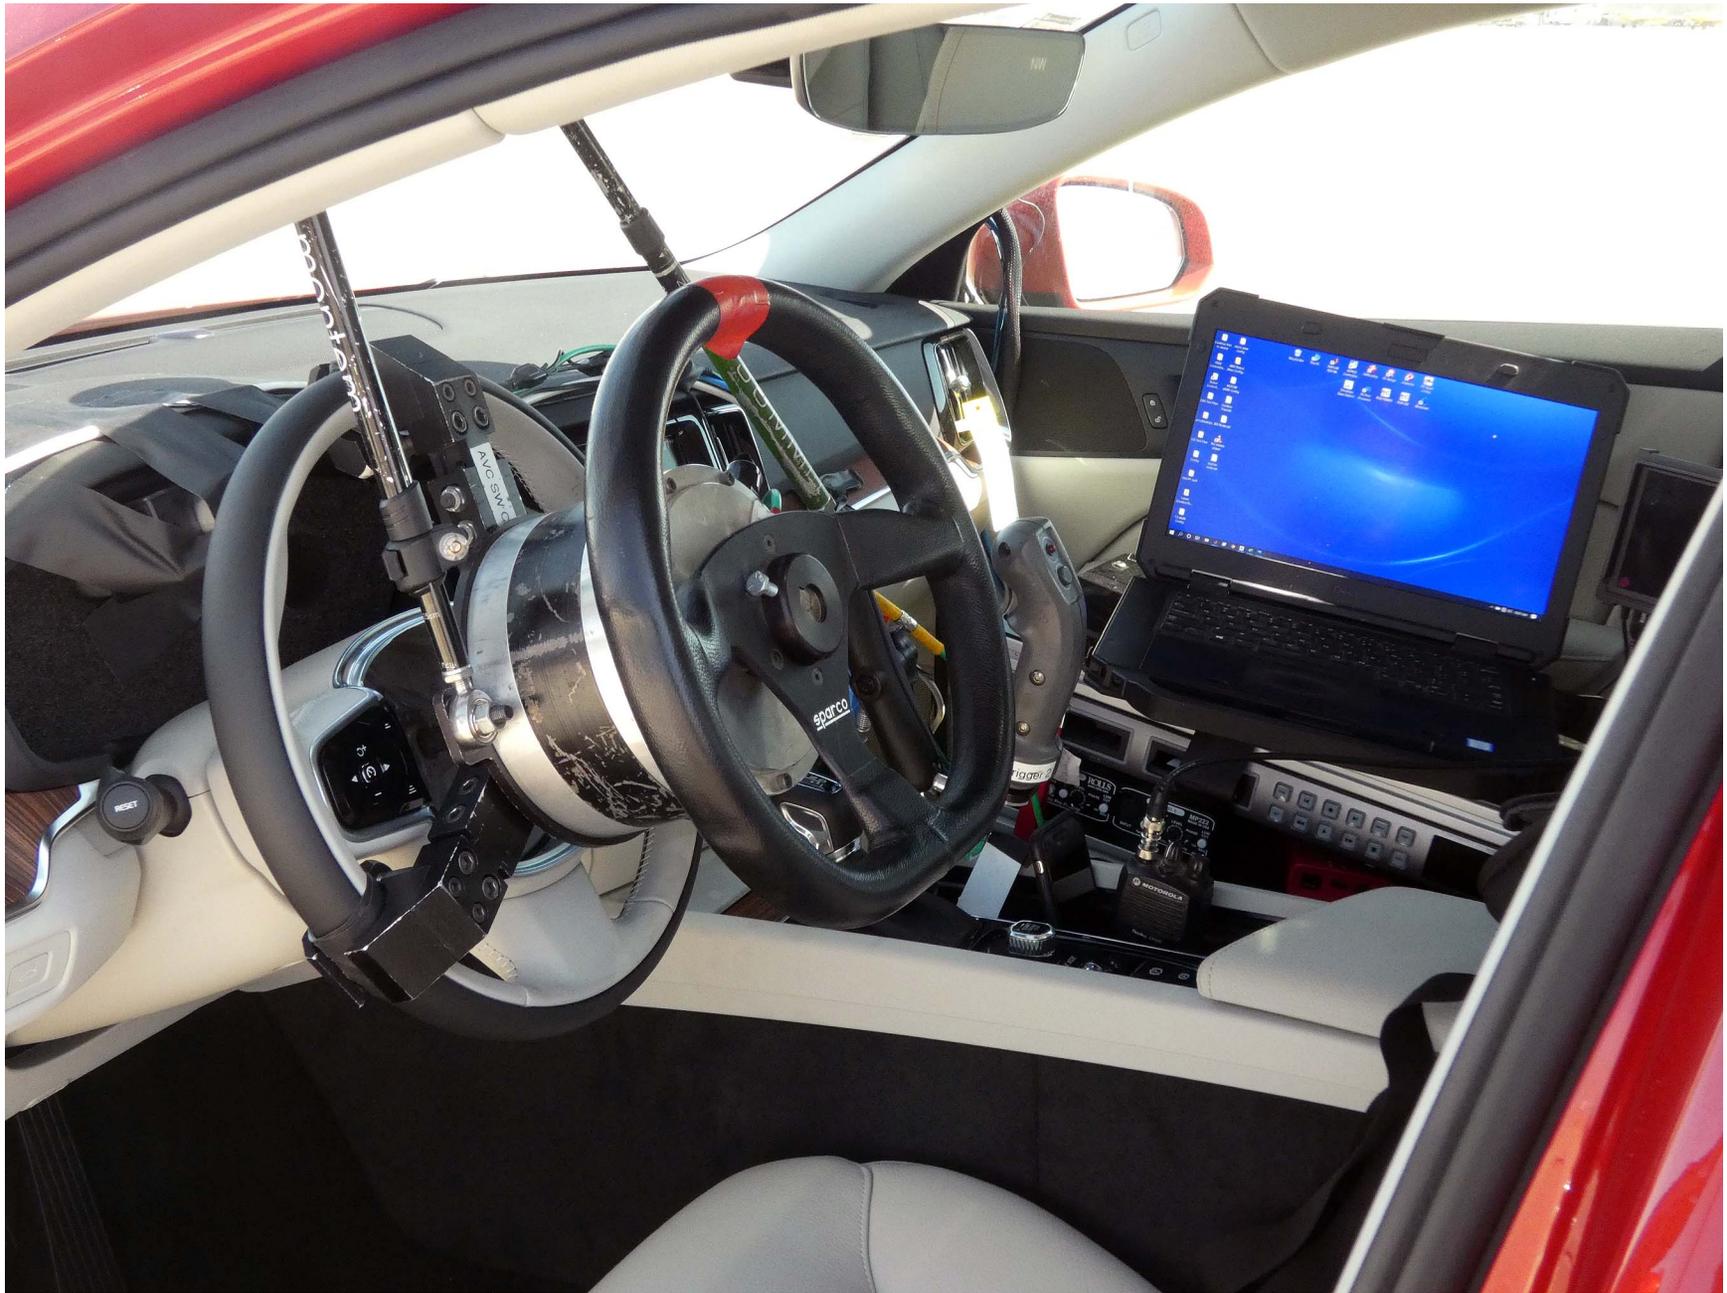
Figure A10. Computer and Steering Controller Installed in Subject Vehicle

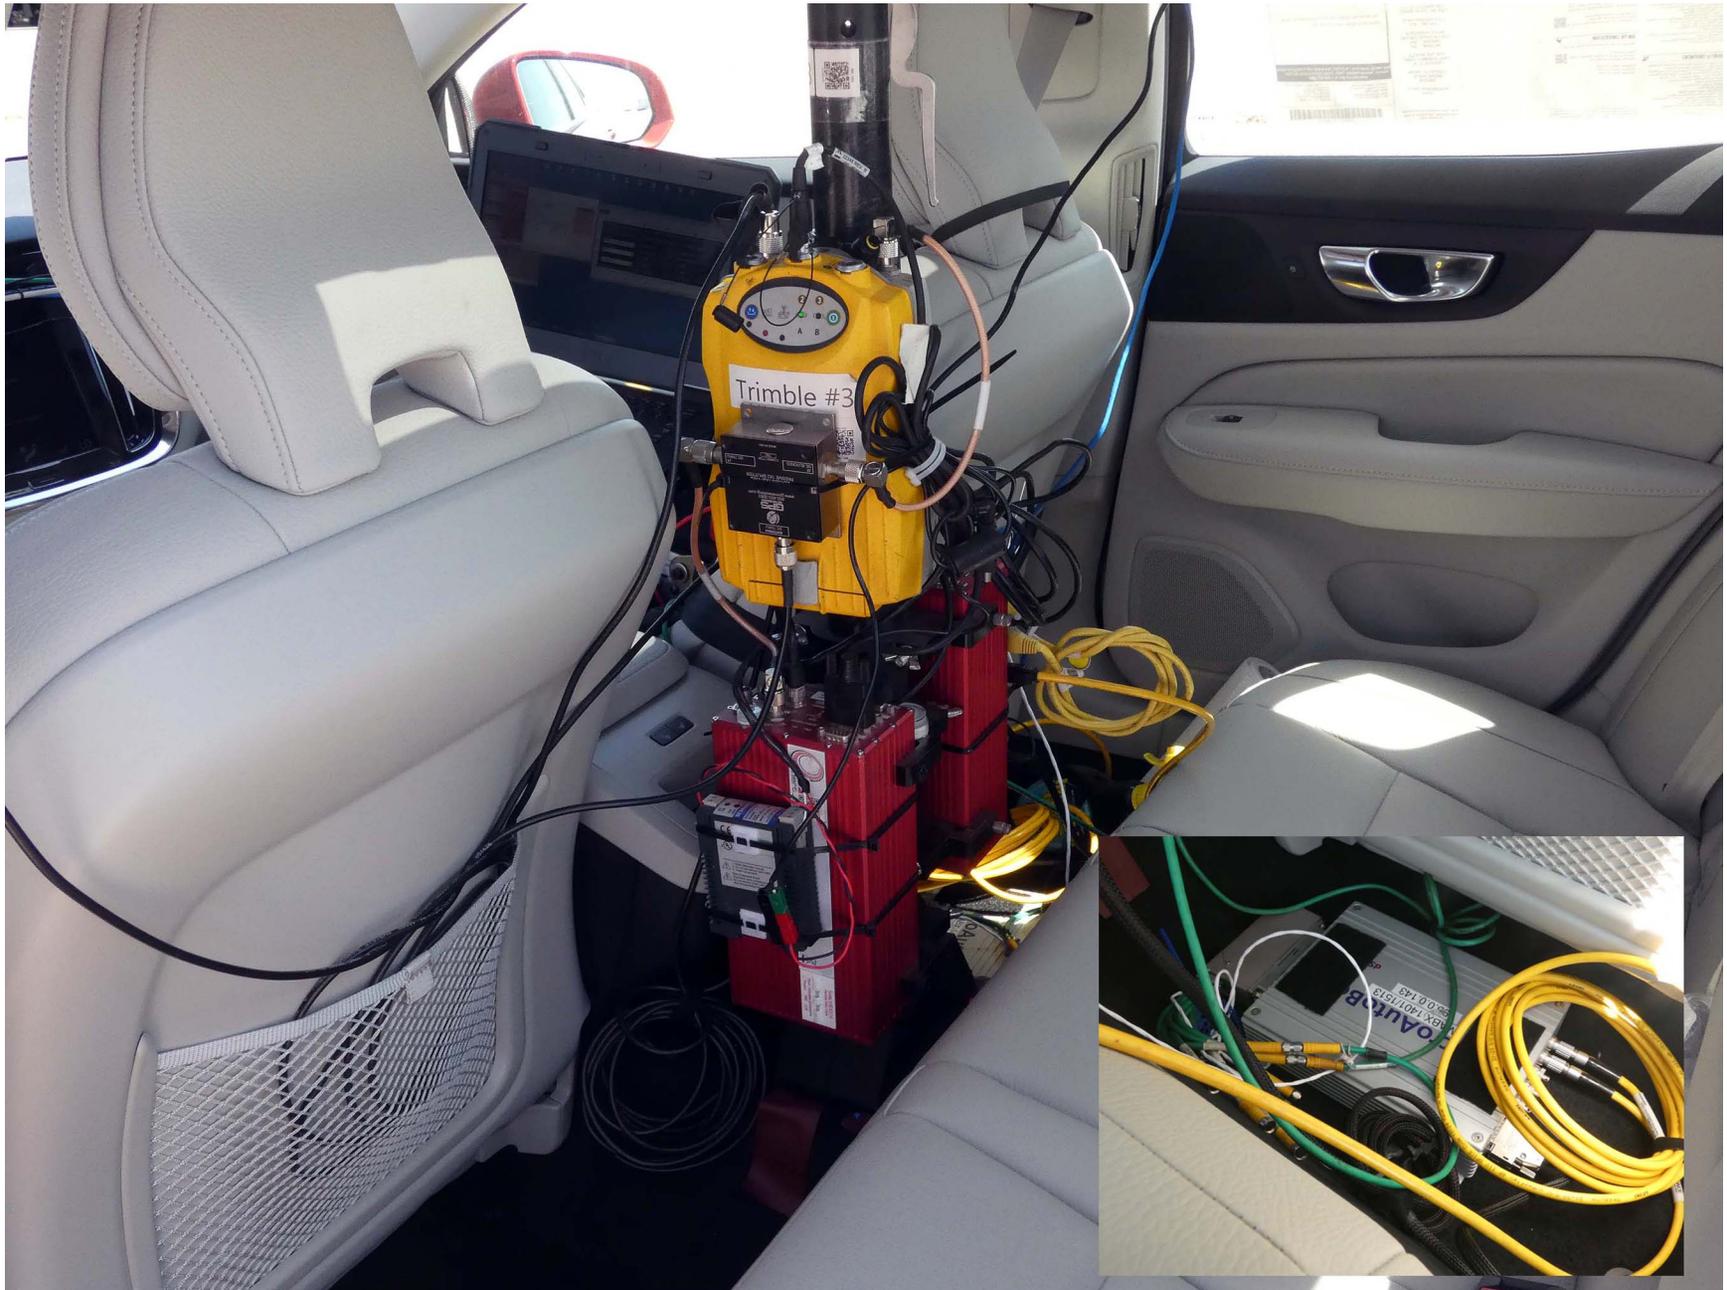
Figure A11. DGPS, Inertial Measurement Unit, and MicroAutoBox Installed in Subject Vehicle

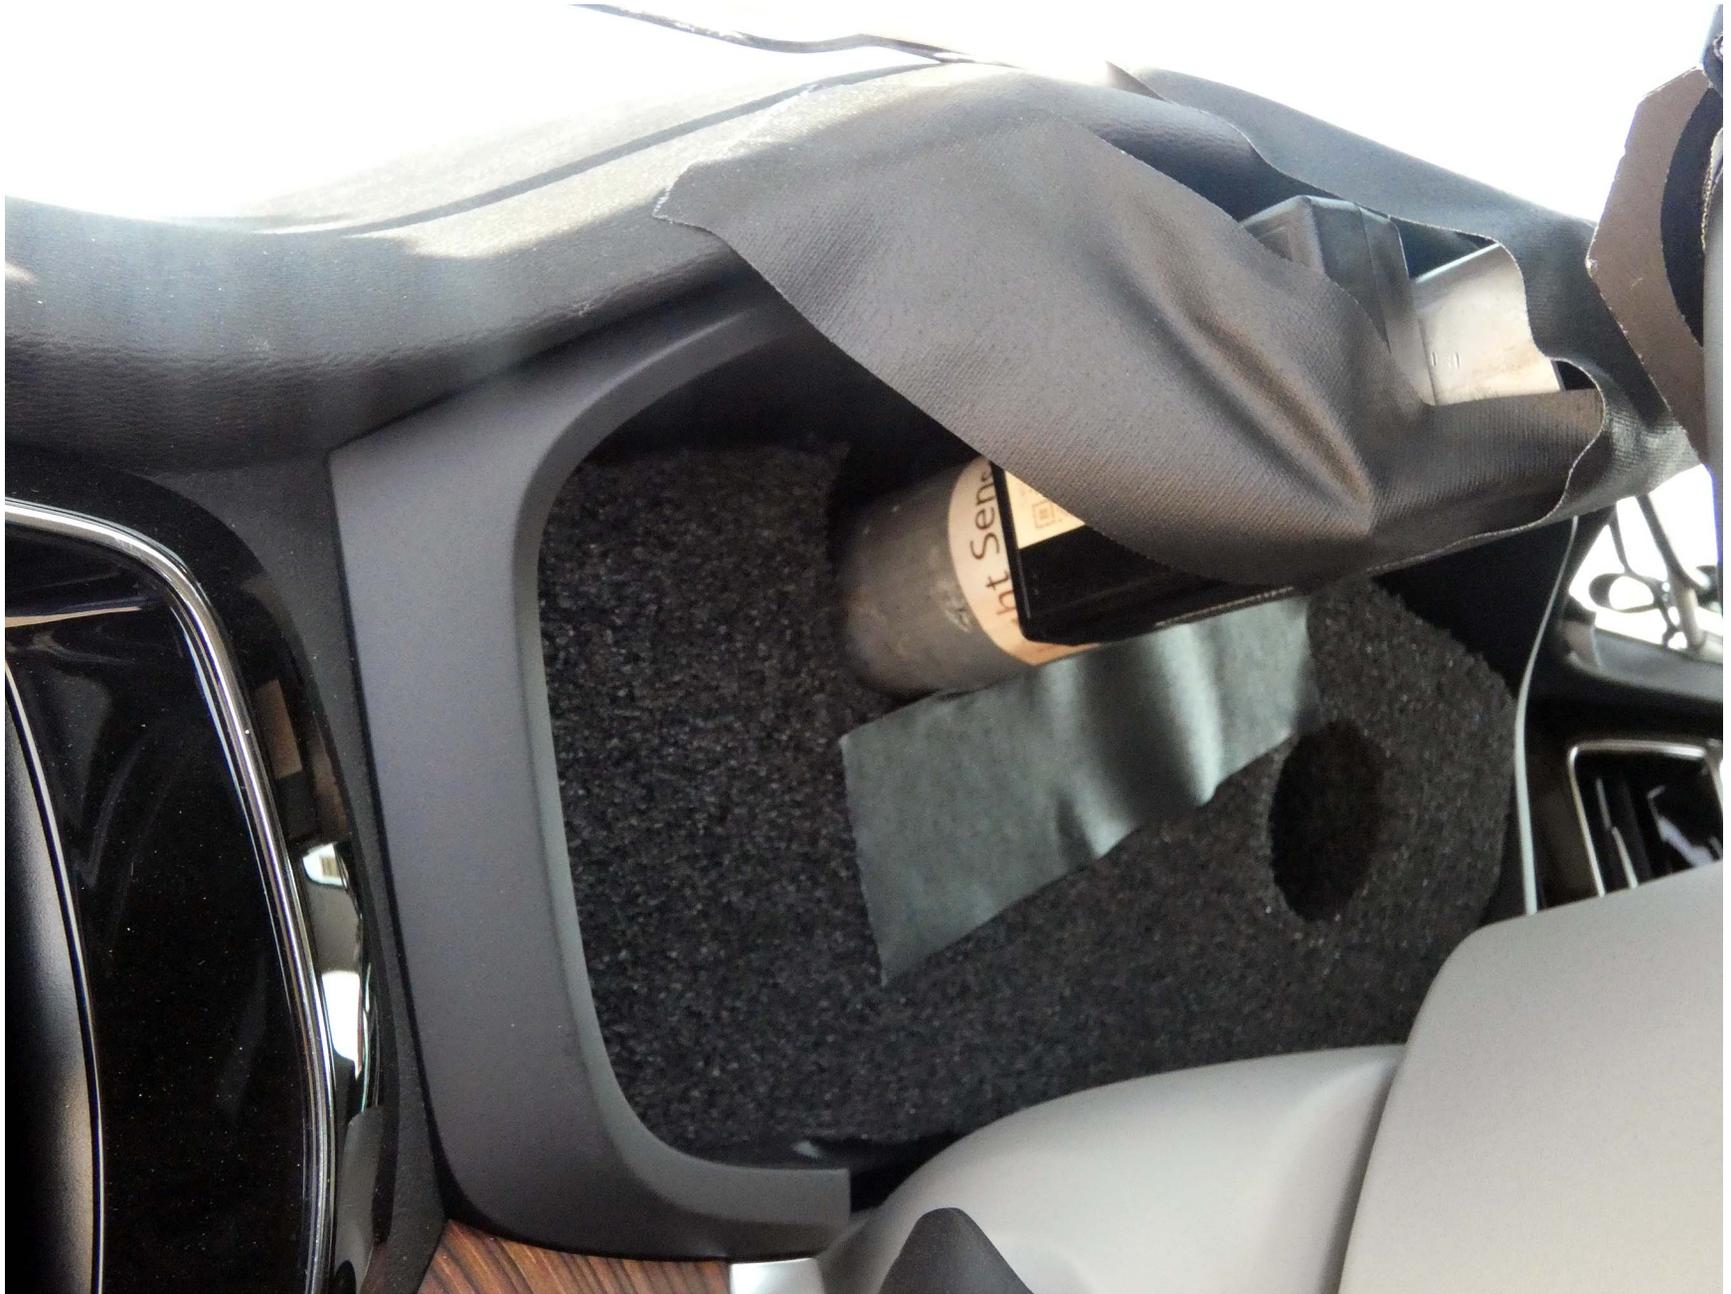
Figure A12. Sensor for Monitoring Turn Signal On/Off
