**CRASH IMMINENT BRAKING SYSTEM RESEARCH TEST
NCAP-DRI-CIBHS-20-11**

2020 Hyundai Palisade SEL FWD

Final Report

1. Report No. NCAP-DRI-CIBHS-20-11	2. Government Accession No.	3. Recipient's Catalog No.	
4. Title and Subtitle Final Report of Crash Imminent Braking System Research Test of a 2020 Hyundai Palisade SEL FWD.		5. Report Date 8 December 2020

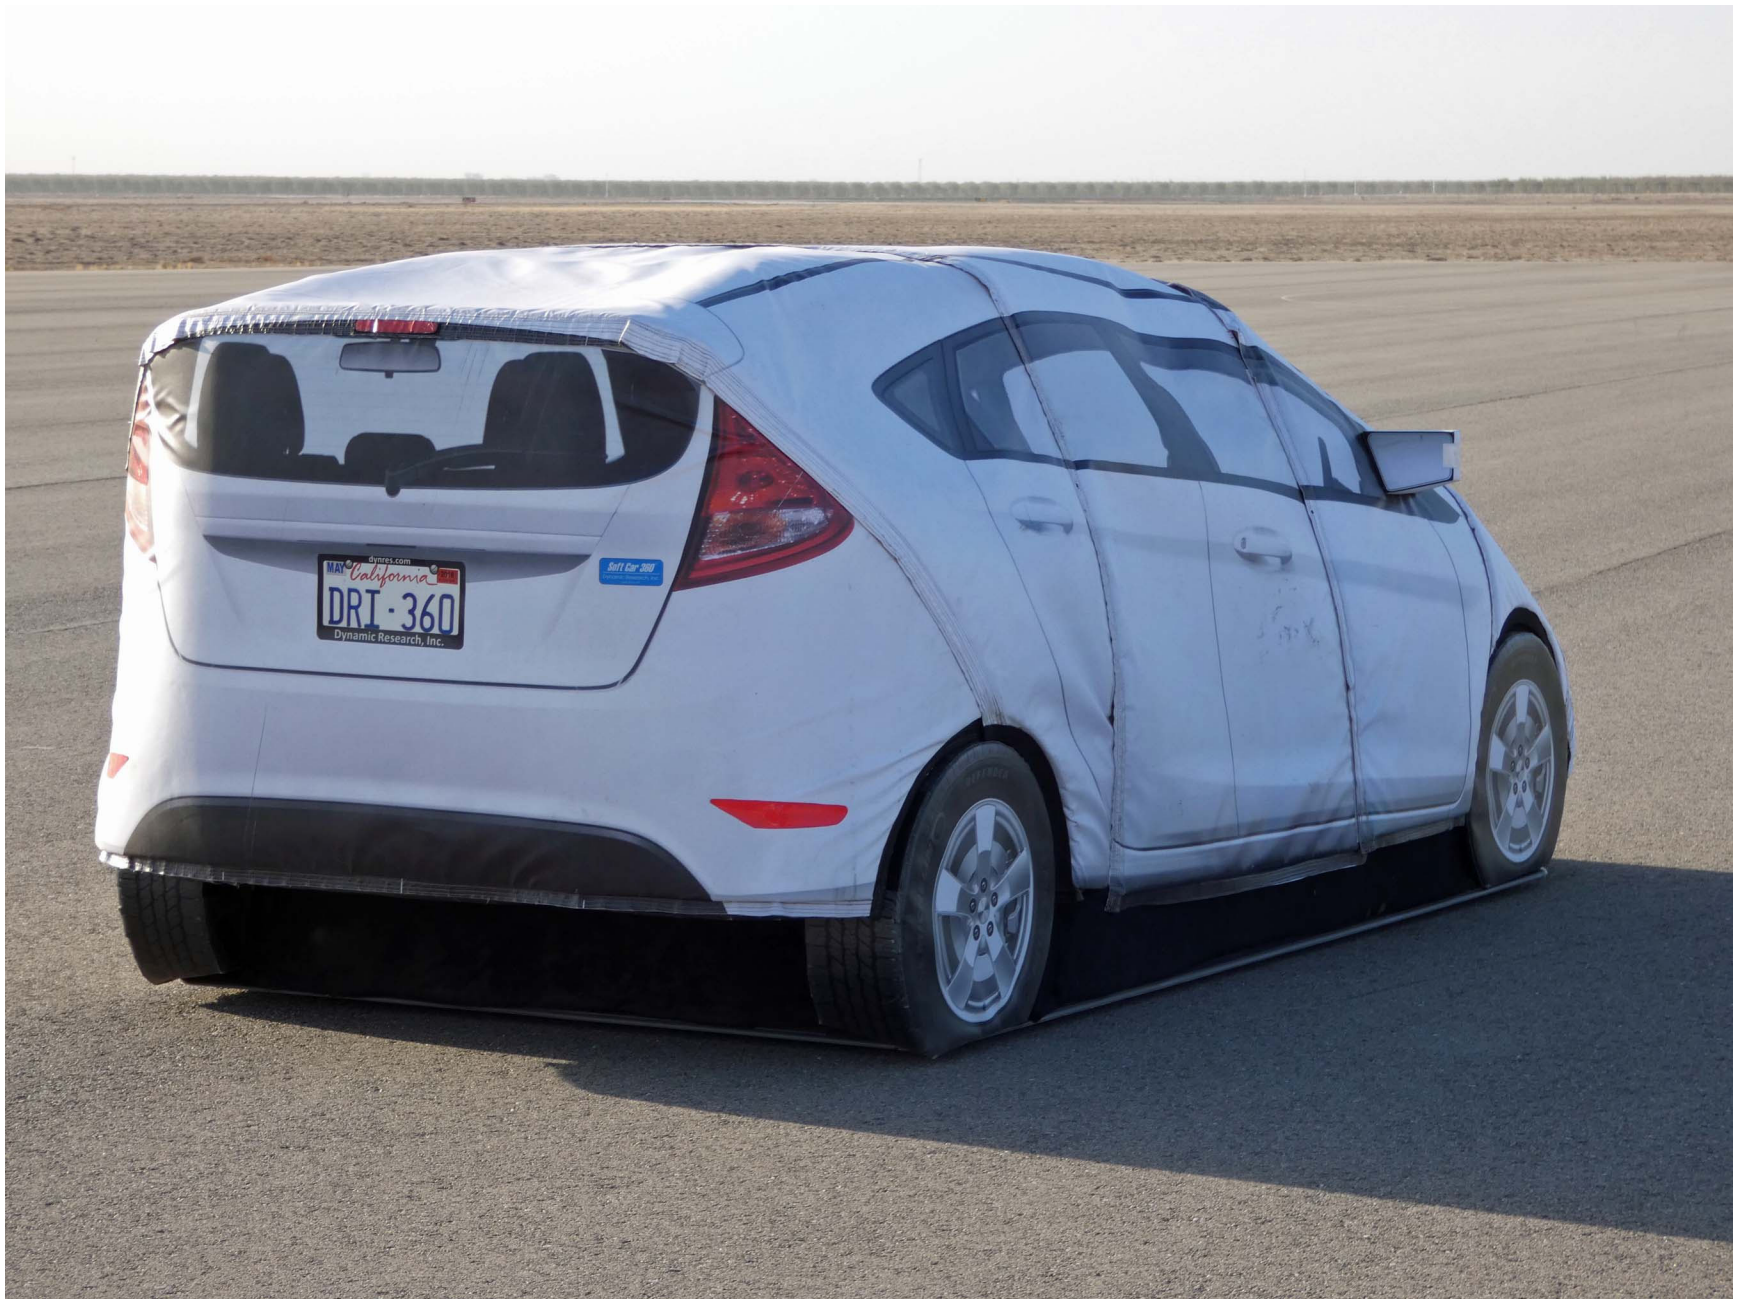
Figure A7. Rear View of Principal Other Vehicle: Global Vehicle Target

Operationally, the GVT body is attached to LPRV using Velcro hook and loop fasteners. The GVT and LPRV are designed to separate if the GVT is struck by the SV. The GVT/LPRV system is shown in Figures A6 and A7 in Appendix A and a detailed description can be found in the NHTSA report: "A Test Track Comparison of the Global Vehicle Target (GVT) and NHTSA's Strikeable Surrogate Vehicle (SSV)".⁴

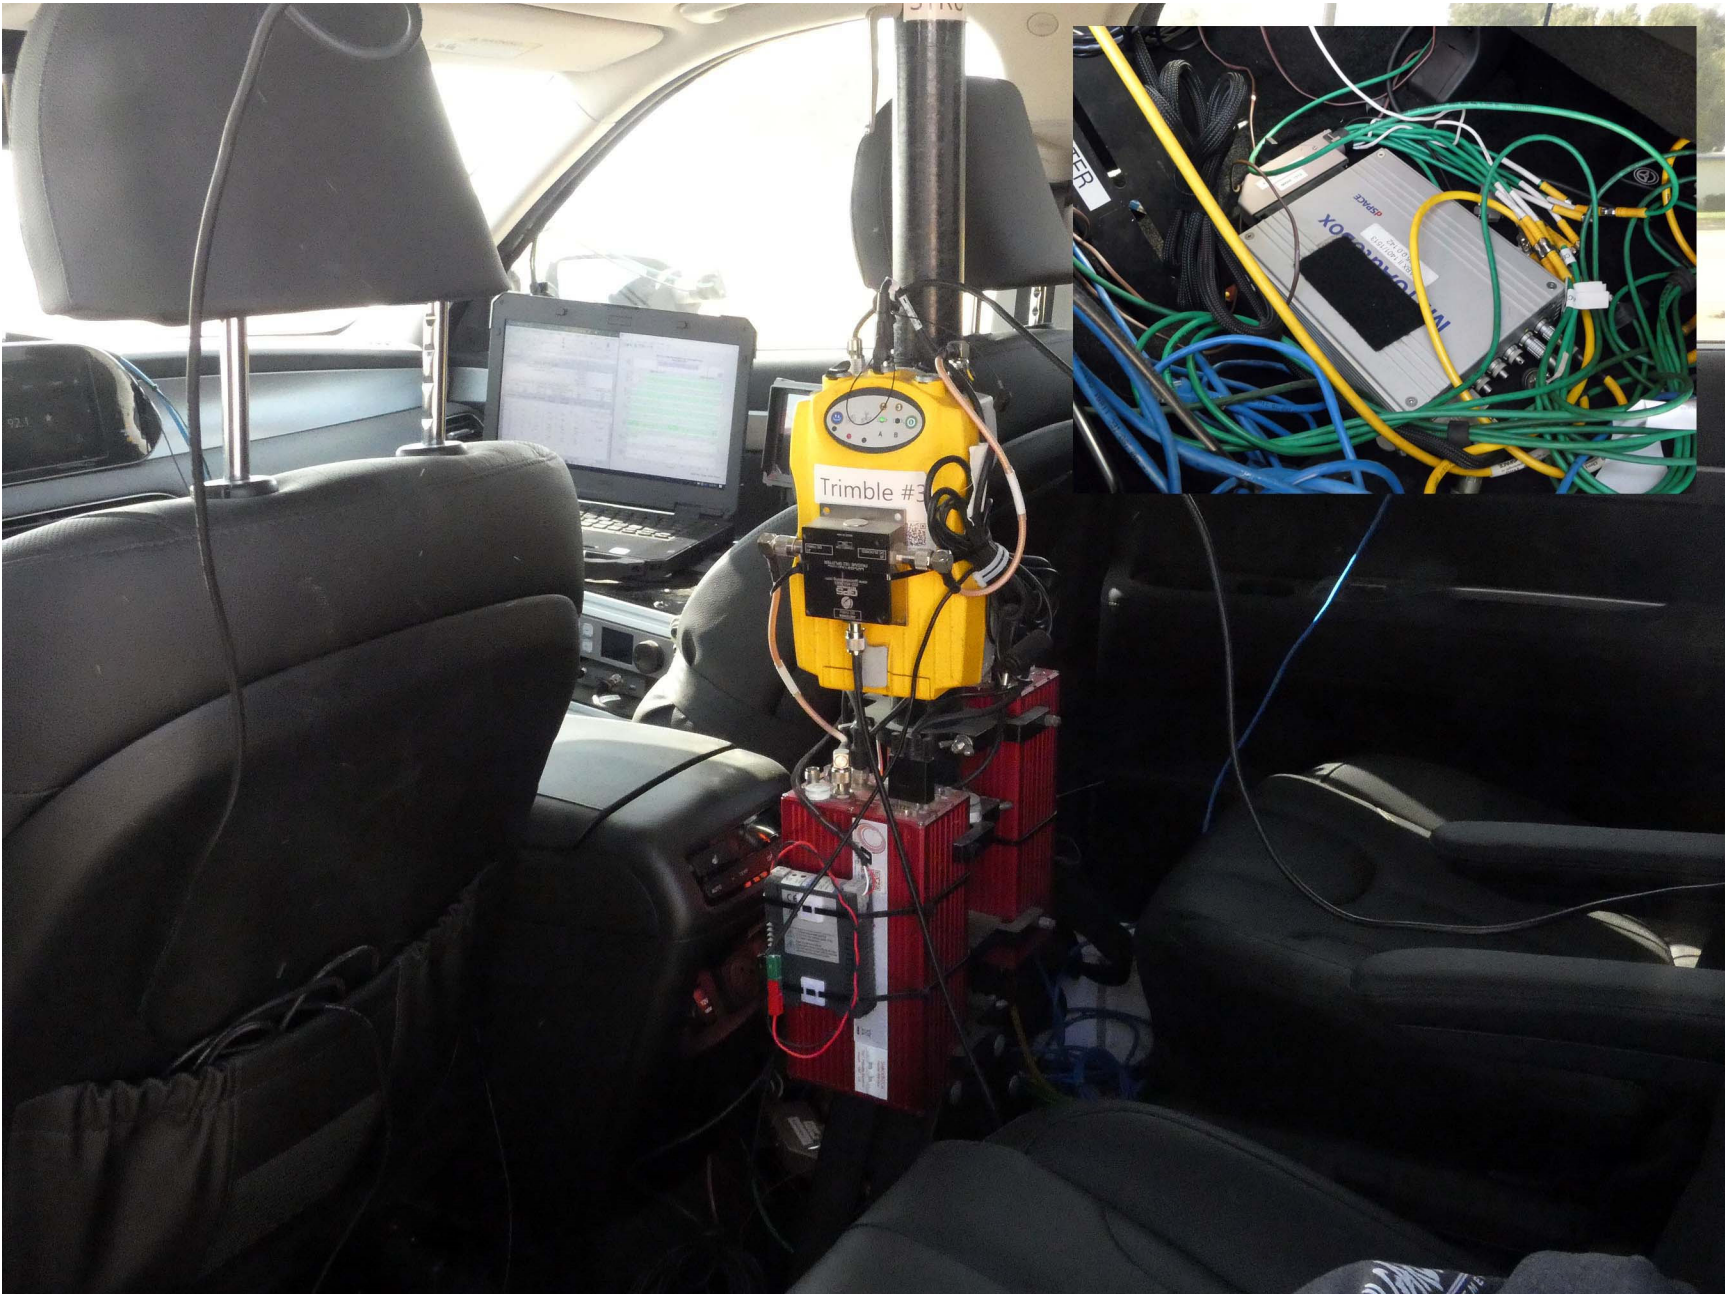
Figure A8. DGPS, Inertial Measurement Unit, and MicroAutoBox Installed in Subject Vehicle

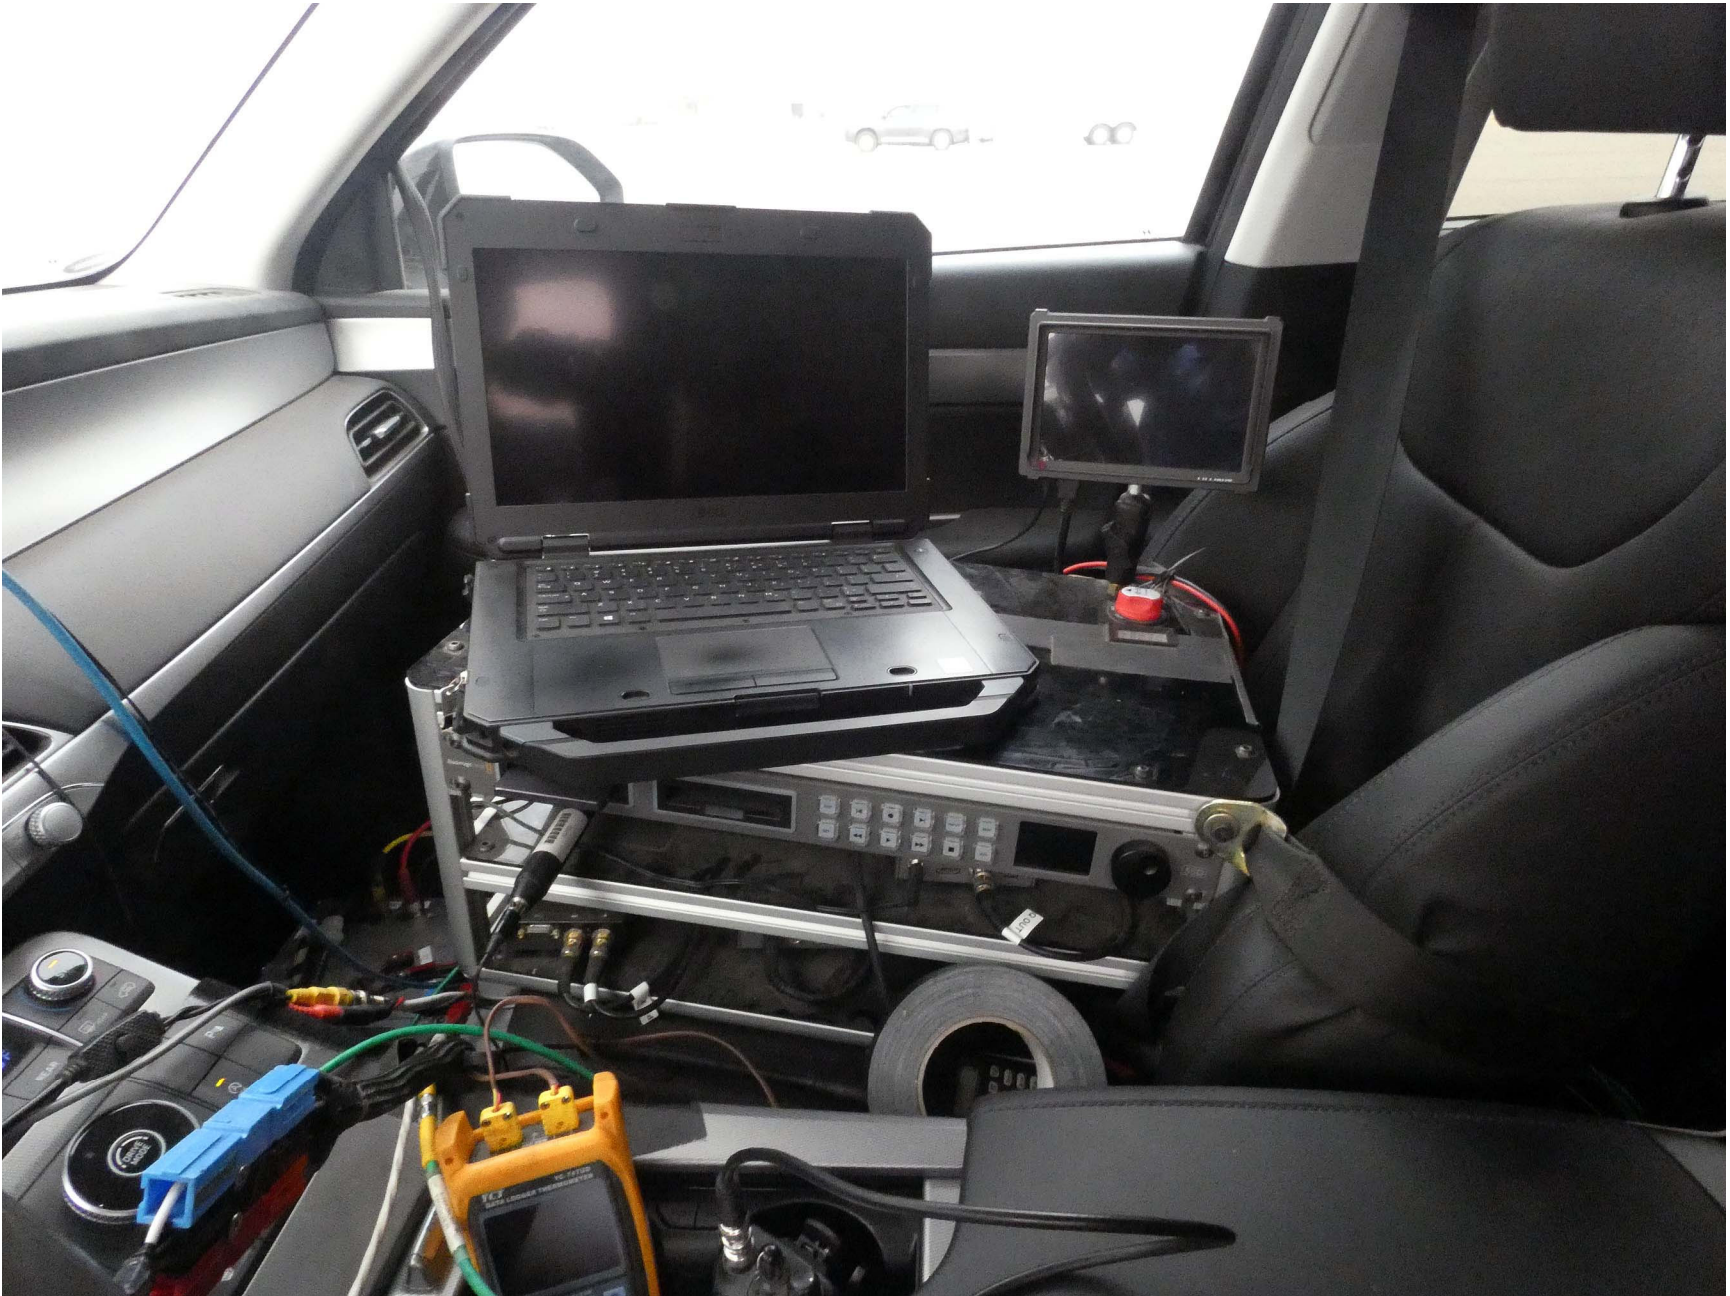
Figure A10. Computer Installed in Subject Vehicle

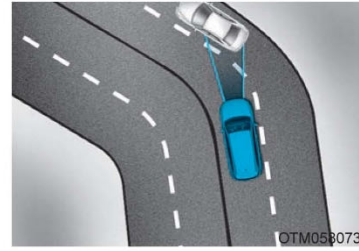
- Driving on a curve

The performance of the FCA system may be limited when driving on a curved road.

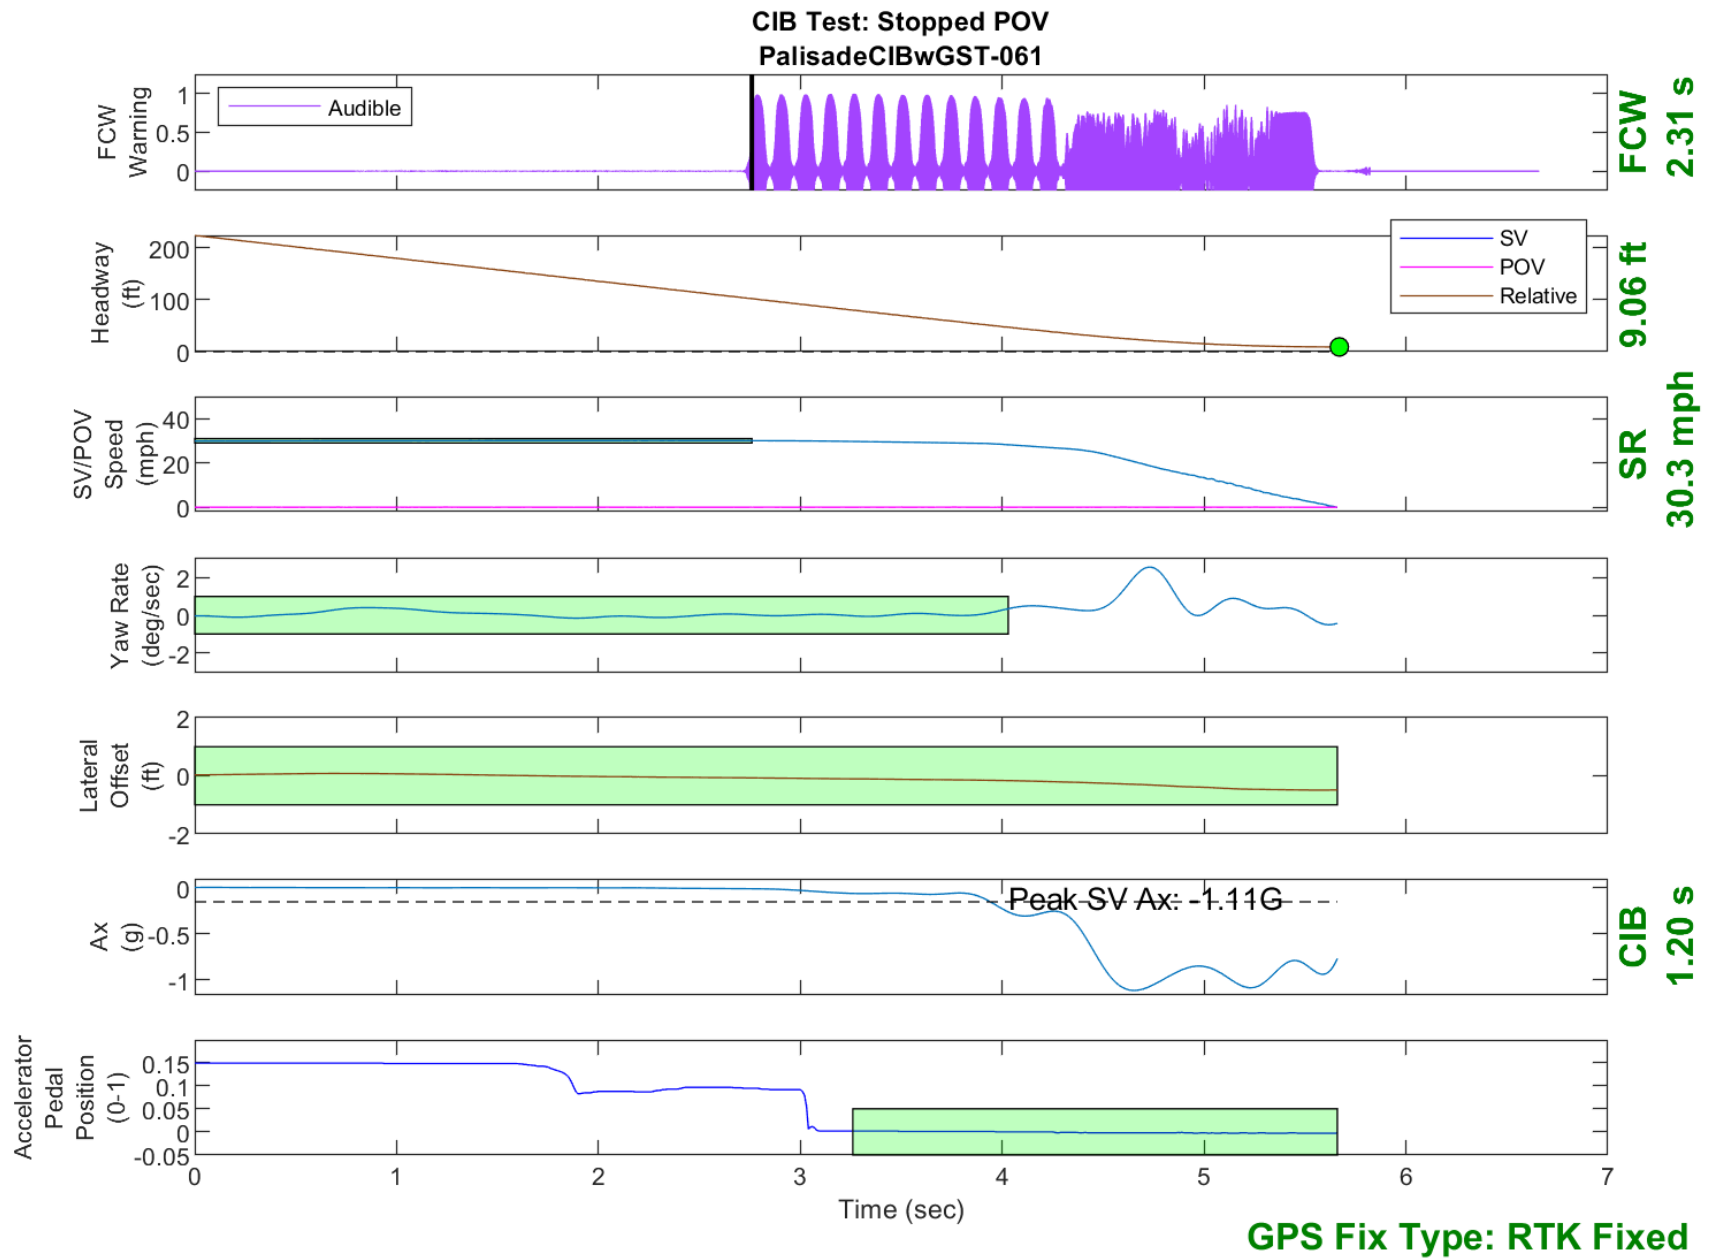
Figure D15. Time History for CIB Run 61, Stopped POV, 30 mph
