**REPORT NUMBER: SideNCAPPole-MGA-22-005**

**NEW CAR ASSESSMENT PROGRAM (NCAP)  
Side Impact Pole Test**

**HYUNDAI MOTOR MANUFACTURING ALABAMA, LLC  
2022 Hyundai Tucson SEL 5-Door SUV  
NHTSA No.: M20224207**

**FINAL REPORT**

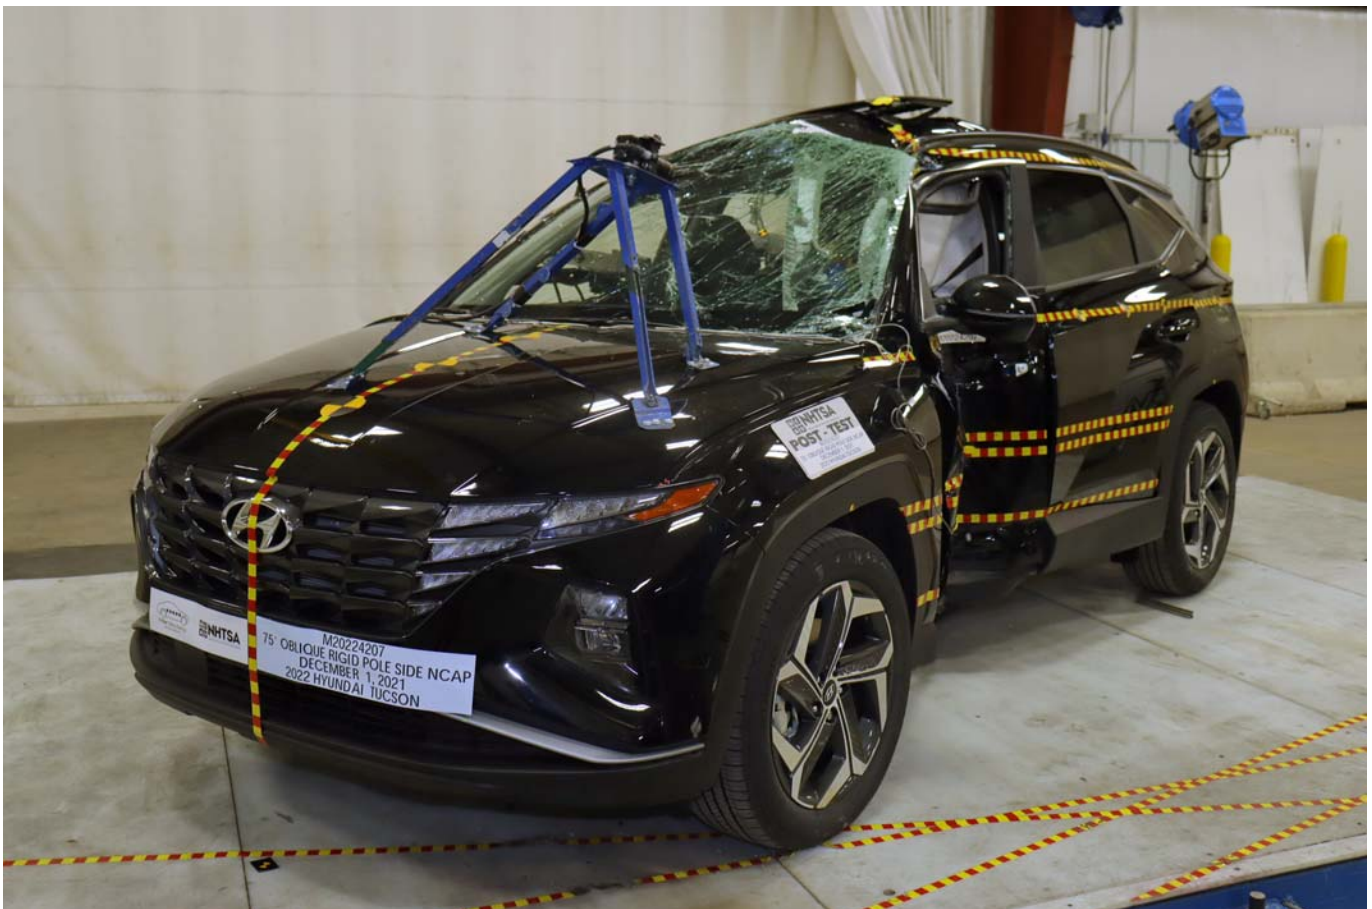
Photo No. 006 - Post-Test Left Front Three-Quarter View of Test Vehicle

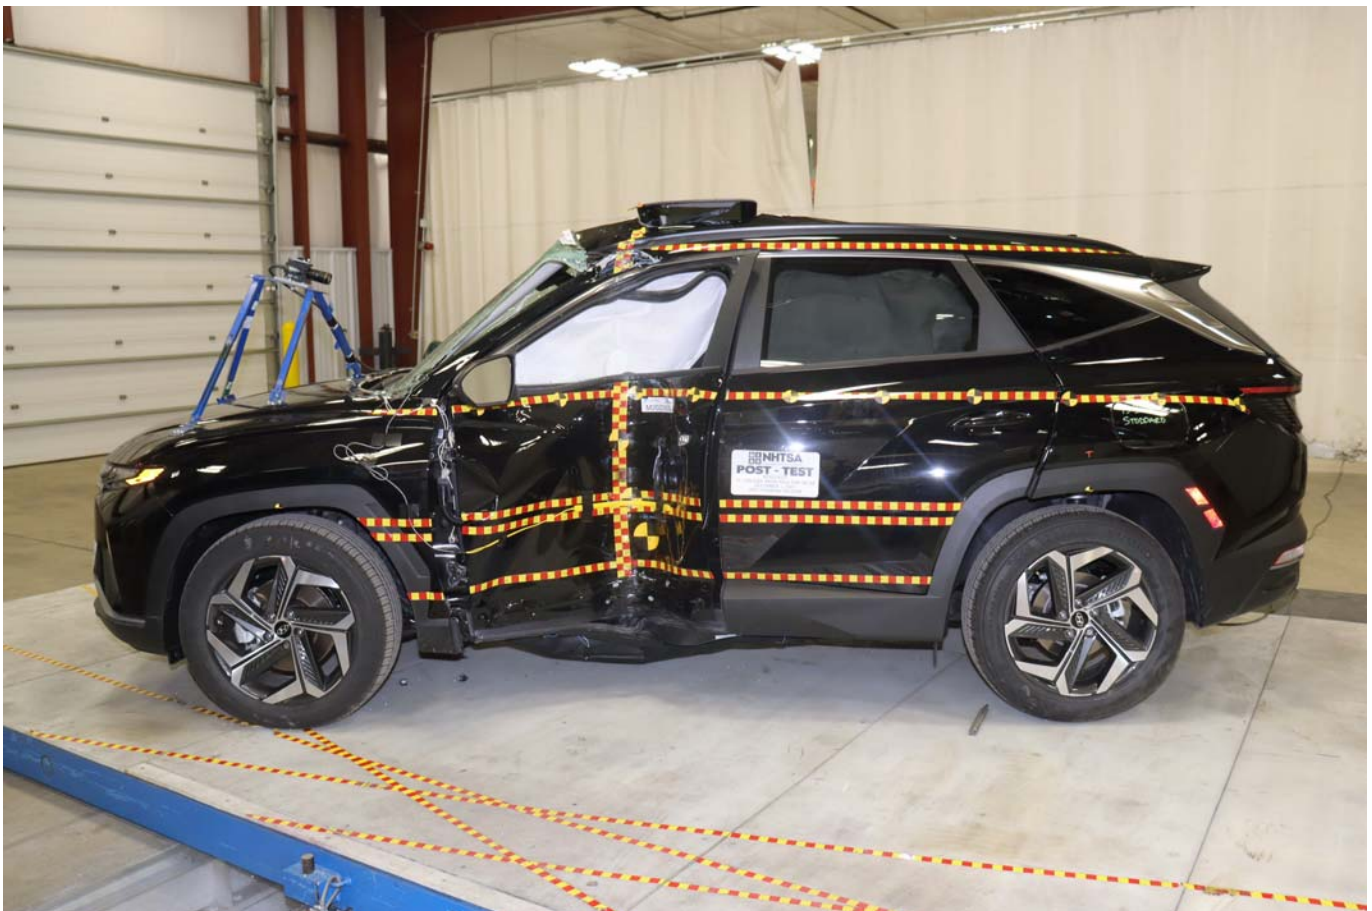
Photo No. 008 - Post-Test Left Side View of Test Vehicle

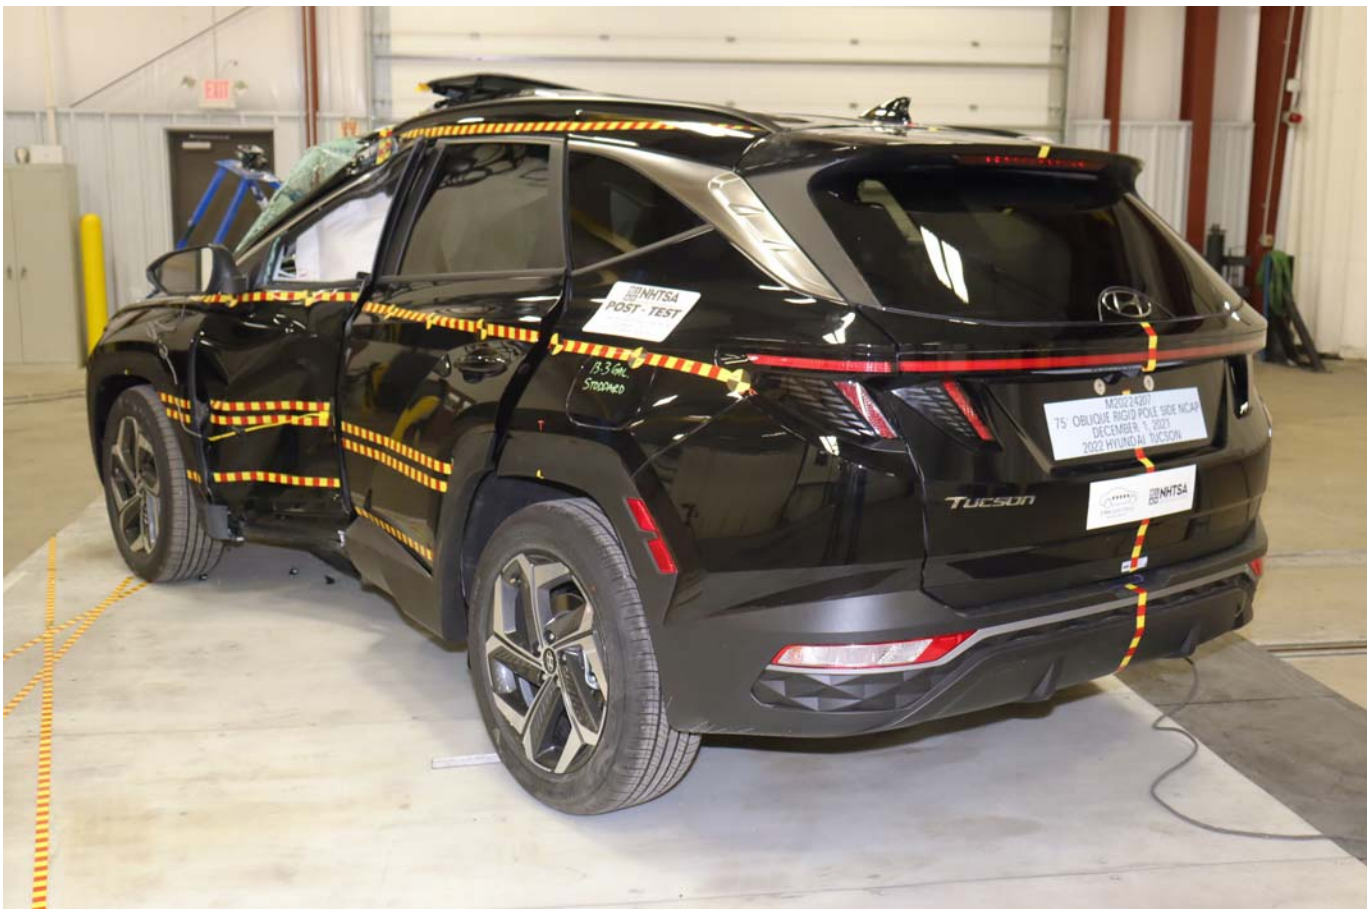
Photo No. 010 - Post-Test Left Rear Three-Quarter View of Test Vehicle

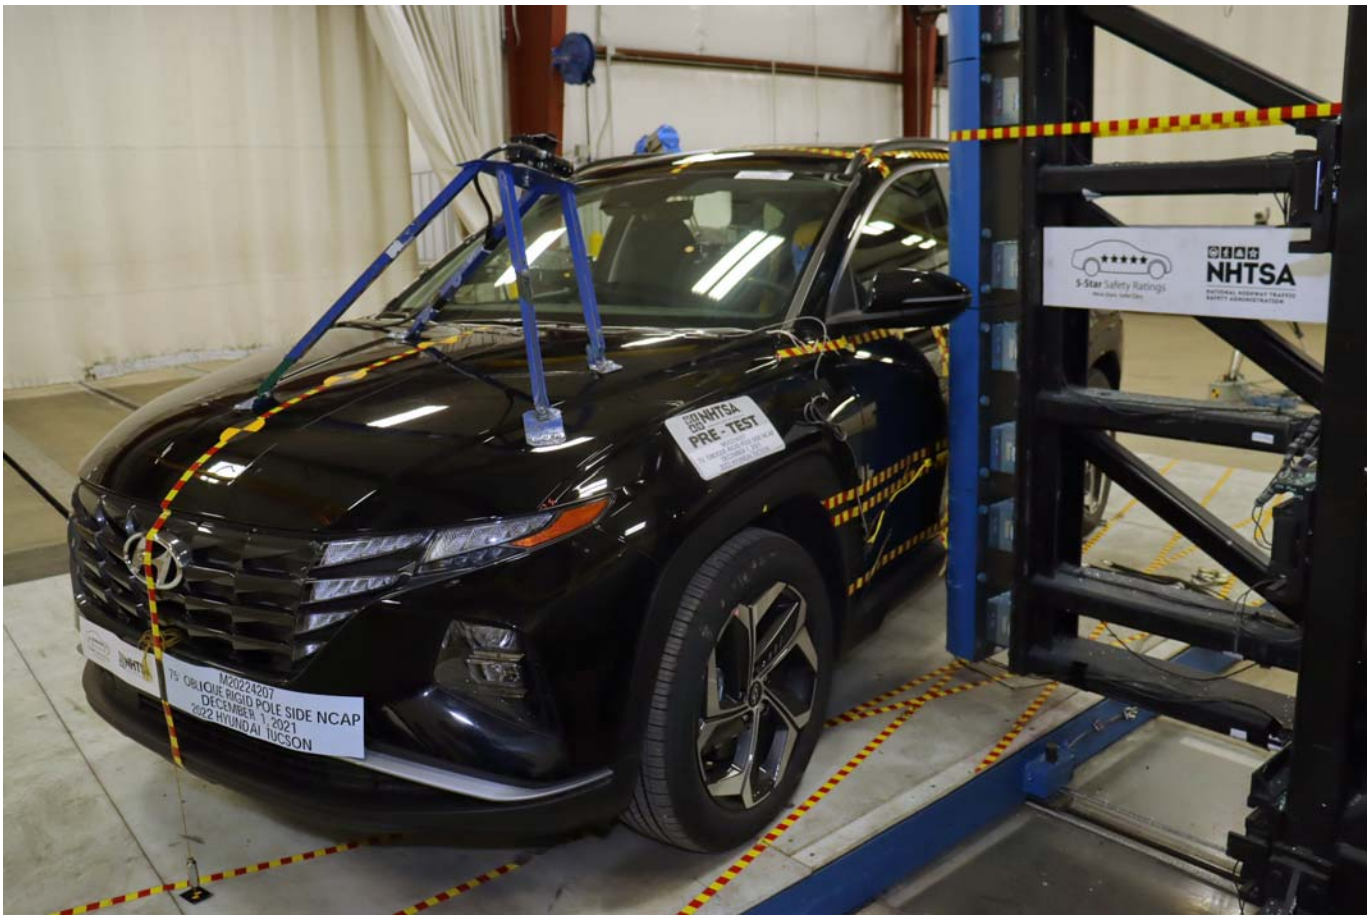
Photo No. 017 - Pre-Test Left Side View of Pole Positioned Against Side of Vehicle

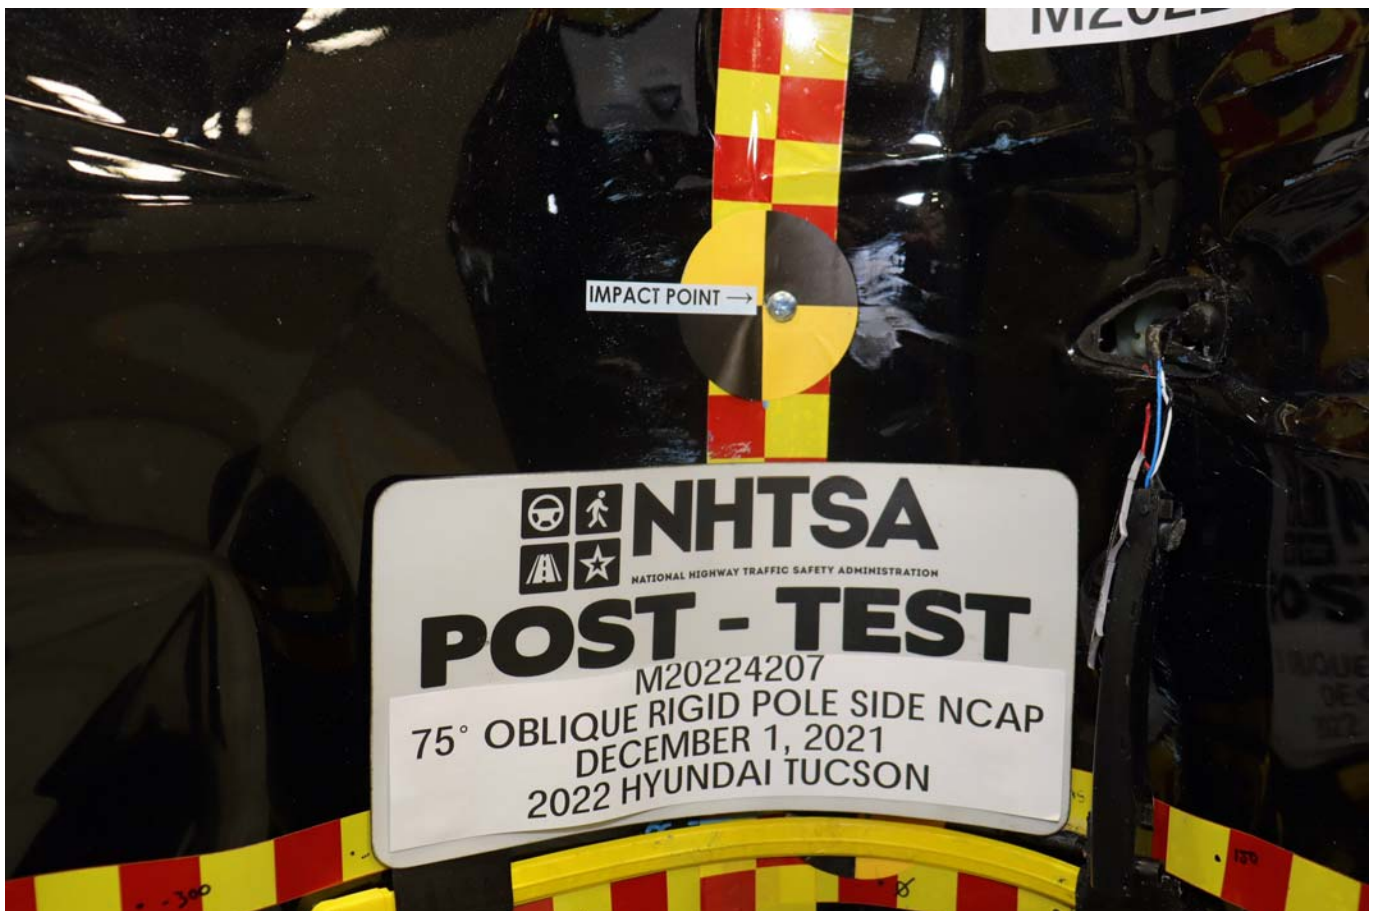
Photo No. 020 - Post-Test Close-Up View of Impact Point Target Showing Impact Location

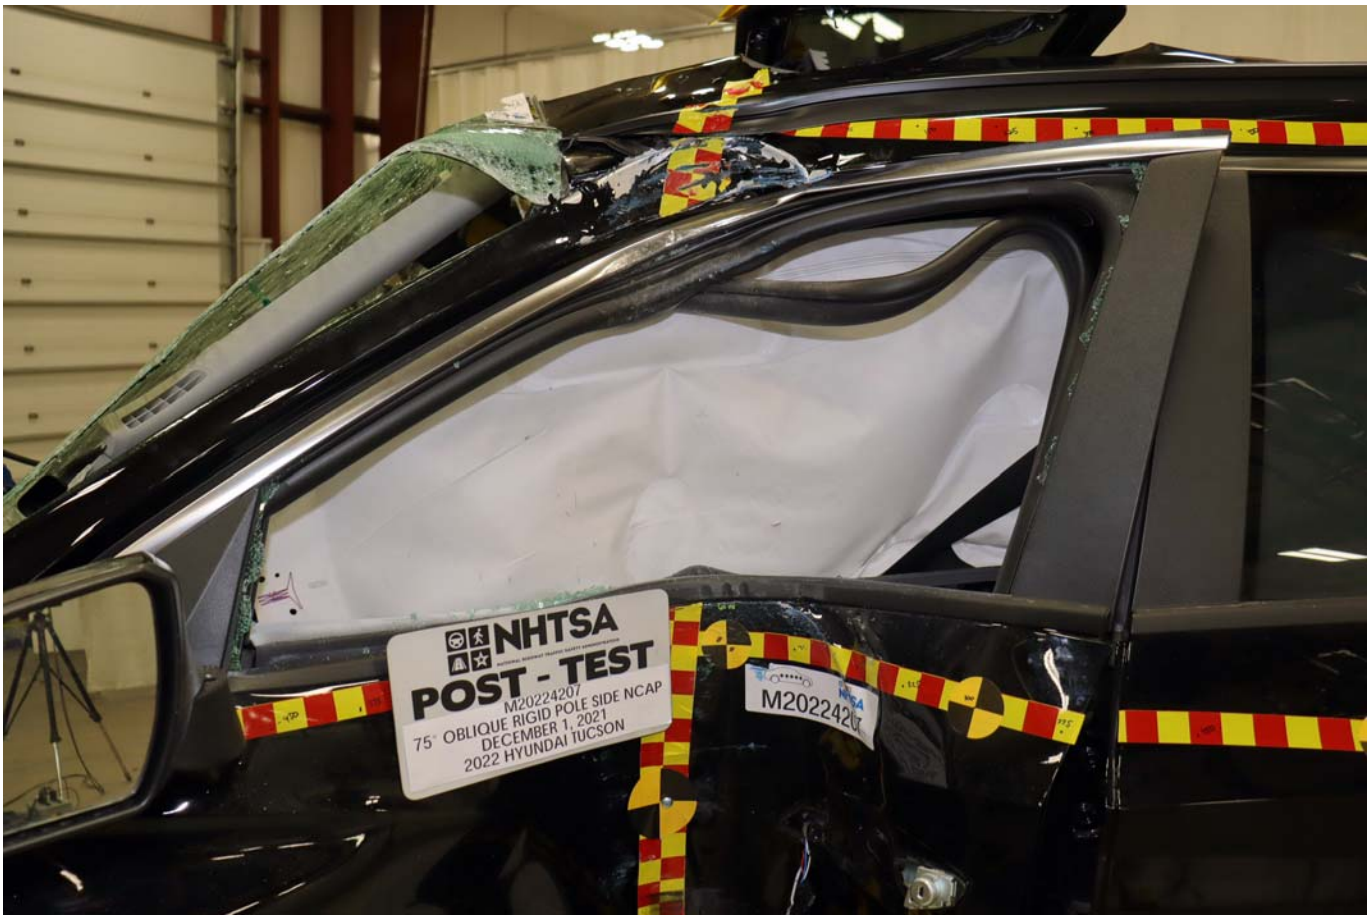
Photo No. 025 - Post-Test Left Side View of Dummy Shoulder and Door Top View

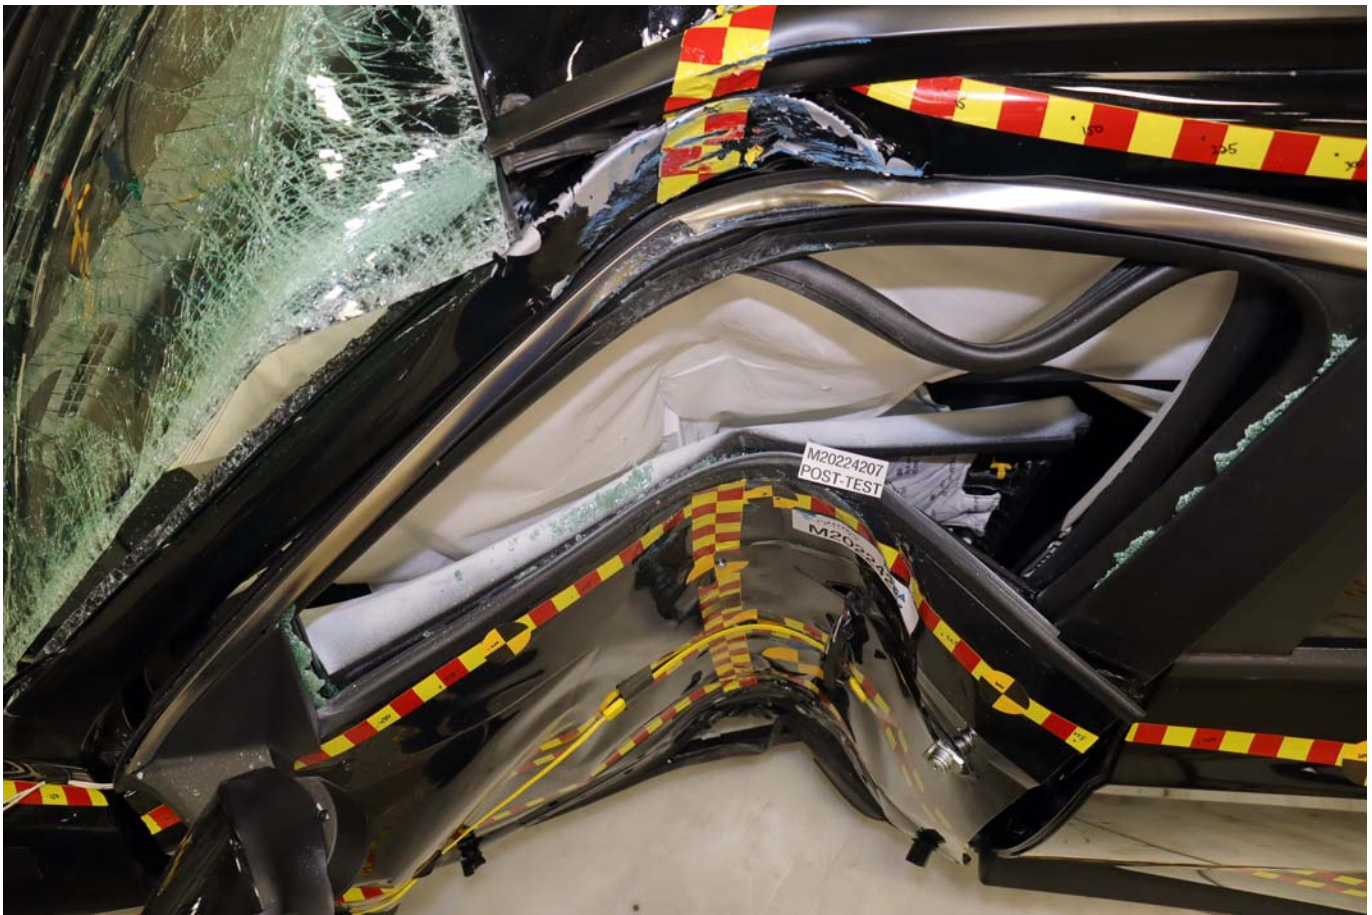
Photo No. 041 - Post-Test Dummy and Door Clearance View

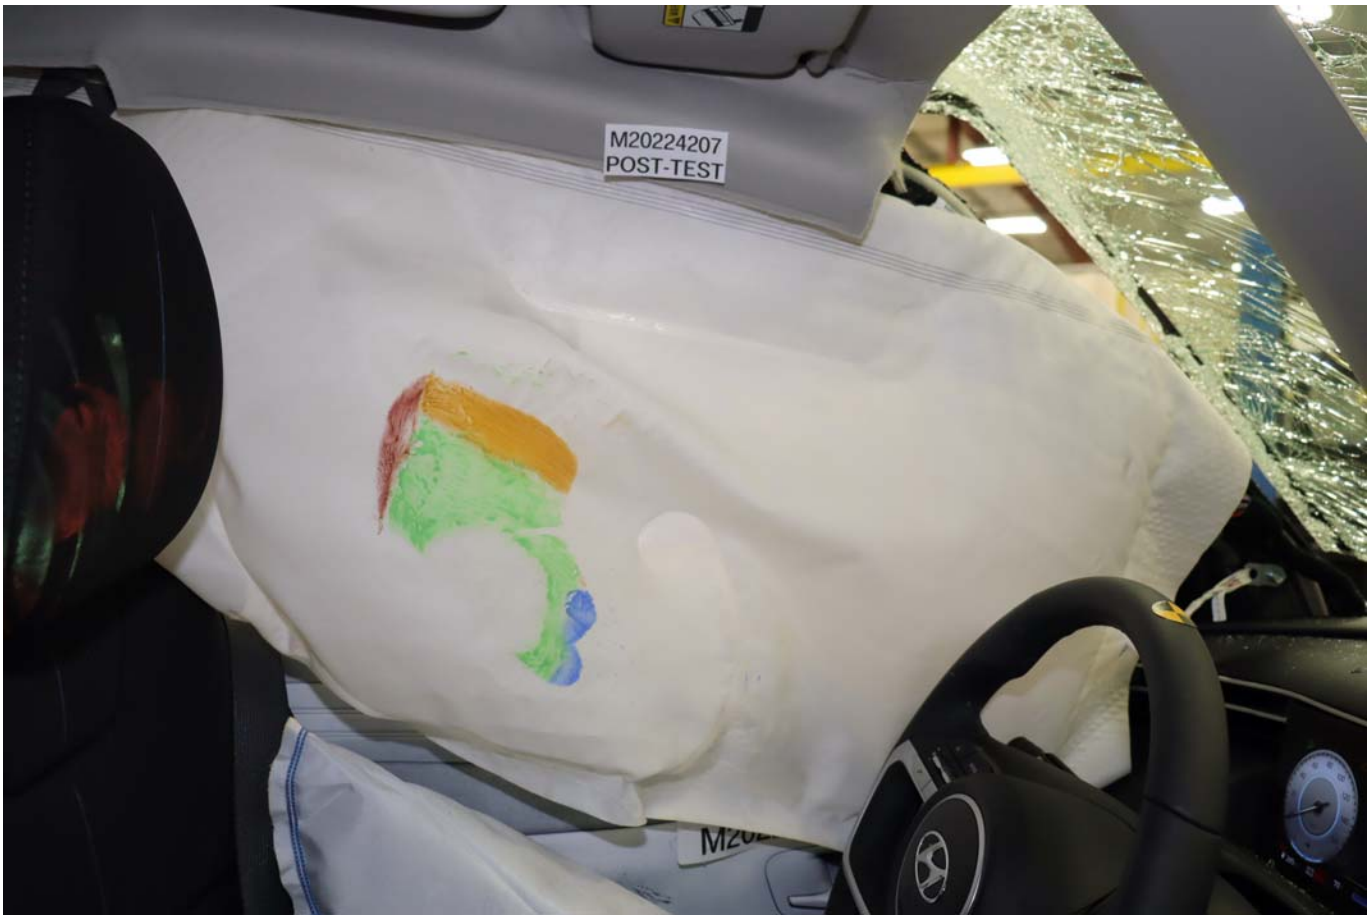
Photo No. 047 - Post-Test Dummy Close-Up Head Contact with Side Air Bag View

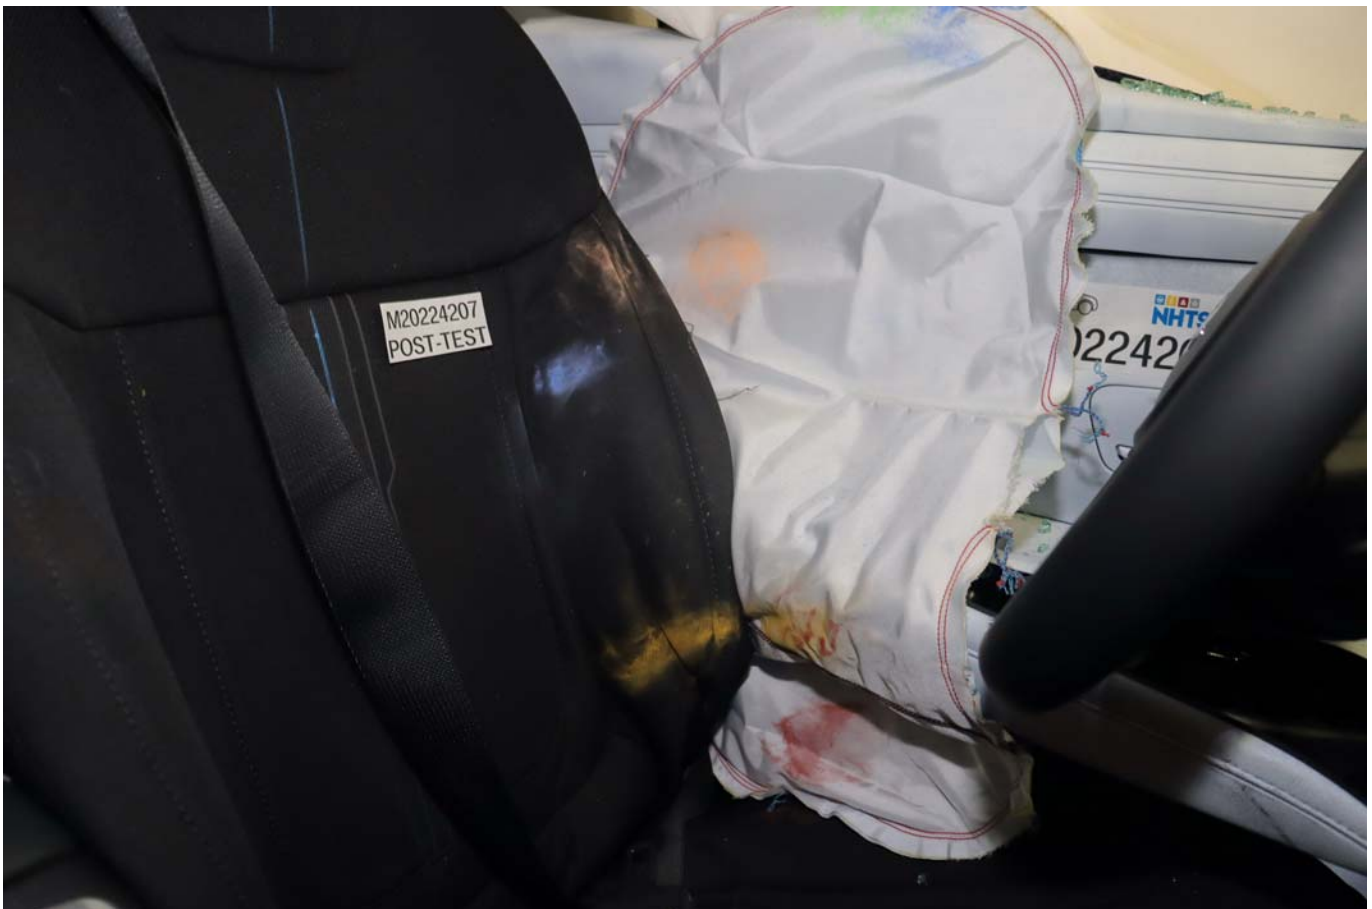
Photo No. 048 - Post-Test Dummy Close-Up Torso Contact with Vehicle Interior View

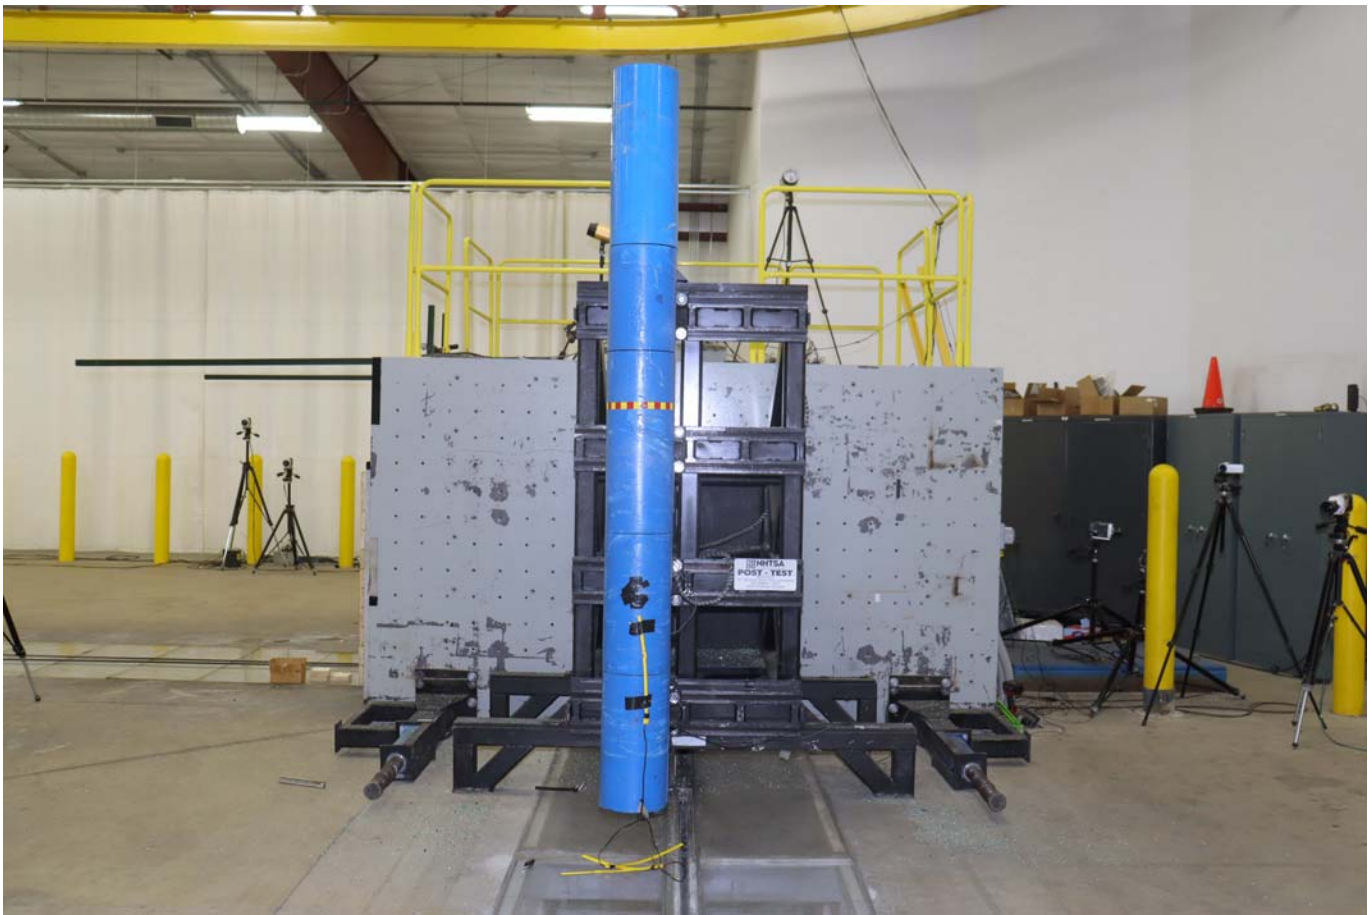
Photo No. 060 - Post-Test Pole Barrier Front View

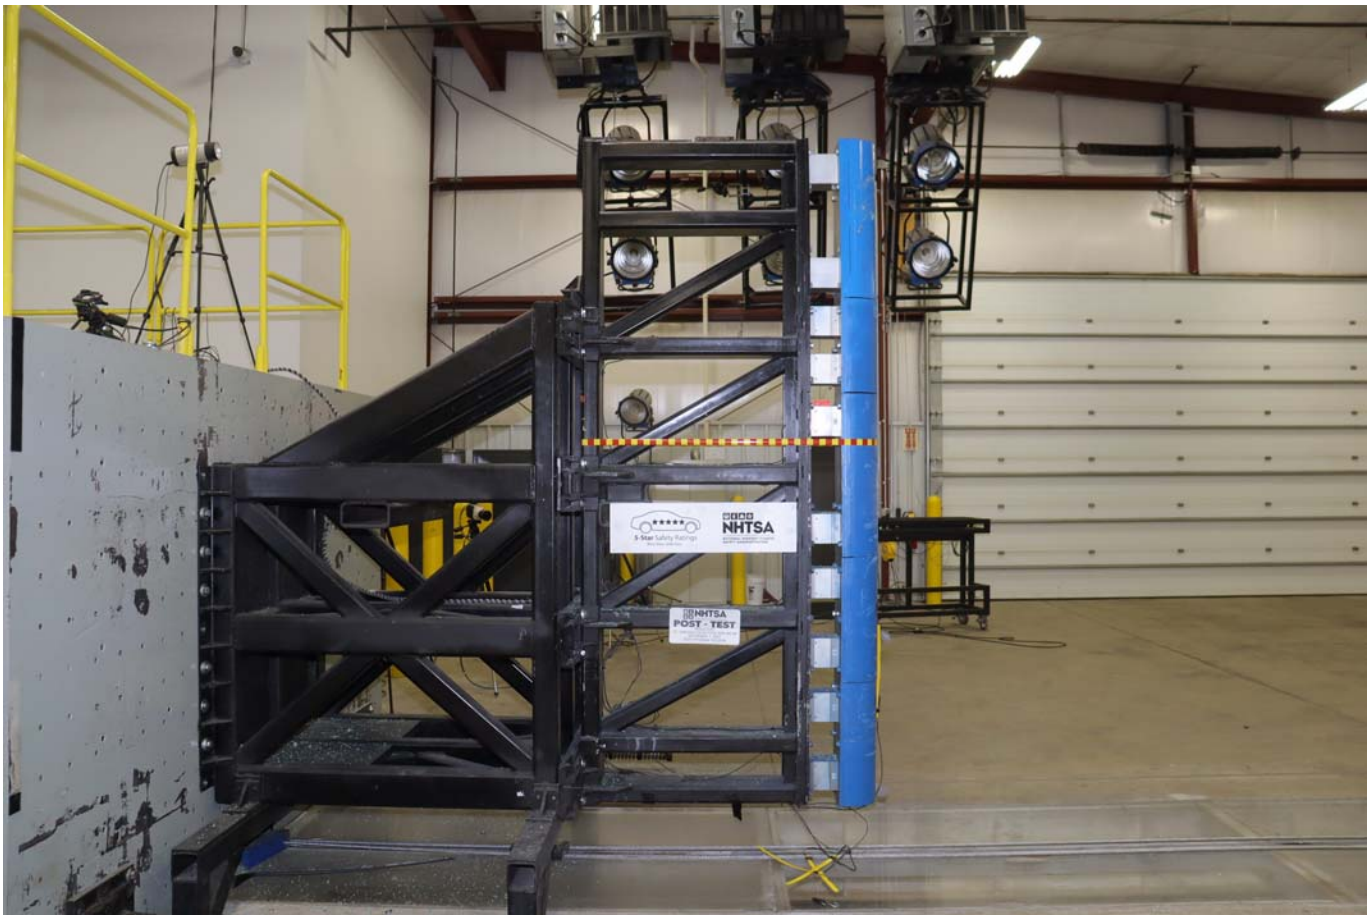
Photo No. 062 - Post-Test Pole Barrier Side View

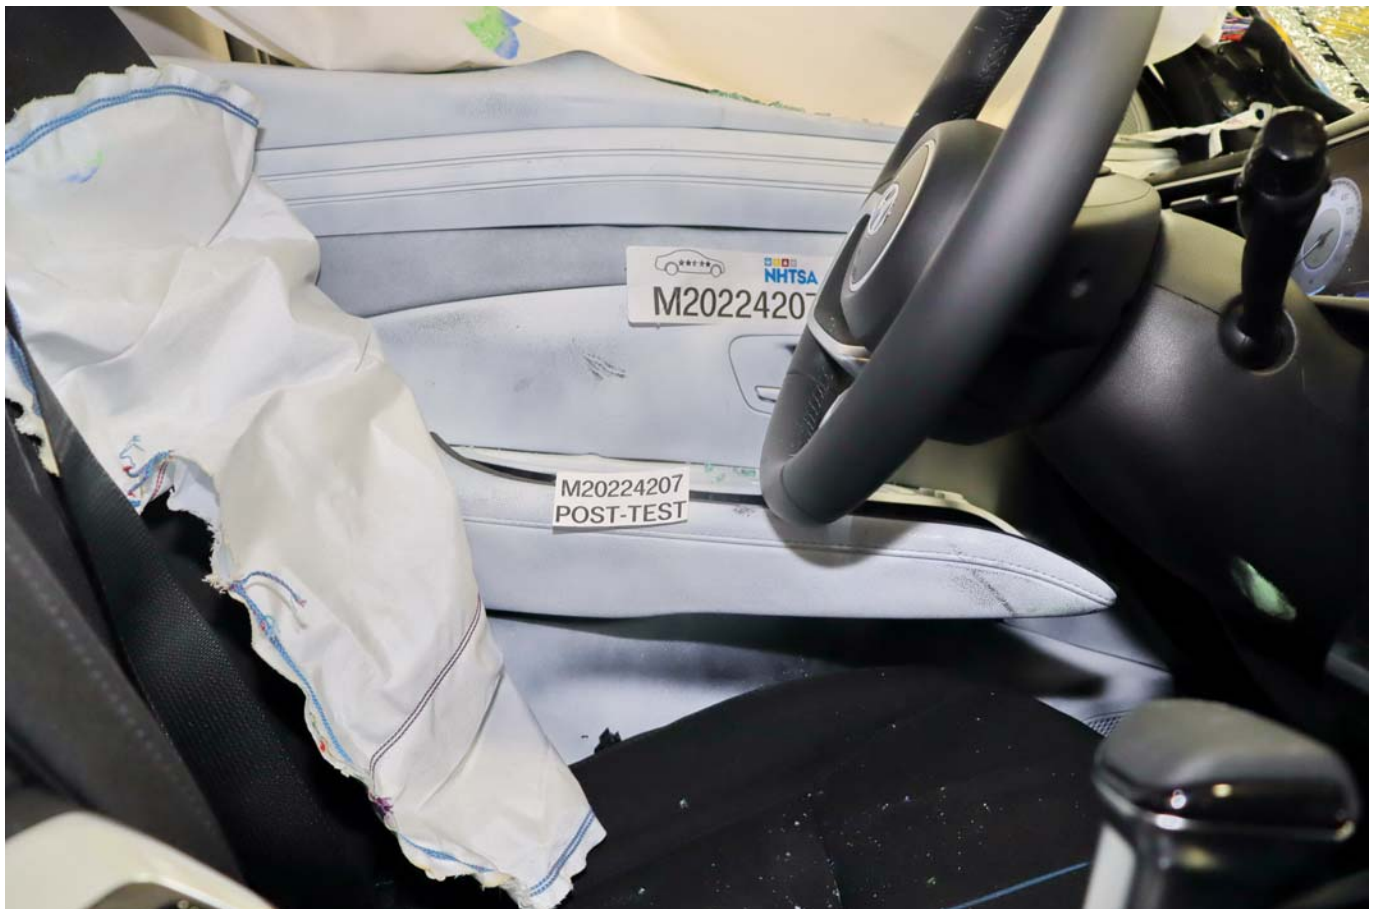
Photo No. 073 - Post-Test View of Shattered Vehicle Inner Door Panel
