**REPORT NUMBER: SideNCAPMDB-MGA-22-011**

**NEW CAR ASSESSMENT PROGRAM (NCAP)  
Moving Deformable Barrier Side Impact Test**

**MAZDA MOTOR CORPORATION  
2022 Mazda MX-30 5-Door Hatchback  
NHTSA No.: O20225402**

**MGA RESEARCH CORPORATION  
5000 Warren Road  
Burlington, WI 53105**

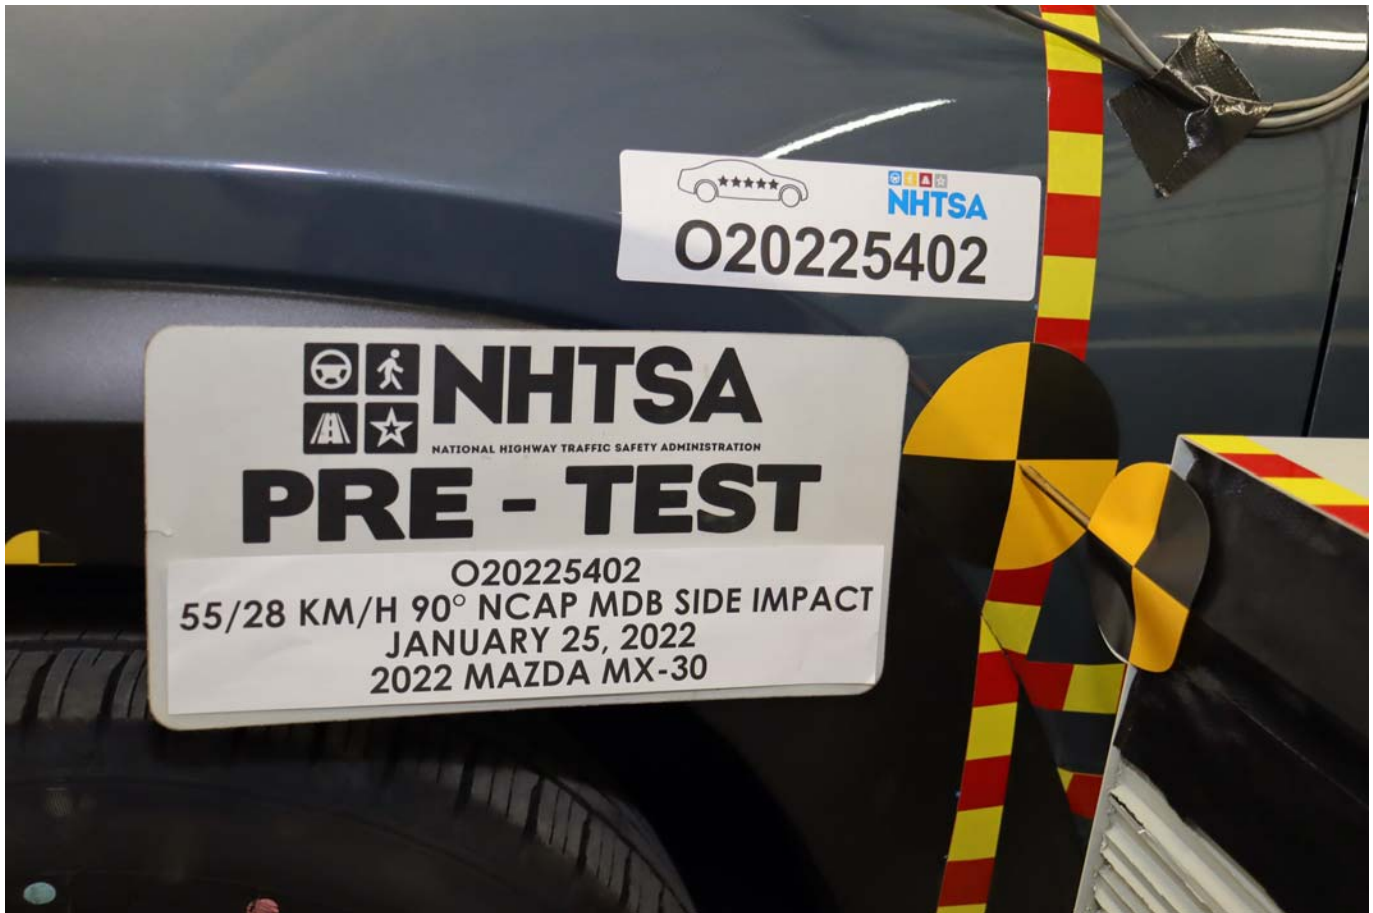
Photo No. 019 - Pre-Test Close-Up View of Impact Point Target

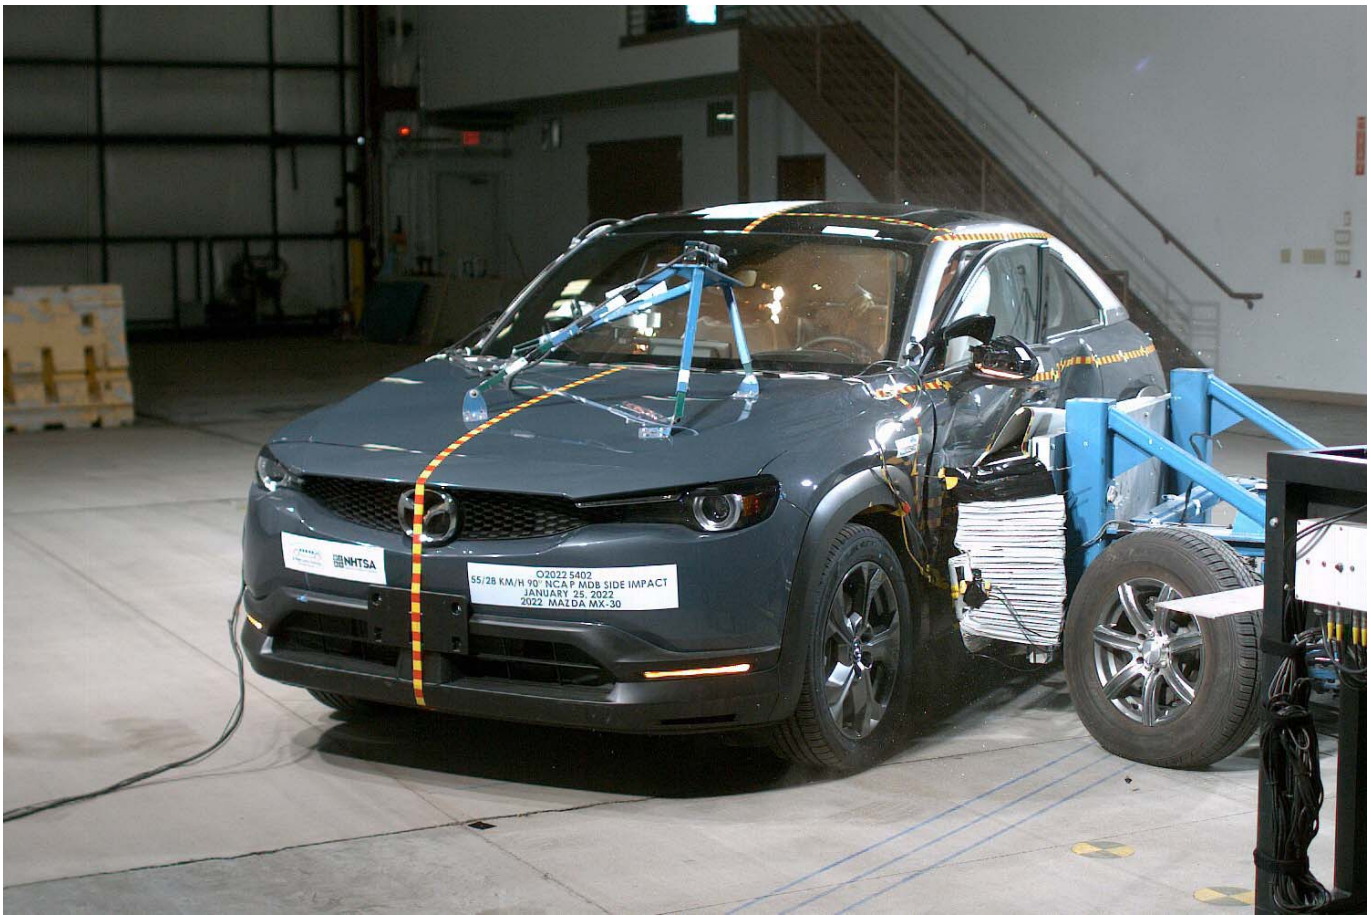
Photo No. 101 - Impact Event

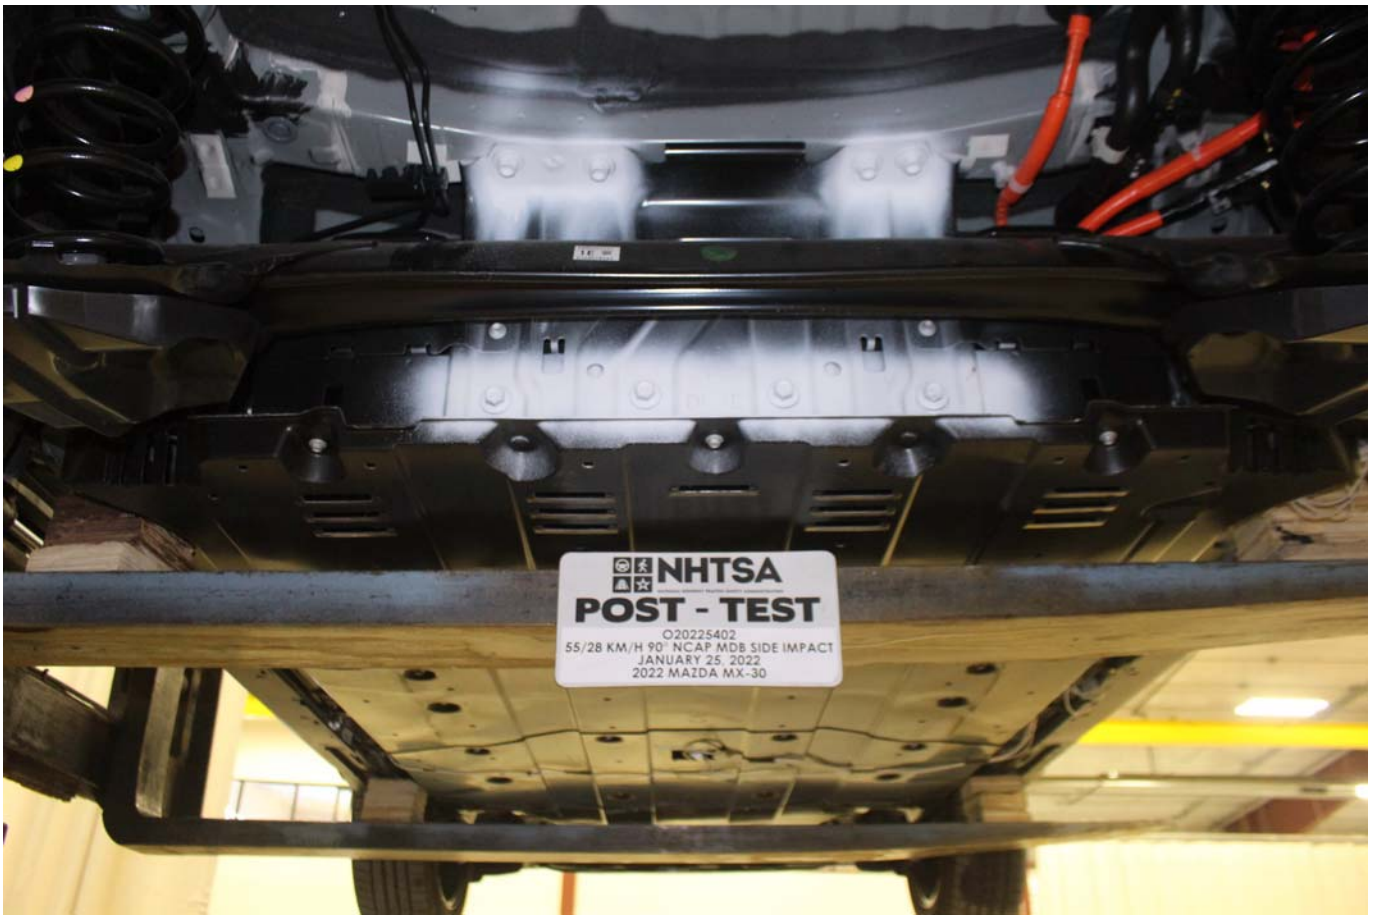
Photo No. 305-11 - Post-Impact Rear View of Propulsion Battery

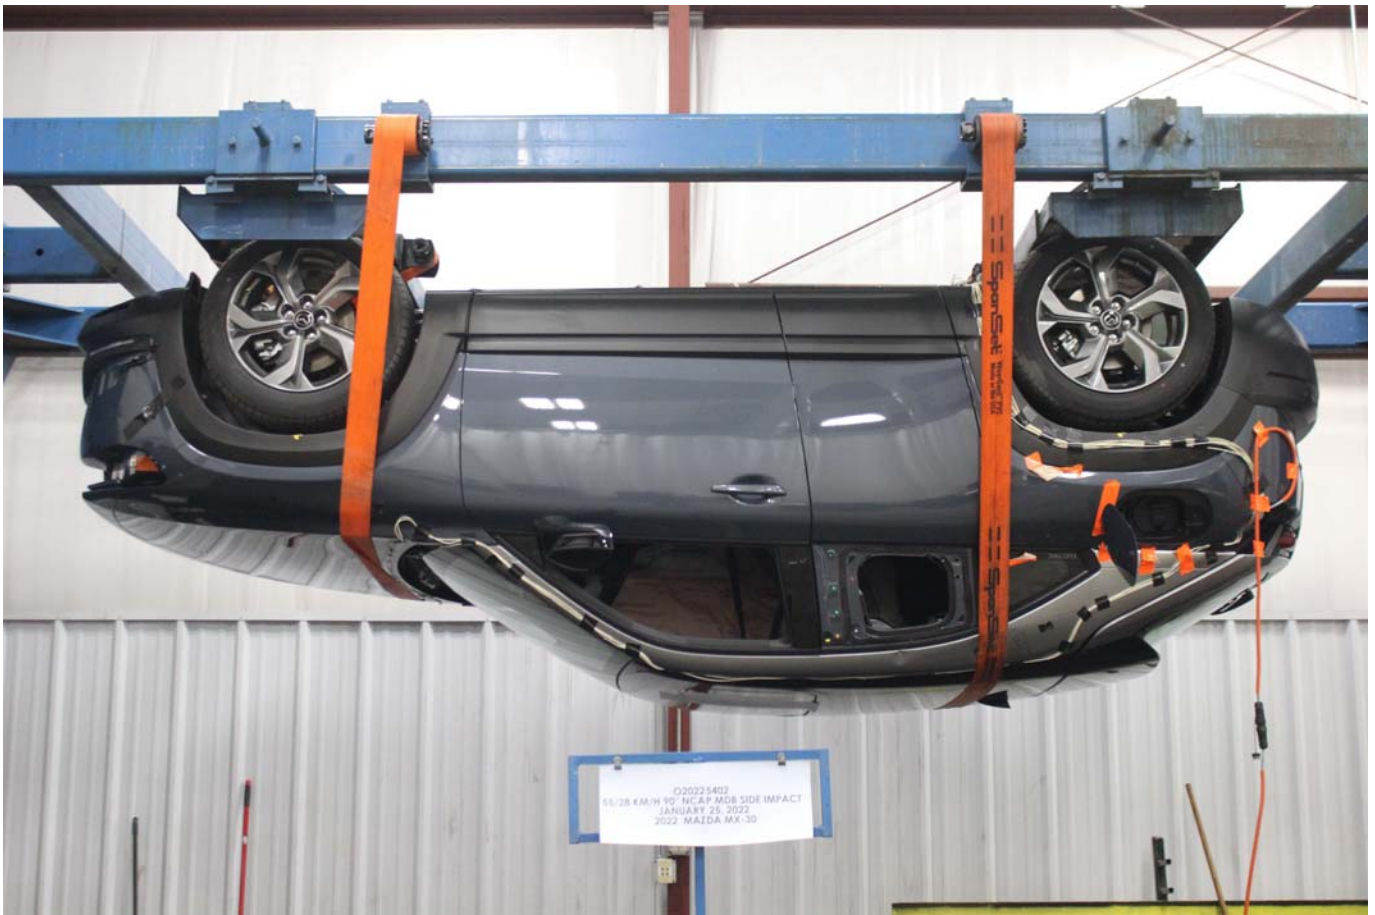
Photo No. 305-29 - FMVSS No. 305 Static Rollover at 180 Degrees

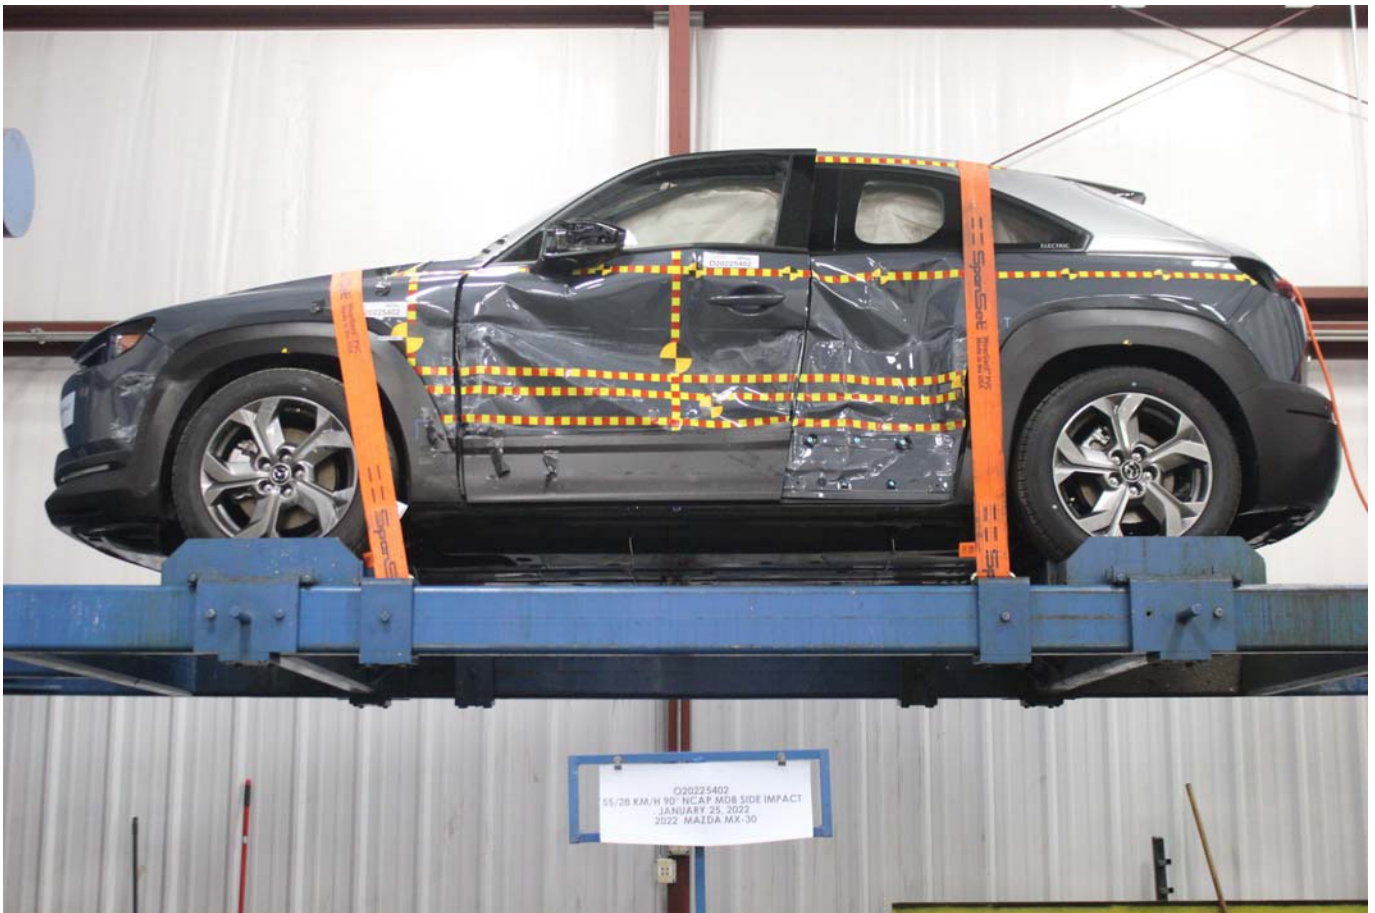
Photo No. 305-31 - FMVSS No. 305 Static Rollover at 360 Degrees
