REPORT NUMBER: NCAP-MGA-22-010

**NEW CAR ASSESSMENT PROGRAM (NCAP)
Frontal Barrier Impact Test**

**MAZDA MOTOR CORPORATION
2022 Mazda MX-30 5-Door Hatchback
NHTSA No.: O20225400**

**MGA RESEARCH CORPORATION
5000 Warren Road
Burlington, WI 53105**

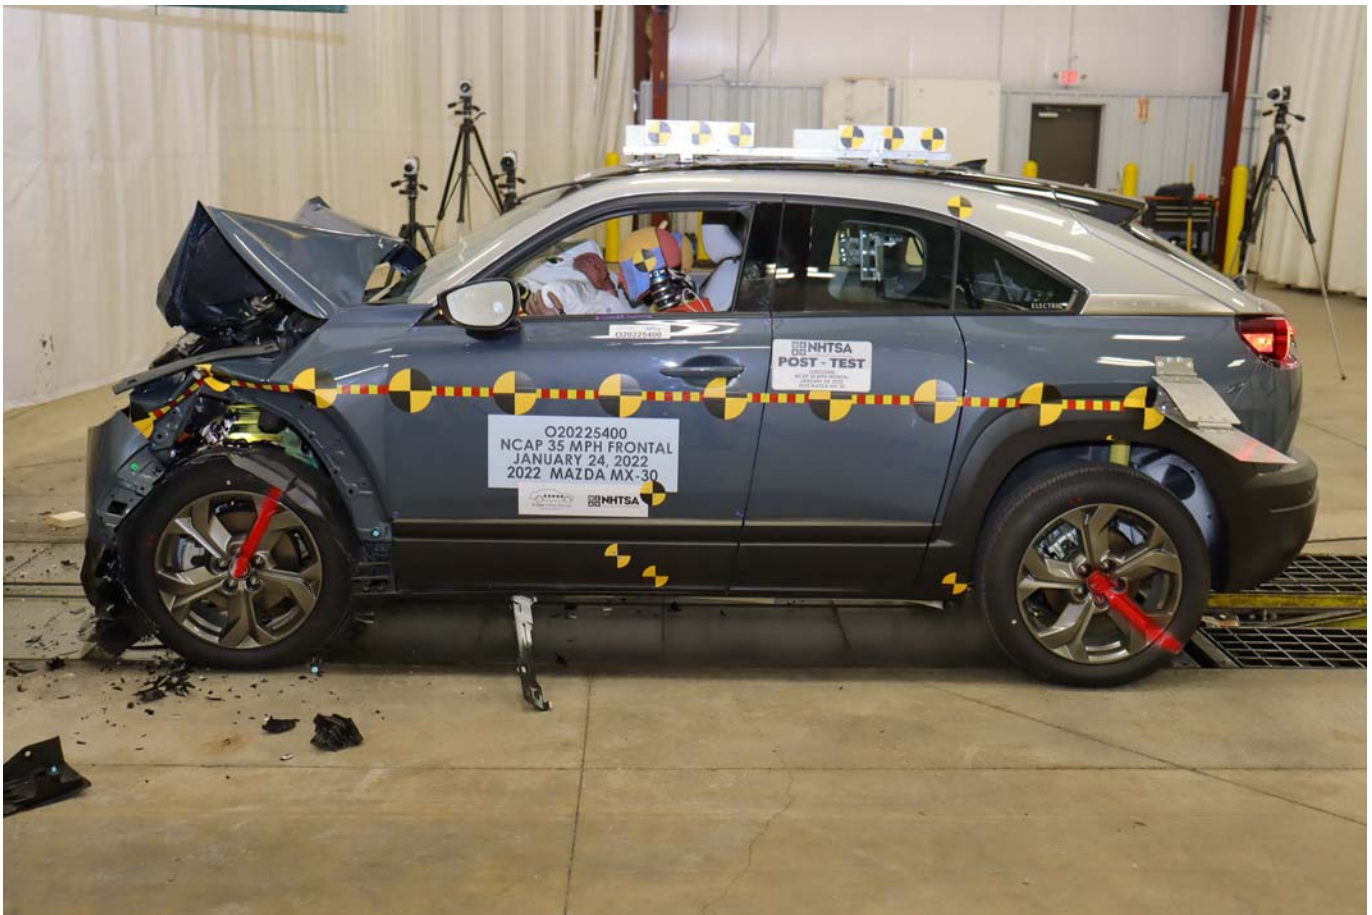
Photo No. 011 - Post-Test Left View of Test Vehicle

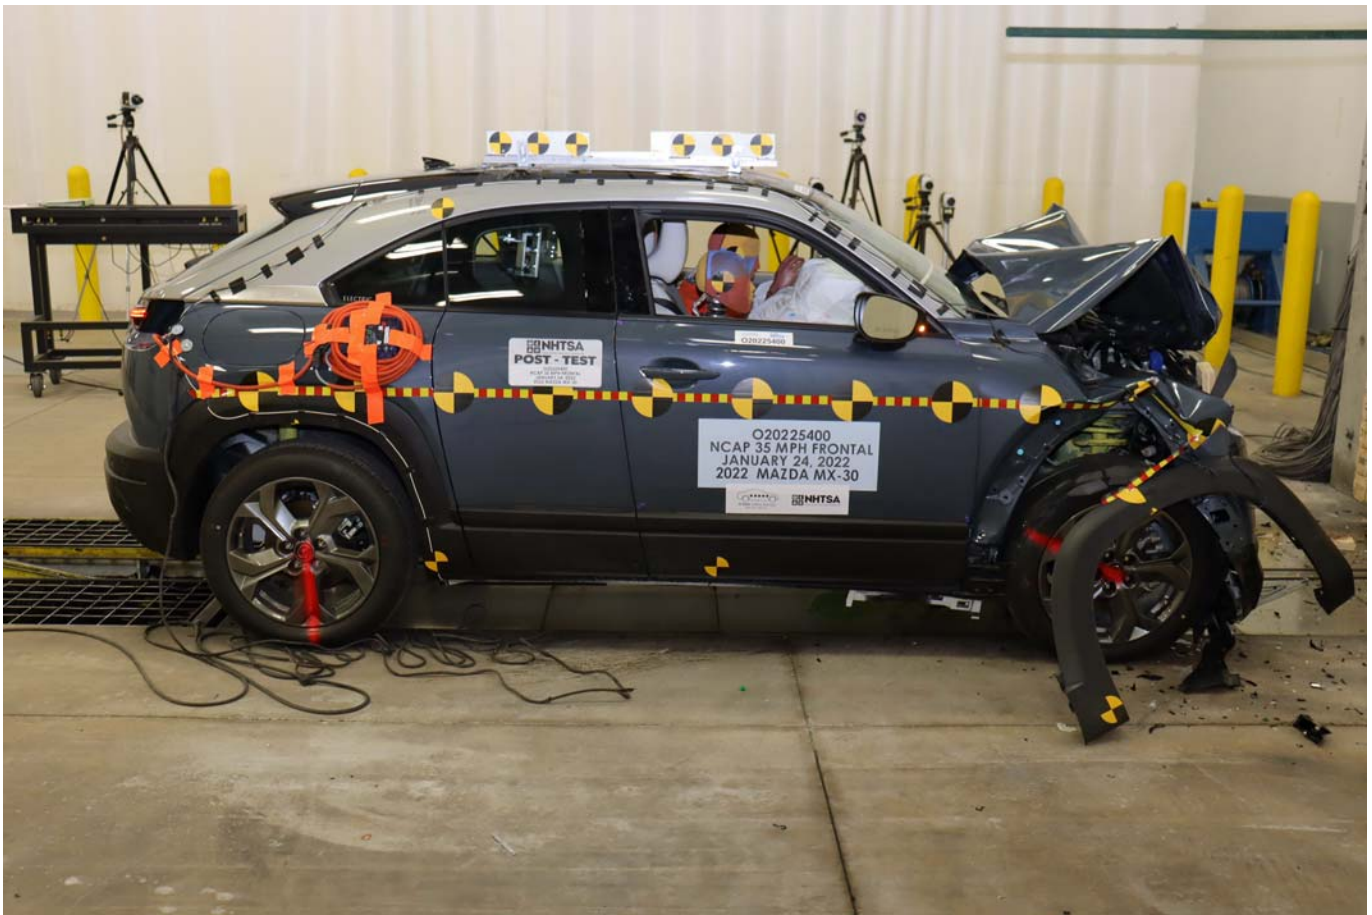
Photo No. 013 - Post-Test Right View of Test Vehicle

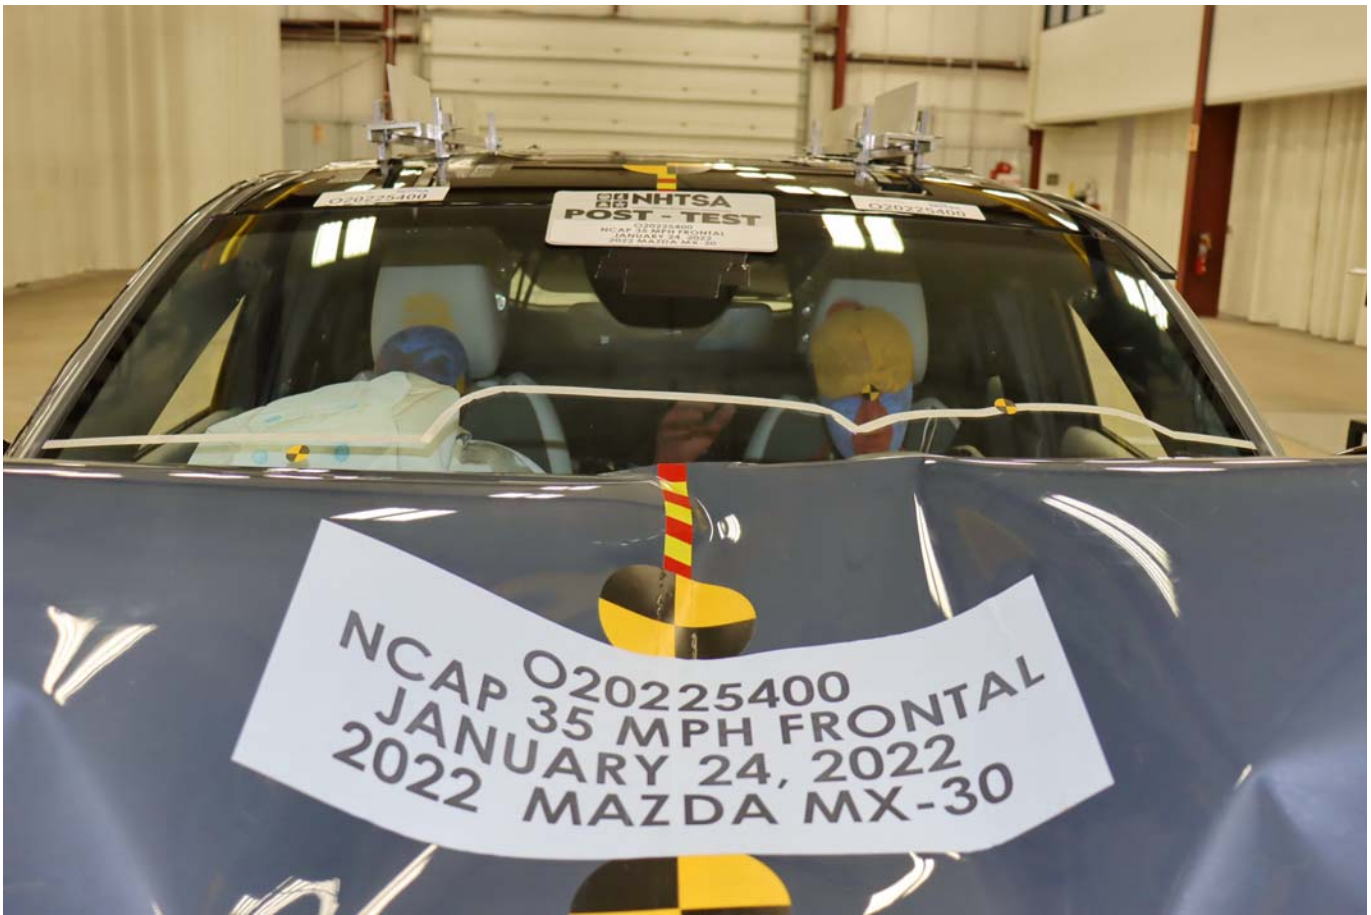
Photo No. 019 - Post-Test Windshield View

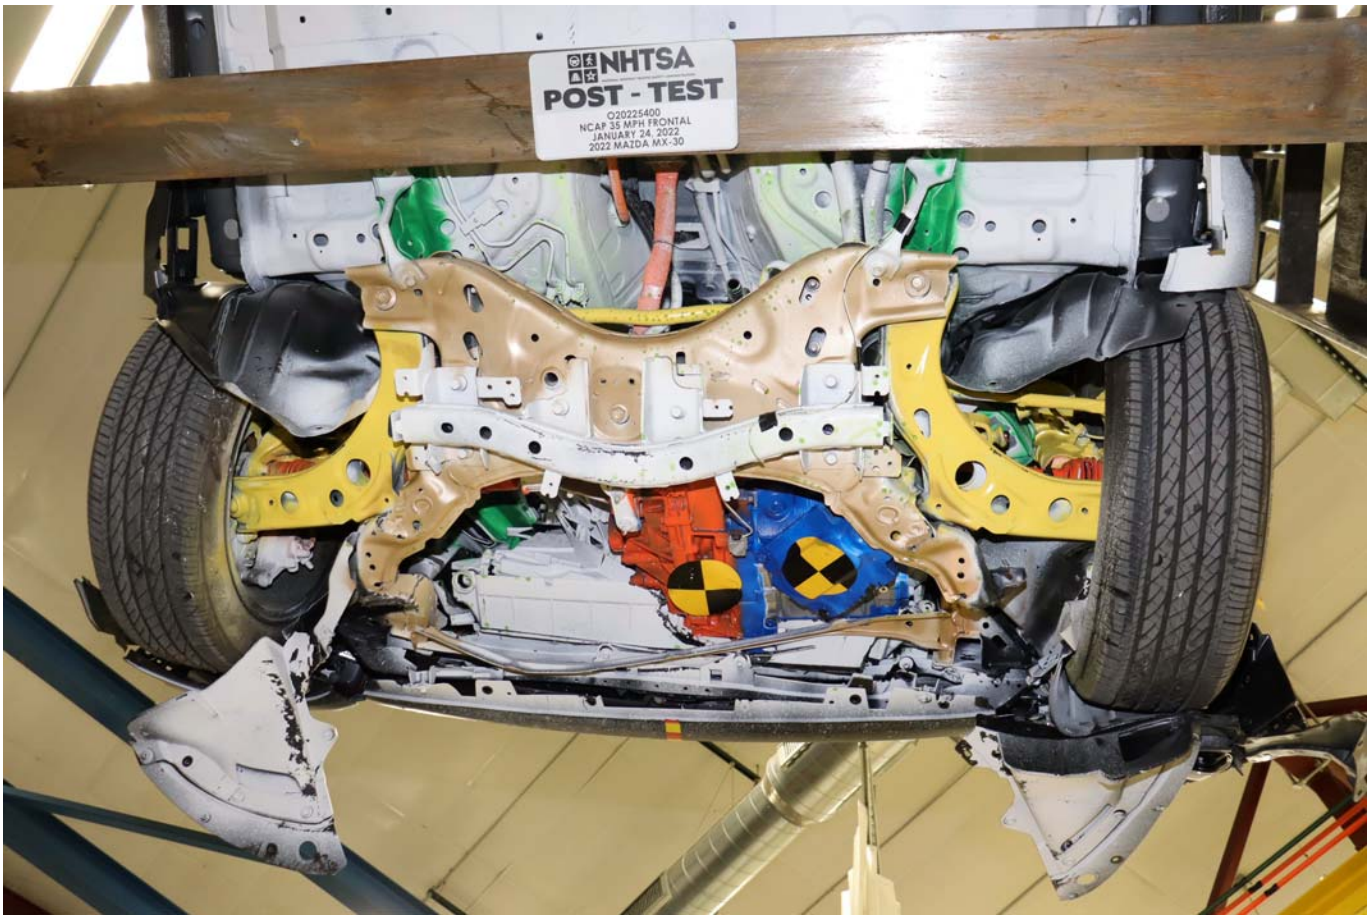
Photo No. 025 - Post-Test Front Underbody View

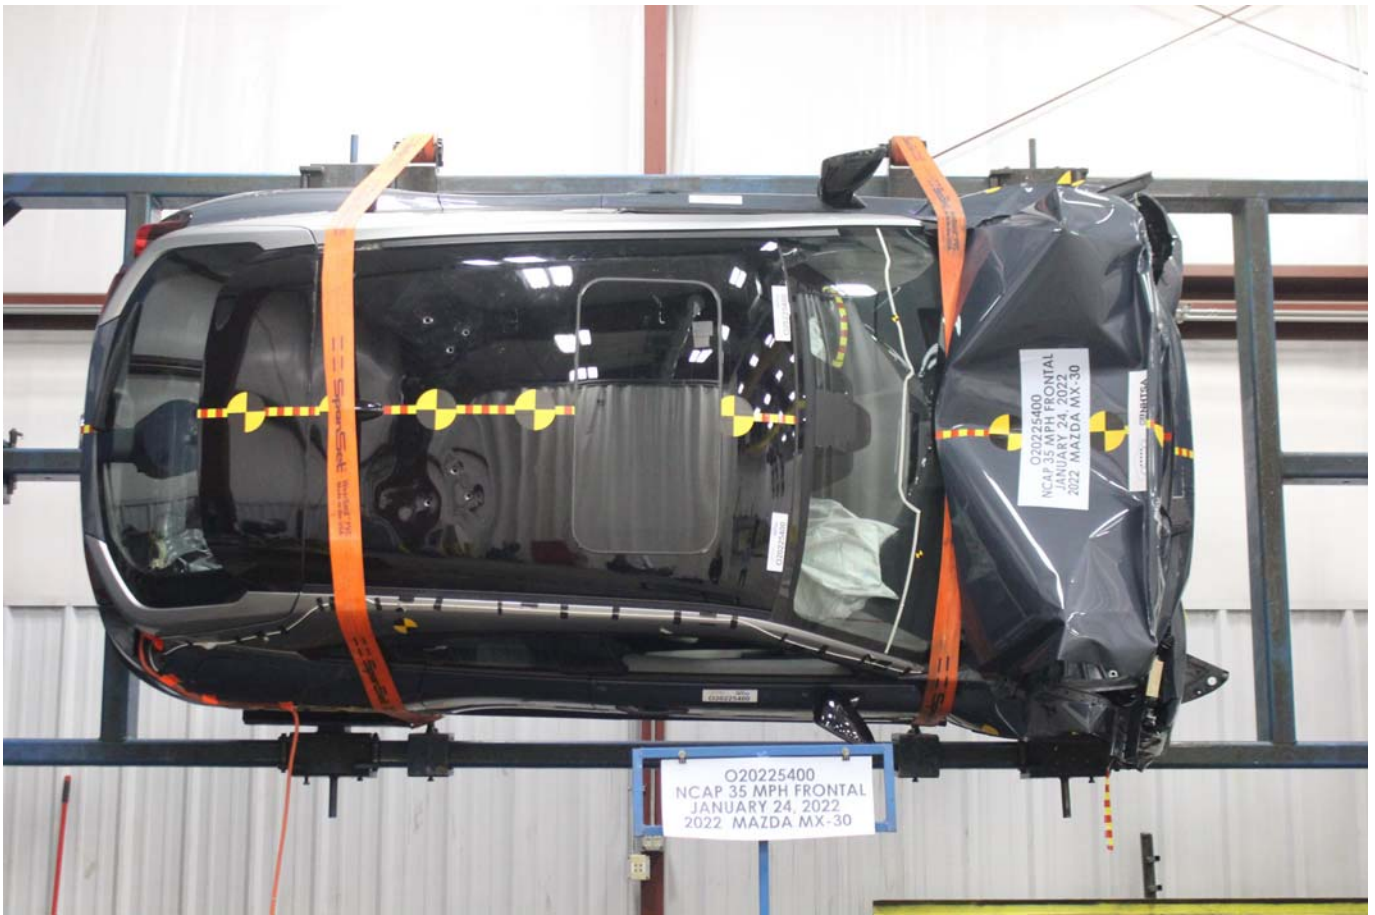
Photo No. 305-28 - FMVSS No. 305 Static Rollover at 90 Degrees

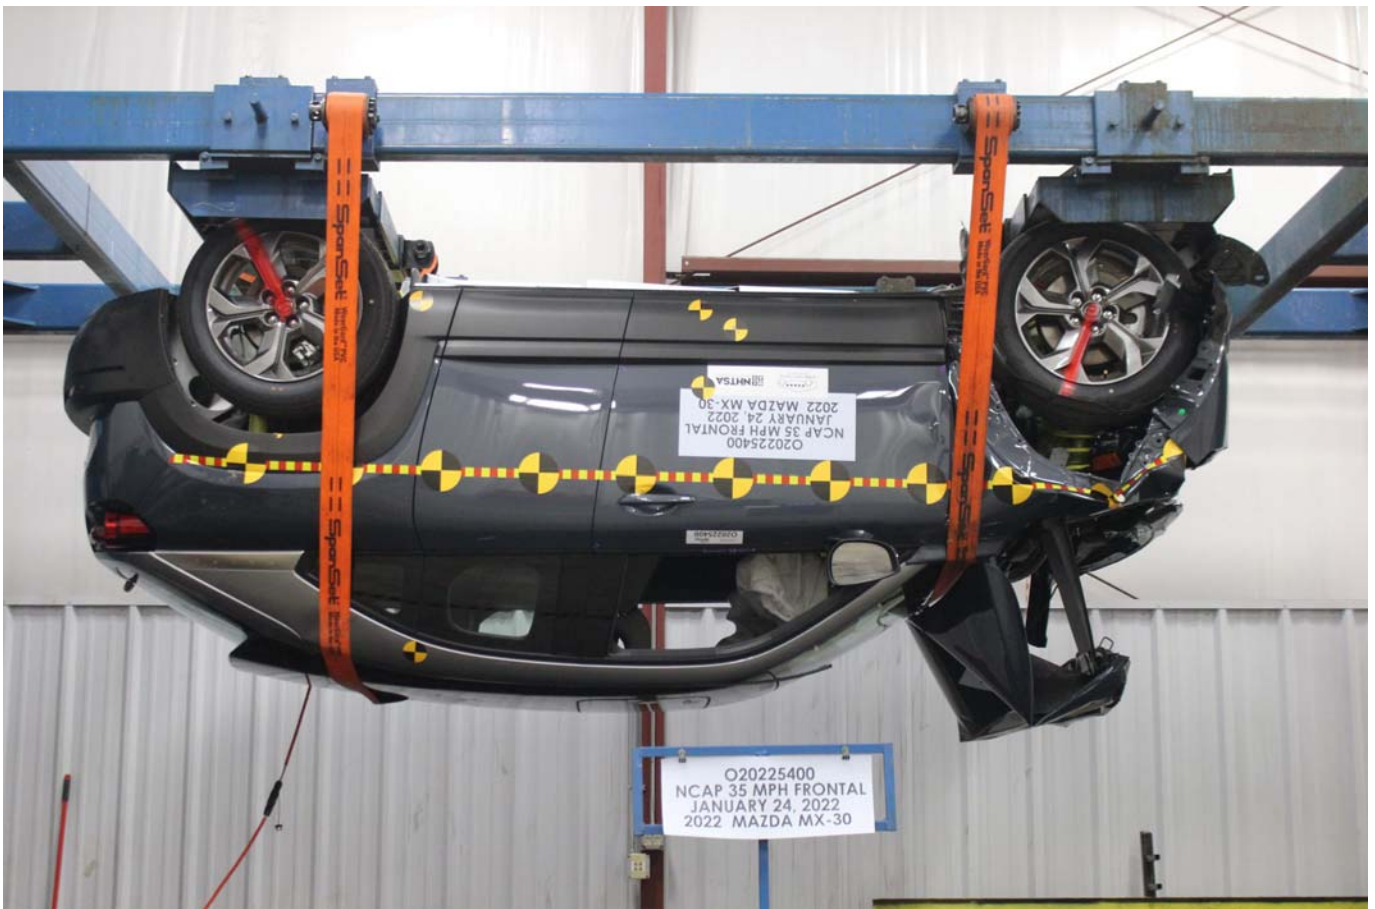
Photo No. 305-29 - FMVSS No. 305 Static Rollover at 180 Degrees
