**REPORT NUMBER: SideNCAPPole-MGA-22-009**

**NEW CAR ASSESSMENT PROGRAM (NCAP)  
Side Impact Pole Test**

**HONDA OF CANADA MFG.  
2022 Honda Civic LX 4-Door Sedan  
NHTSA No.: O20225304**

**FINAL REPORT**

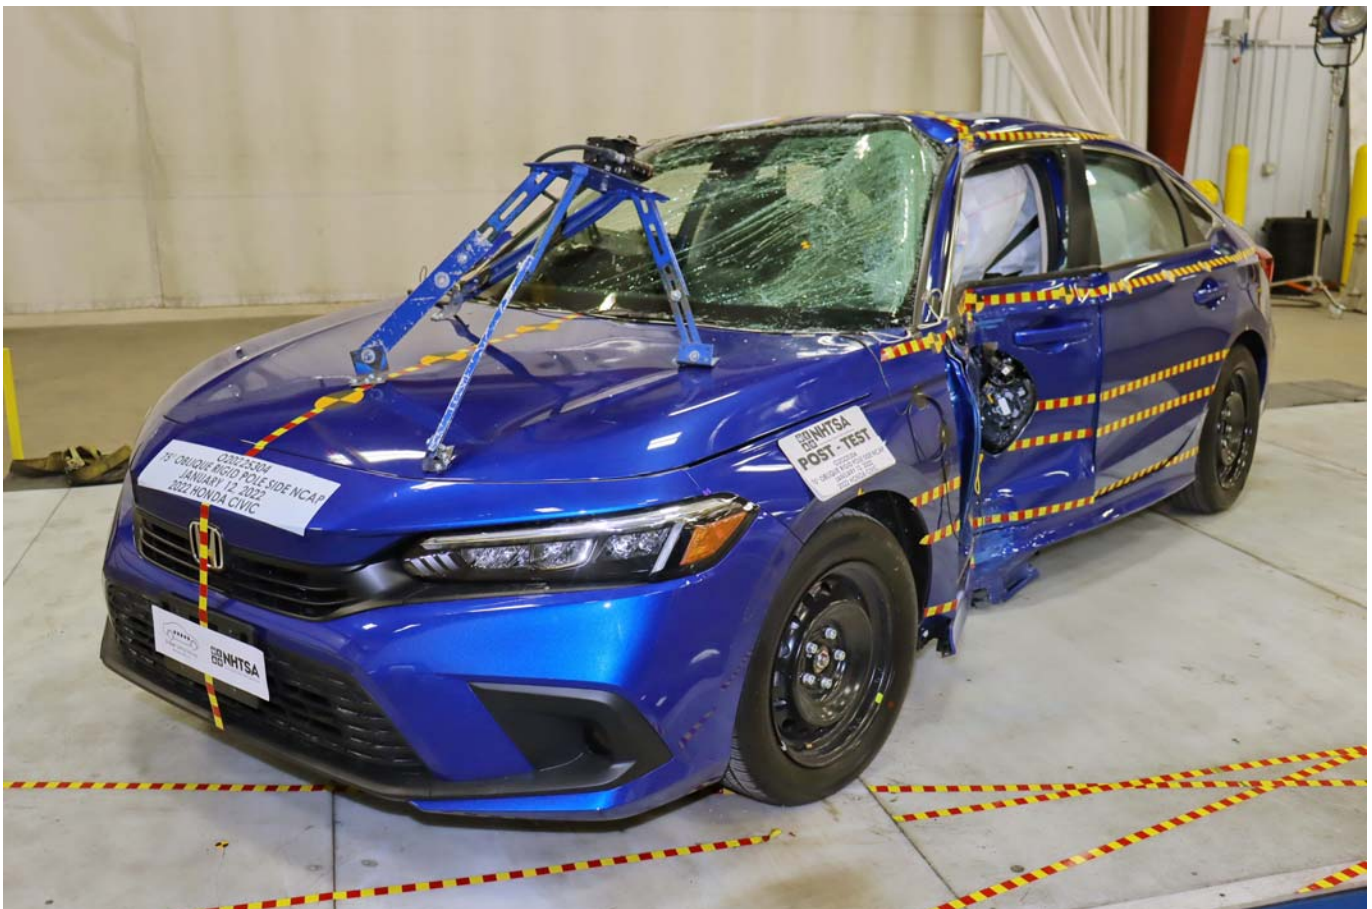
Photo No. 006 - Post-Test Left Front Three-Quarter View of Test Vehicle

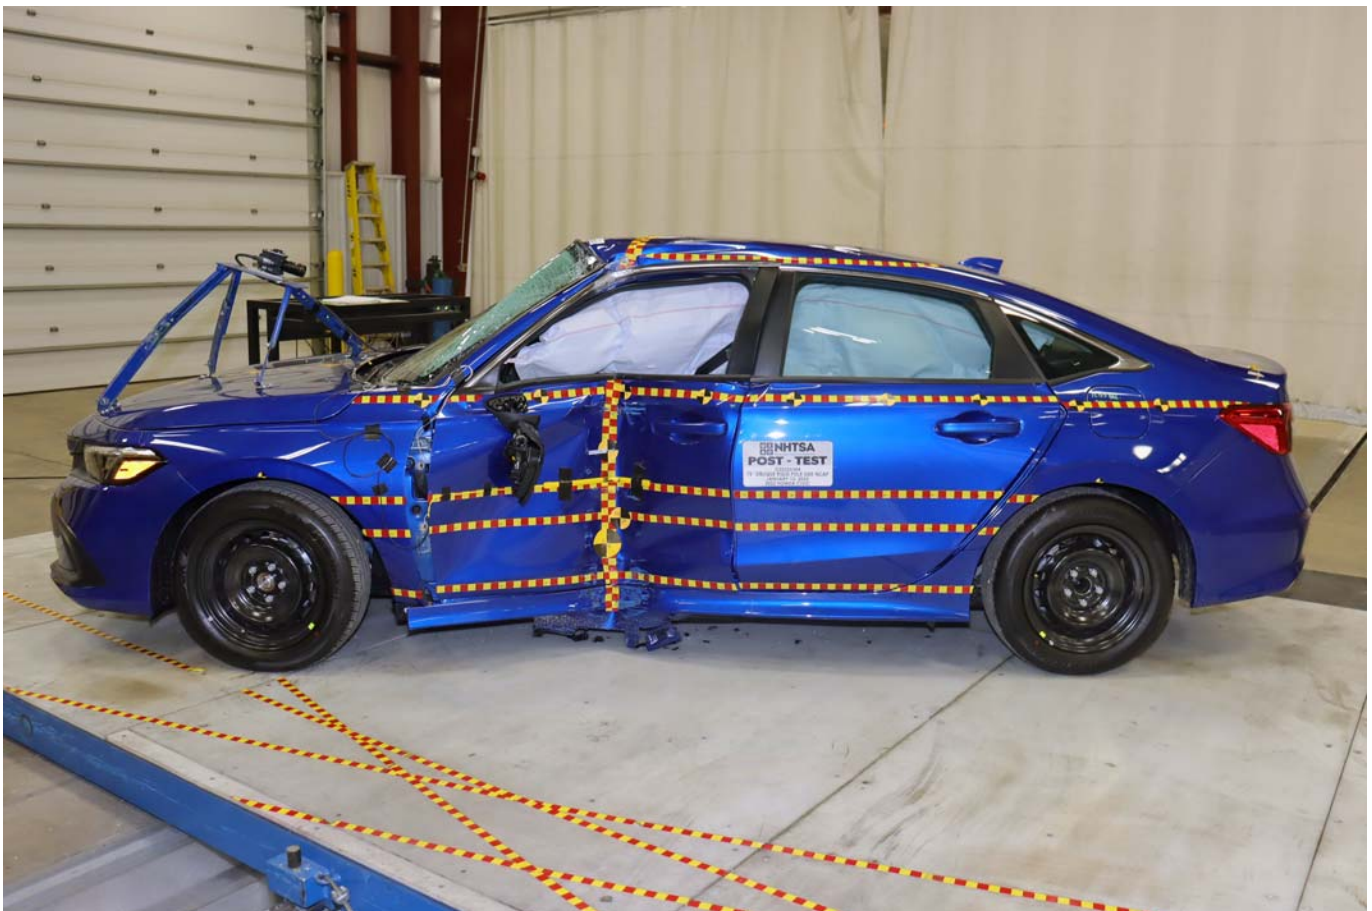
Photo No. 008 - Post-Test Left Side View of Test Vehicle

Critical Areas of Performance	Observations and Conclusions
Pillar Performance	No Separation
Sill Separation	No Separation
Windshield Damage	Cracked
Side Window Damage	LF window broken
Other Notable Effects	None

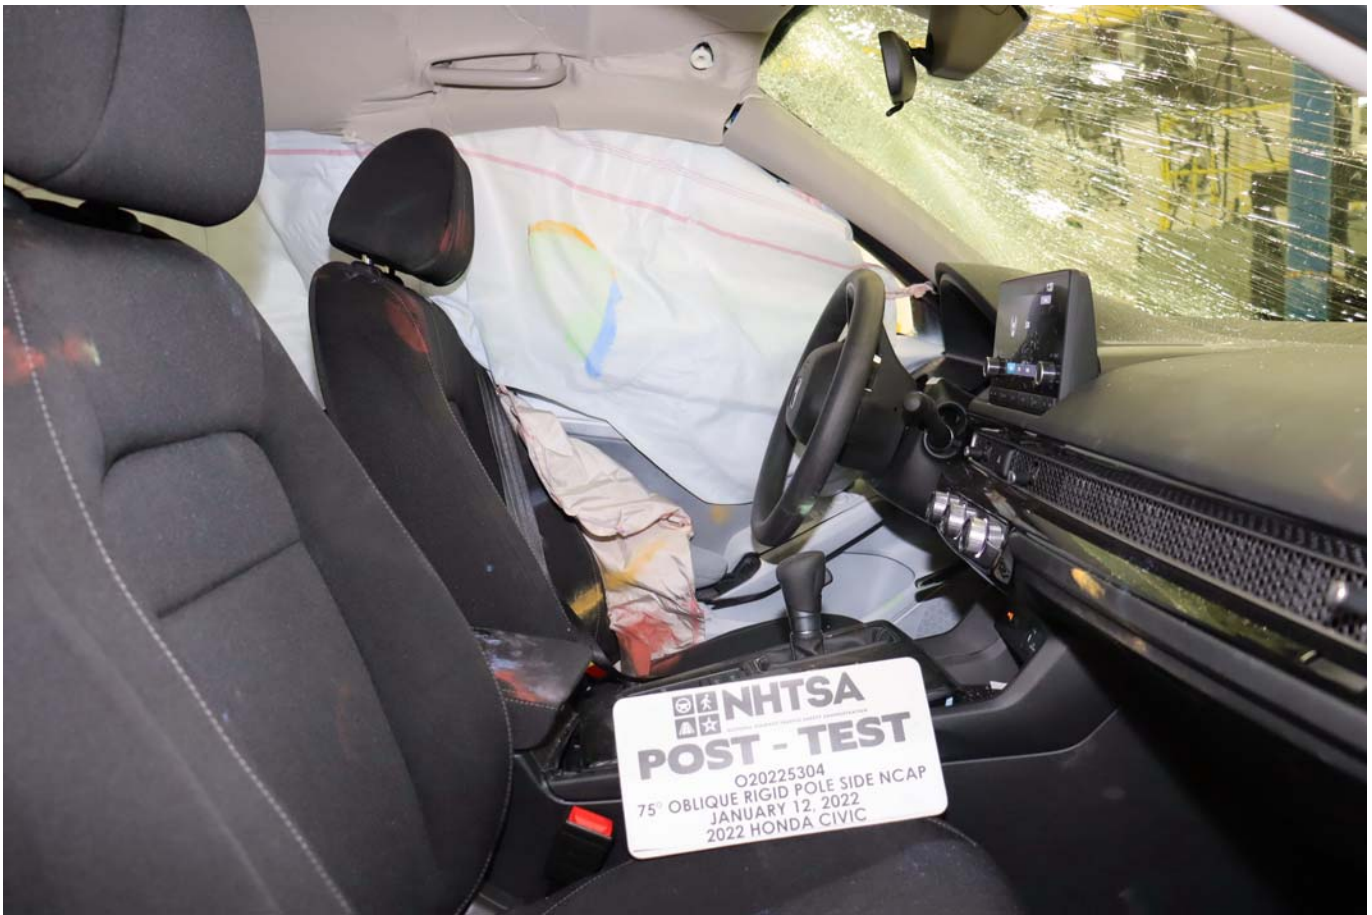
Photo No. 045 - Post-Test Inner Door Panel View Showing Dummy Contact Location

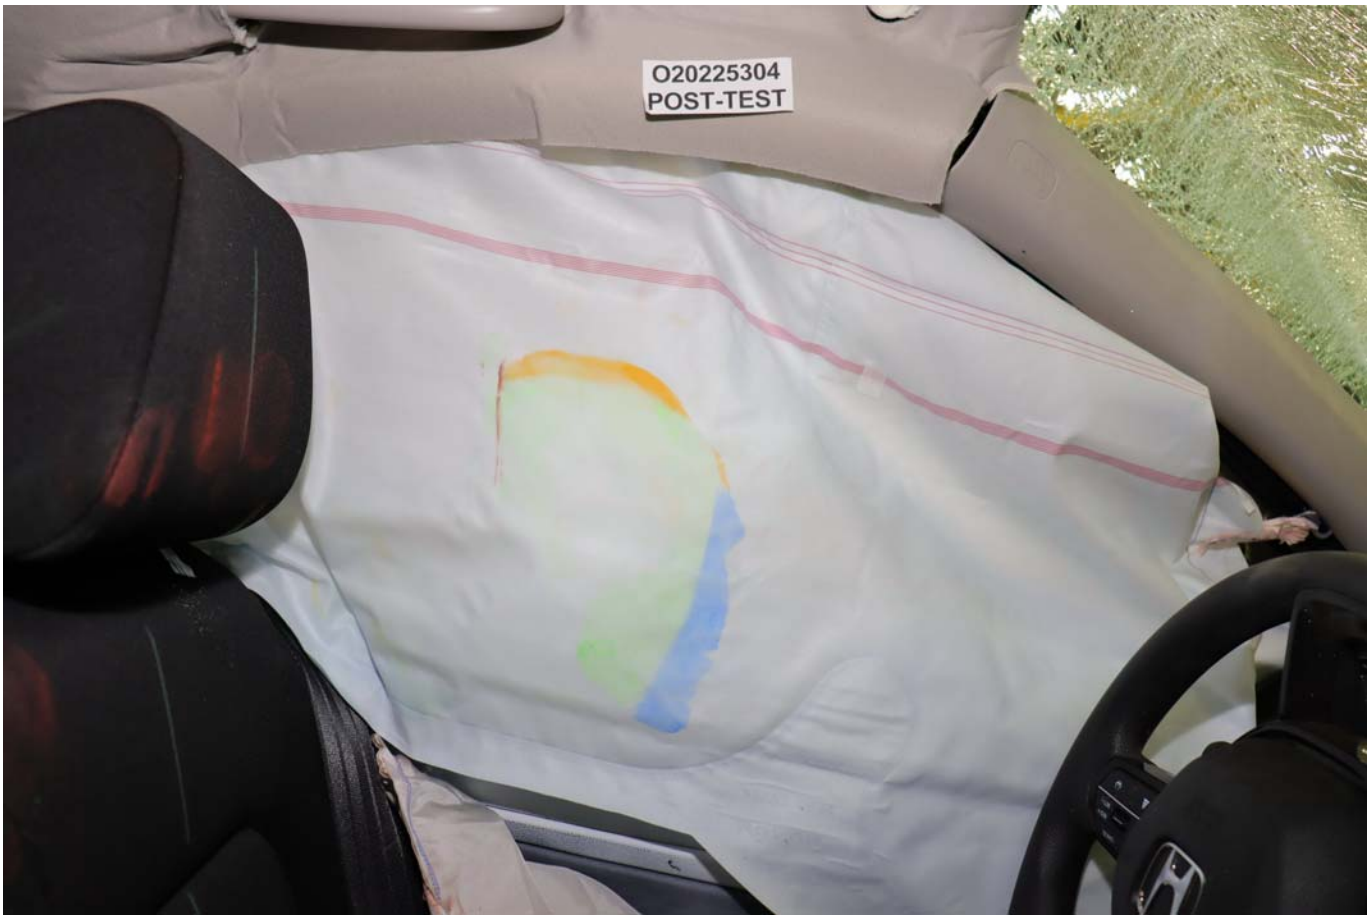
Photo No. 047 - Post-Test Dummy Close-Up Head Contact with Side Air Bag View

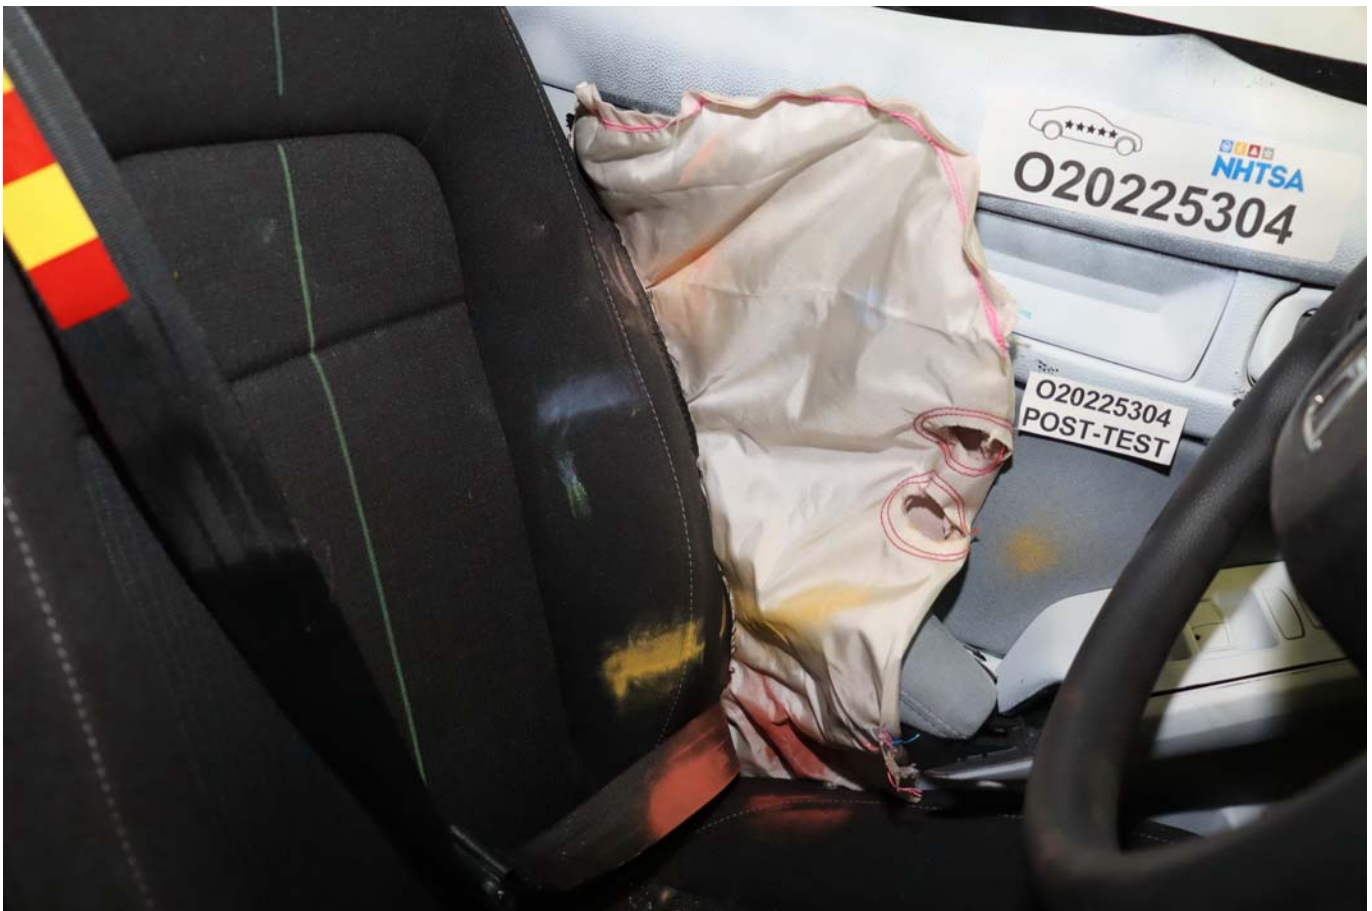
Photo No. 048 - Post-Test Dummy Close-Up Torso Contact with Vehicle Interior View

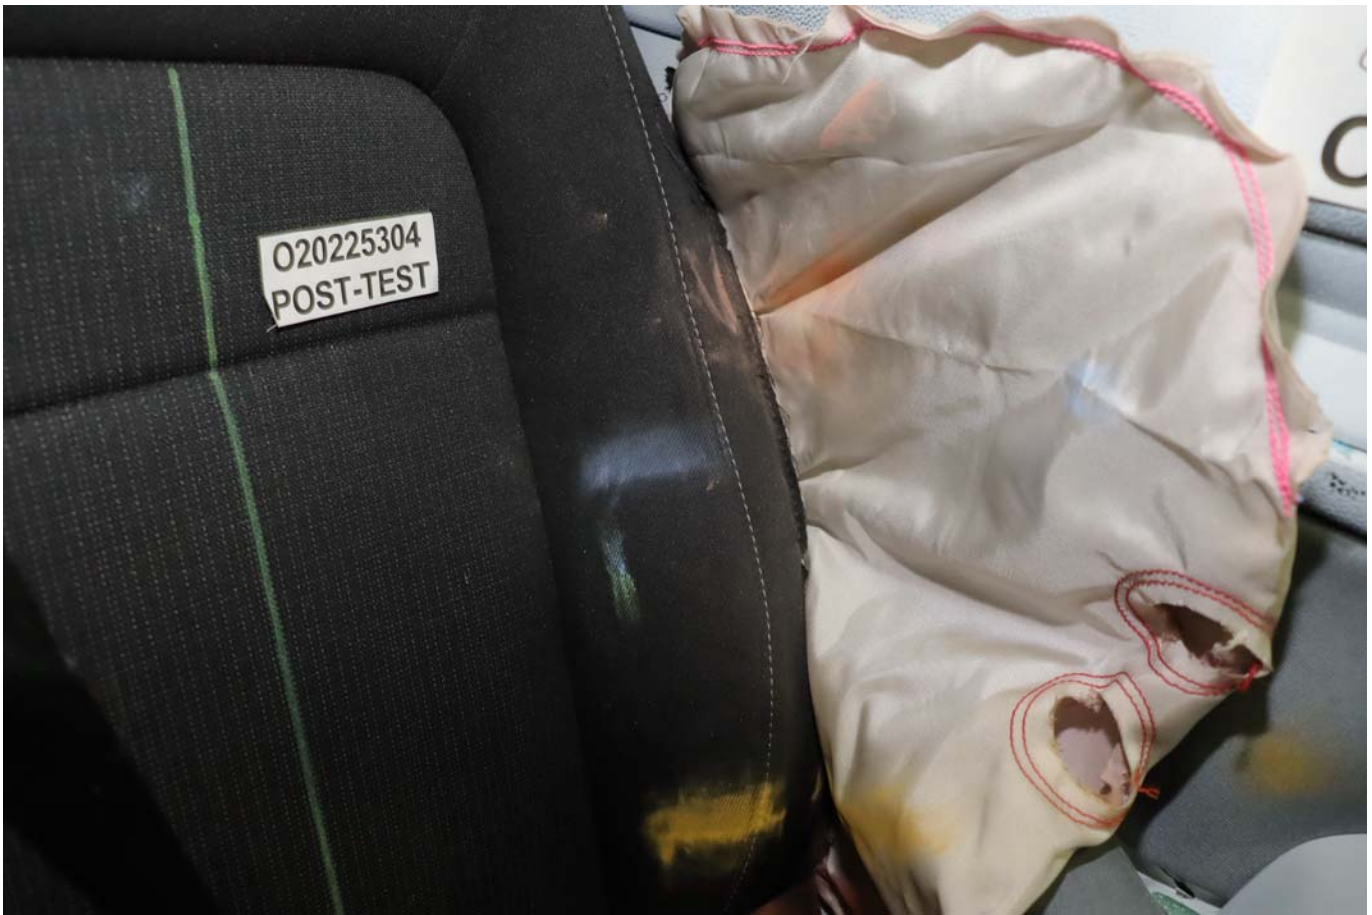
Photo No. 049 - Post-Test Dummy Close-Up Torso Contact with Side Air Bag View

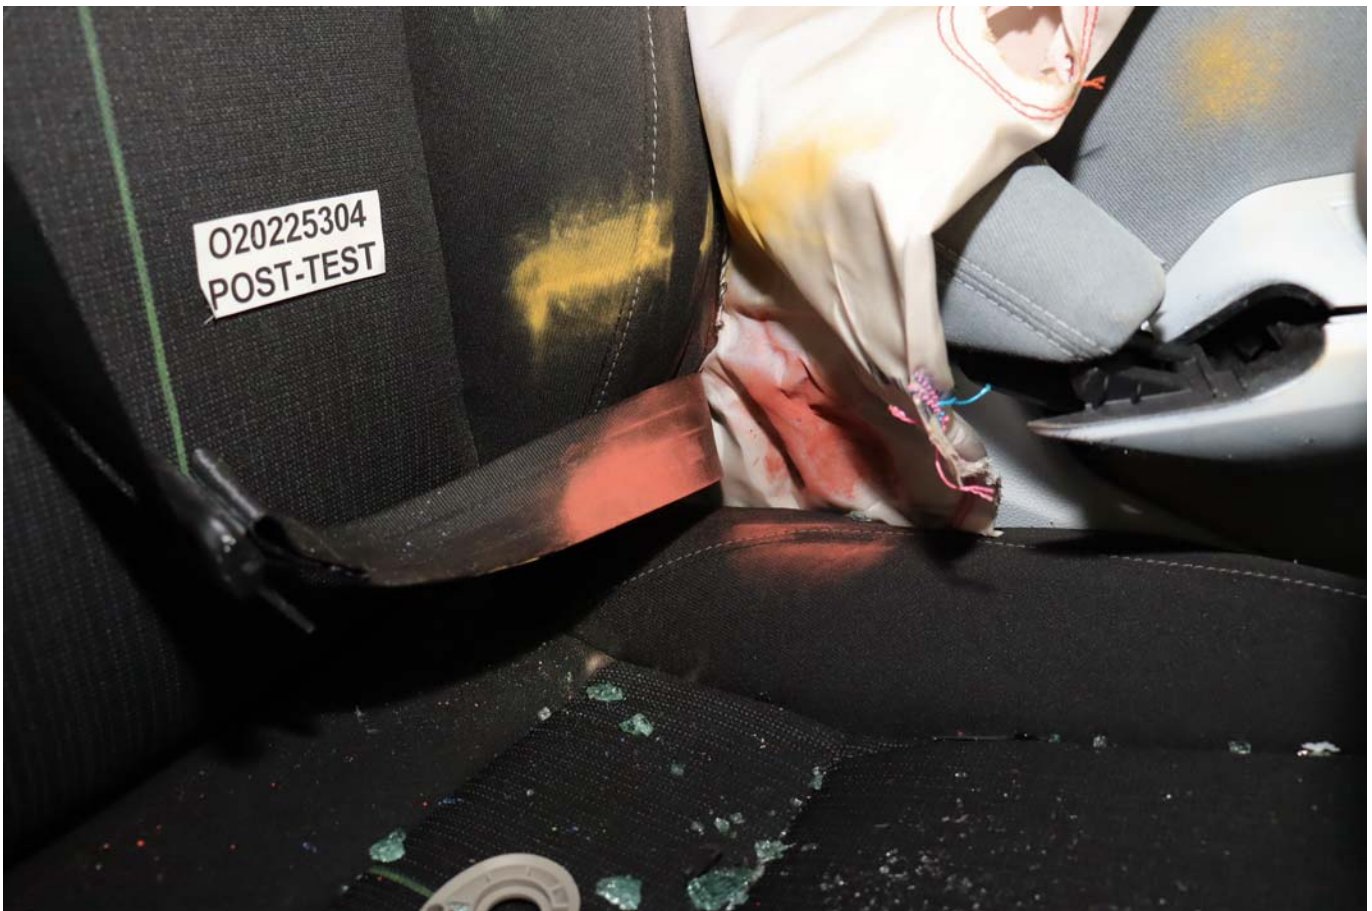
Photo No. 050 - Post-Test Dummy Close-Up Pelvis Contact with Vehicle Interior View

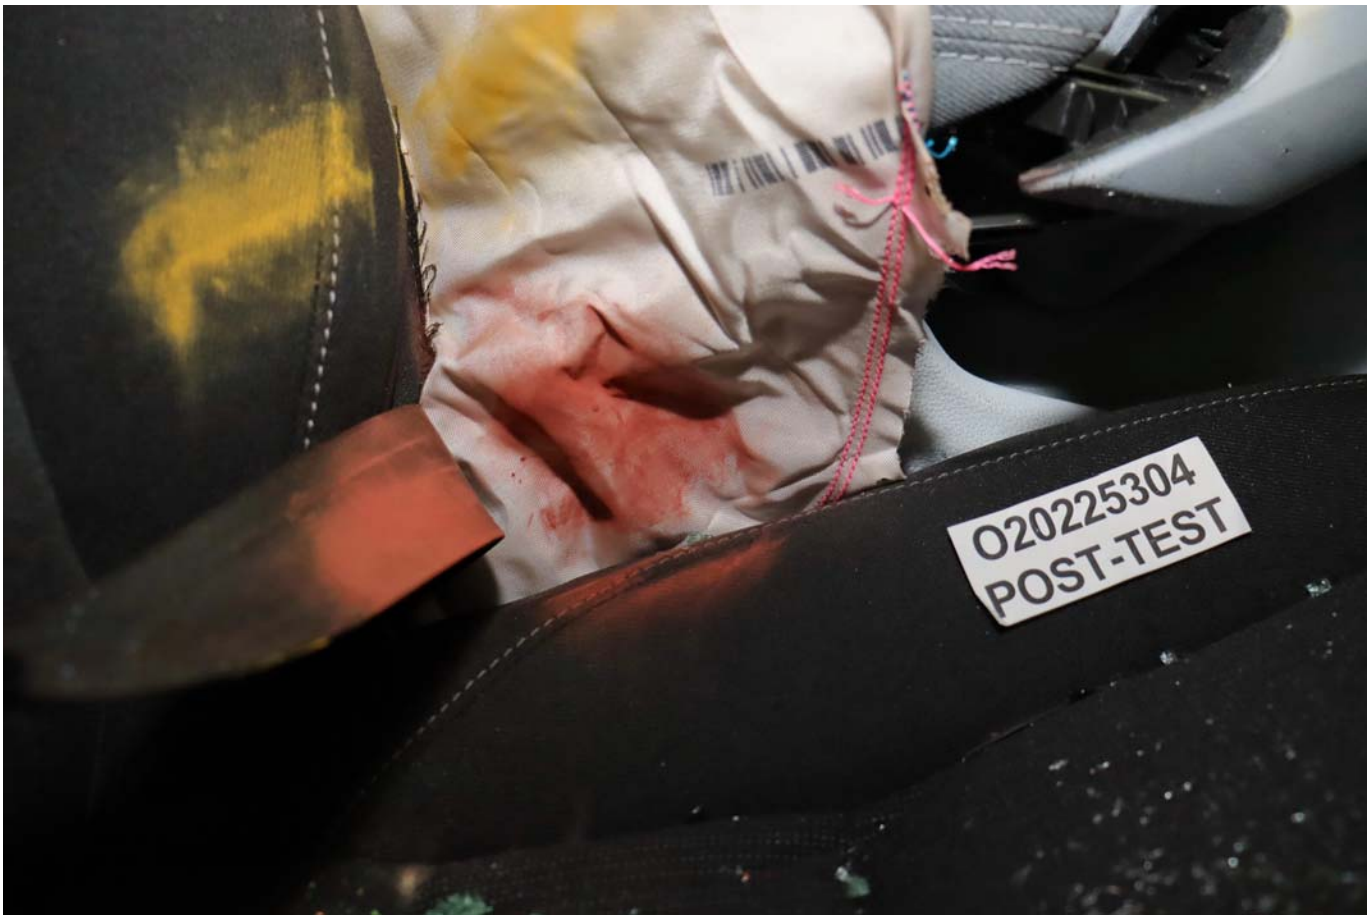
Photo No. 051 - Post-Test Dummy Close-Up Pelvis Contact with Side Air Bag View

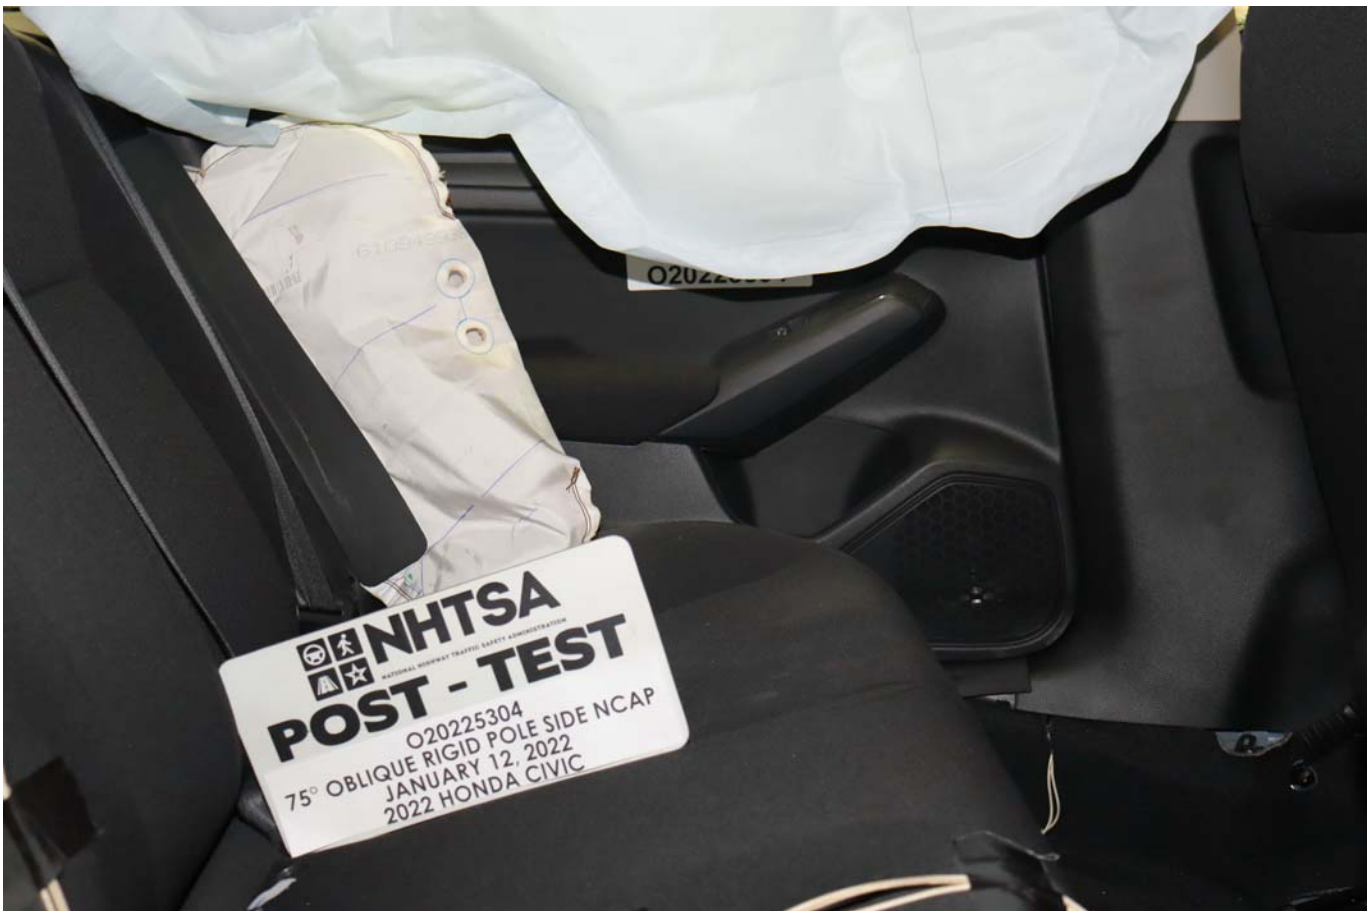
Photo No. 054 - Post-Test Inner Rear Passenger Torso Air Bag Deployment View

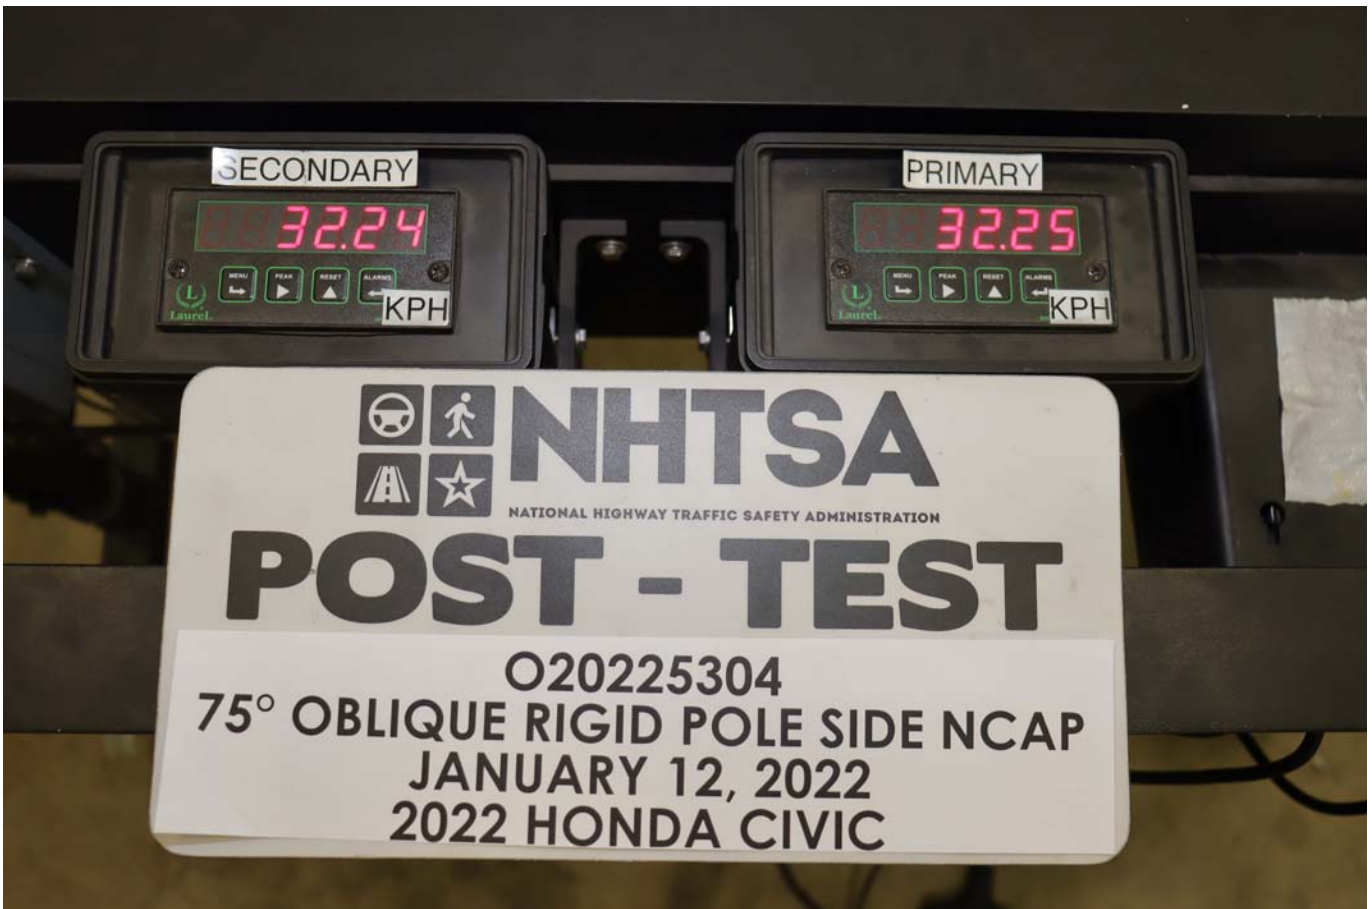
Photo No. 064 - Post-Test Primary and Redundant Speed Trap Read-Out

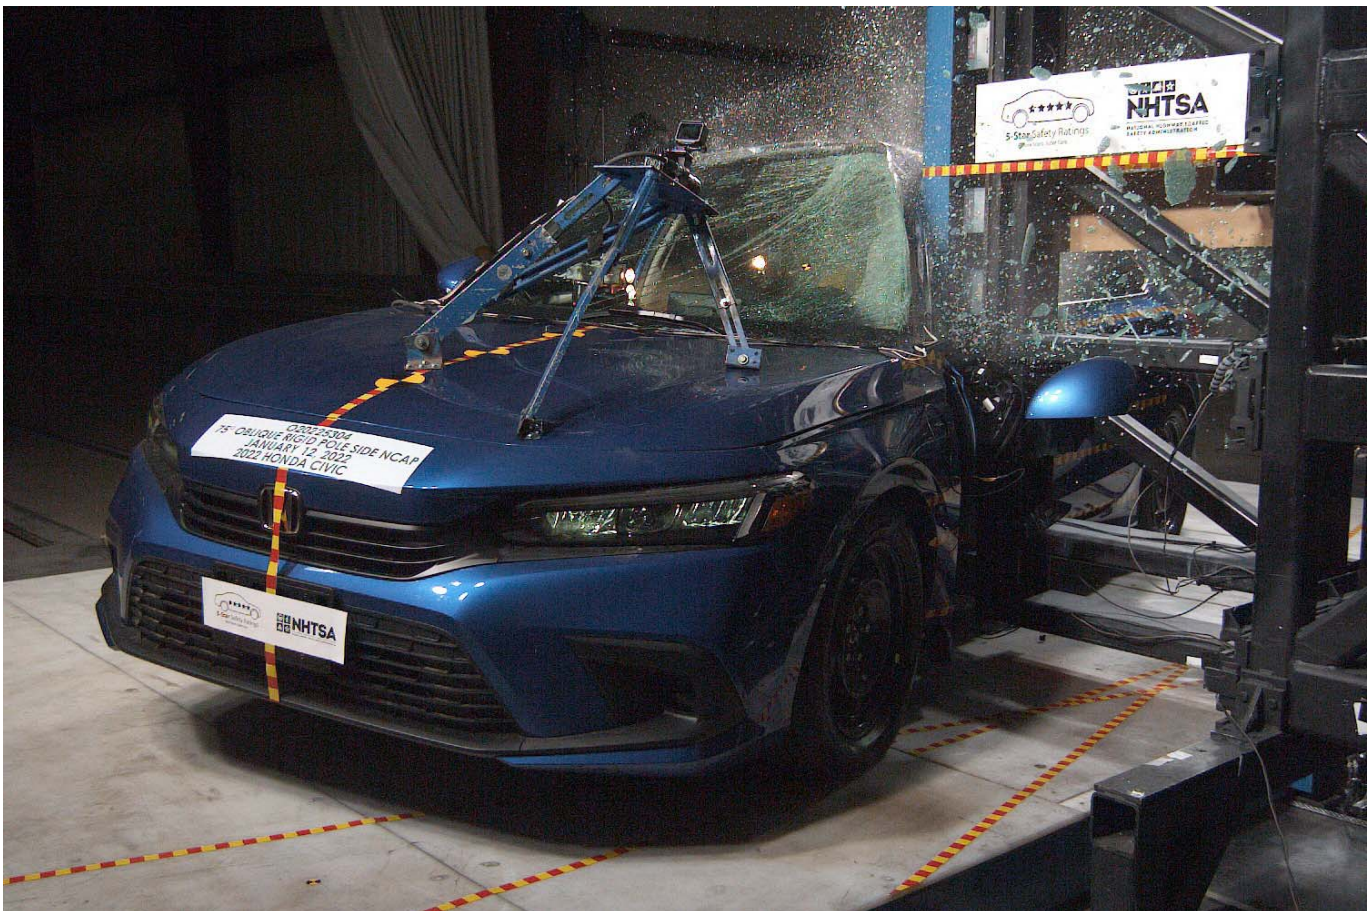
Photo No. 070 - Impact Event

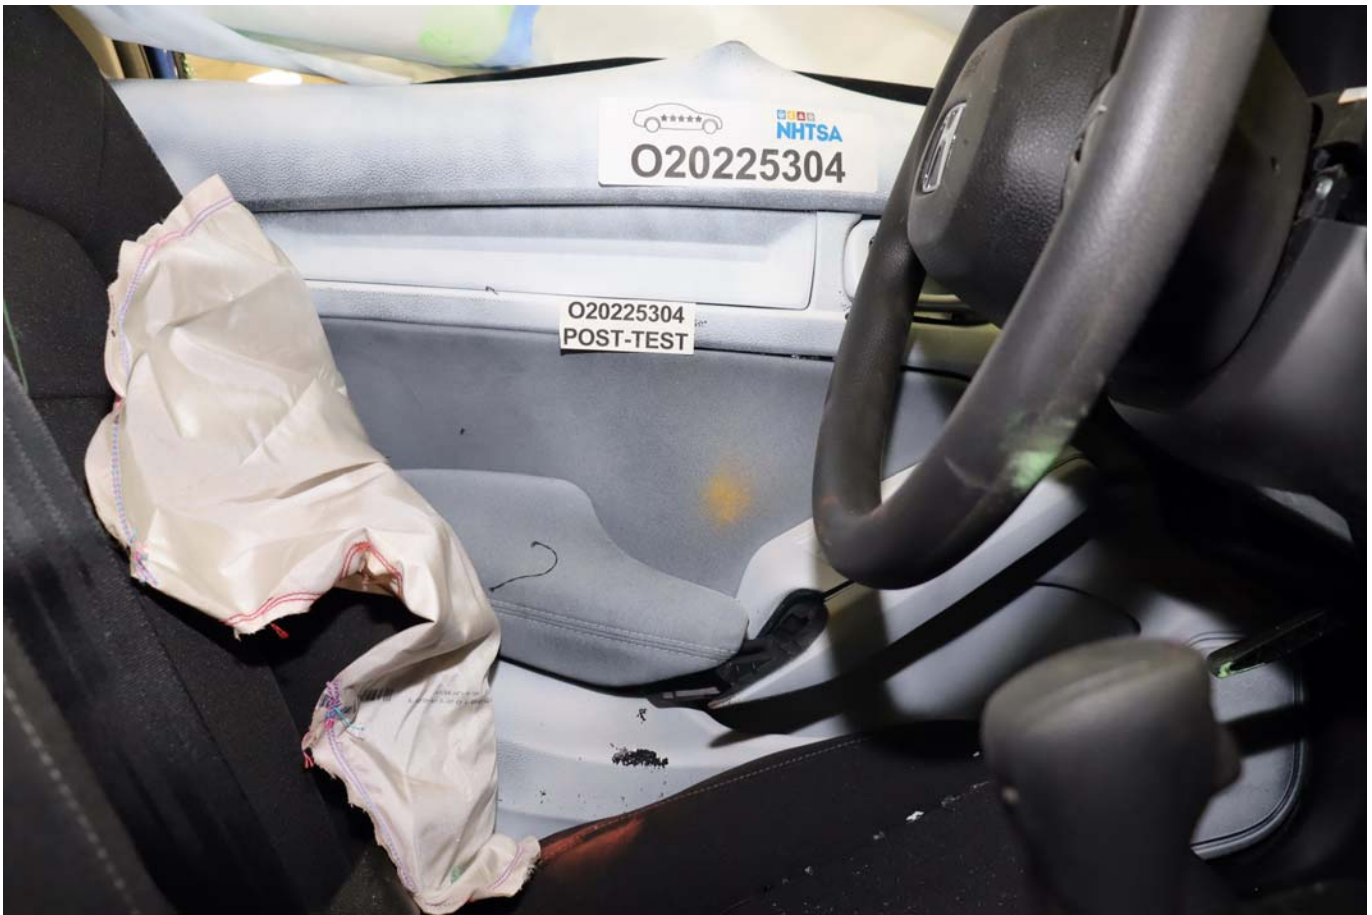
Photo No. 073 - Post-Test View of Shattered Vehicle Inner Door Panel
