**NEW CAR ASSESSMENT PROGRAM  
LANE DEPARTURE WARNING CONFIRMATION TEST  
NCAP-DRI-LDW-22-07**

**2022 Mazda CX-5 AWD W/ PREMIUM PLUS PKG**

**DYNAMIC RESEARCH, INC.**

**10 March 2022**

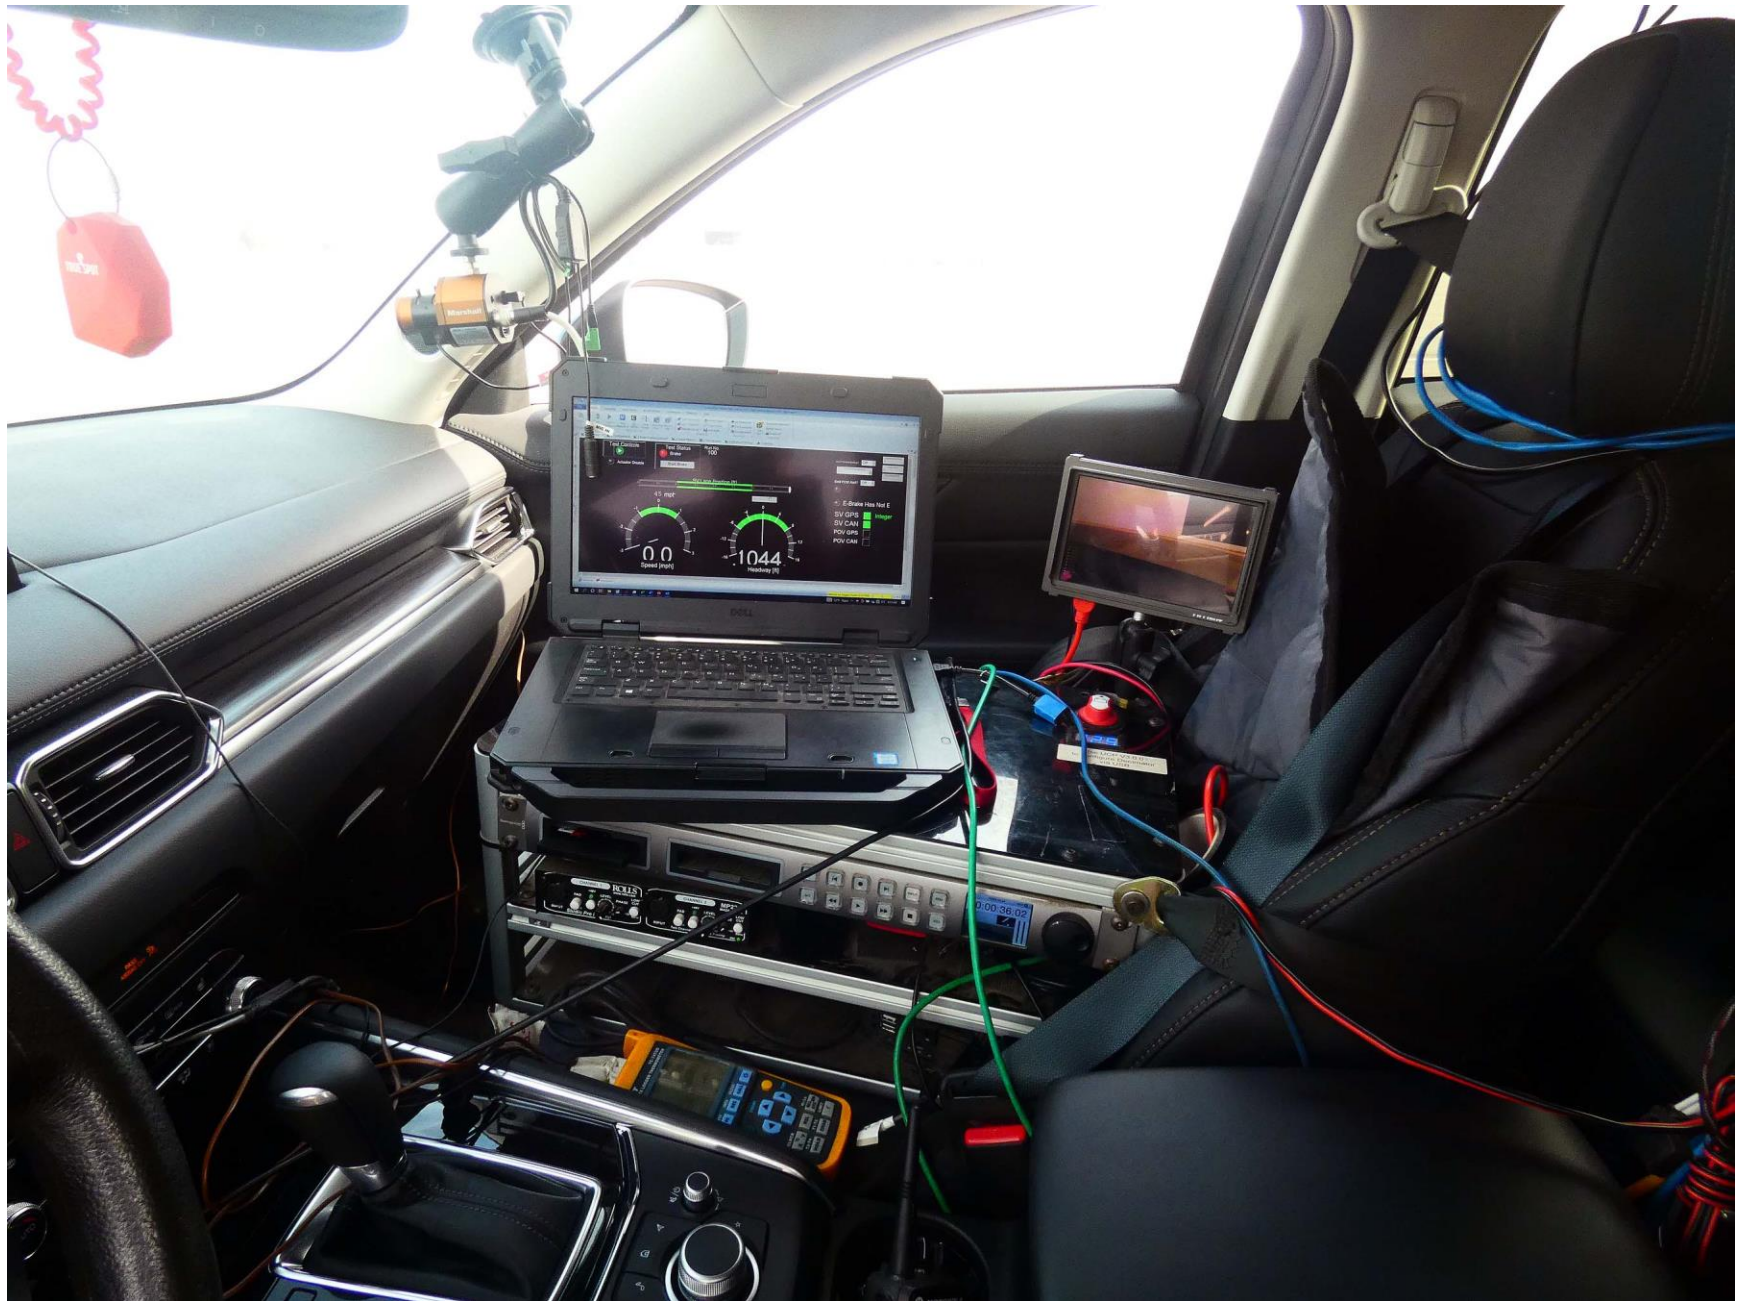
Figure A7. Computer Installed in Subject Vehicle

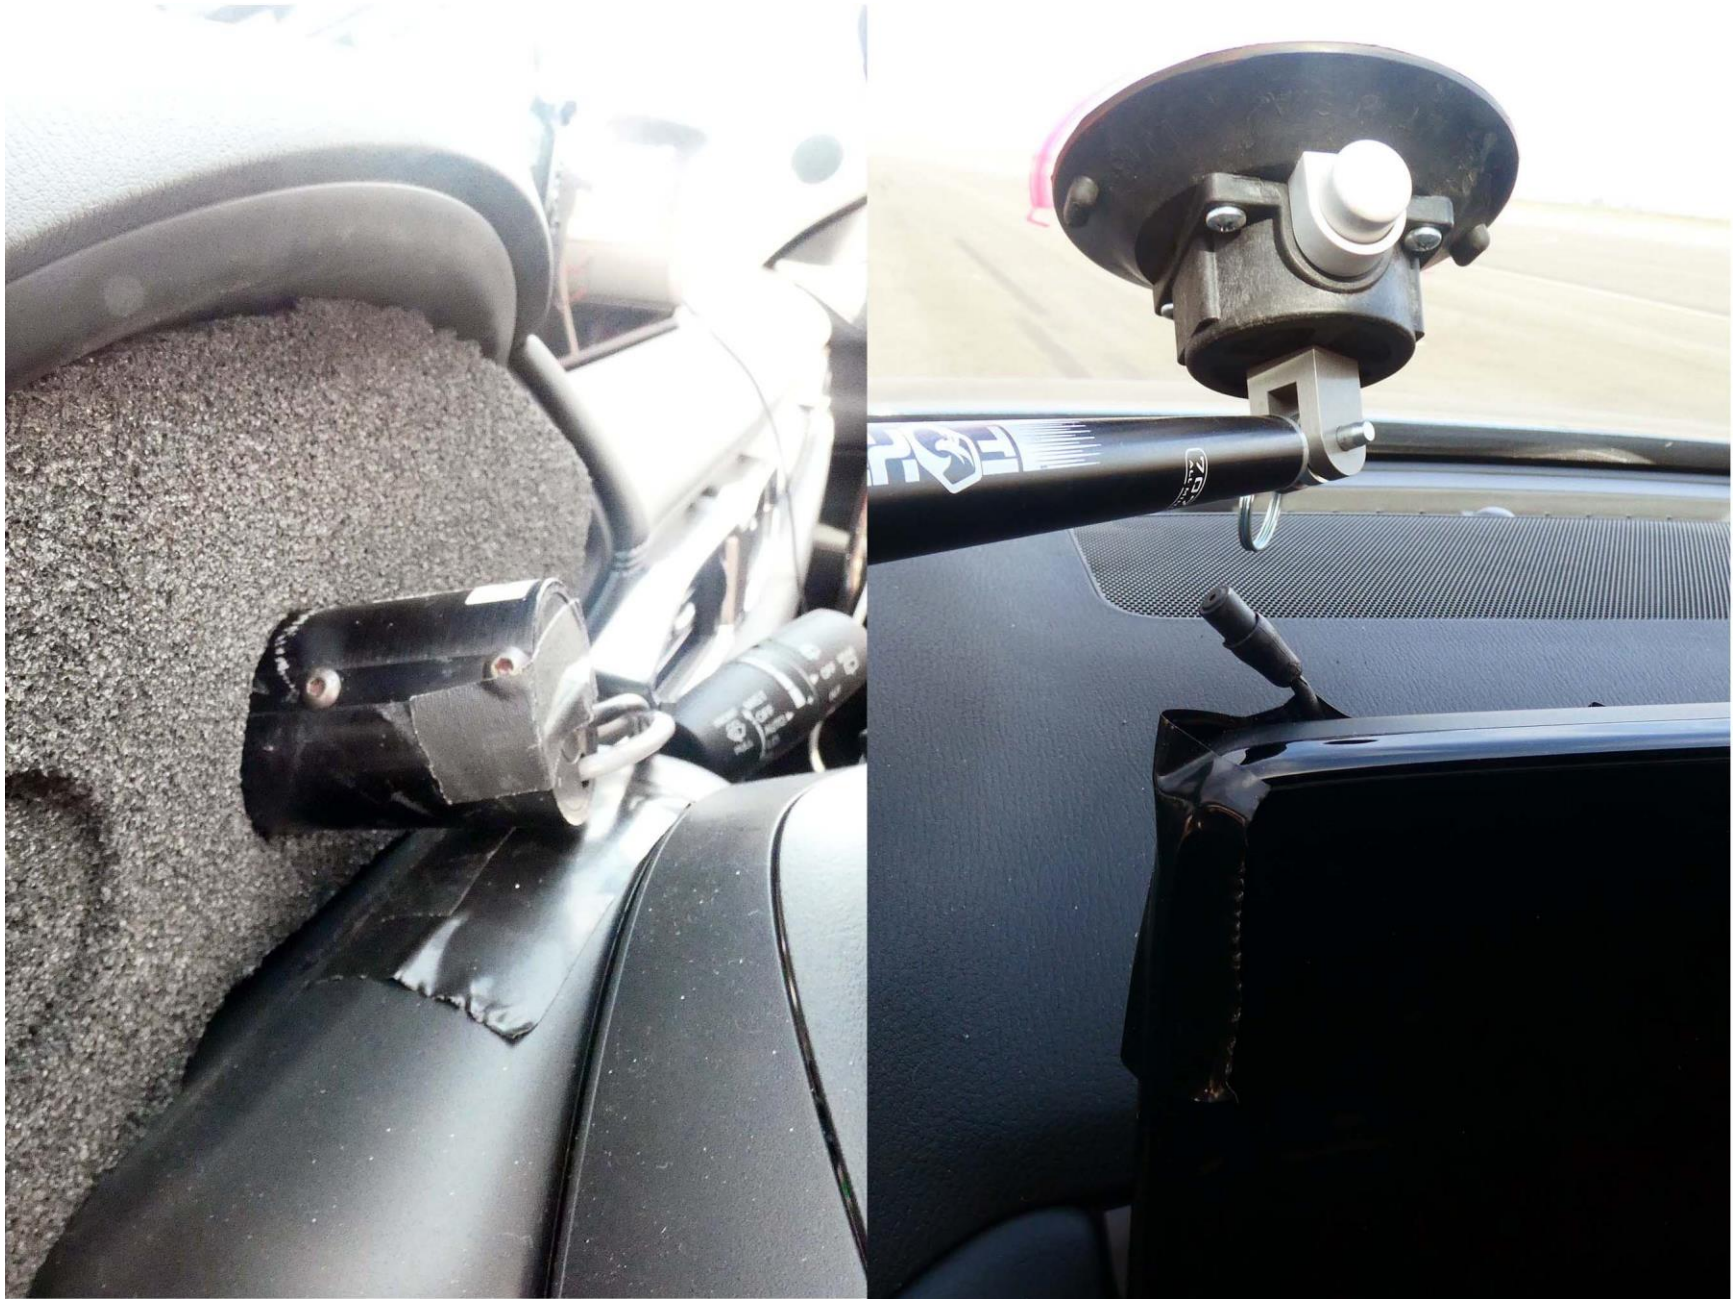
Figure A8. Sensors for Detecting Visual and Auditory Alerts

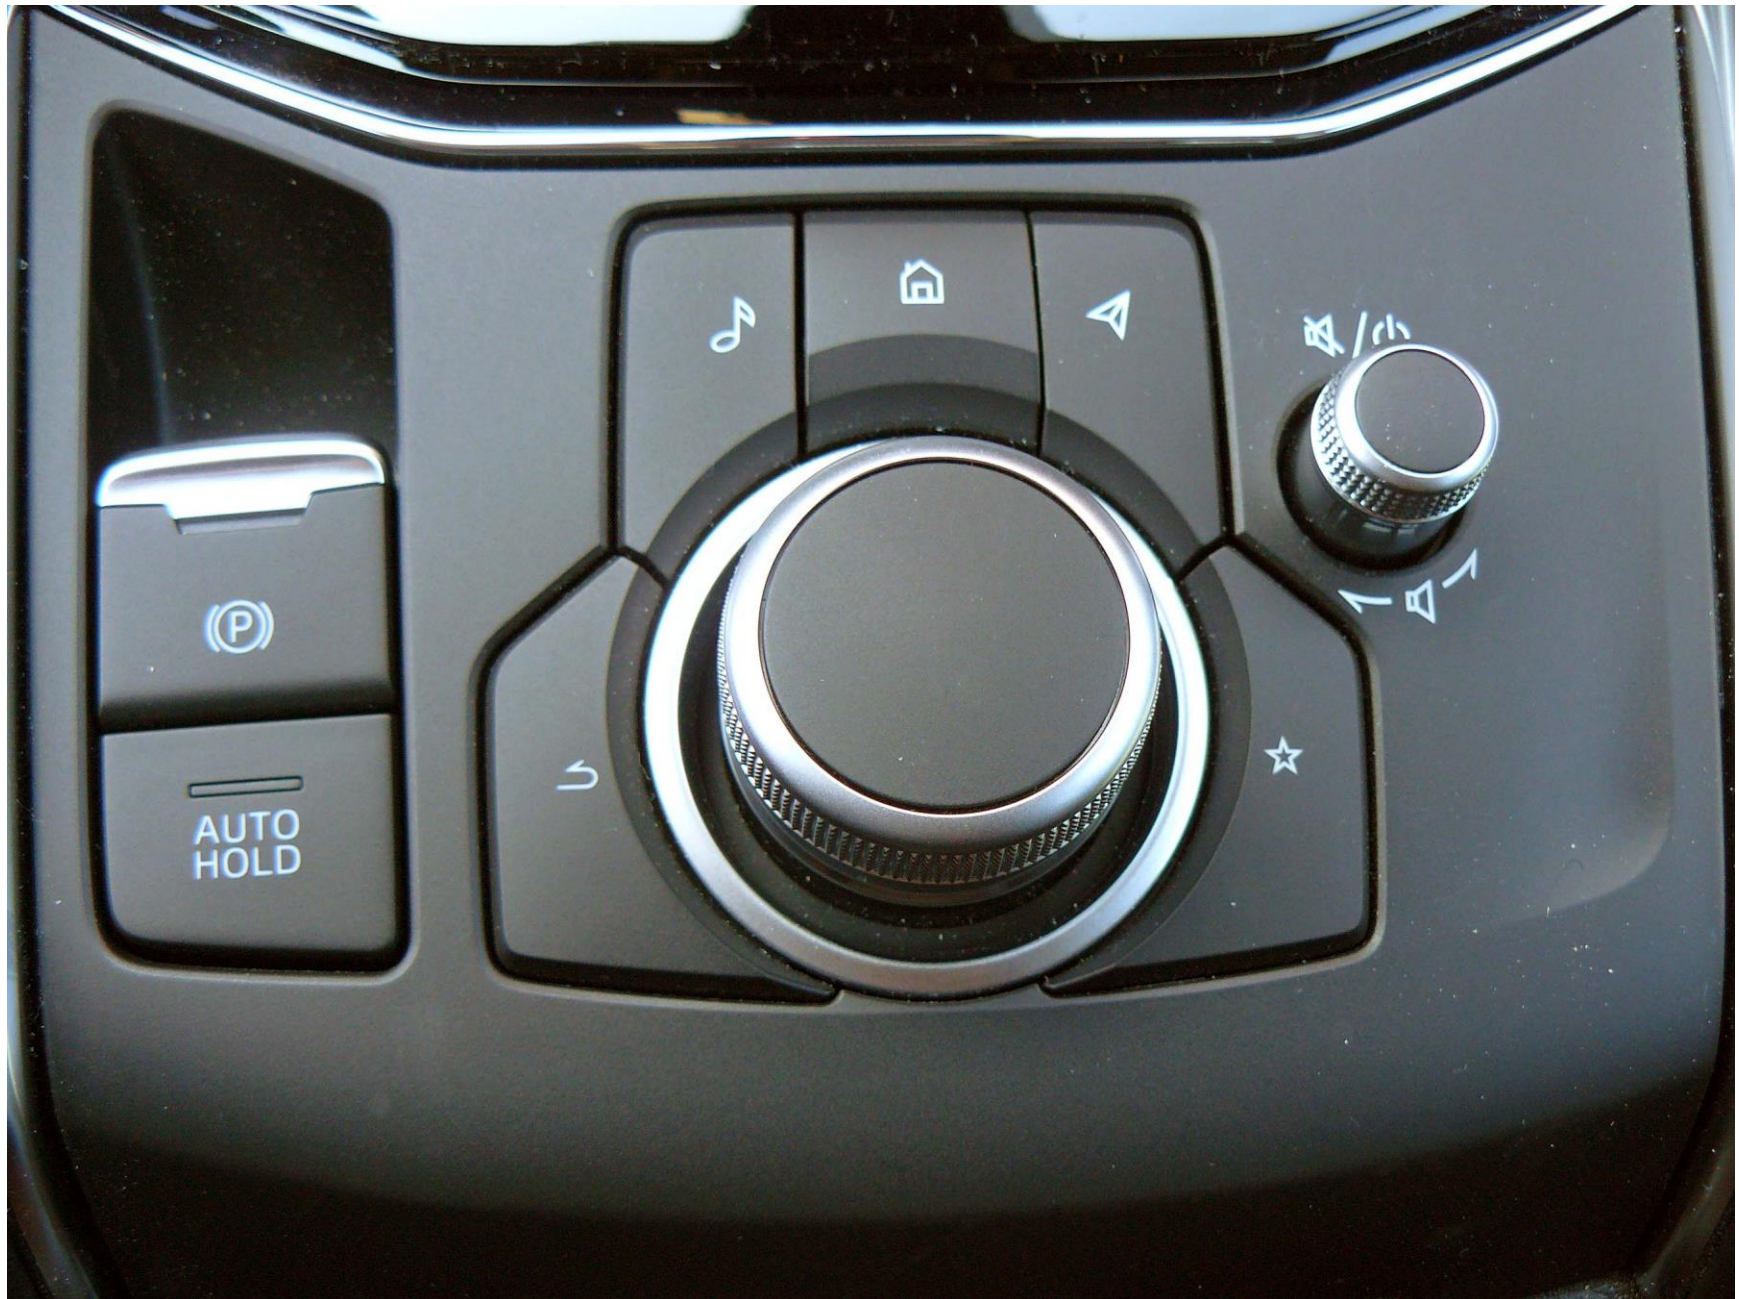
Figure A9. Button for Accessing System Setup Menus

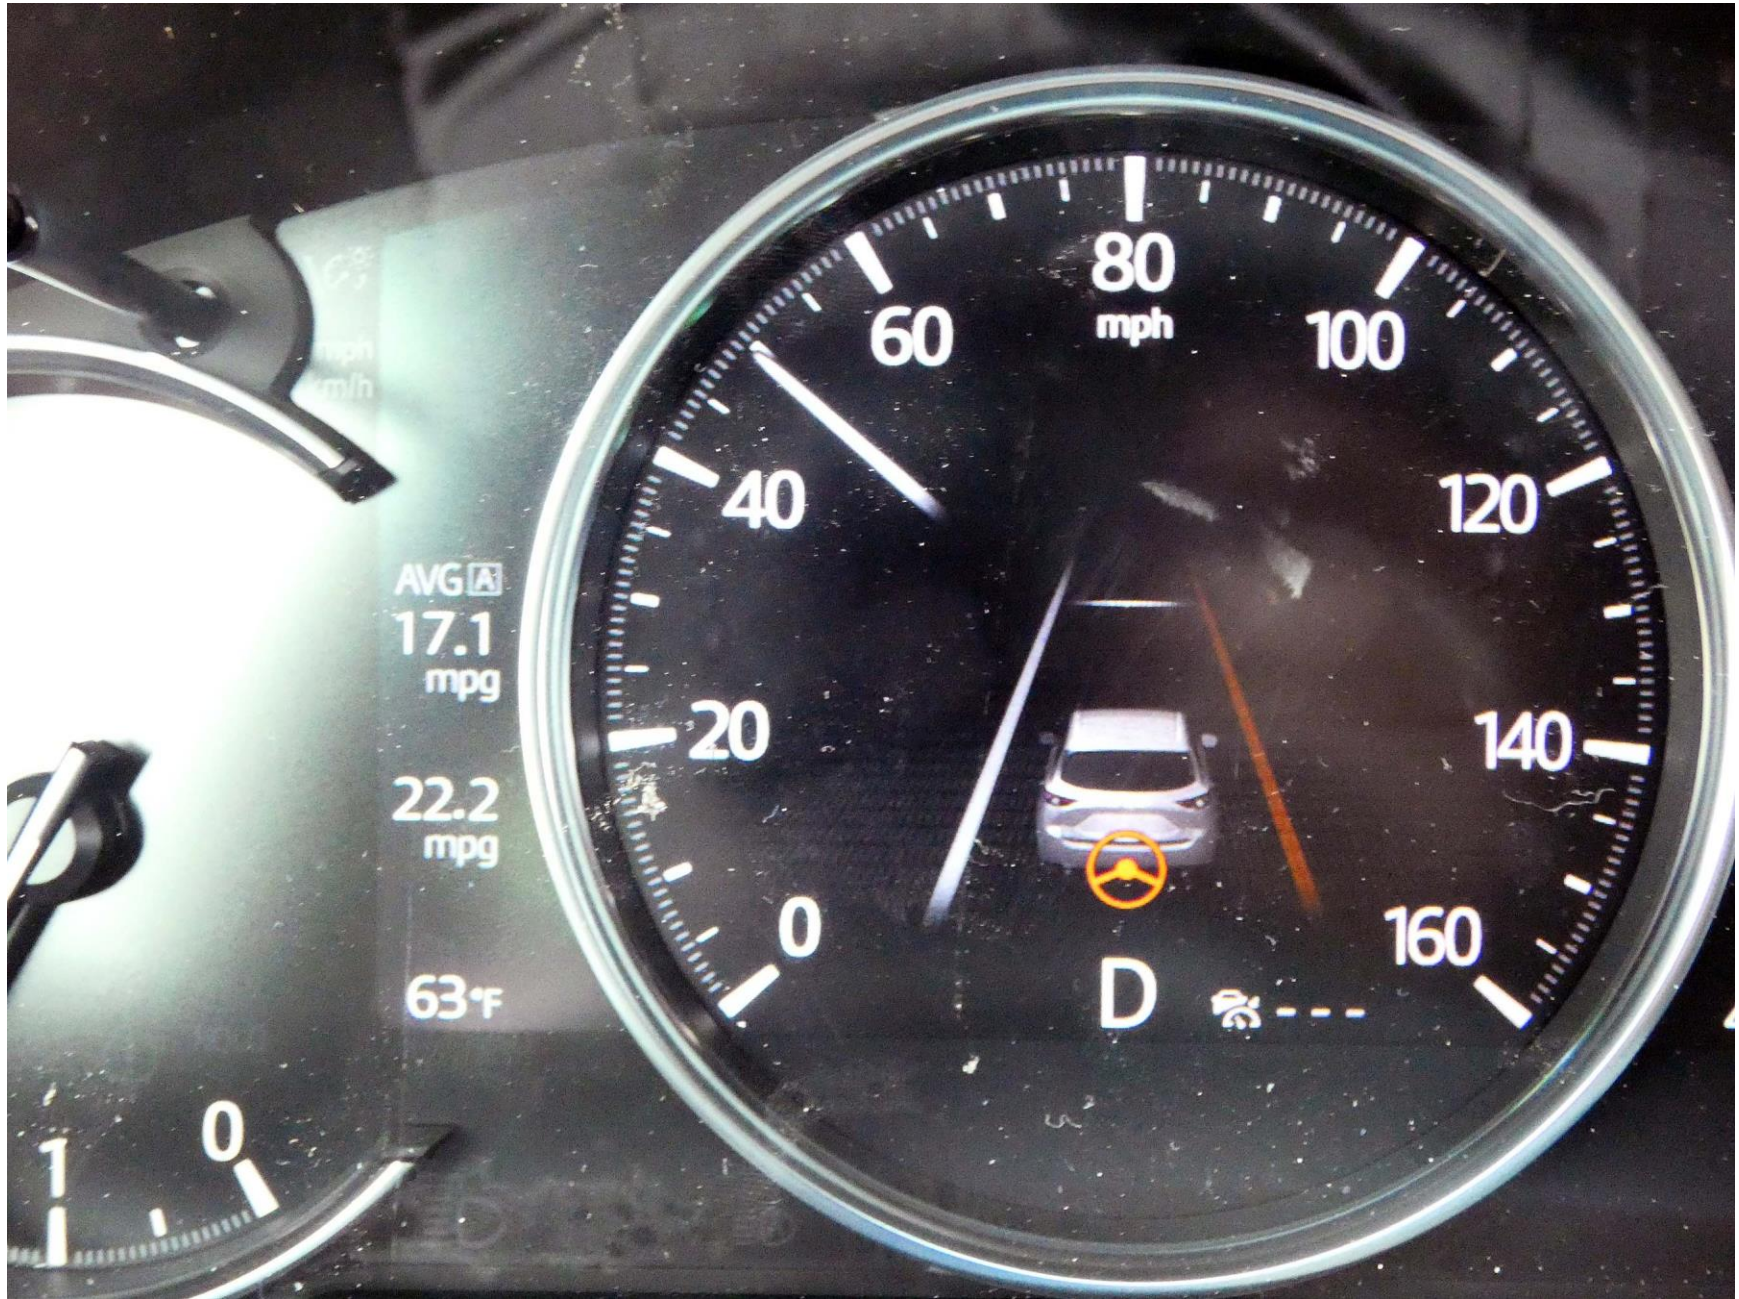
Figure A11. LDW Visual Alert
