# NEW CAR ASSESSMENT PROGRAM CRASH IMMINENT BRAKING SYSTEM CONFIRMATION TEST NCAP-DRI-CIB-22-10

2022 Kia Forte

#### **Final Report**

The purpose of the testing reported herein was to objectively quantify the performance of a Crash Imminent Braking system installed on a 2022 Kia Forte. This test is part of the New Car Assessment Program to assess Crash Imminent Braking Systems sponsored by the National Highway Traffic Safety Administration under Contract No. DTNH22-14-D-00333.

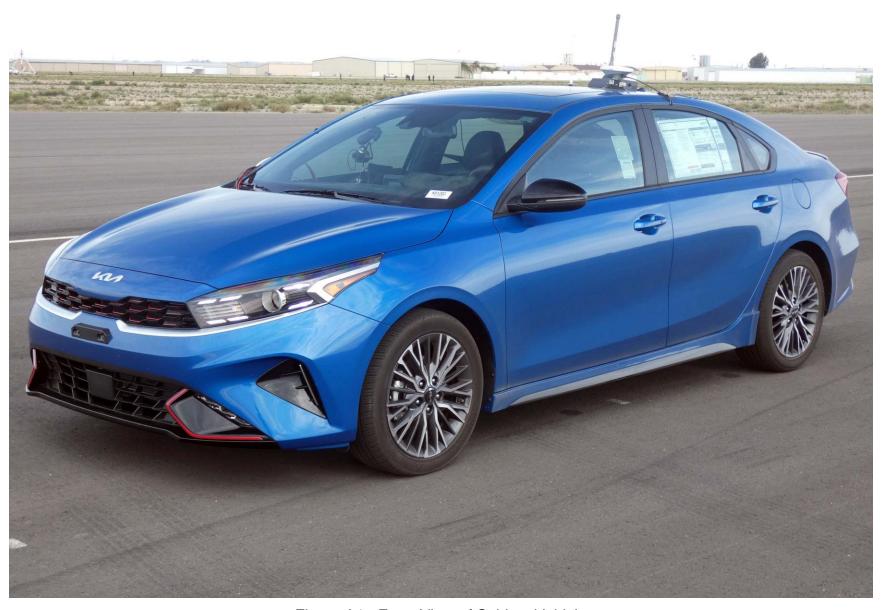
Figure A1. Front View of Subject Vehicle

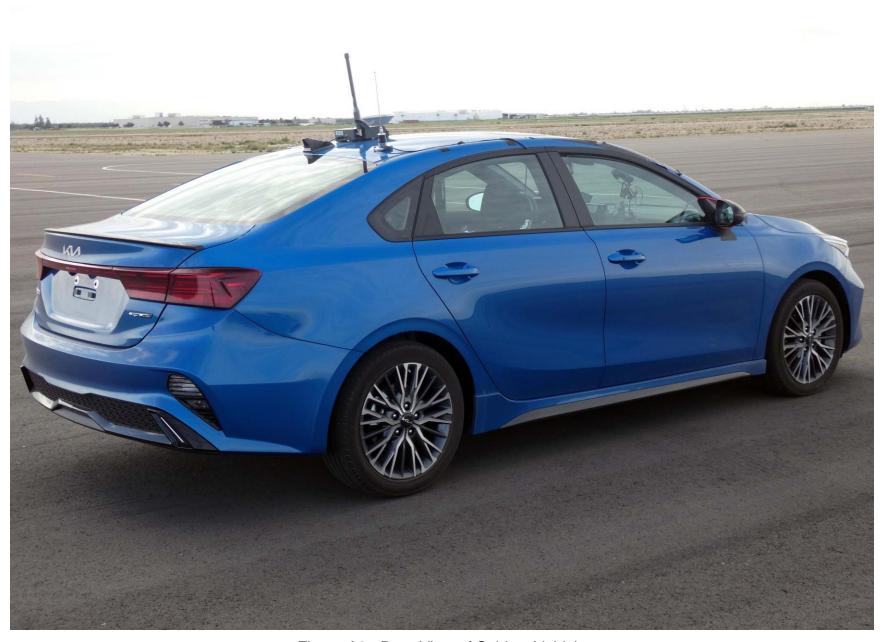
Figure A2. Rear View of Subject Vehicle

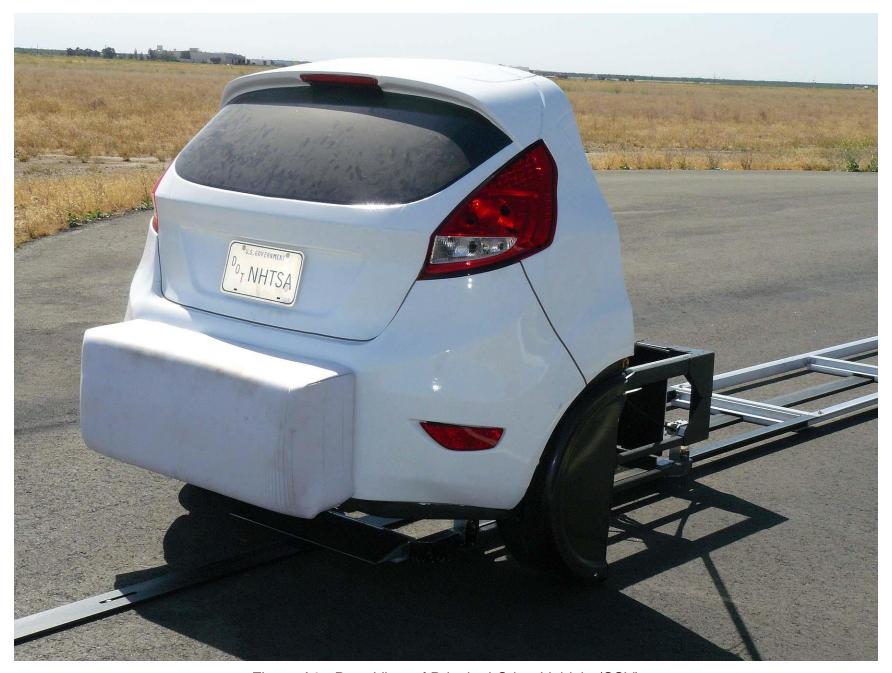
Figure A6. Rear View of Principal Other Vehicle (SSV)

CIB testing requires a POV that realistically represents typical vehicles, does not suffer damage or cause damage to a test vehicle in the event of collision, and can be accurately positioned and moved during the tests. The tests reported herein made use of the NHTSA developed Strikeable Surrogate Vehicle (SSV).

- Provide an accurate representation of a real vehicle to CIB sensors, including cameras and radar.
- Be resistant to damage and inflict little or no damage to the SV as a result of repeated SV-to-POV impacts.

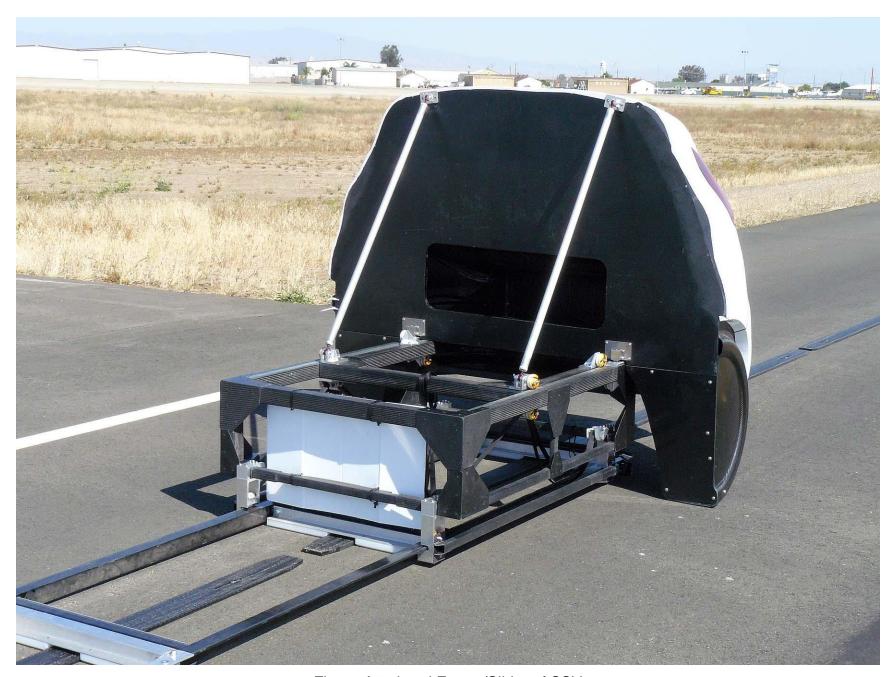
Figure A7. Load Frame/Slider of SSV

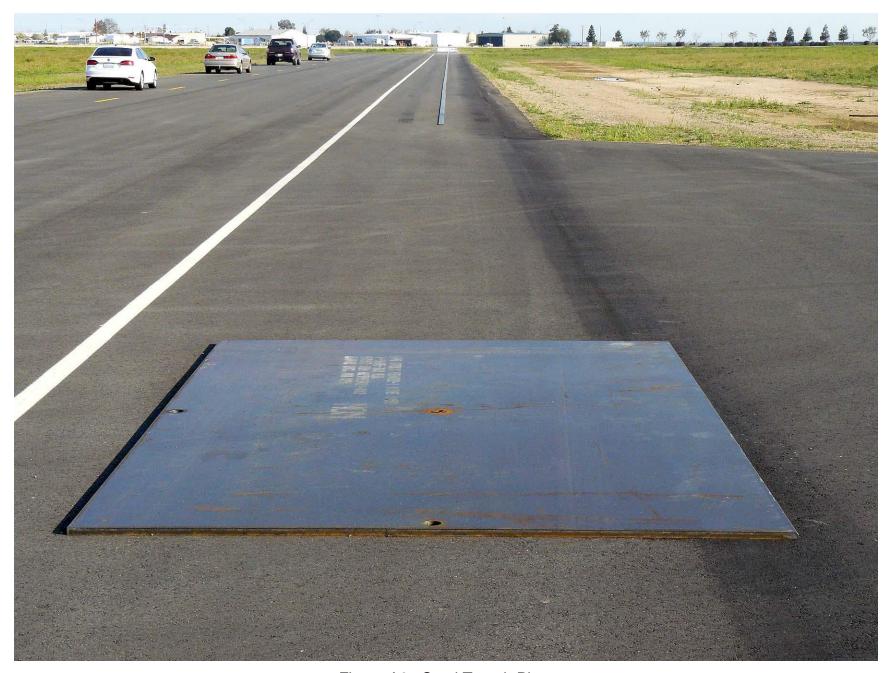
Figure A9. Steel Trench Plate

The false positive suppression test series evaluates the ability of a CIB system to differentiate a steel trench plate (STP) from an object presenting a genuine safety risk to the SV. Although the STP is large and metallic, it is designed to be driven over without risk of injury to the driver or damage to the SV. Therefore, in this scenario, the automatic braking available from CIB is not necessary and should be suppressed. The test condition is nearly equivalent to that previously defined for Test 1, the stopped POV condition, but

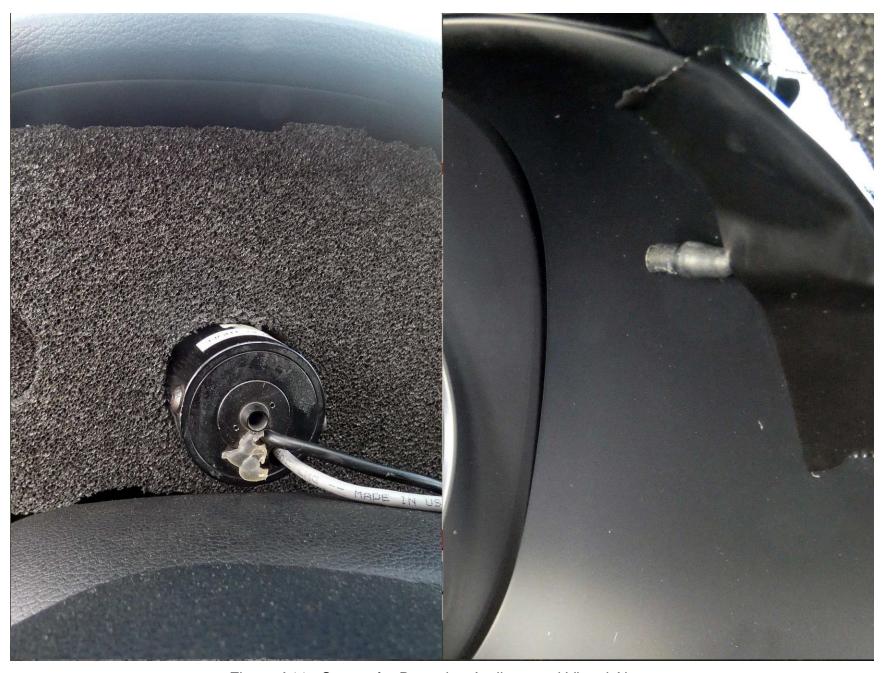
Figure A11. Sensor for Detecting Auditory and Visual Alerts

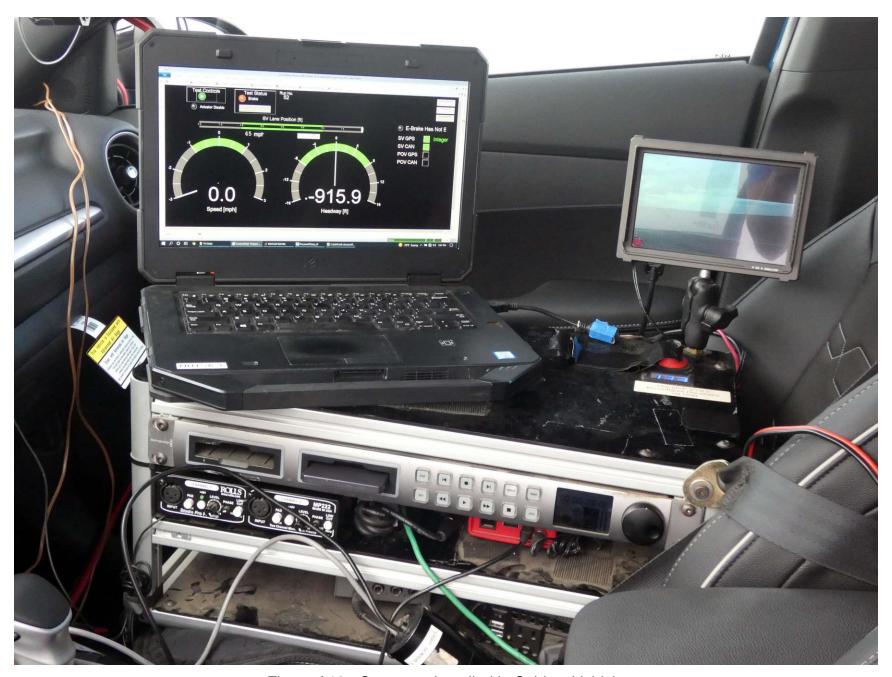
Figure A12. Computer Installed in Subject Vehicle

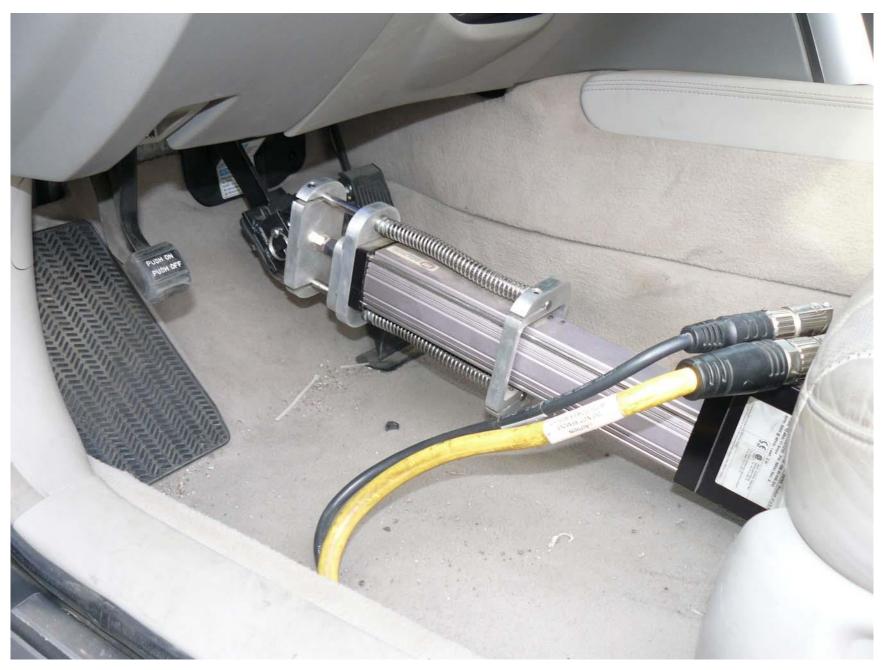
Figure A13. Brake Actuator Installed in POV System

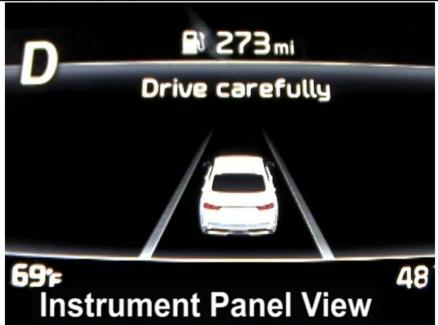
Figure A15. Visual Alert

The AEB system alerts the driver with a visual and auditory alert. The visual alert is three stages and is displayed in the multi-information display located in the center of the instrument panel. It consists of an image of two vehicles between lane lines. Additionally, the first stage displays the words "Collision Warning", the second "Emergency Braking", and lastly "Drive Carefully". The auditory alert consists of repeated beeps with a primary frequency at approximately 1500 Hz.

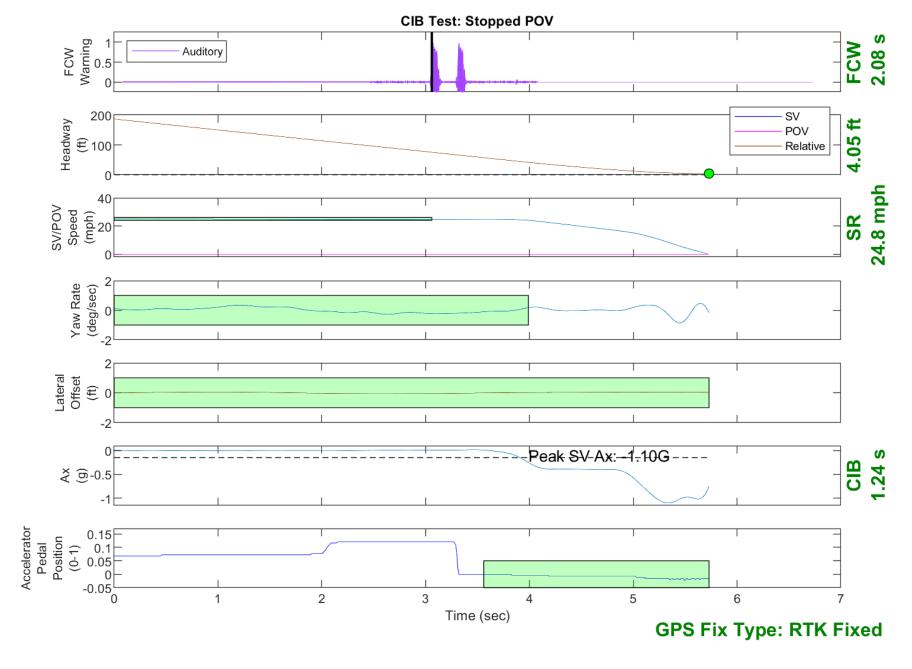
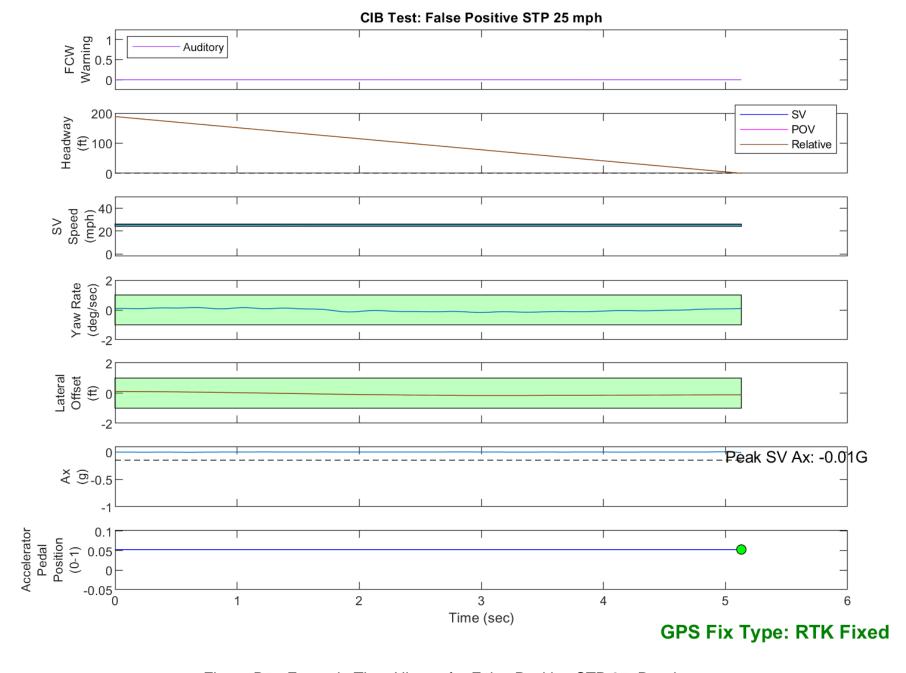
Figure D1. Example Time History for Stopped POV, Passing

Figure D2. Example Time History for Slower POV 25 vs. 10, Passing

Figure D3. Example Time History for Slower POV 45 vs. 20, Passing

Figure D4. Example Time History for Decelerating POV 35, Passing

Figure D5. Example Time History for False Positive STP 25, Passing

Figure D6. Example Time History for False Positive STP 45, Passing

Some of the time history plot figures contain either green or yellow envelopes and/or black threshold lines. These envelopes and thresholds are used to programmatically and visually determine the validity of a given test run. Envelope and threshold exceedances are indicated with either red shading or red asterisks, and red text is placed to the right side of the plot indicating the type of exceedance. Such exceedances indicate either that the test was invalid or that the requirements of the test were not met (i.e., failure of the AEB system).

Examples of time history plots for each test type (including passing, failing and invalid runs) are shown in Figure D1 through Figure D9. Figures D1 through D6 show passing runs for each of the 6 test types. Figures D7 and D8 show examples of invalid runs. Figure D9 shows an example of a valid test that failed the CIB requirements.

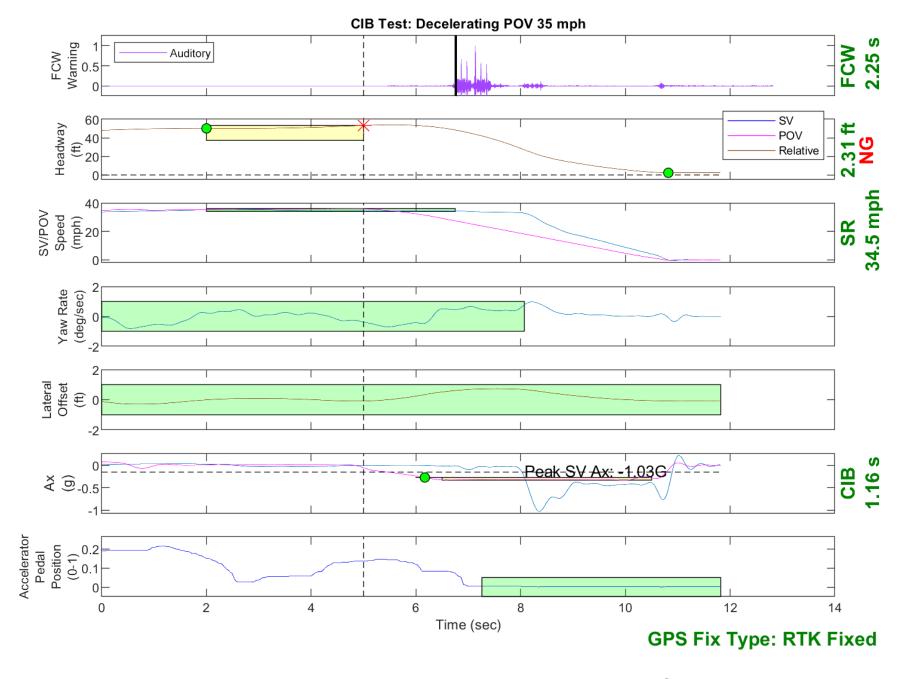
Figure D7. Example Time History Displaying Invalid Headway Criteria

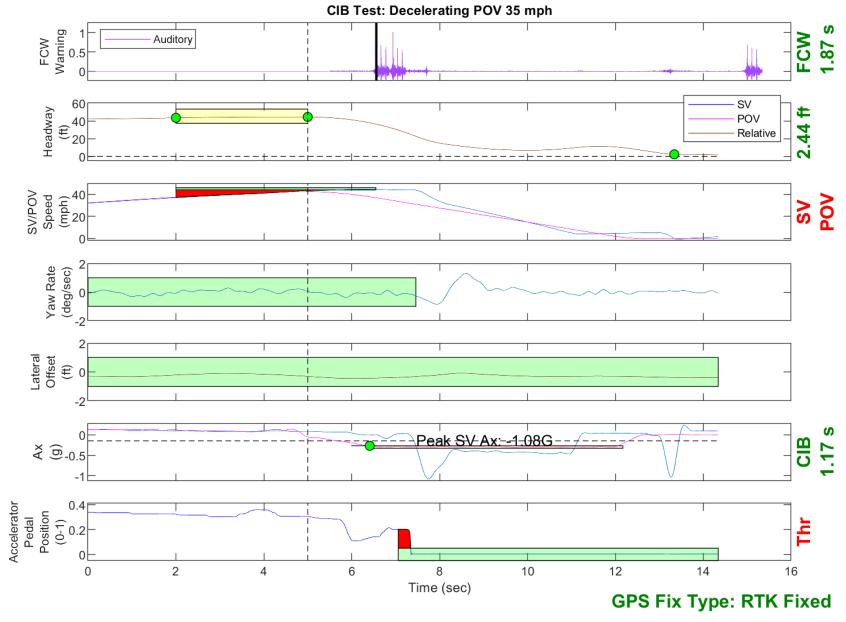
Figure D8. Example Time History Displaying Various Invalid Criteria
