NEW CAR ASSESSMENT PROGRAM FORWARD COLLISION WARNING CONFIRMATION TEST NCAP-DRI-FCW-22-06

2022 Kia Forte

DYNAMIC RESEARCH, INC.

Final Report

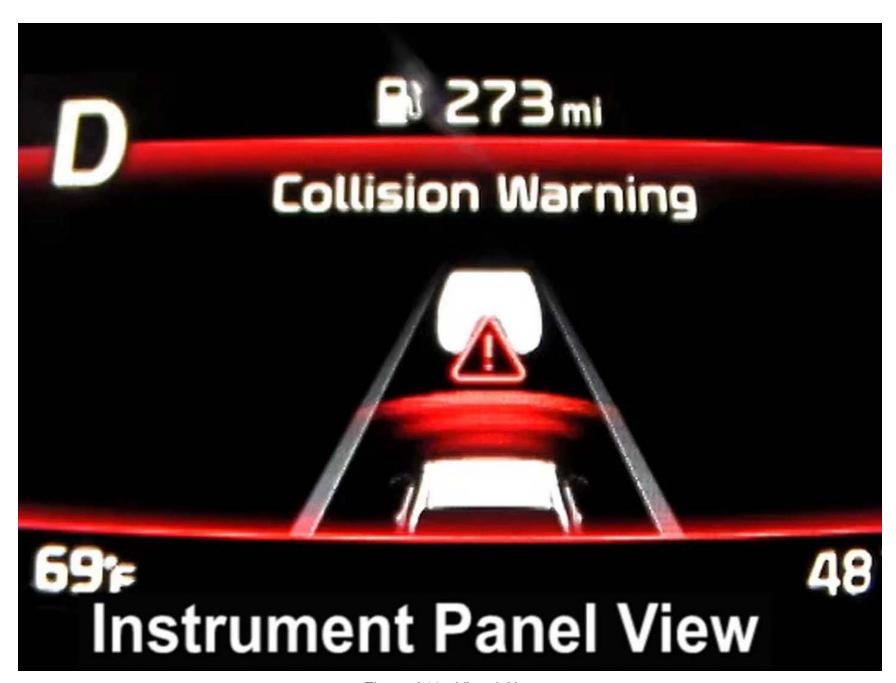
Figure A13. Visual Alert

The FCW system alerts the driver with a visual and auditory alert. The visual alert is displayed in the multi-information display located in the center of the instrument panel and consists of an image of two vehicles between lane lines and the words "Collision Warning". The auditory alert consists of repeated beeps with a primary frequency at approximately 1500 Hz.
