**NEW CAR ASSESSMENT PROGRAM
LANE DEPARTURE WARNING CONFIRMATION TEST
NCAP-DRI-LDW-22-06**

2022 Kia Forte

DYNAMIC RESEARCH, INC.

Final Report

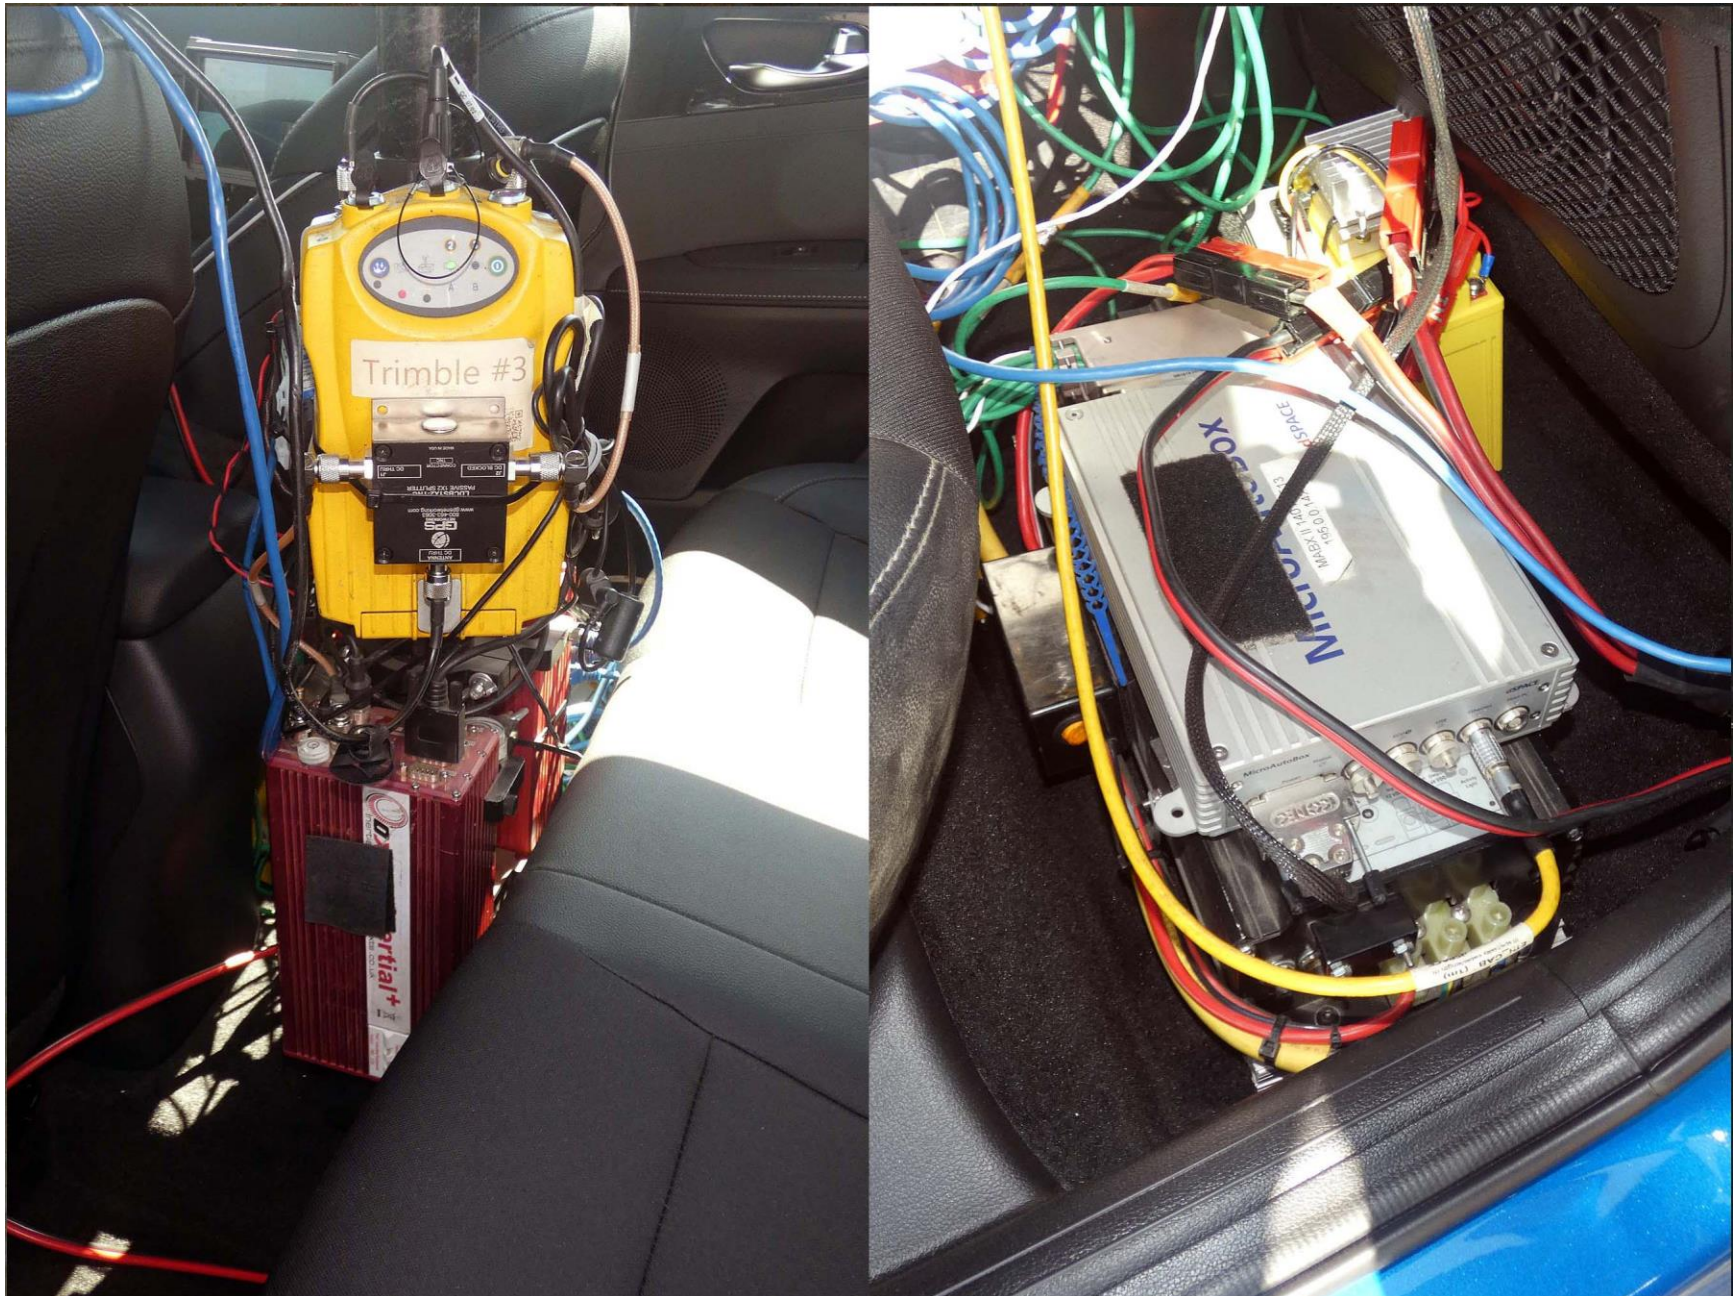
Figure A6. DGPS, Inertial Measurement Unit, and MicroAutoBox Installed in Subject Vehicle

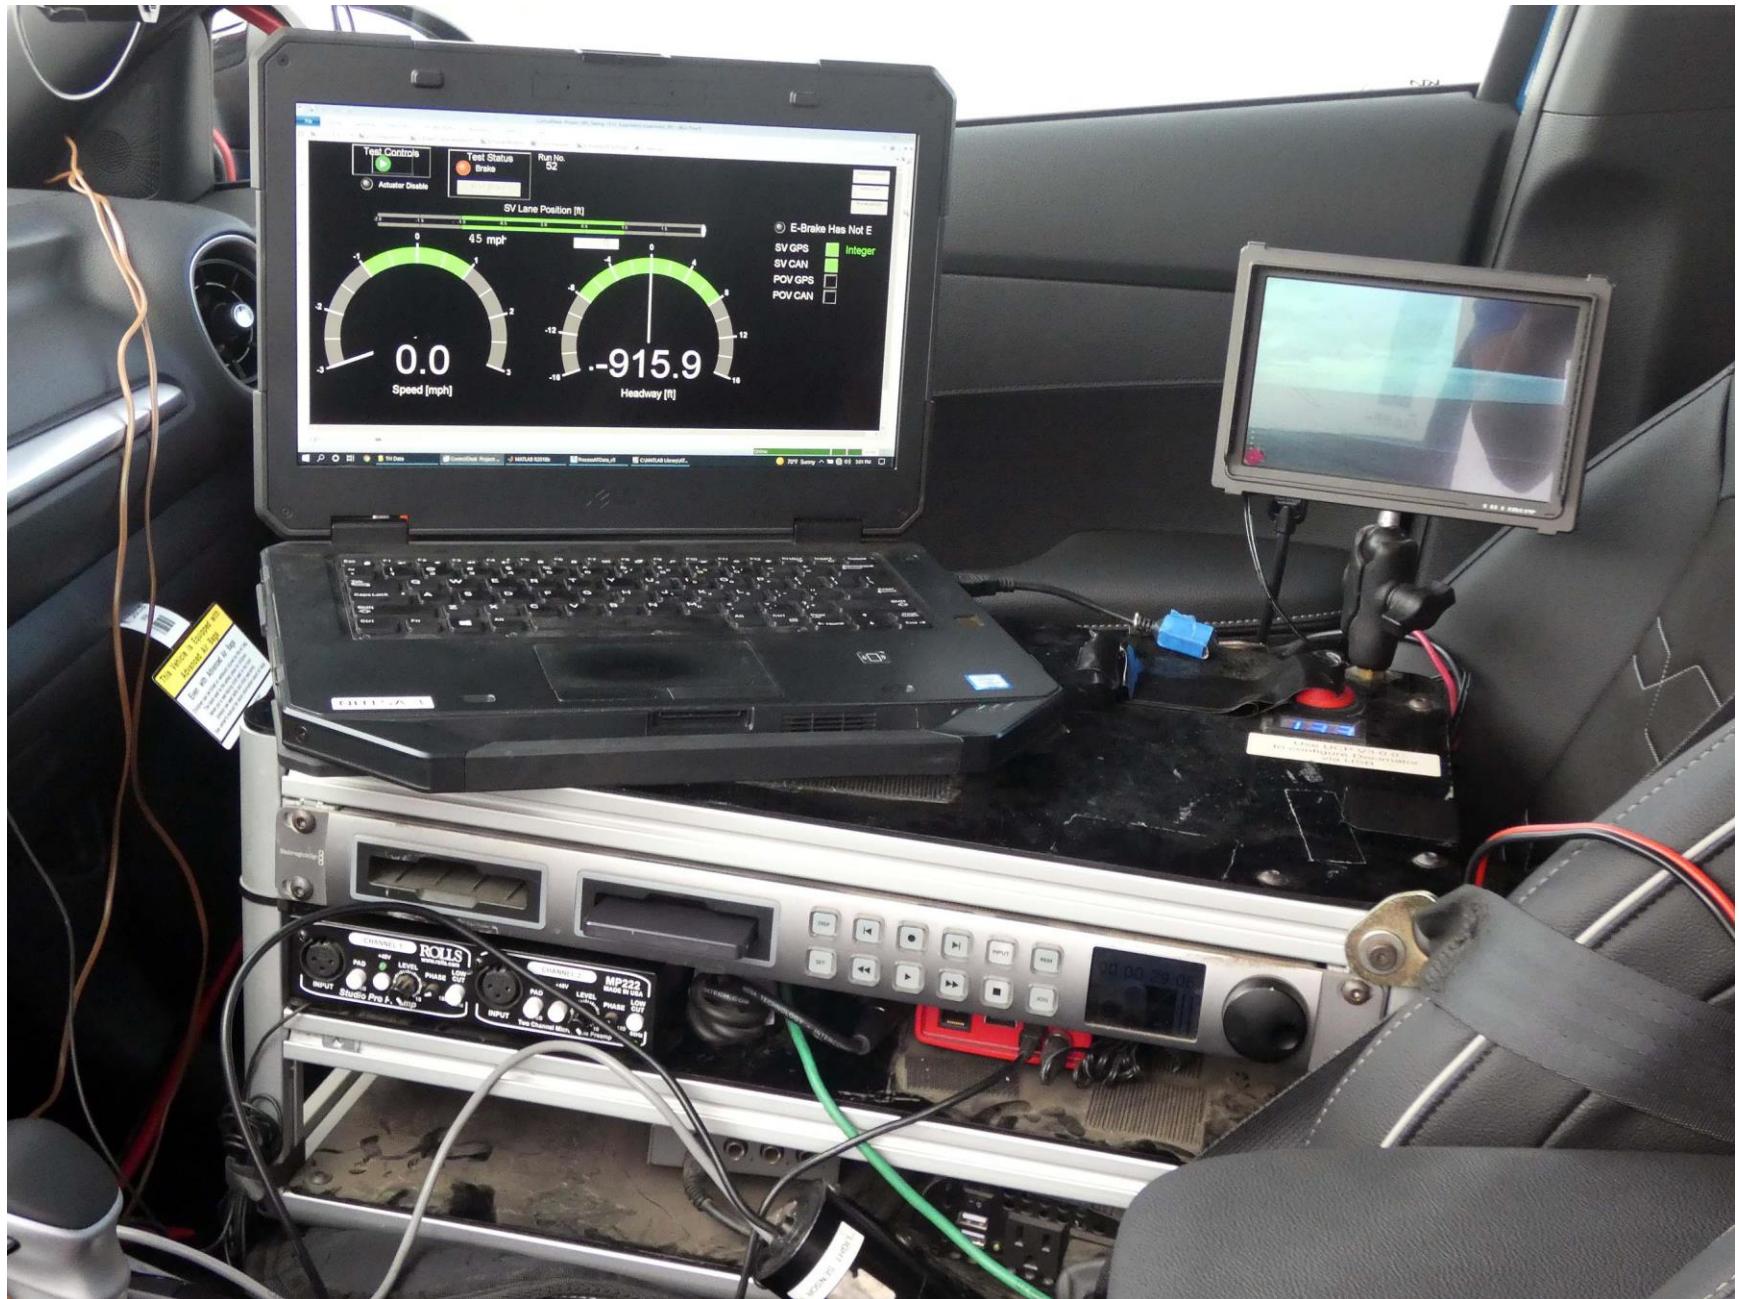
Figure A7. Computer Installed in Subject Vehicle

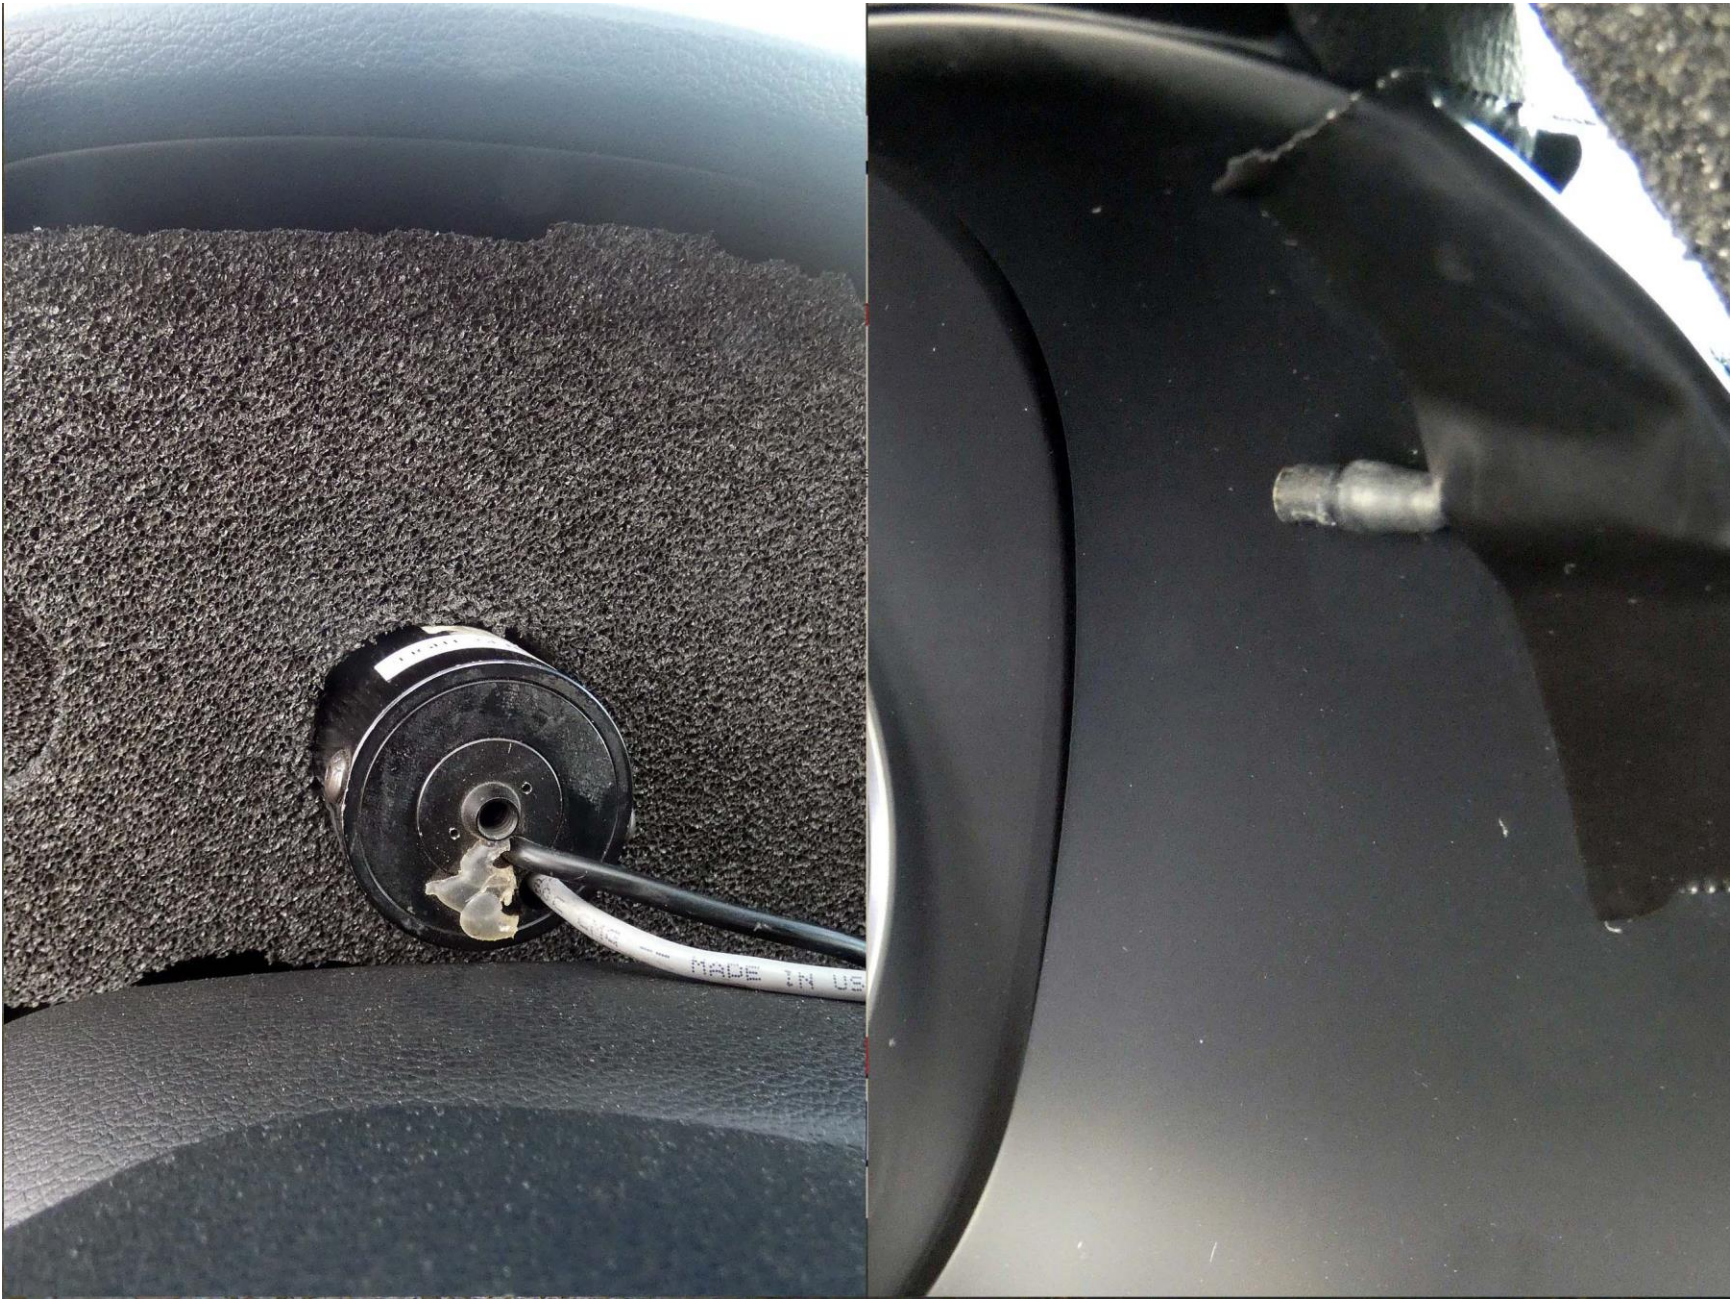
Figure A8. Sensors for Detecting Visual and Auditory Alerts

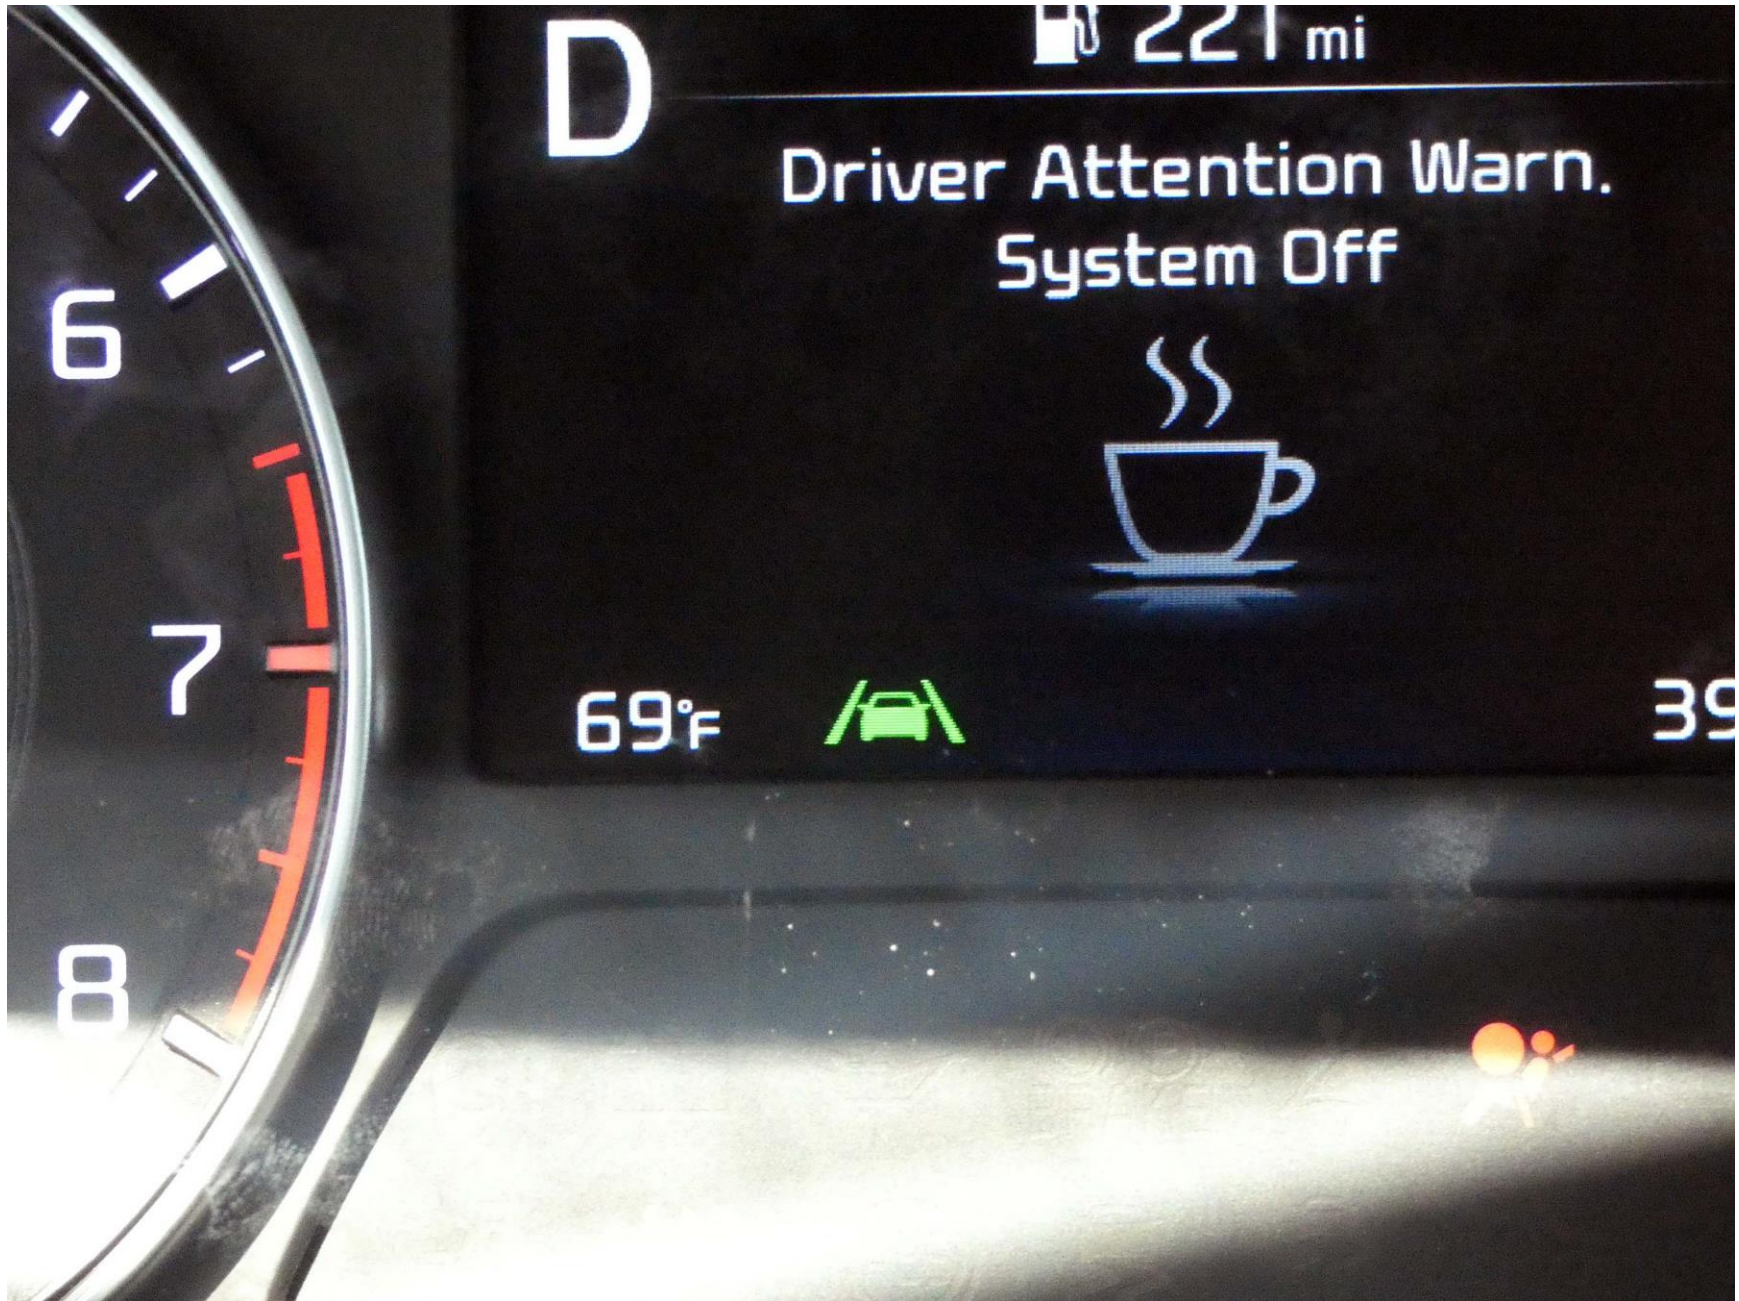
Figure A10. LDW Visual Alert
