NEW CAR ASSESSMENT PROGRAM FORWARD COLLISION WARNING CONFIRMATION TEST NCAP-DRI-FCW-22-09

2022 Nissan Sentra CVT

DYNAMIC RESEARCH, INC.

Final Report

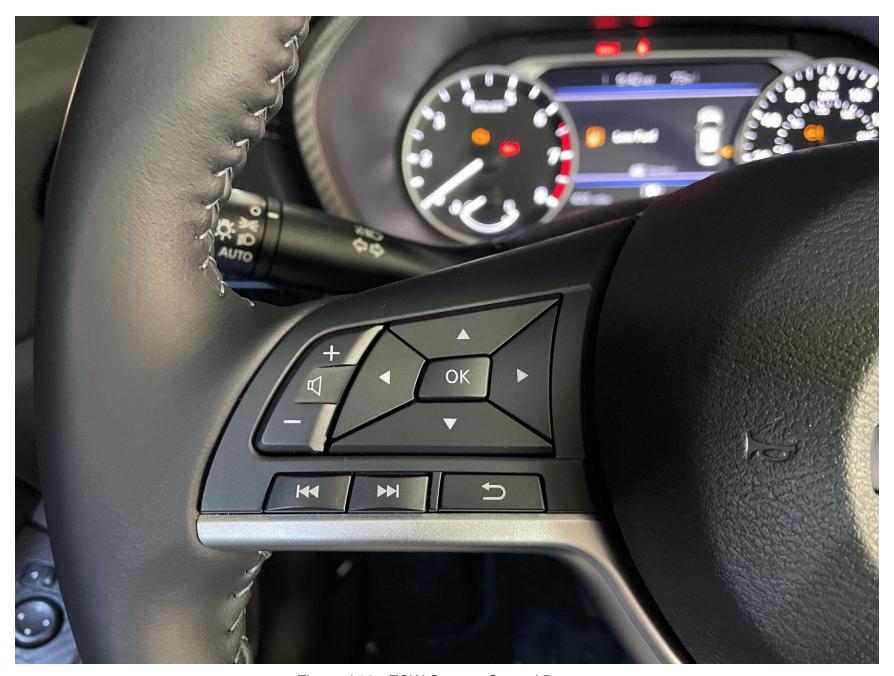
Figure A12. FCW System Control Buttons

Is the vehicle equipped with a switch whose purpose is to render		Yes
FCW inoperable?		No
If yes, please provide a full description including the switch location a operation, any associated instrument panel indicator, etc.	ınd me	ethod of
The AEB system can be turned on/off using the buttons on the lasteering wheel. The procedure is as follows:	left sia	<u>le of the</u>
 Select the Left or Right button to reach the "Settings" menu in information display. 	n the v	<u>rehicle</u>
 Select the Up or Down button to reach the "Driver Assistance press "OK". 	<u>" men</u>	<u>u and</u>

3. Select "Emergency Brake" and press "OK".		
4. Select "Front" and press "OK" to turn the AEB system on/off.		
When the AEB system is turned off, a warning light illuminates. is automatically enabled each time the engine switch is turned of		system .
Is the vehicle equipped with a control whose purpose is to adjust		Yes
the range setting or otherwise influence the operation of FCW?	X	No

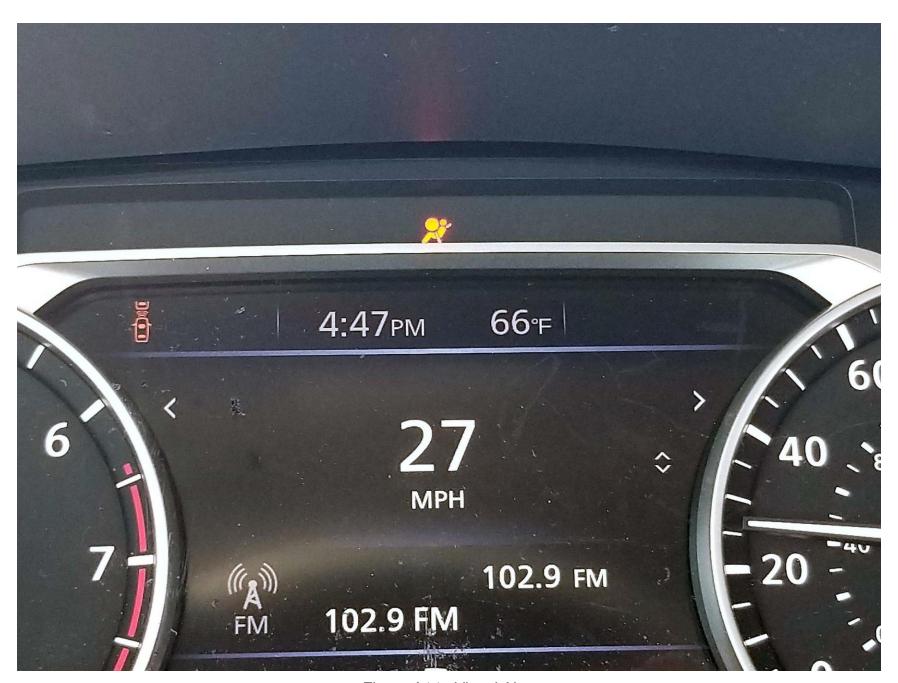
Figure A14. Visual Alert

The AEB system alerts the driver with a visual and auditory alert. The visual alert consists of a yellow flashing vehicle icon in the top left corner of the vehicle information display. The auditory alert consists of repeated beeps with a primary frequency of 1800 Hz.
