**NEW CAR ASSESSMENT PROGRAM
LANE DEPARTURE WARNING CONFIRMATION TEST
NCAP-DRI-LDW-22-09**

2022 Nissan Sentra CVT

Final Report

1. Report No. NCAP-DRI-LDW-22-09	2. Government Accession No.	3. Recipient's Catalog No.	
4. Title and Subtitle Final Report of Lane Departure Warning Confirmation Test of a 2022 Nissan Sentra CVT.		5. Report Date 29 April 2022

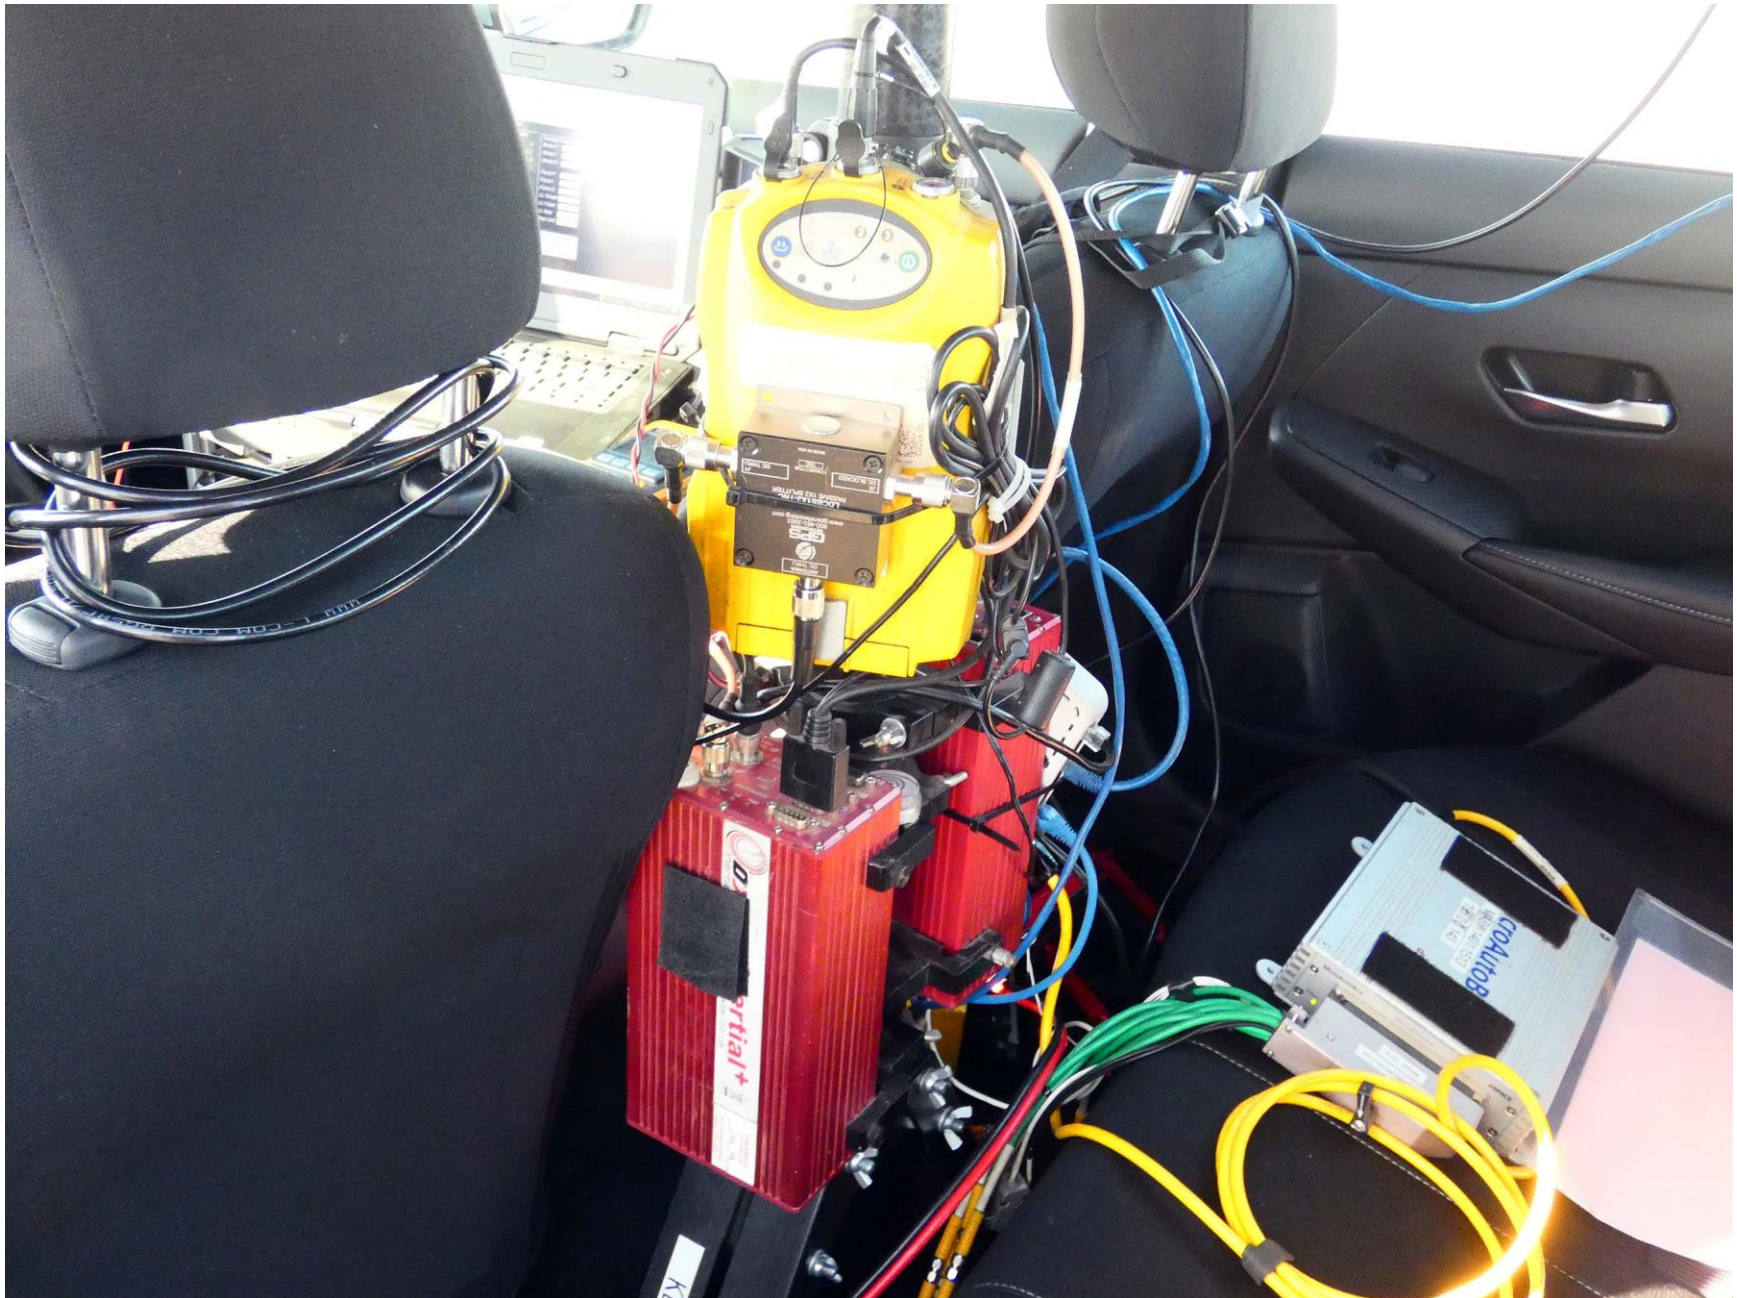
Figure A6. DGPS, Inertial Measurement Unit, and MicroAutoBox Installed in Subject Vehicle

Table 2 lists the sensors, signal conditioning, and data acquisition equipment used for these tests.

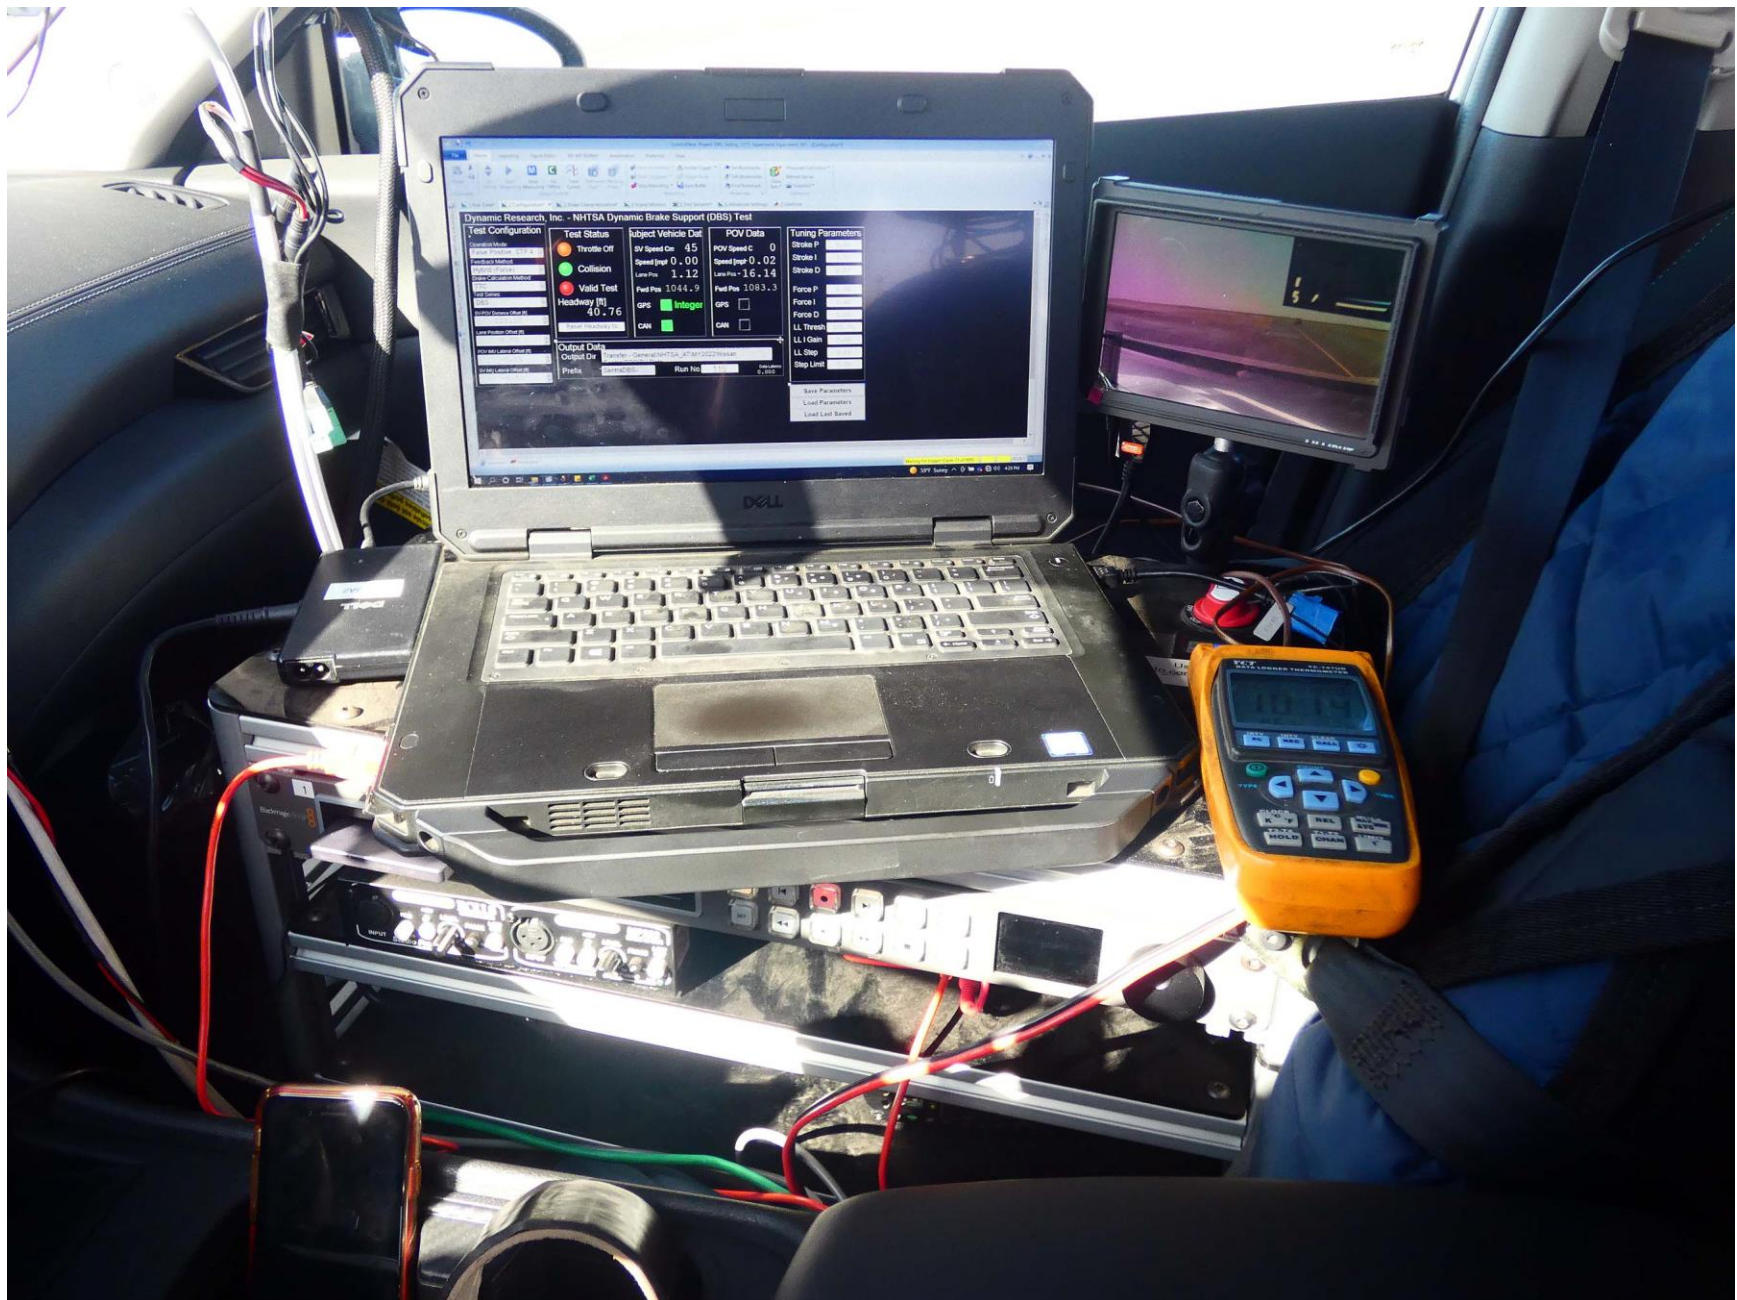
Figure A7. Computer Installed in Subject Vehicle

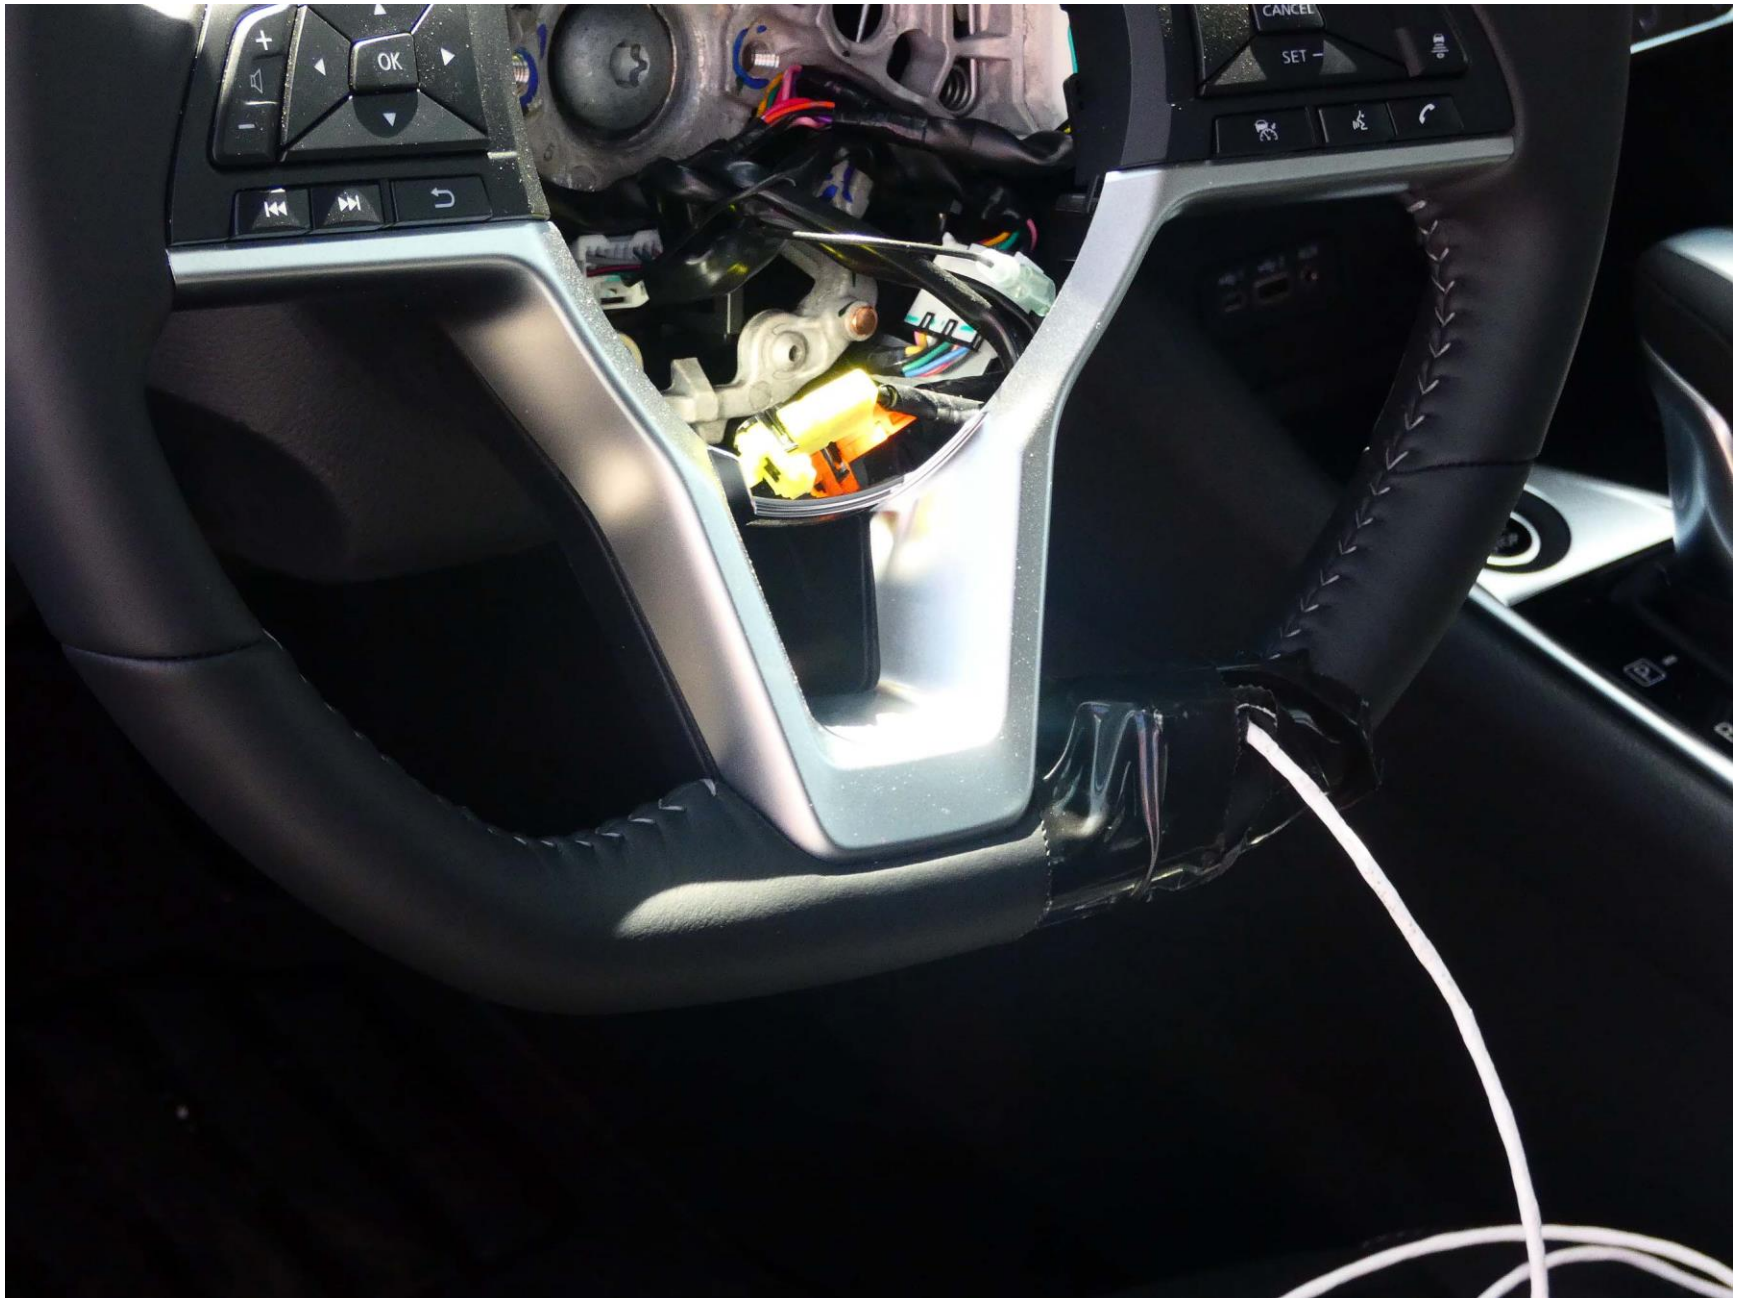
Figure A8. Sensor for Detecting Haptic Alert

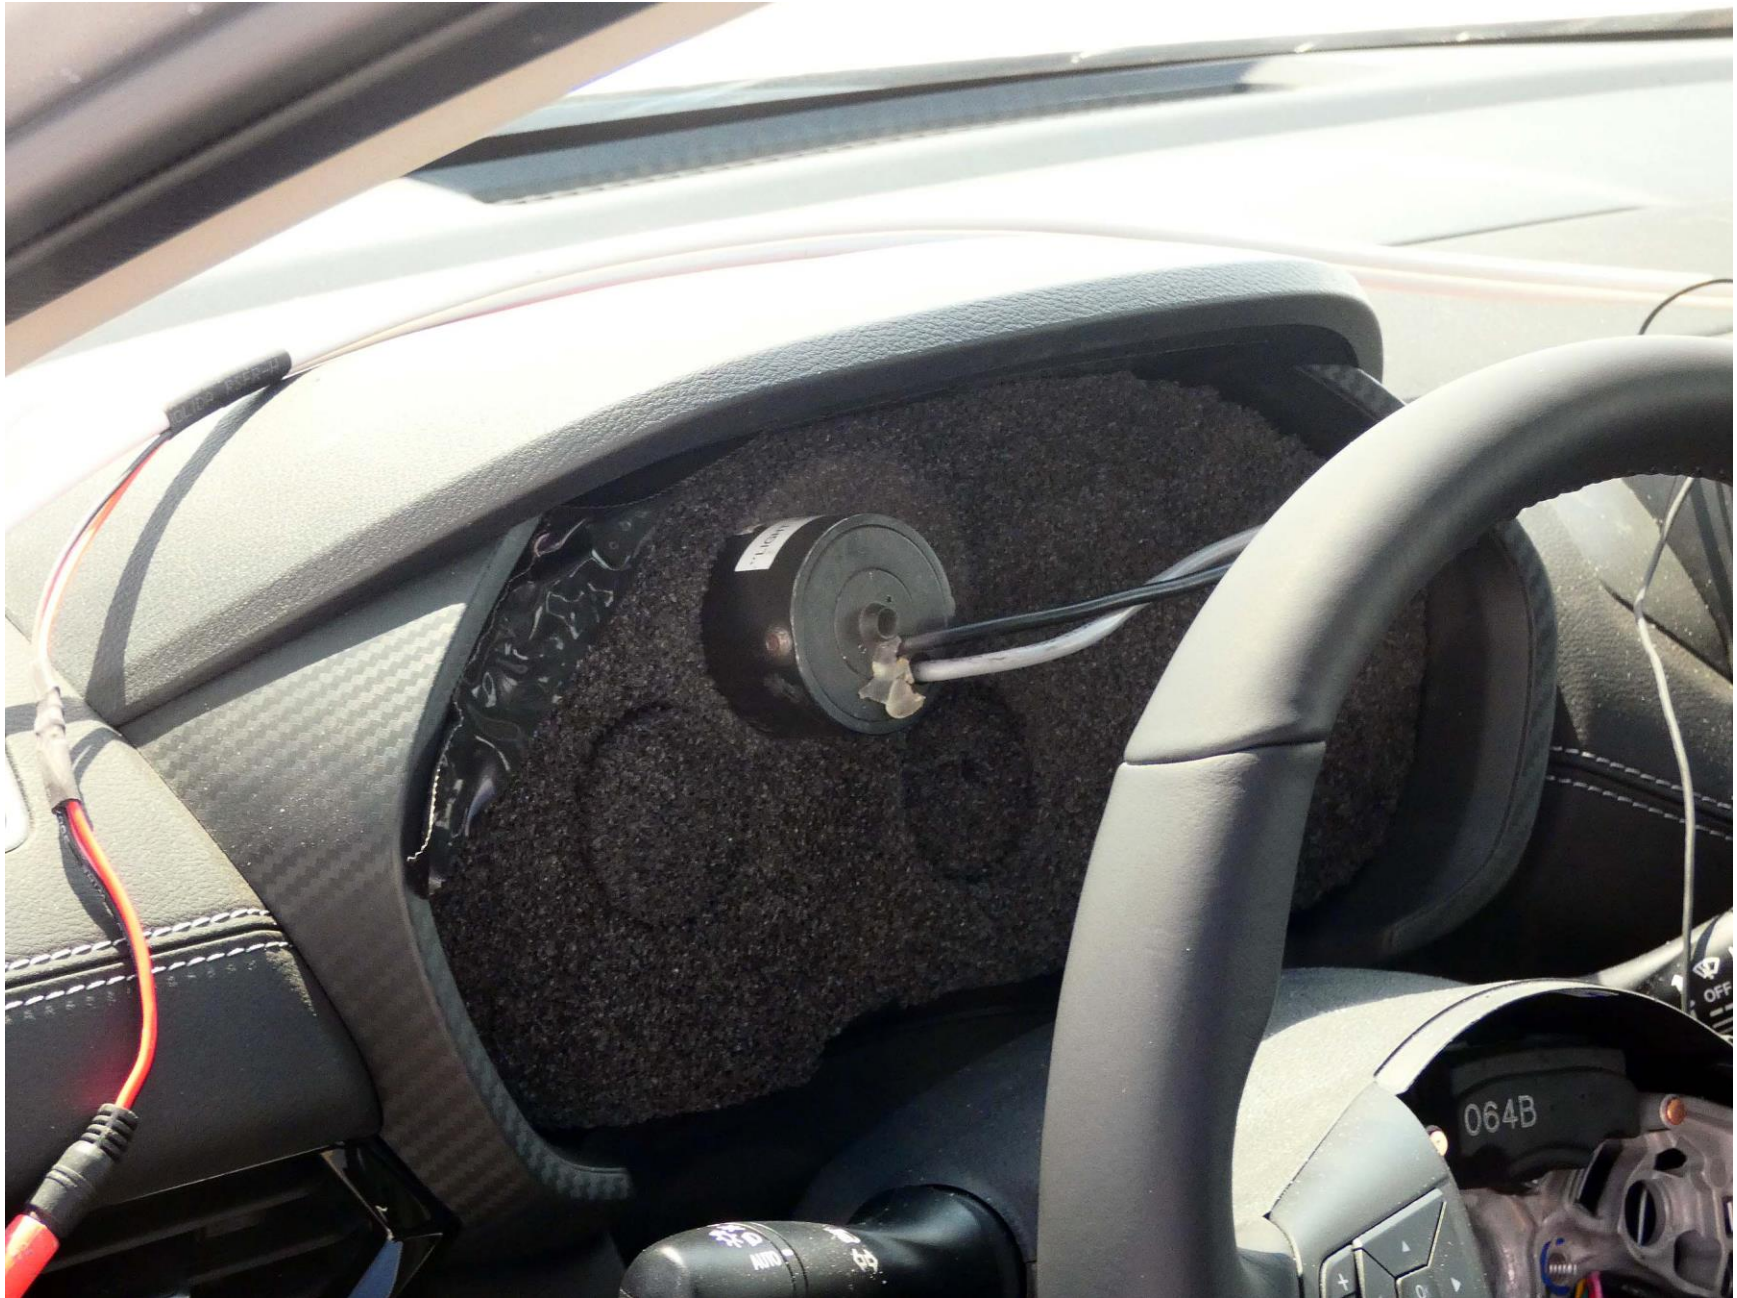
Figure A9. Sensor for Detecting Visual Alert

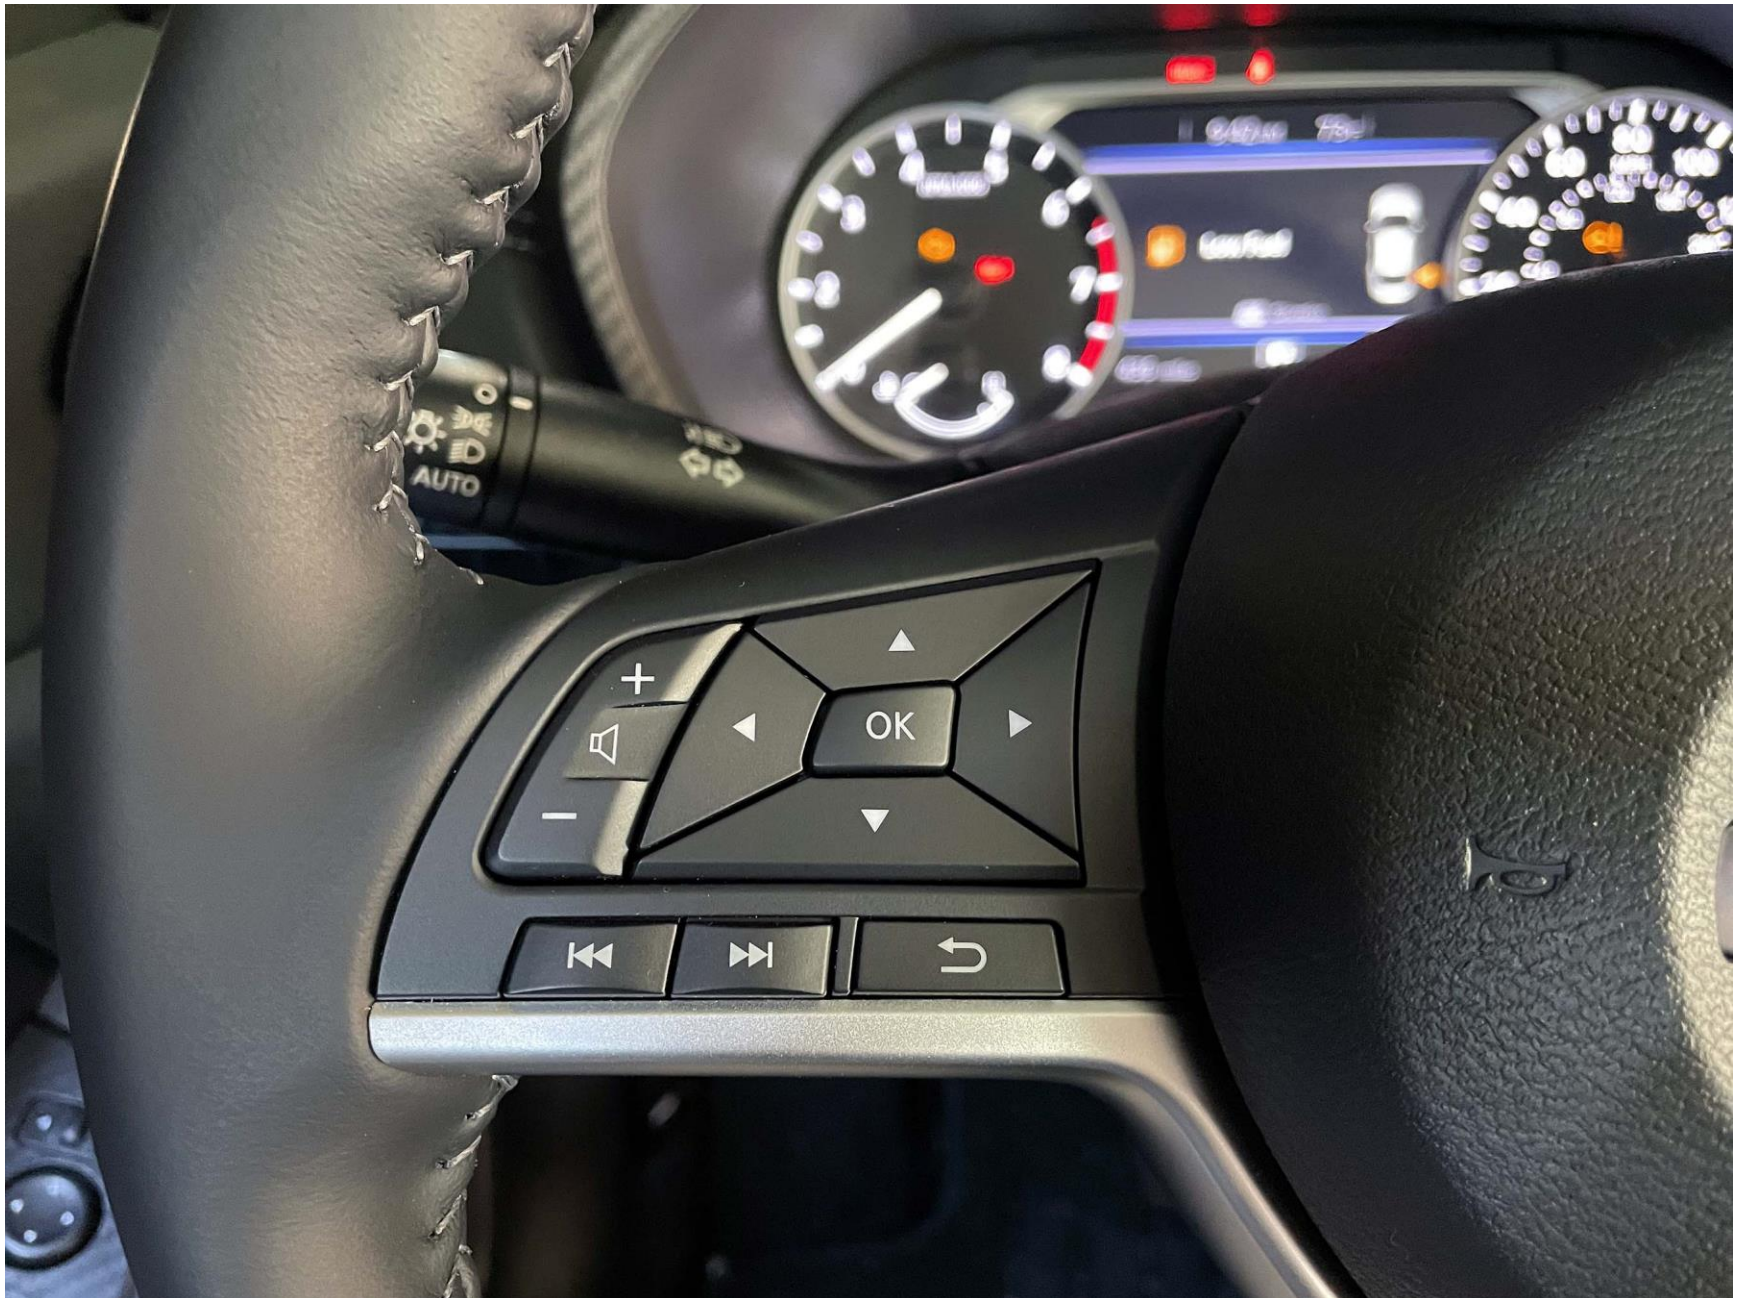
Figure A10. LDW System Control Buttons

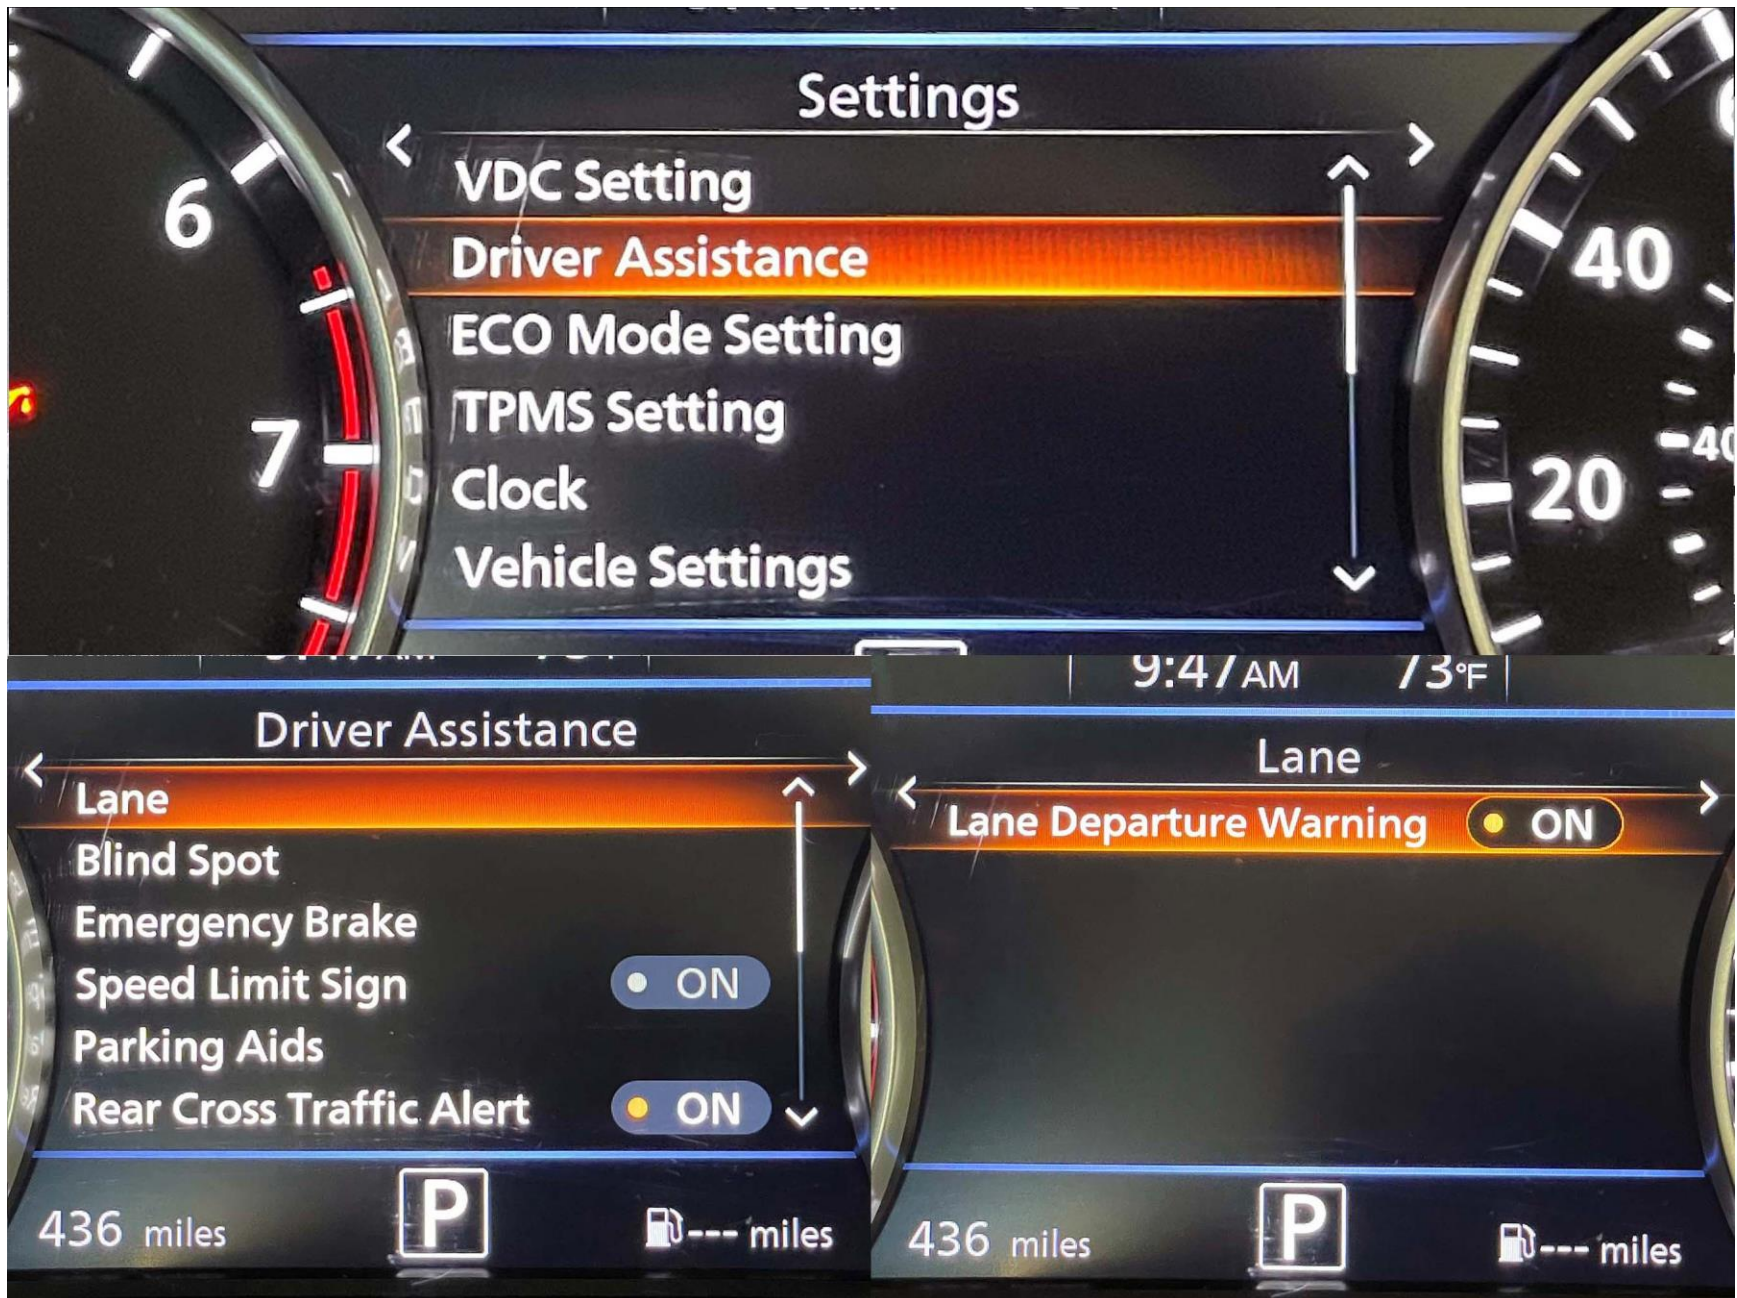
Figure A11. LDW System Setup Menus

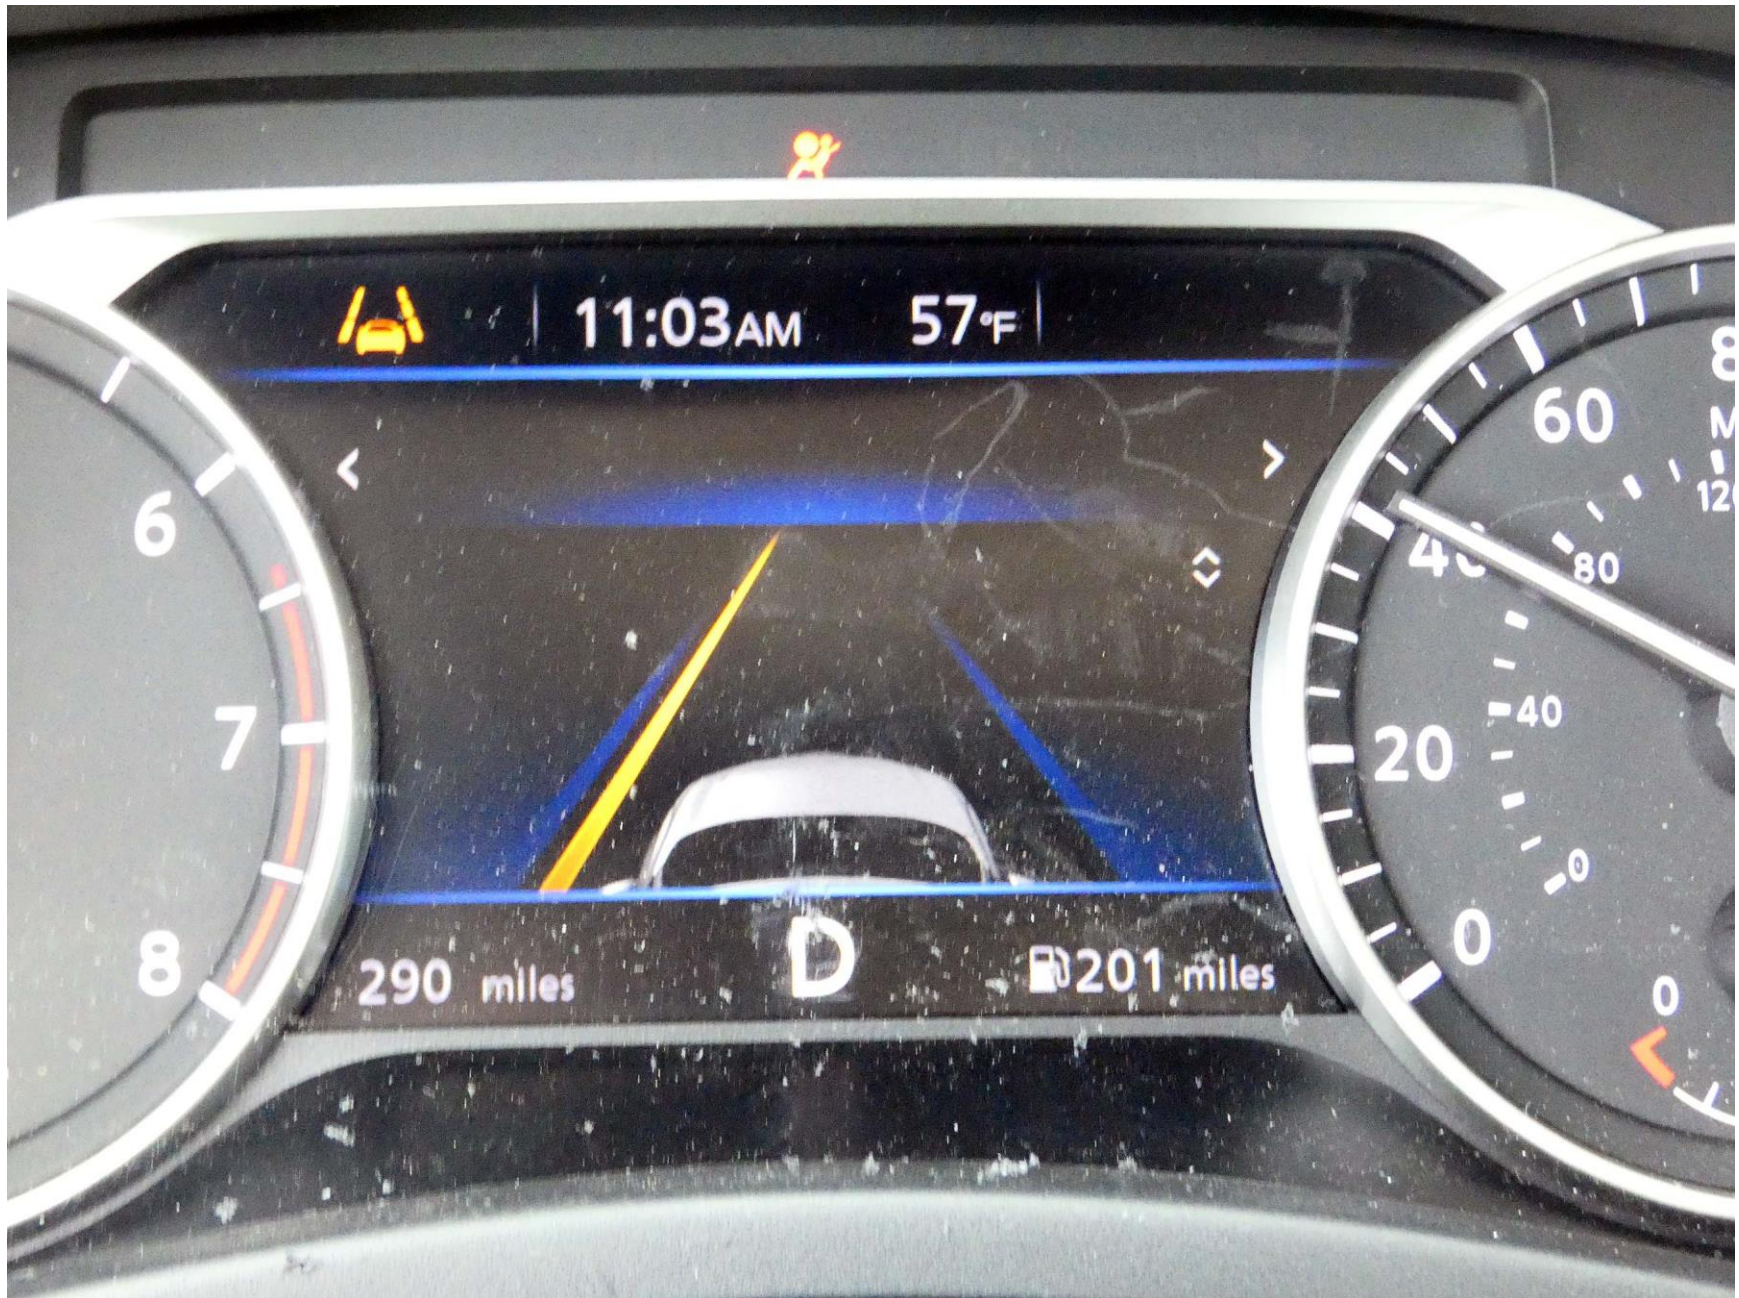
Figure A12. Visual Alert
