# NEW CAR ASSESSMENT PROGRAM CRASH IMMINENT BRAKING SYSTEM CONFIRMATION TEST NCAP-DRI-CIB-22-08

2022 Hyundai Santa Cruz AWD

**Final Report**

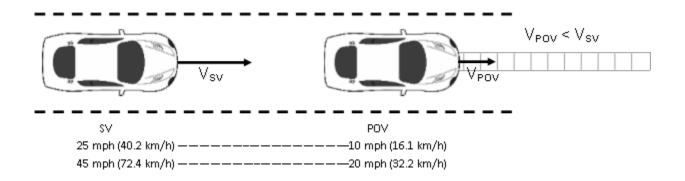
• This test evaluates the ability of the CIB system to detect and respond to a slowermoving lead vehicle traveling at a constant speed in the immediate forward path of the SV, as depicted in Figure 2.

Figure 2. Depiction of Test 2

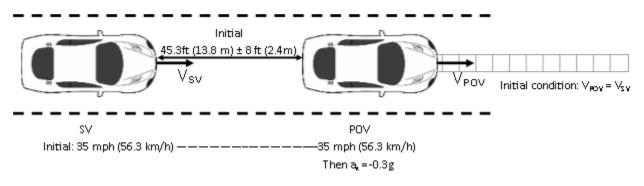
This test evaluates the ability of the CIB system to detect and respond to a lead vehicle slowing with a constant deceleration in the immediate forward path of the SV, as depicted in Figure 3.

Figure 3. Depiction of Test 3

The SV ignition was cycled prior to each test run. For this test scenario, both the POV and SV were driven at a constant 35.0 mph (56.3 km/h) in the center of the lane, with a headway of 45.3 ft (13.8 m)  $\pm$  8 ft (2.4 m). Once these conditions were met, the POV tow vehicle brakes were applied to achieve 0.3  $\pm$  0.03 g of deceleration within 1.5  $\pm$  0.1 sec. The test concluded when either:

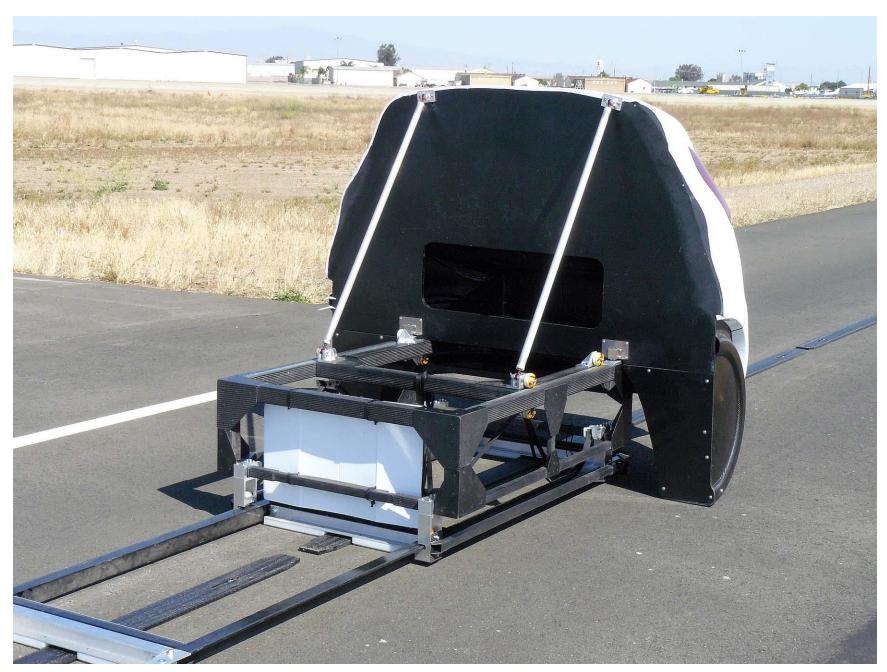
Figure A7. Load Frame/Slider of SSV

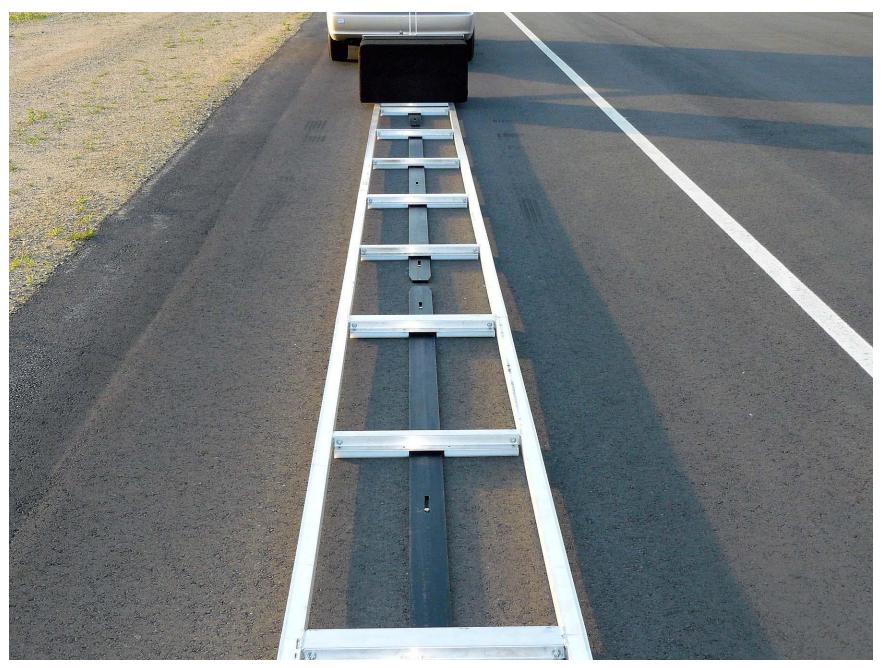
Figure A8. Two-Rail Track and Road-Based Lateral Restraint Track

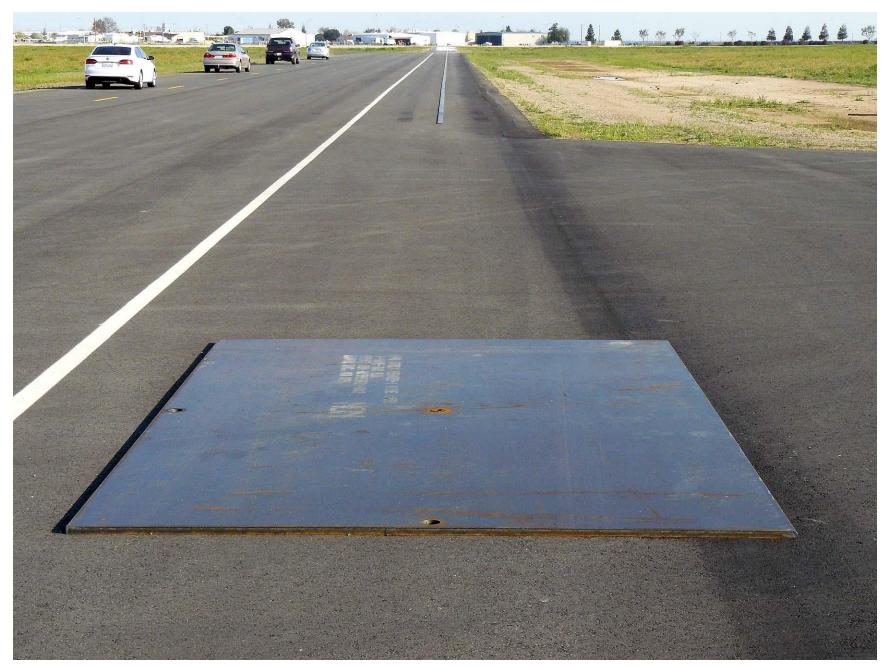
Figure A9. Steel Trench Plate

The false positive suppression test series evaluates the ability of a CIB system to differentiate a steel trench plate (STP) from an object presenting a genuine safety risk to the SV. Although the STP is large and metallic, it is designed to be driven over without risk of injury to the driver or damage to the SV. Therefore, in this scenario, the automatic braking available from CIB is not necessary and should be suppressed. The test condition is nearly equivalent to that previously defined for Test 1, the stopped POV condition, but

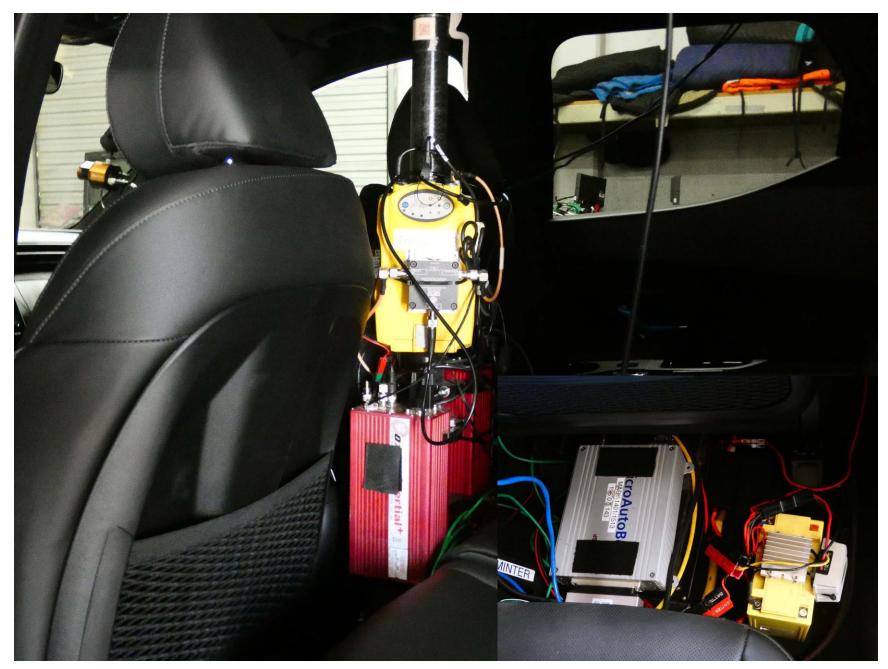
Figure A10. DGPS, Inertial Measurement Unit, and MicroAutoBox Installed in Subject Vehicle

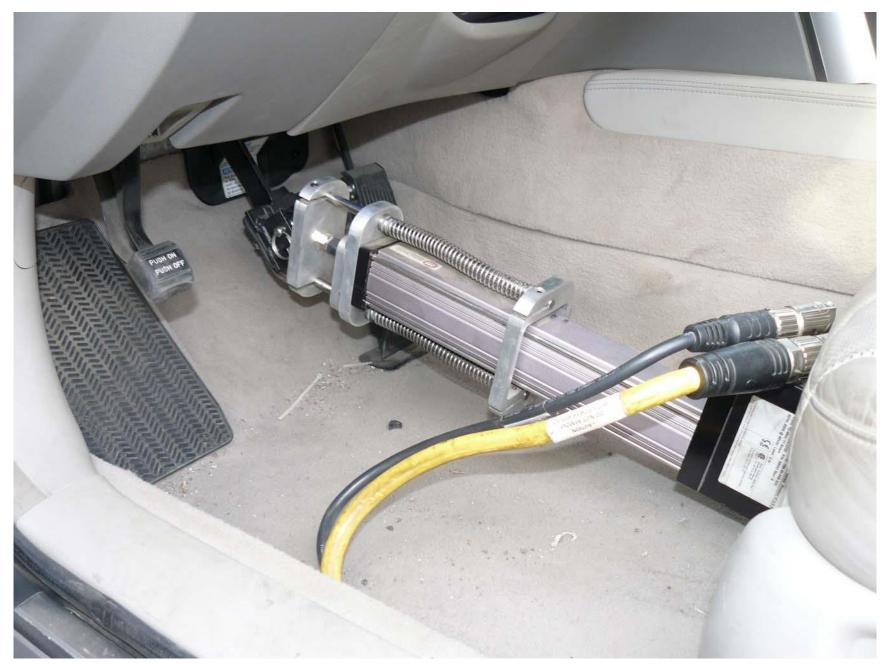
Figure A13. Brake Actuator Installed in POV System

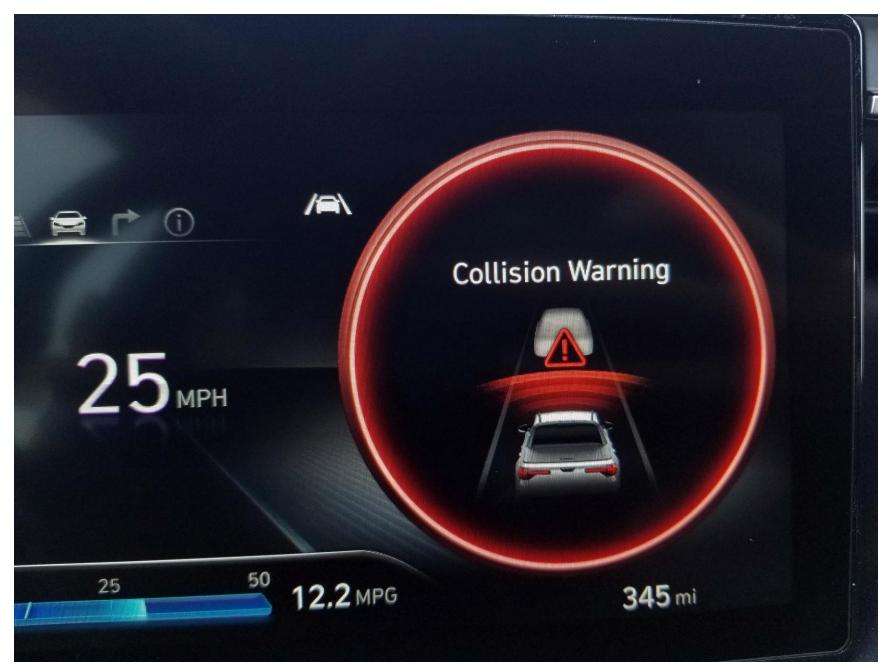
Figure A16. First Stage Visual Alert

The AEB system alerts the driver with a two-stage visual and auditory alert. The visual alert is displayed in the multi-information display located in the center of the instrument panel. The first stage consists of an image of two vehicles between lane lines with the words "Collision Warning" and the words change to "Emergency Braking" in the second stage. The auditory alert consists of repeated beeps for the first stage, and then a continuous beep for the second stage. The primary frequency for both alerts is approximately 1000 Hz.

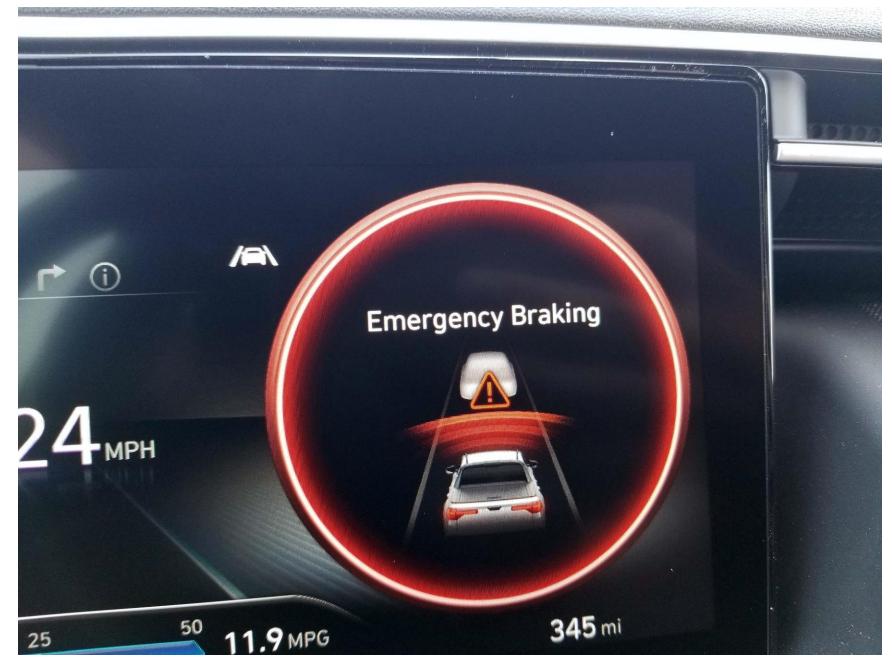
Figure A17. Second Stage Visual Alert

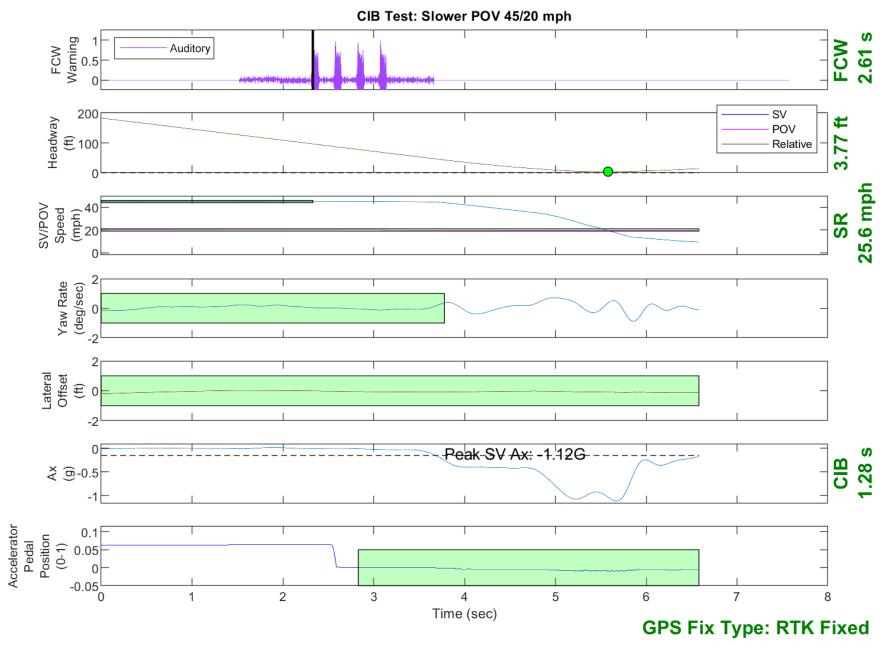
Figure D3. Example Time History for Slower POV 45 vs. 20, Passing

Examples of time history plots for each test type (including passing, failing and invalid runs) are shown in Figure D1 through Figure D9. Figures D1 through D6 show passing runs for each of the 6 test types. Figures D7 and D8 show examples of invalid runs. Figure D9 shows an example of a valid test that failed the CIB requirements.

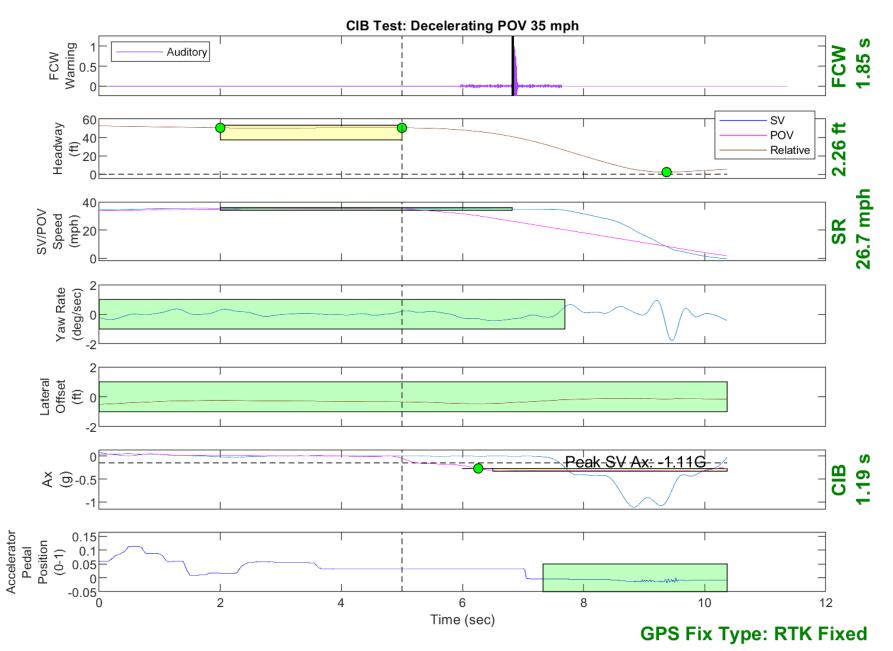
Figure D4. Example Time History for Decelerating POV 35, Passing

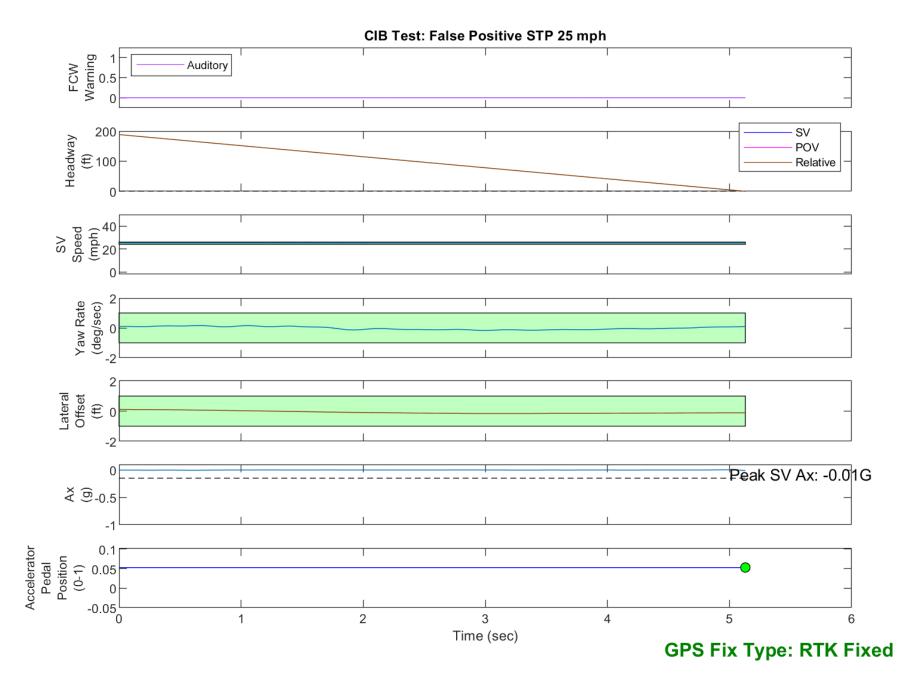
Figure D5. Example Time History for False Positive STP 25, Passing

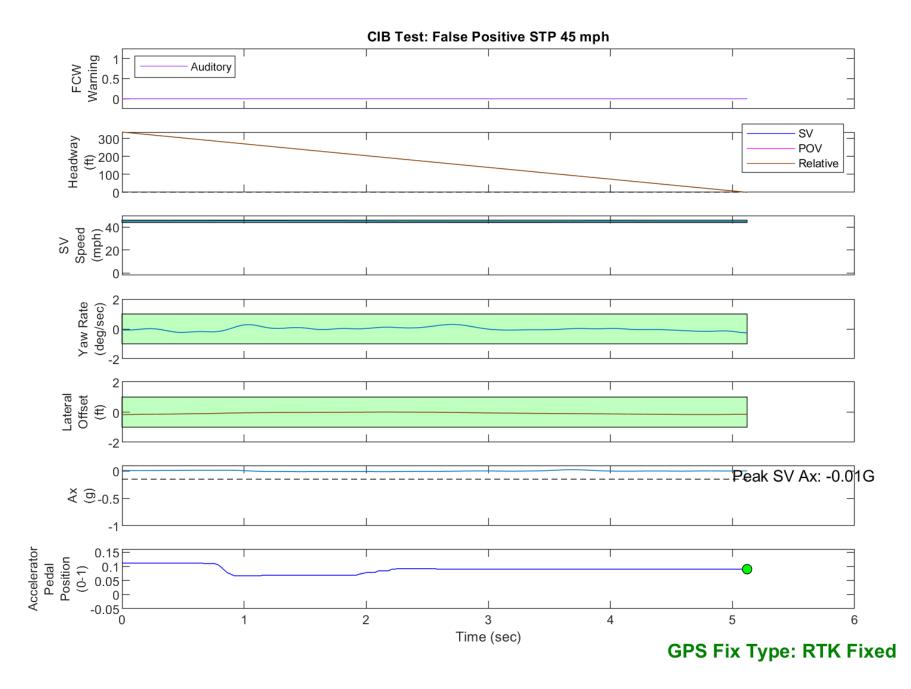
Figure D6. Example Time History for False Positive STP 45, Passing

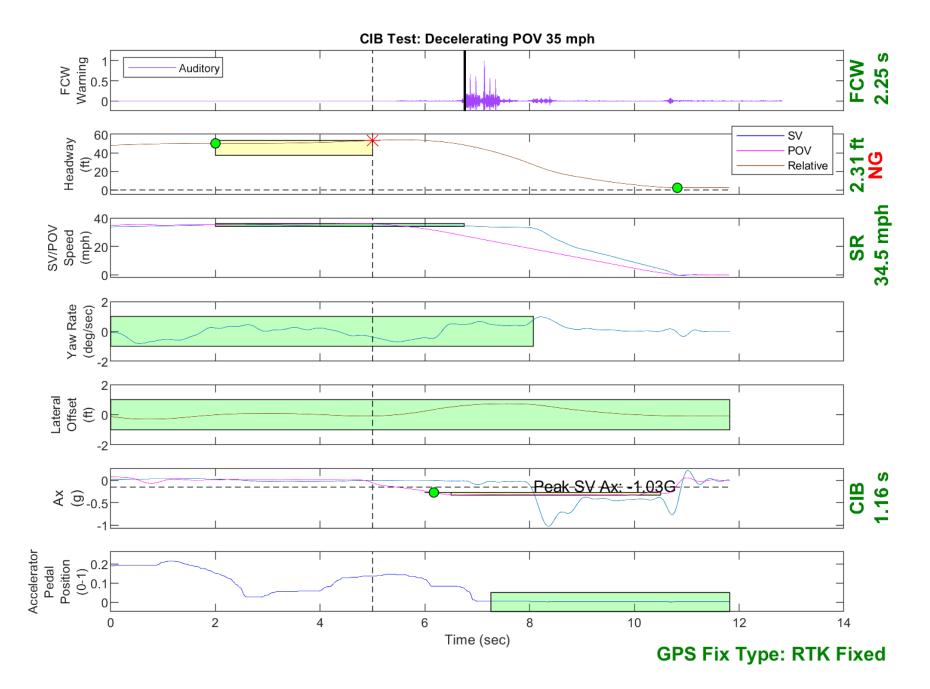
Figure D7. Example Time History Displaying Invalid Headway Criteria

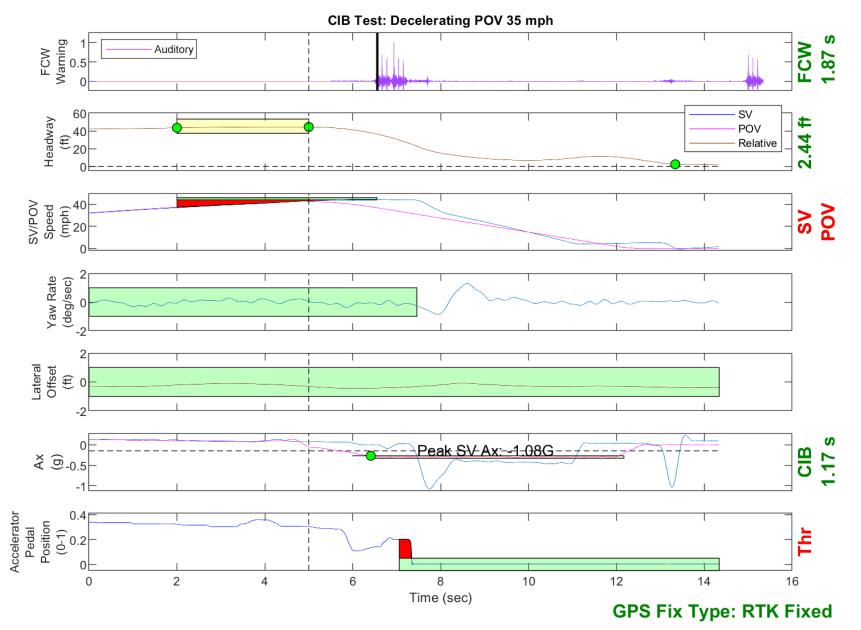
Figure D8. Example Time History Displaying Various Invalid Criteria

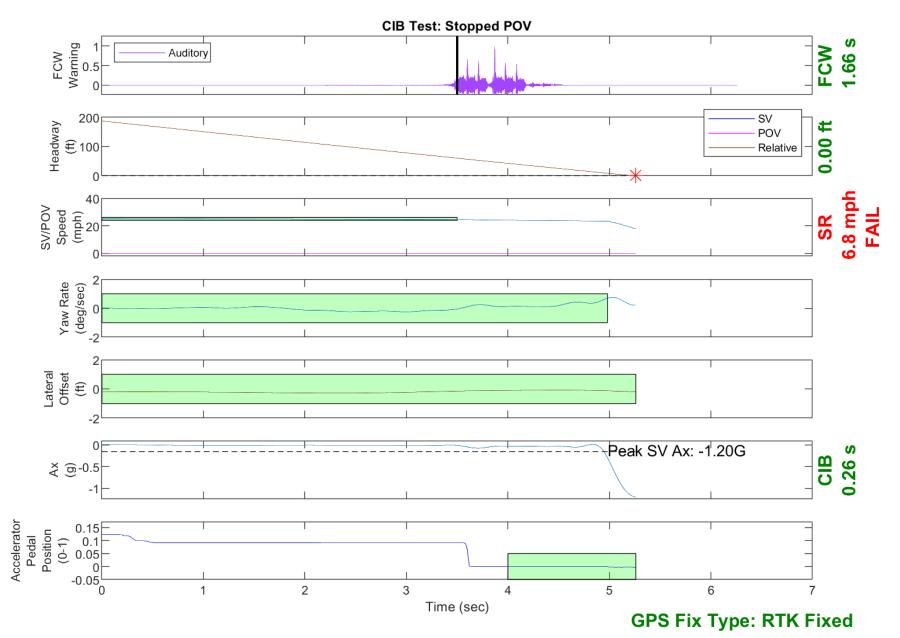
Figure D9. Example Time History for a Failed Run

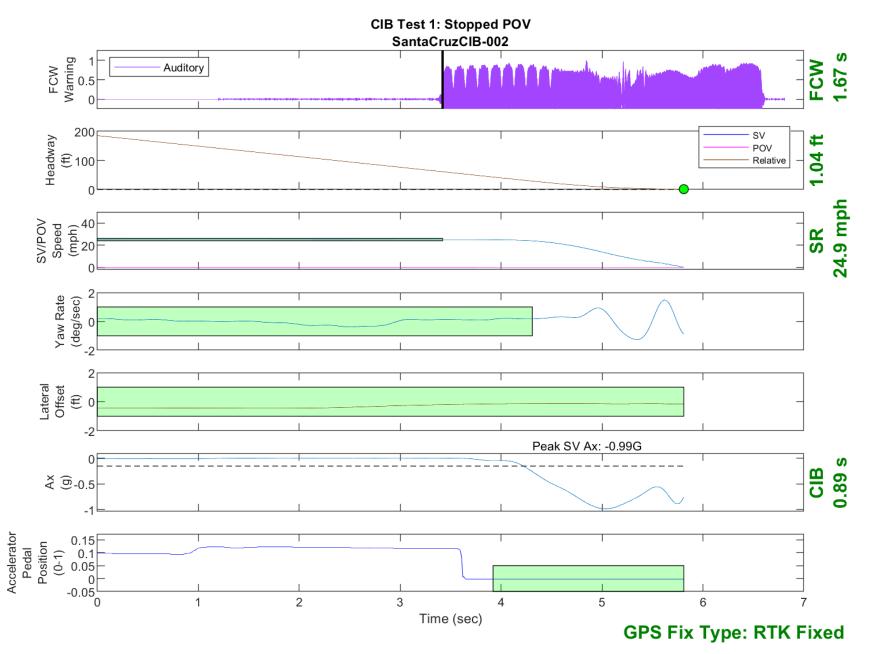
Figure D10. Time History for CIB Run 2, Test 1 - Stopped POV

Time history data plots for the tests of the vehicle under consideration herein are provided beginning with Figure D10.
