**NEW CAR ASSESSMENT PROGRAM
LANE DEPARTURE WARNING CONFIRMATION TEST
NCAP-DRI-LDW-22-14**

2022 Volkswagen Taos

Final Report

| 4. Title and Subtitle Final Report of Lane Departure Warning Confirmation Test of a 2022 Volkswagen Taos. | | 5. Report Date 6 May 2022 | |

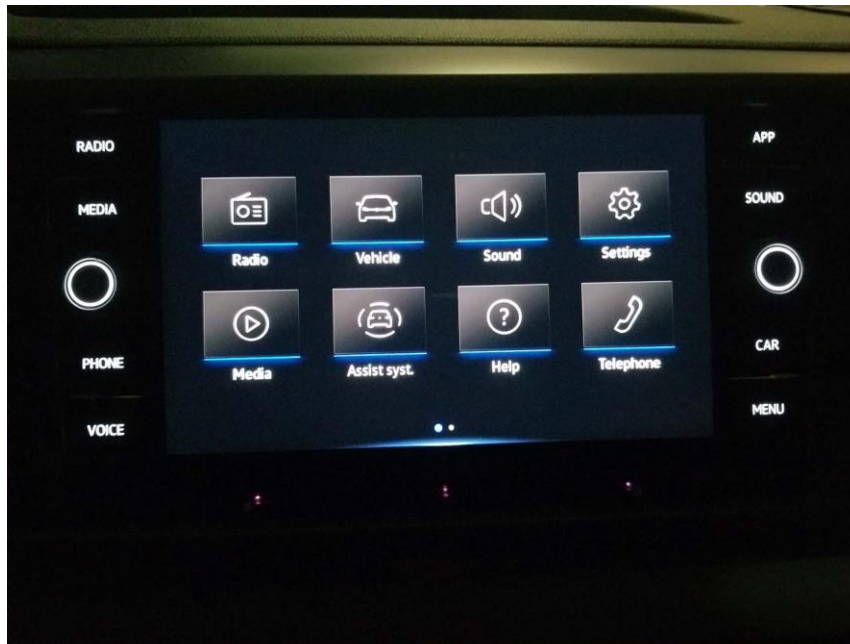
Figure A9. LDW System On/Off Menu

The LDW system can be turned on/off using the touch screen display on the center dash using the following procedure:

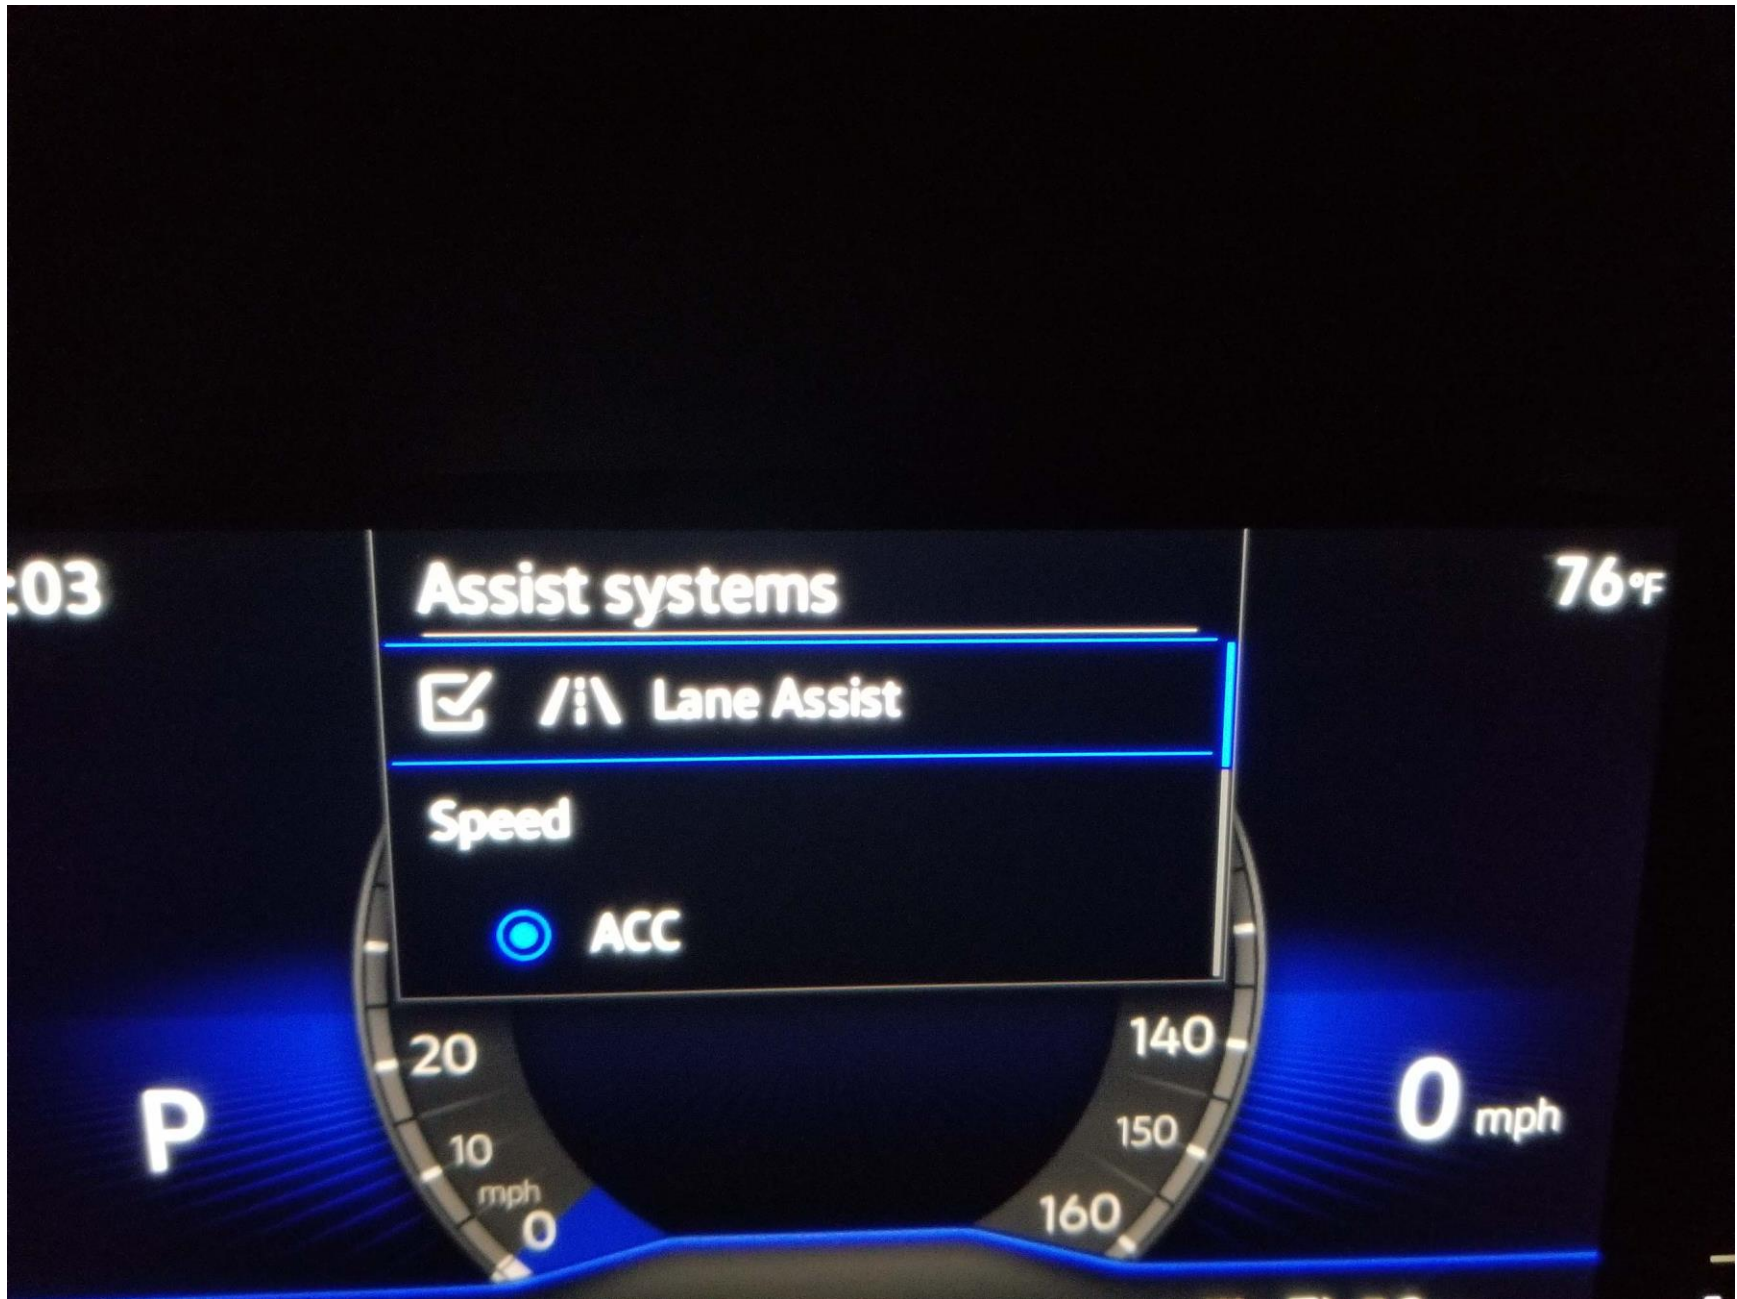
Figure A10. LDW System Instrument Panel On/Off Menu

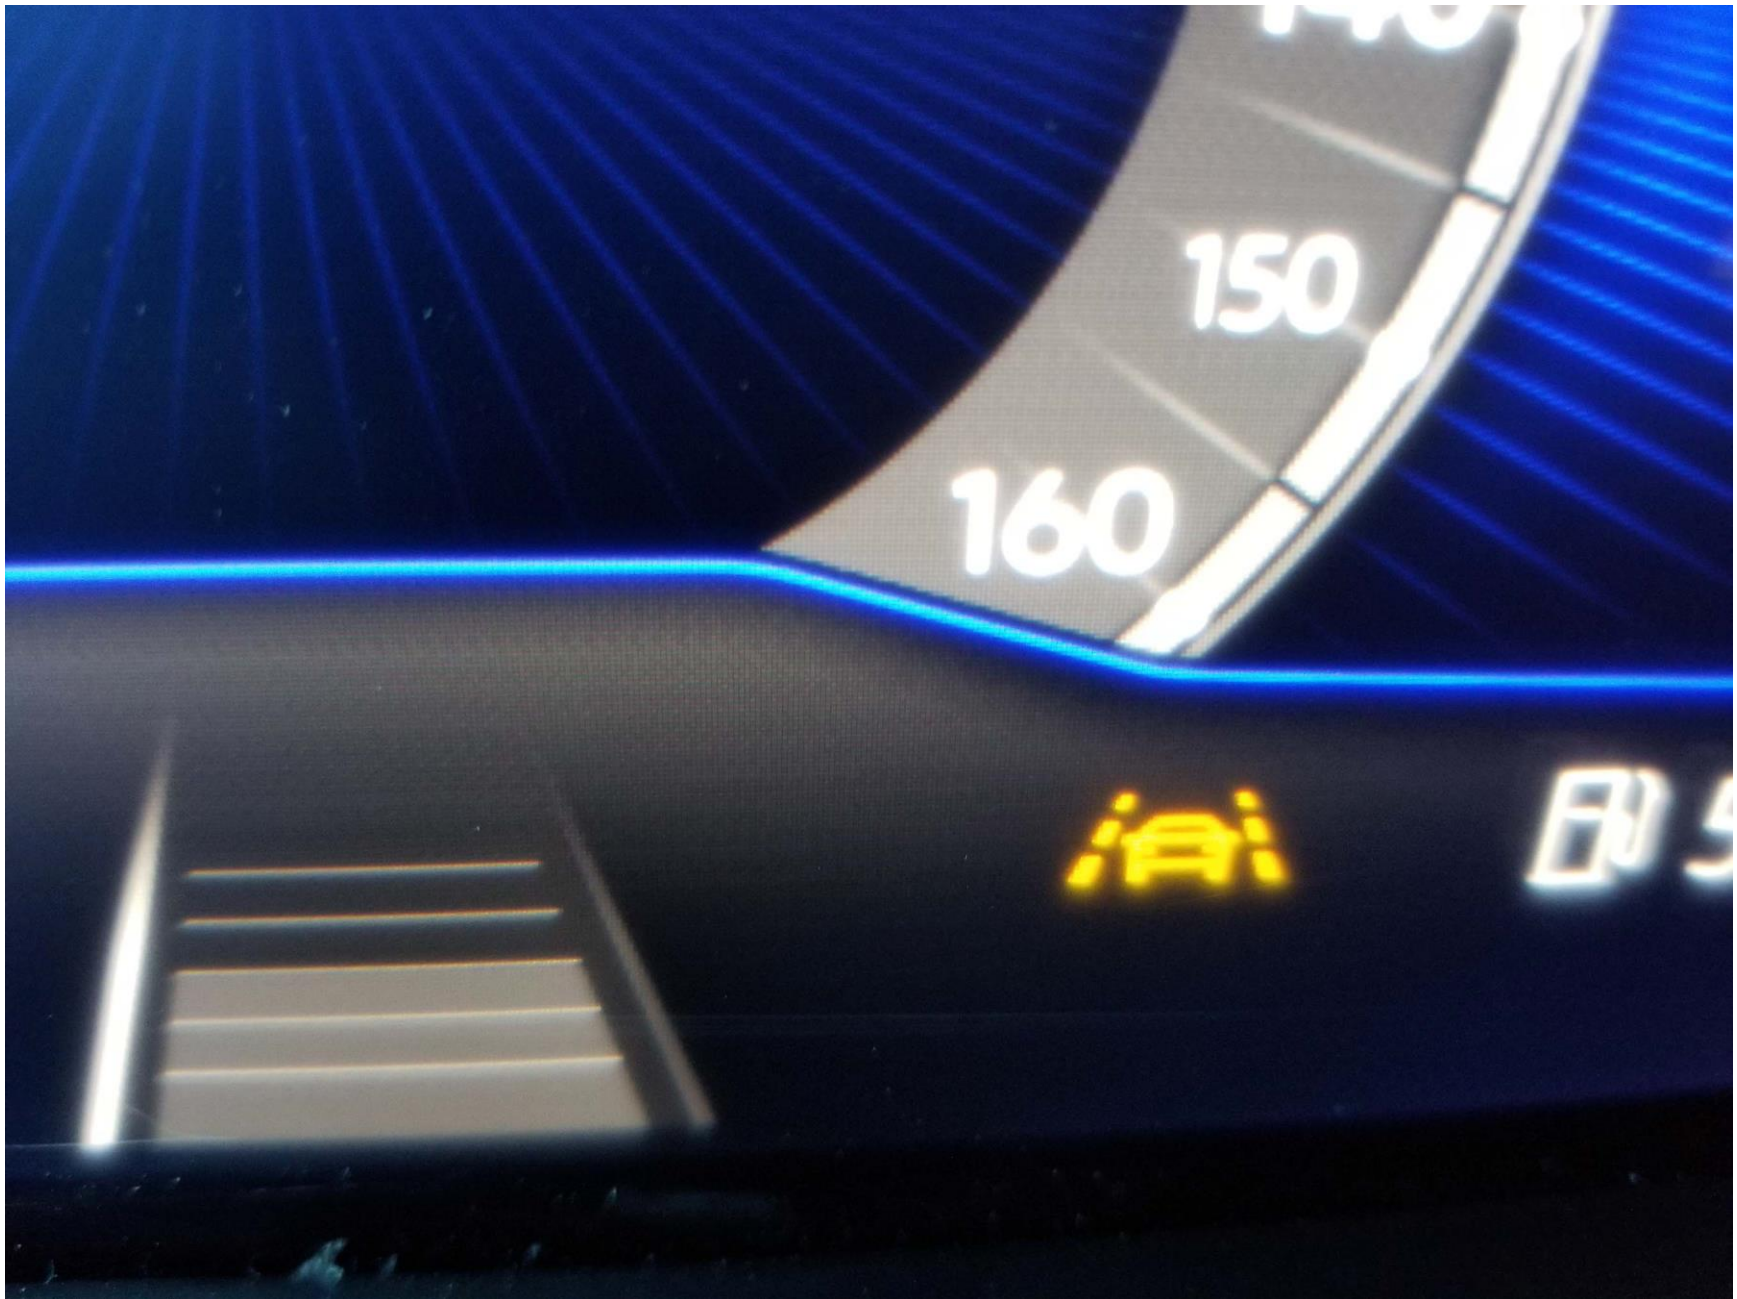
Figure A13. Visual Alert

The LDW system alerts the driver with a visual and haptic alert. The visual alert consists of two gray lane lines. When LDW activates, the lane line corresponding to the side that triggered the warning turns white. Additionally, there is vehicle icon that turns from green to yellow that is associated with the activation of the LKS system. The haptic alert is provided by a vibration in the steering wheel.

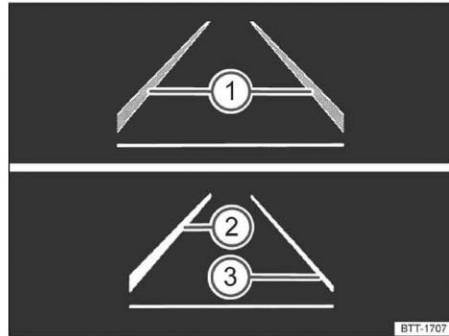
Fig. 106 In the instrument cluster display: Lane Assist indicators.

- ① Lane marking detected. The system is ready to monitor on the indicated side.
- ② Lane marking detected. The system is monitoring on the indicated side.
- ③ The system is not ready to monitor on the indicated side.
