**NEW CAR ASSESSMENT PROGRAM
LANE DEPARTURE WARNING CONFIRMATION TEST
NCAP-DRI-LDW-22-13**

2022 Toyota Tundra 4x4 CrewMax

Final Report

1. Report No. NCAP-DRI-LDW-22-13	2. Government Accession No.	3. Recipient's Catalog No.	
4. Title and Subtitle Final Report of Lane Departure Warning Confirmation Test of a 2022 Toyota Tundra 4x4 CrewMax.		5. Report Date 12 July 2022

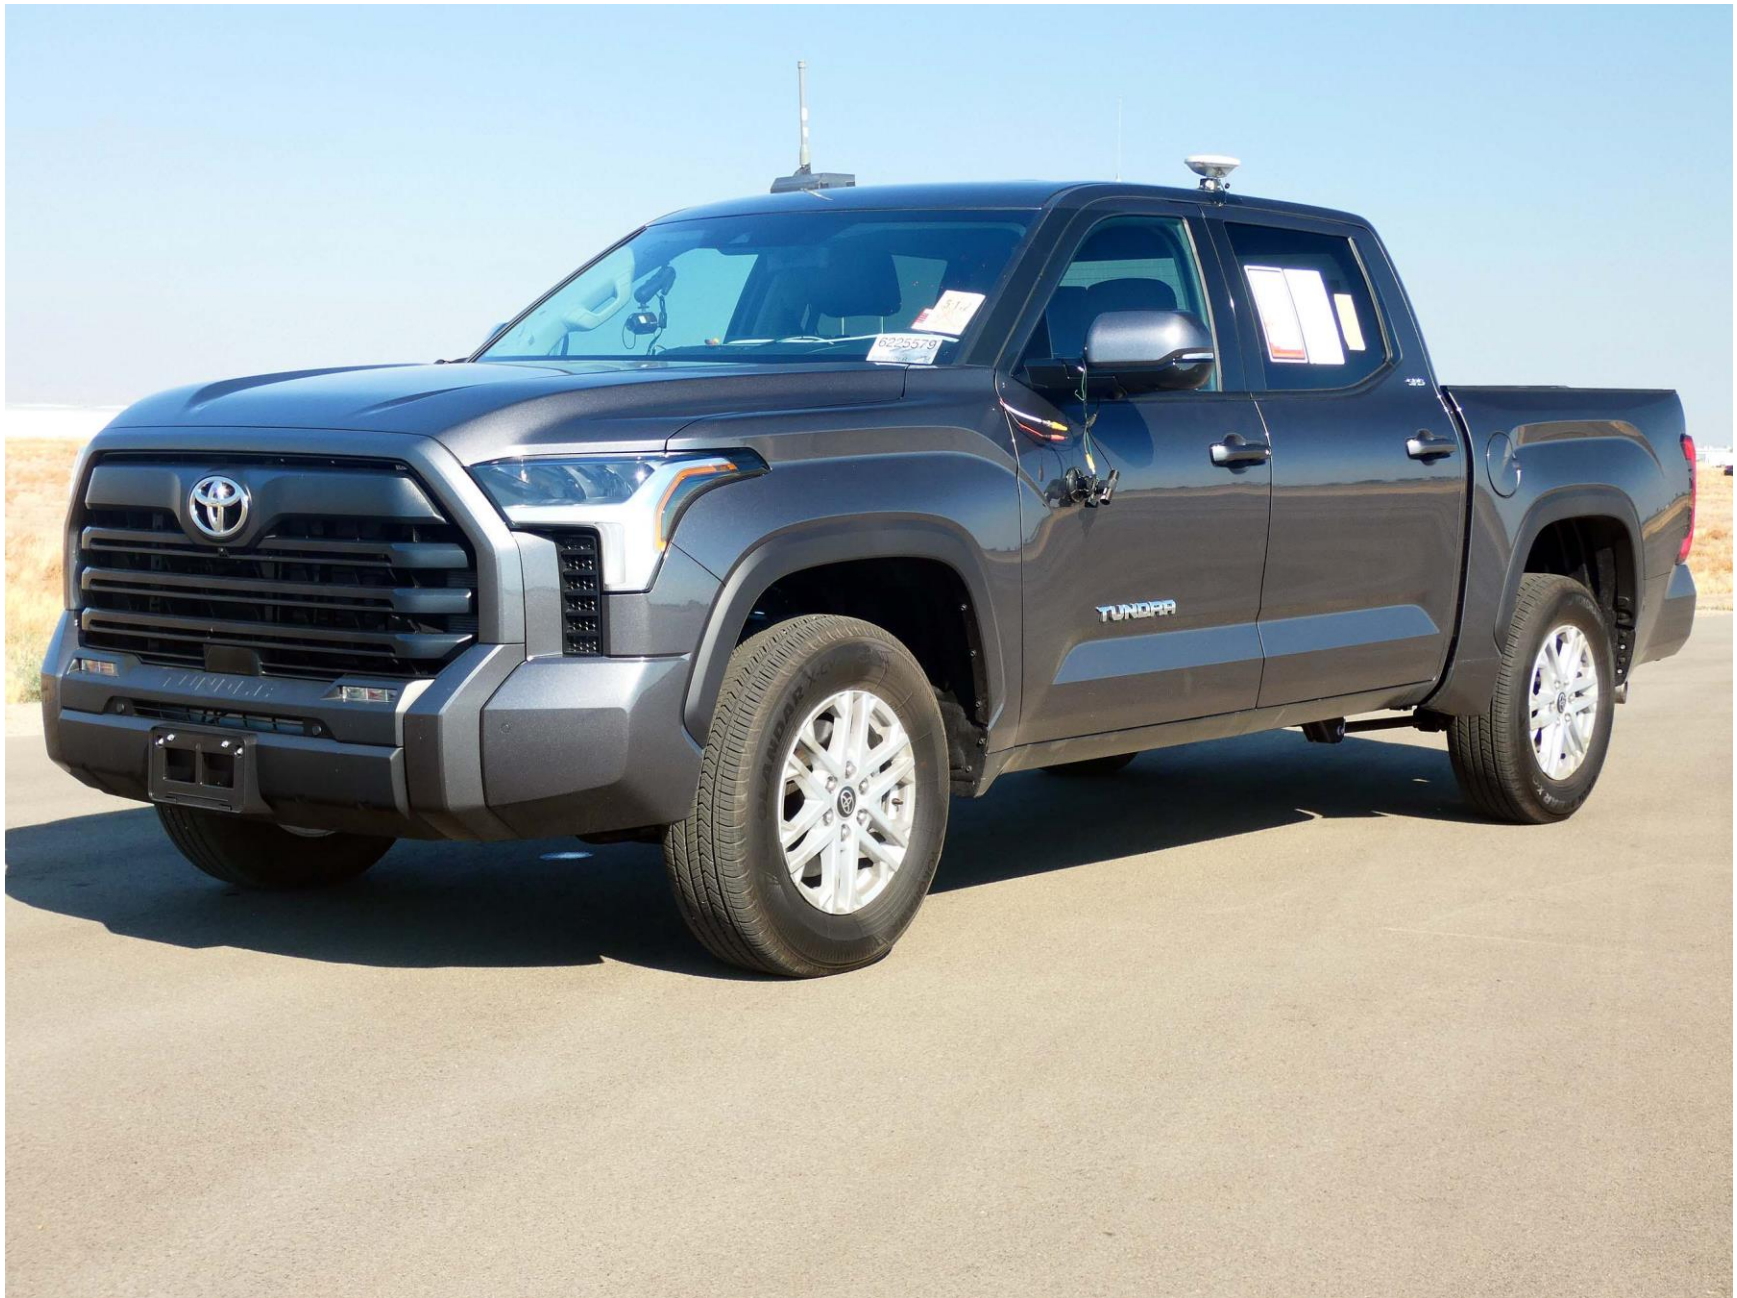
Figure A1. Front View of Subject Vehicle

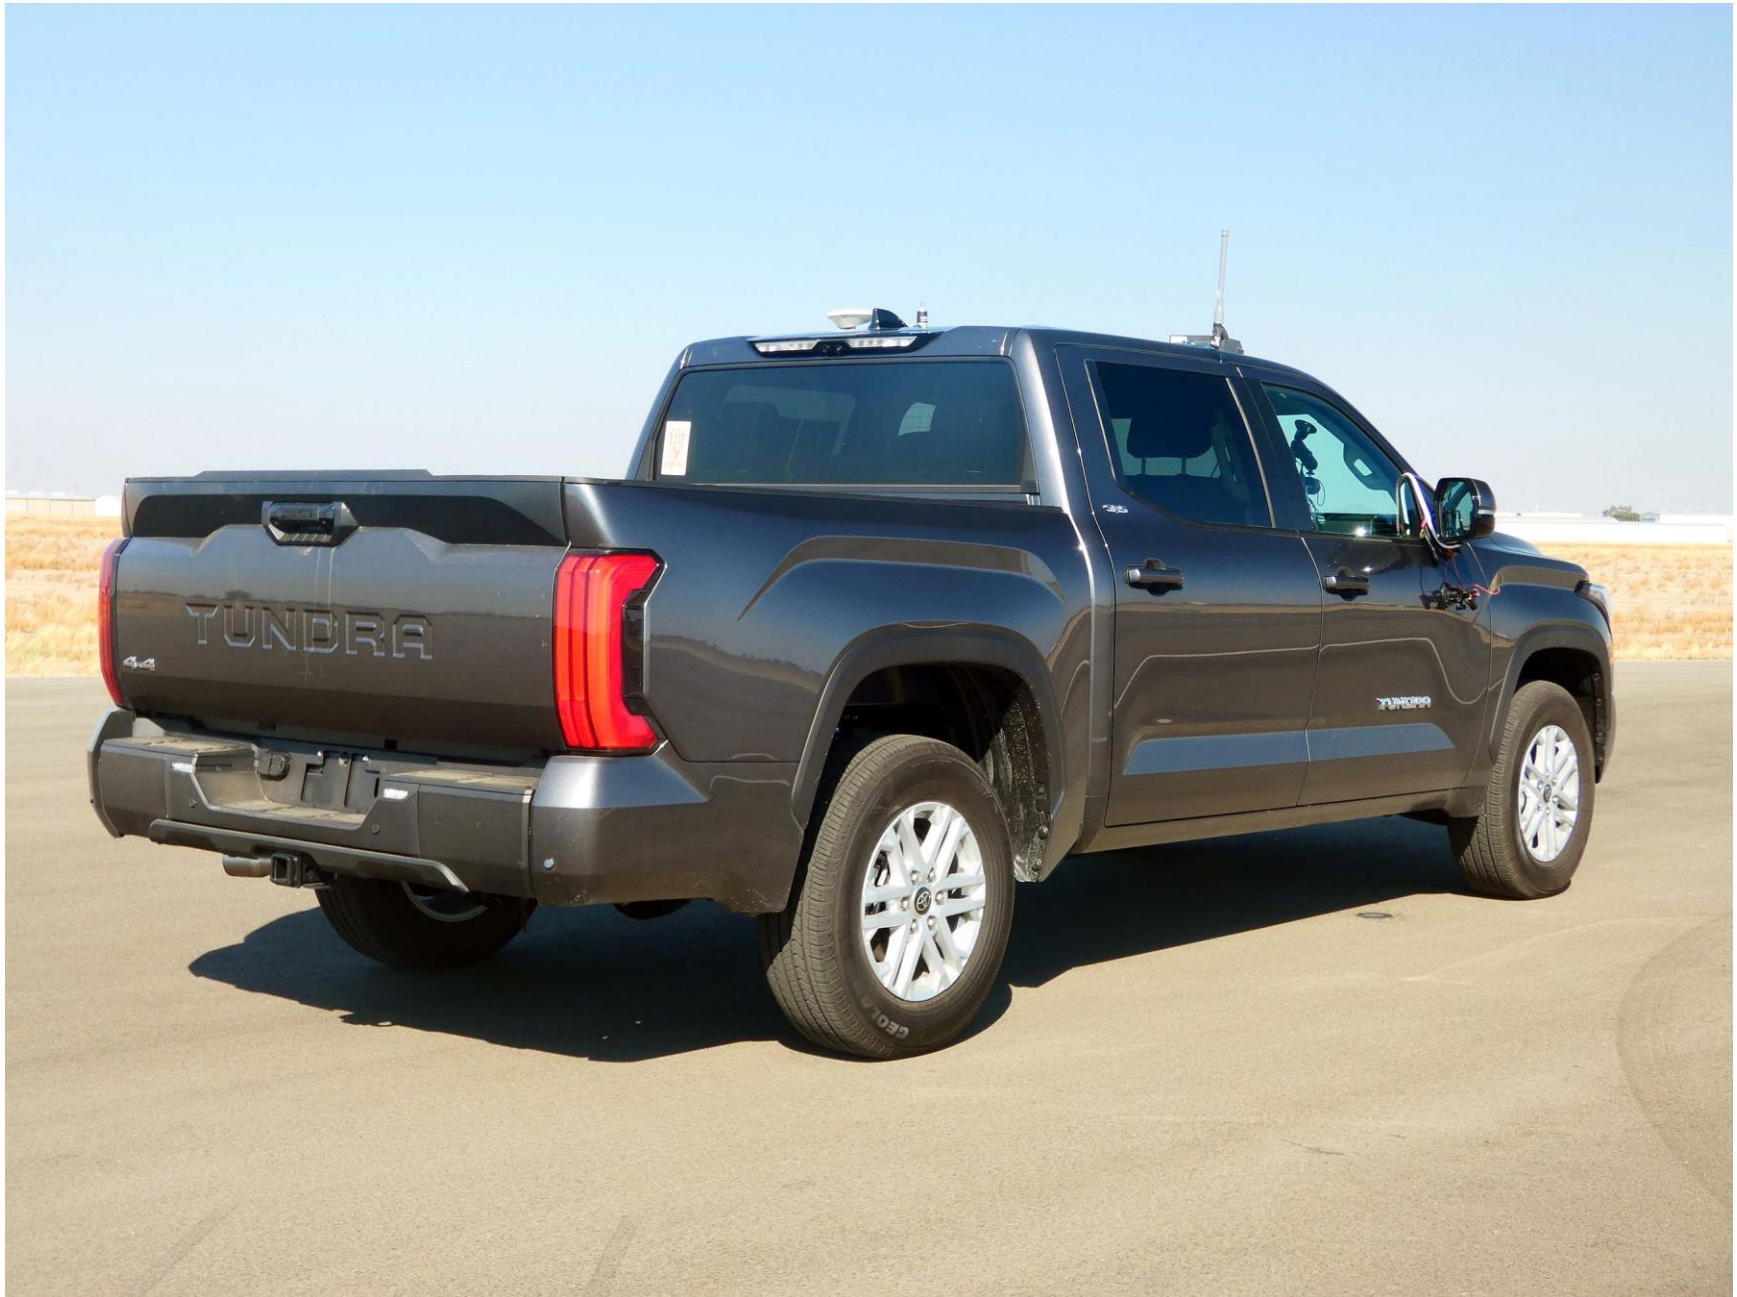
Figure A2. Rear View of Subject Vehicle

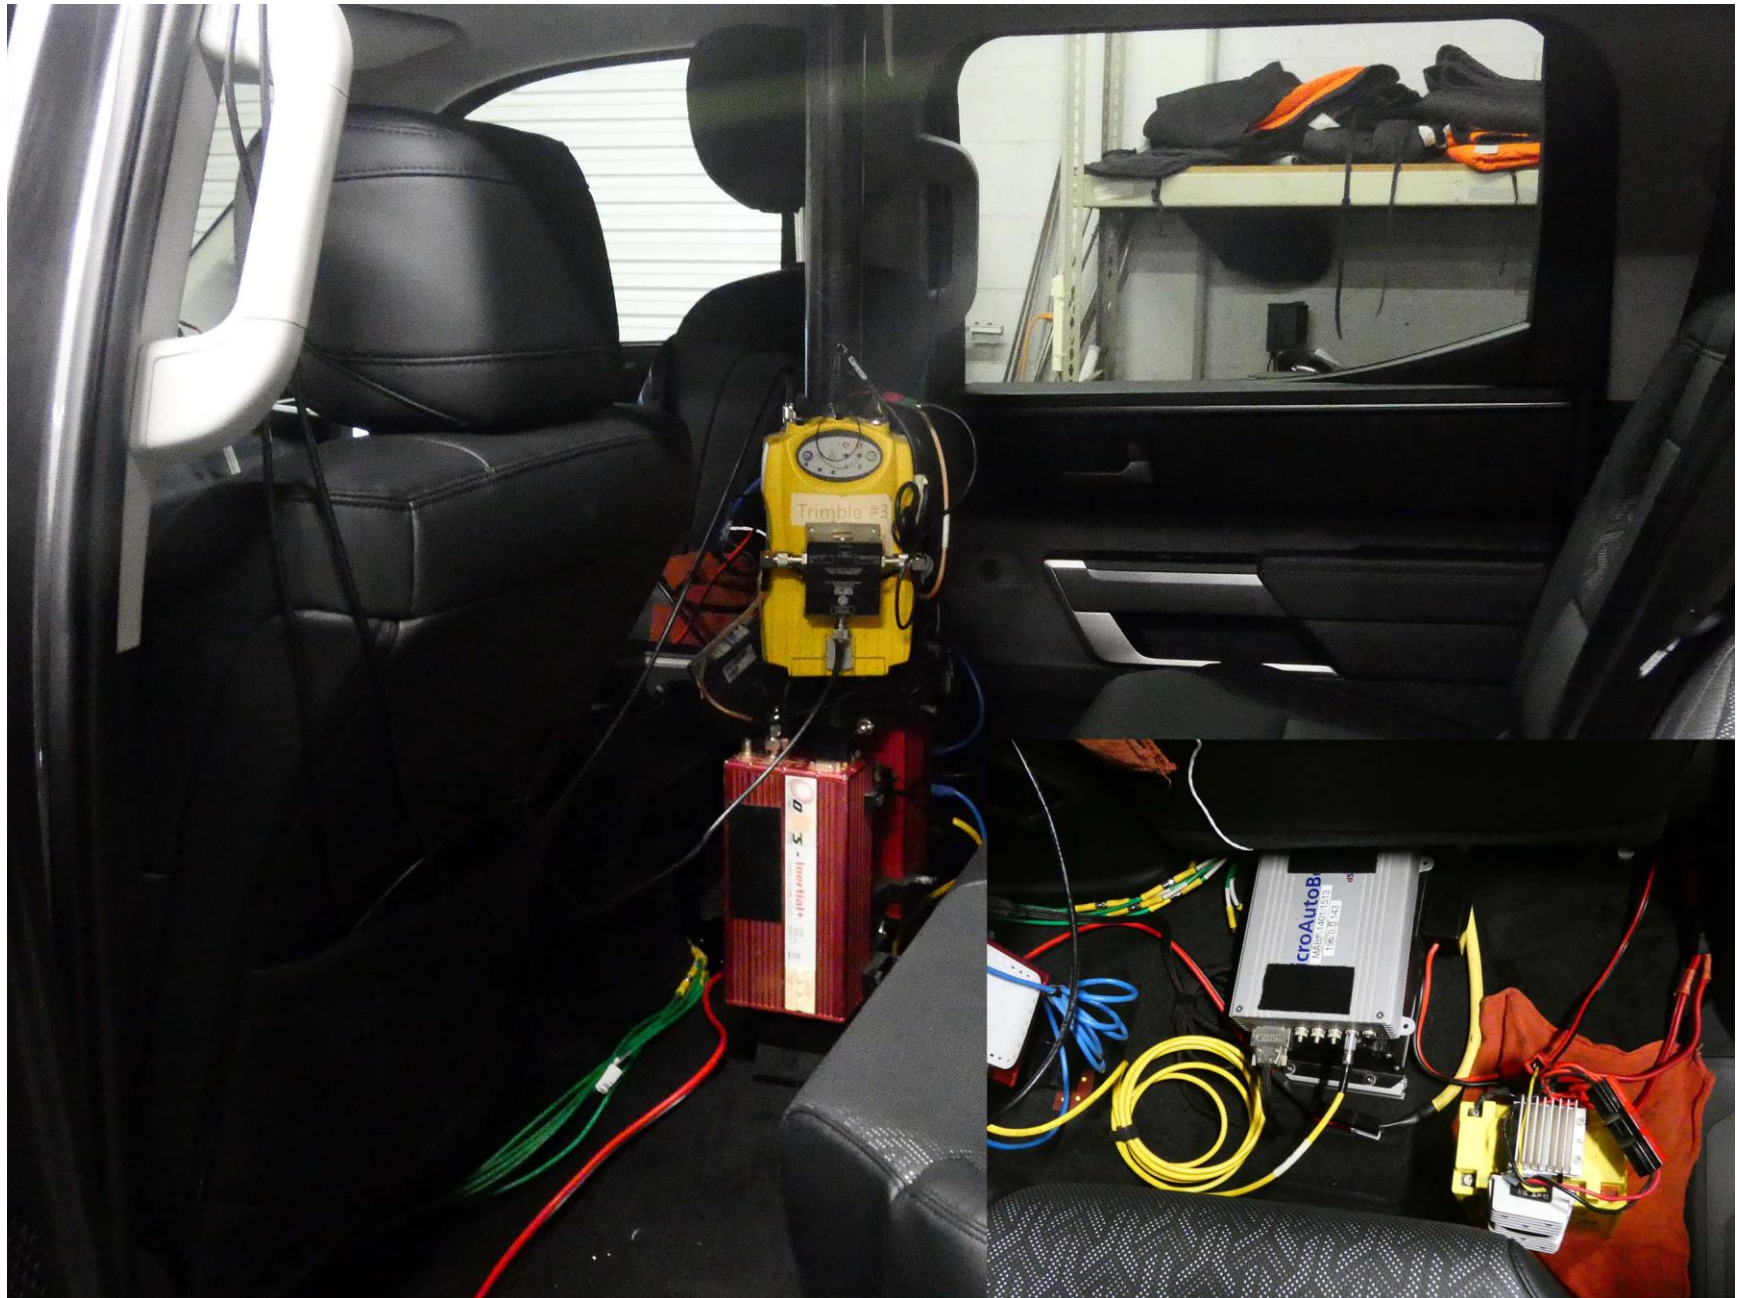
Figure A6. DGPS, Inertial Measurement Unit, and MicroAutoBox Installed in Subject Vehicle

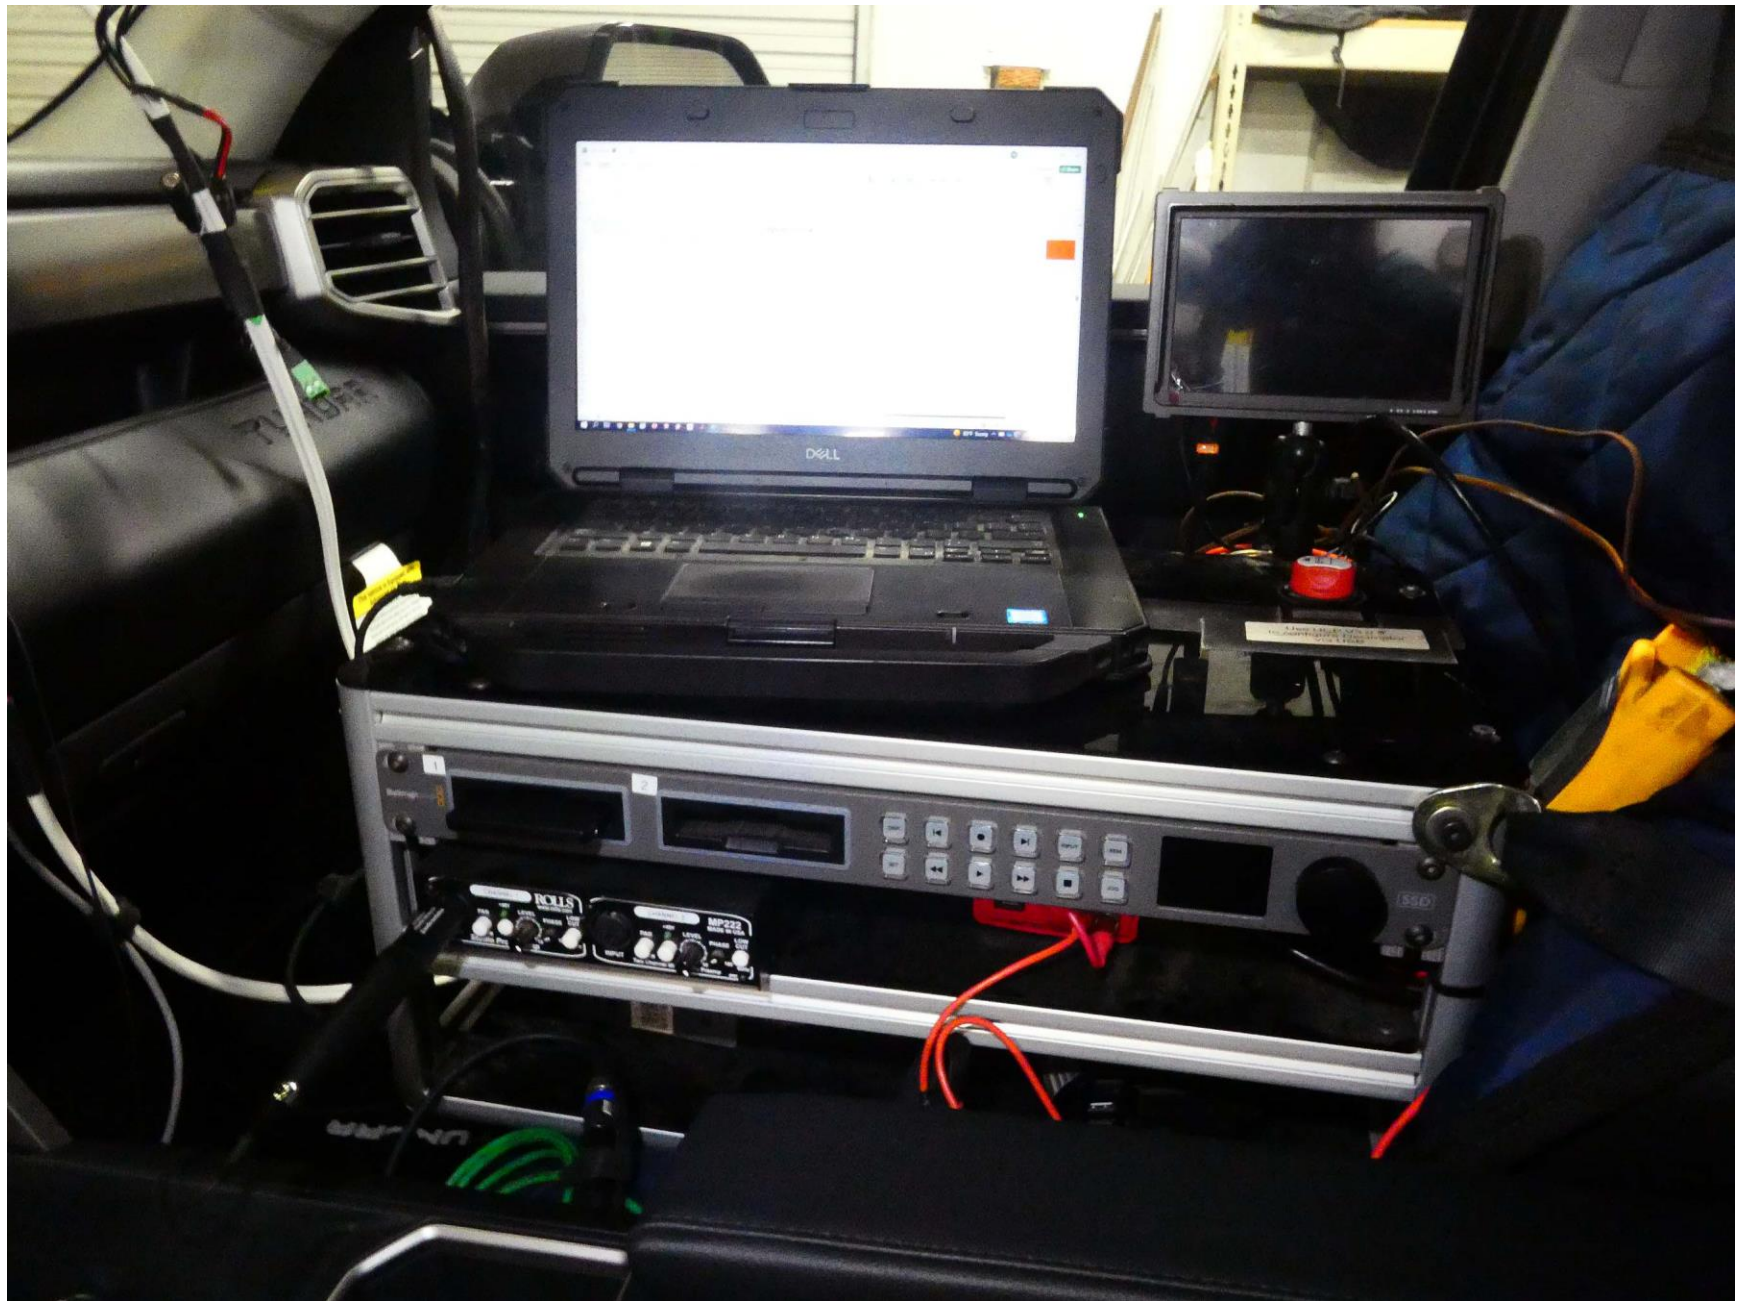
Figure A8. Computer Installed in Subject Vehicle

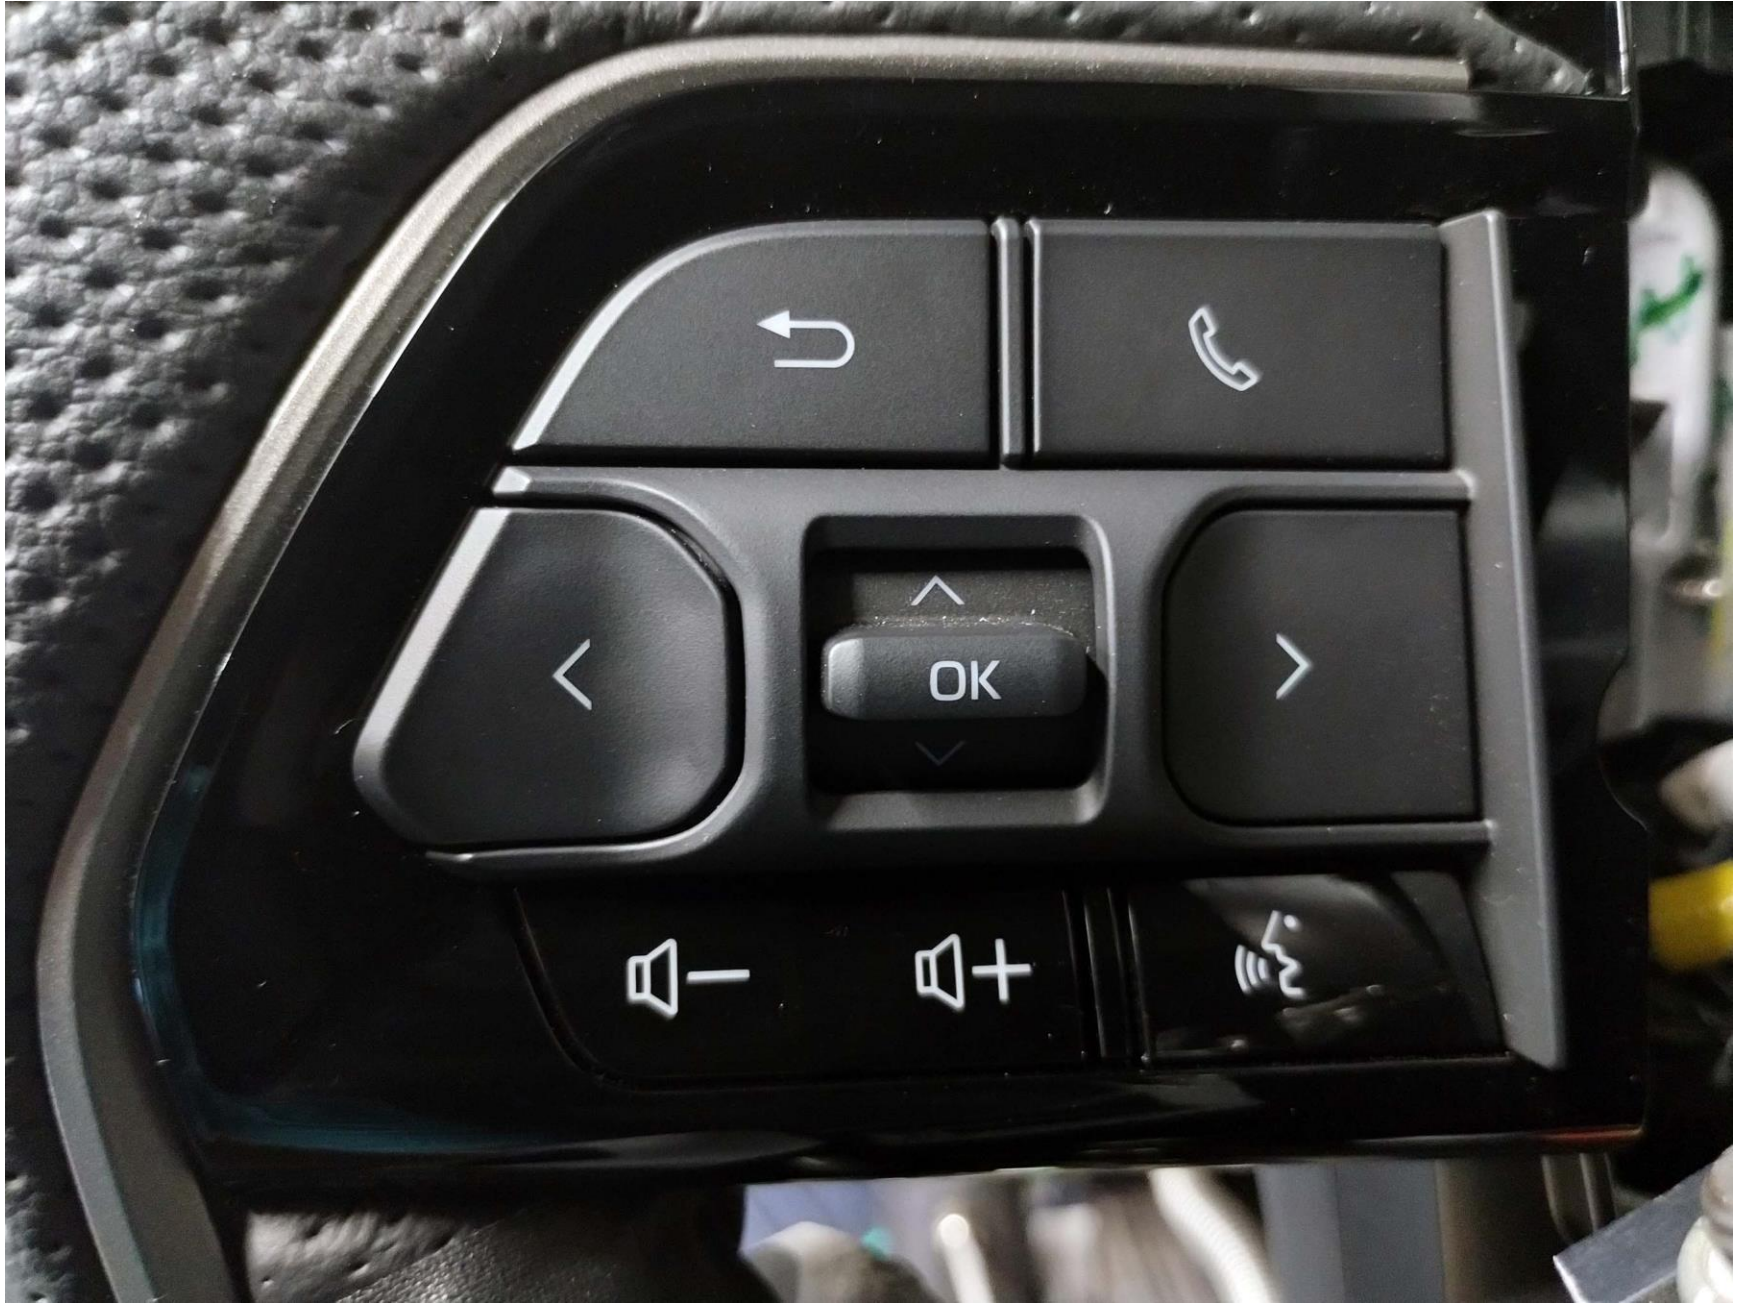
Figure A9. Steering Wheel Buttons for Adjusting LDW Sensitivity and Alert Type

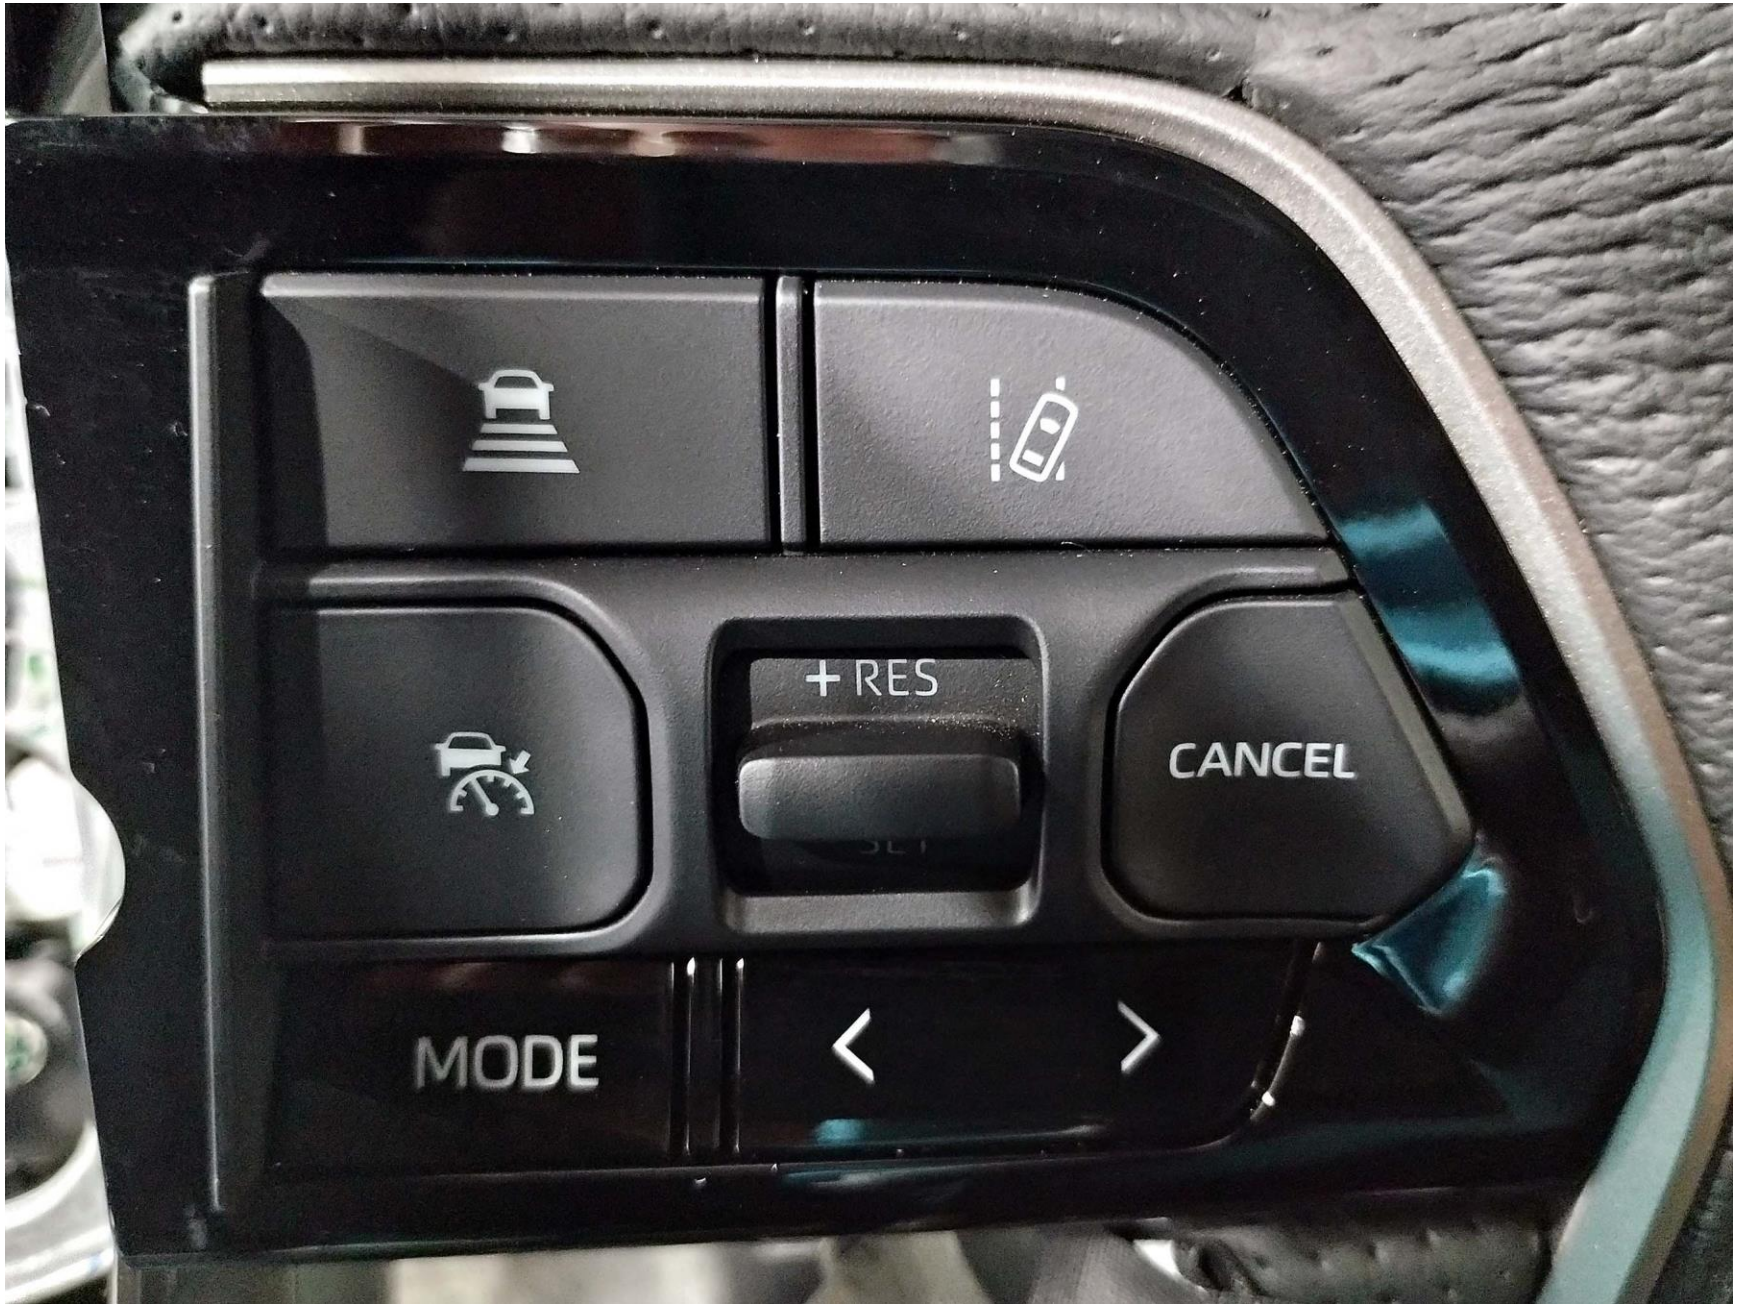
Figure A11. LDW System On/Off Button

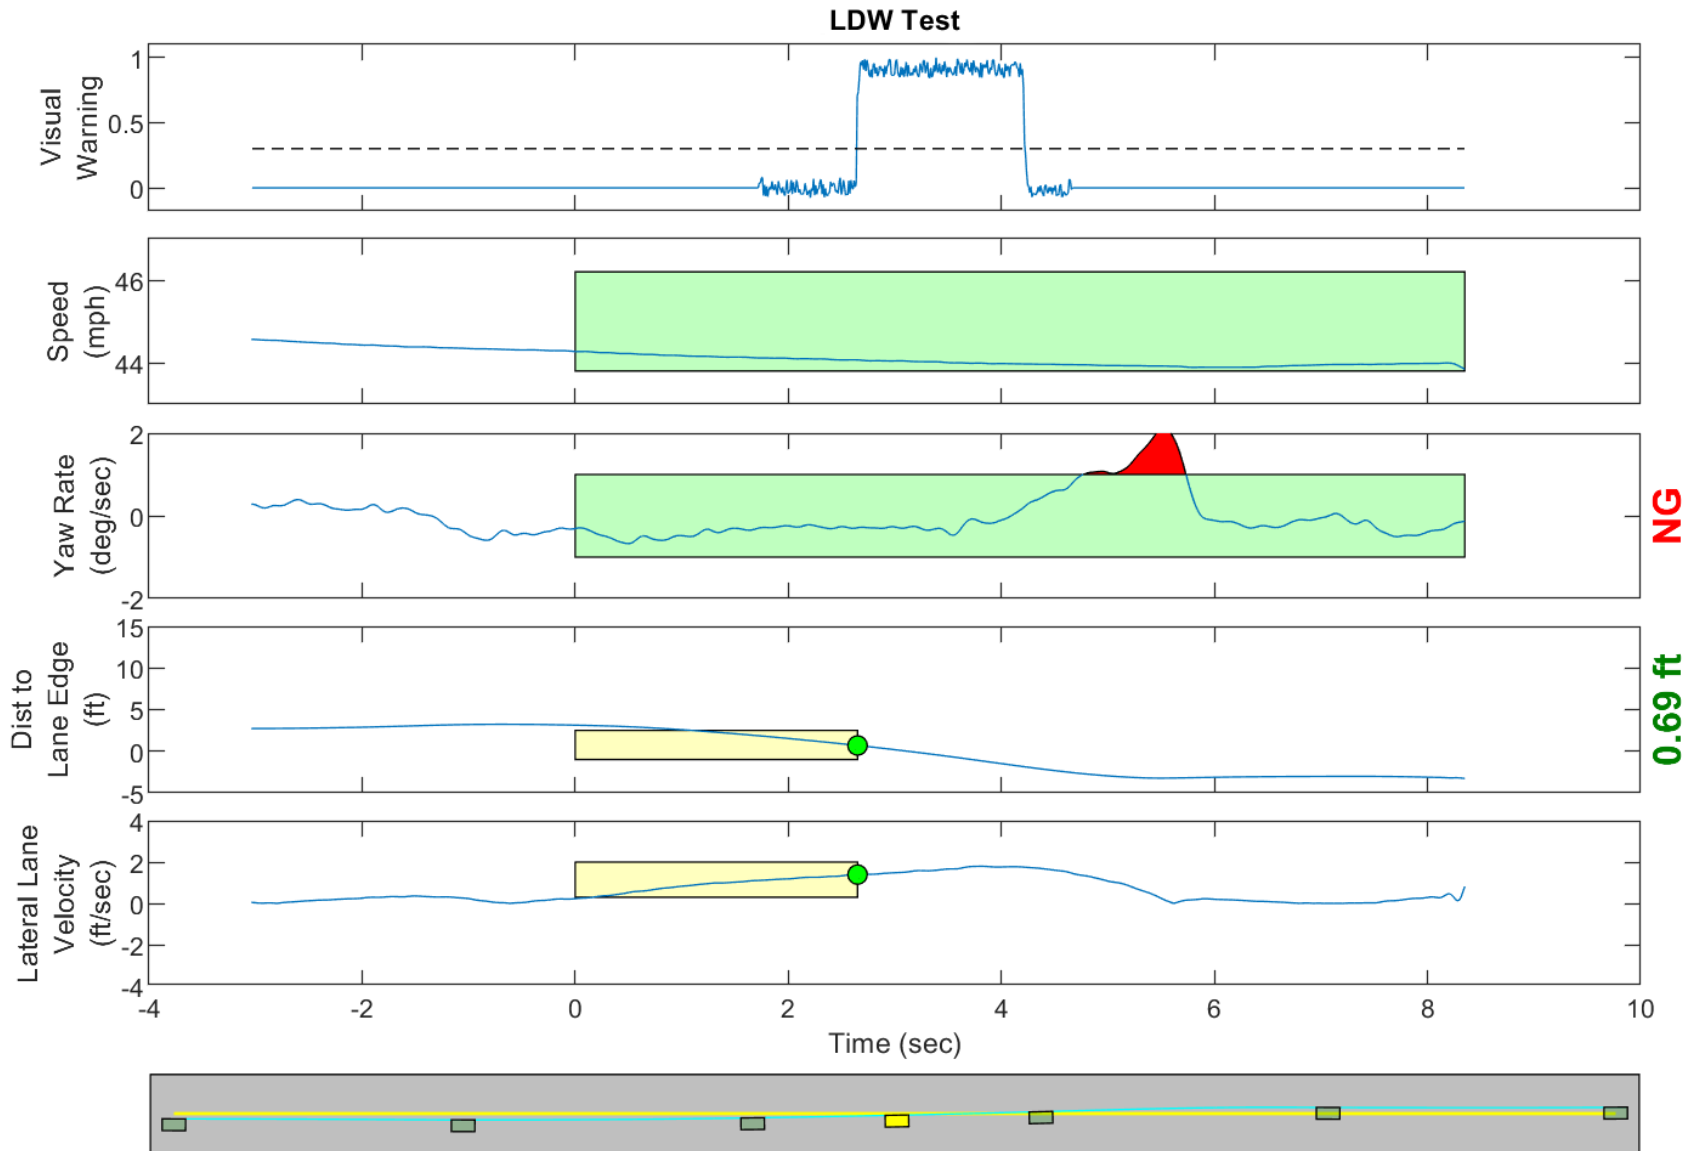
Figure D3. Example Time History for Lane Departure Warning Test, Invalid Run Due to Subject Vehicle Yaw Rate

Examples of time history plots (including passing, failing and invalid runs) are shown in Figure D1 through Figure D3. Actual time history data plots for the vehicle under consideration are provided subsequently.

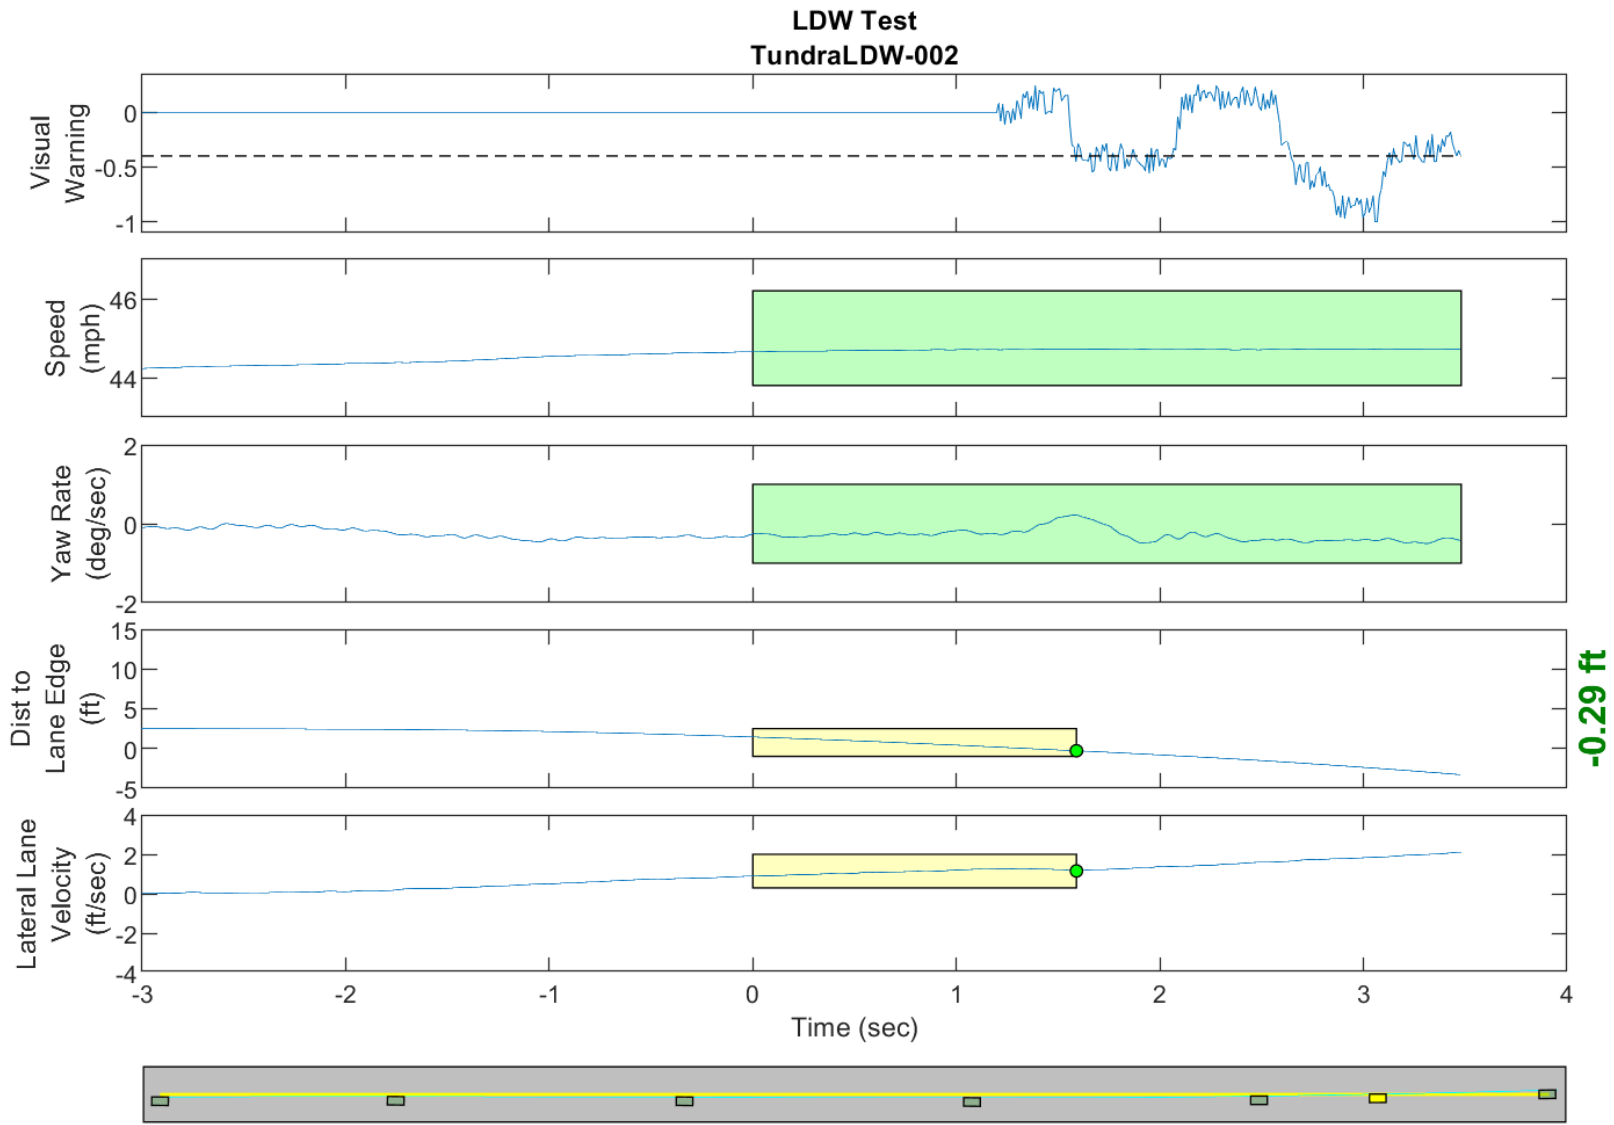
Figure D7. Time History for Run 02, Botts Dots, Left Departure, Visual Warning
