**NEW CAR ASSESSMENT PROGRAM  
LANE DEPARTURE WARNING CONFIRMATION TEST  
NCAP-DRI-LDW-22-04**

**2022 Honda Civic**

**DYNAMIC RESEARCH, INC.**

**Final Report**

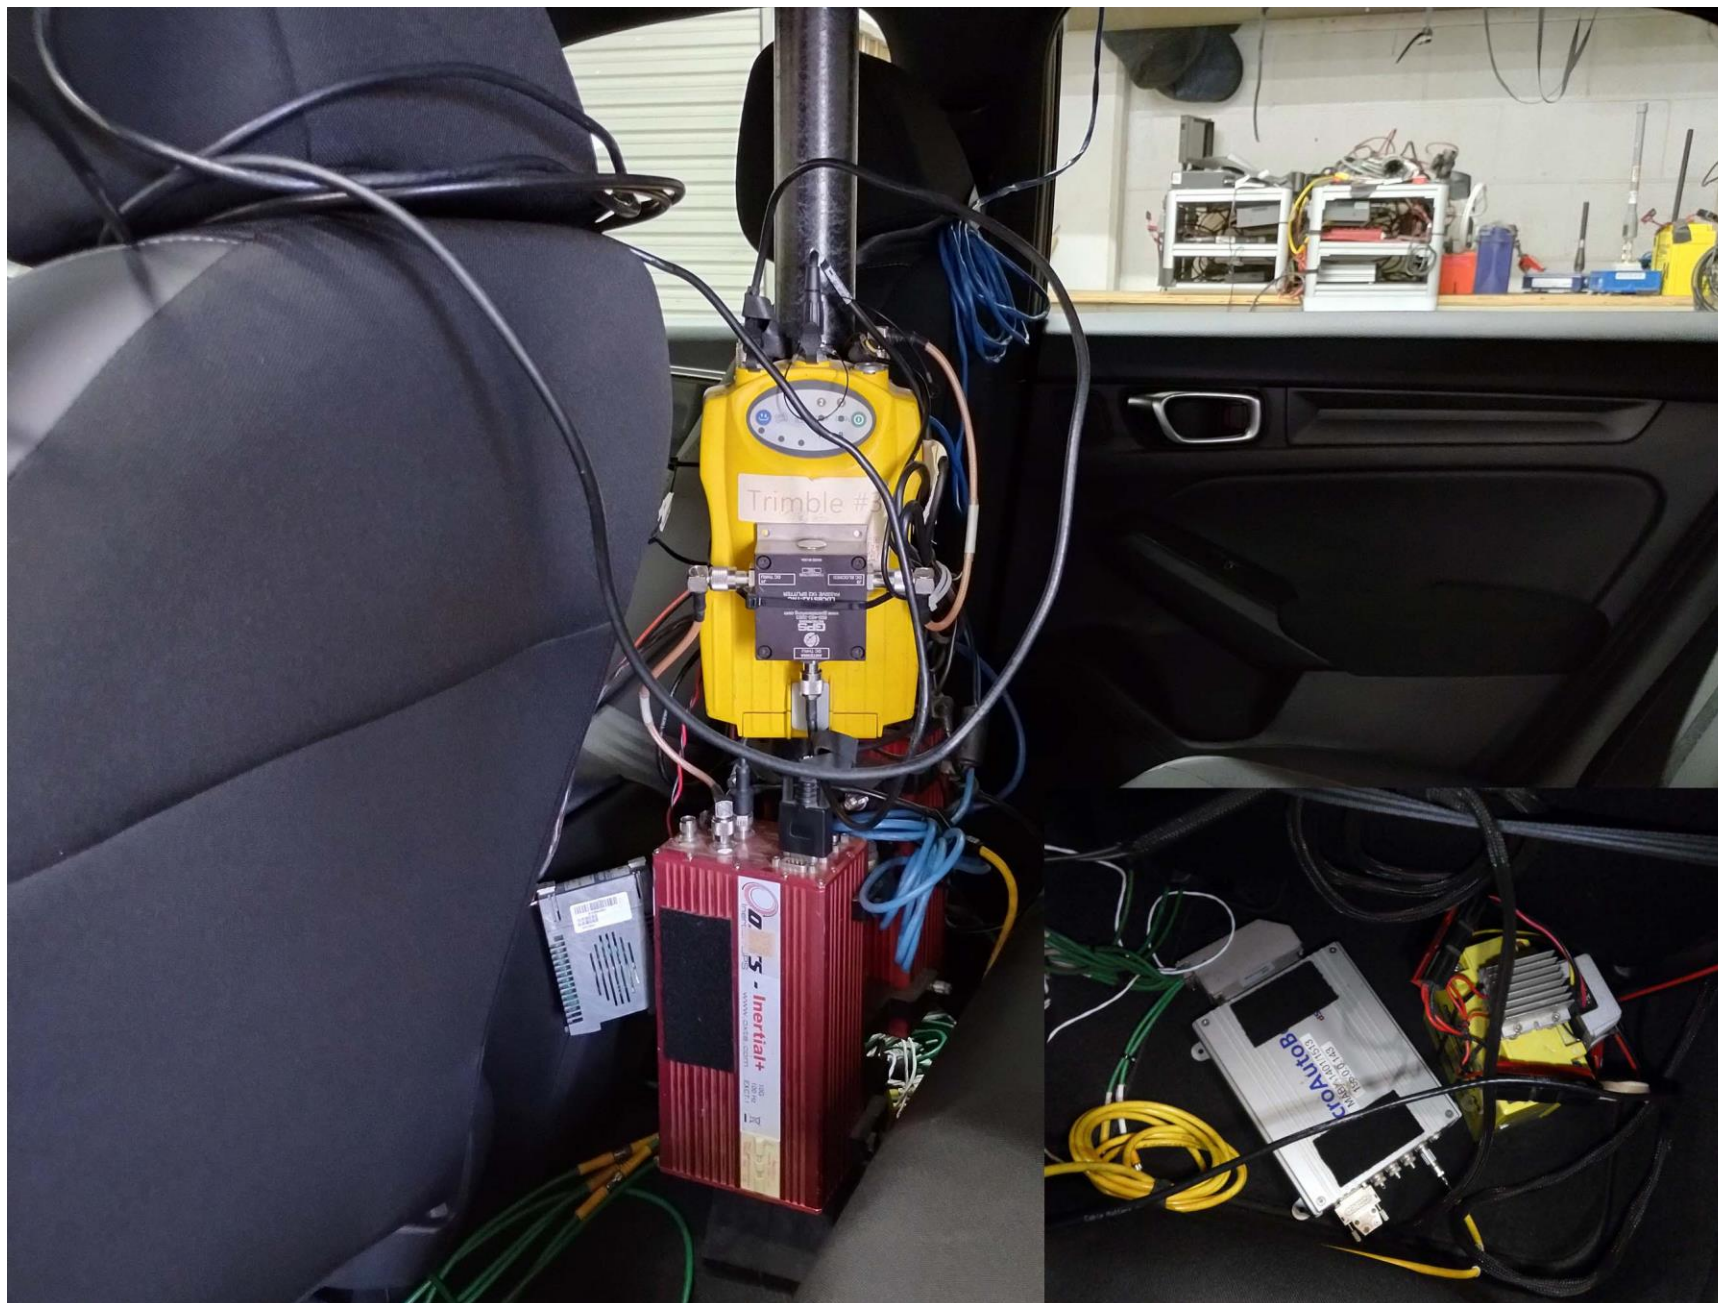
Figure A6. DGPS, Inertial Measurement Unit, and MicroAutoBox Installed in Subject Vehicle

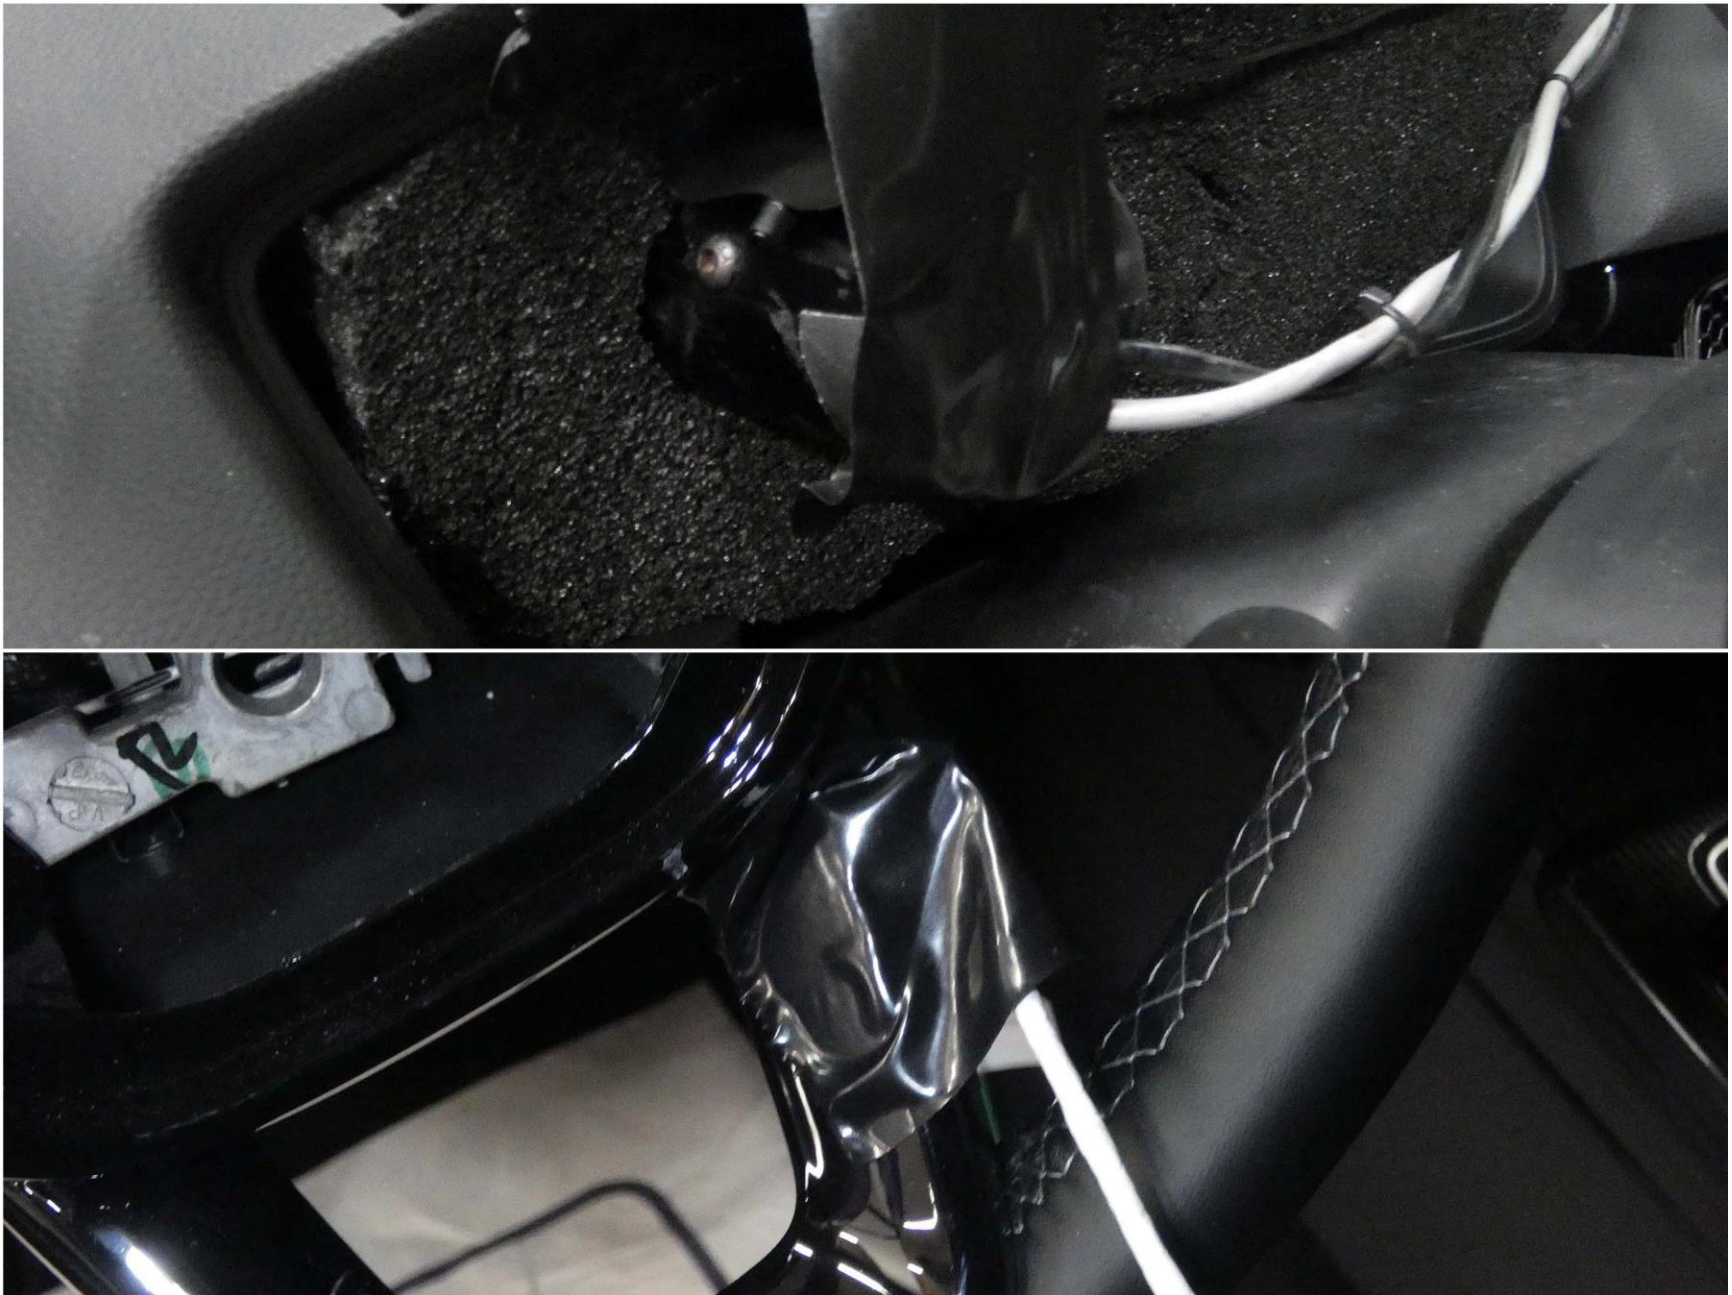
Figure A7. Sensors for Detecting Visual and Haptic Alerts

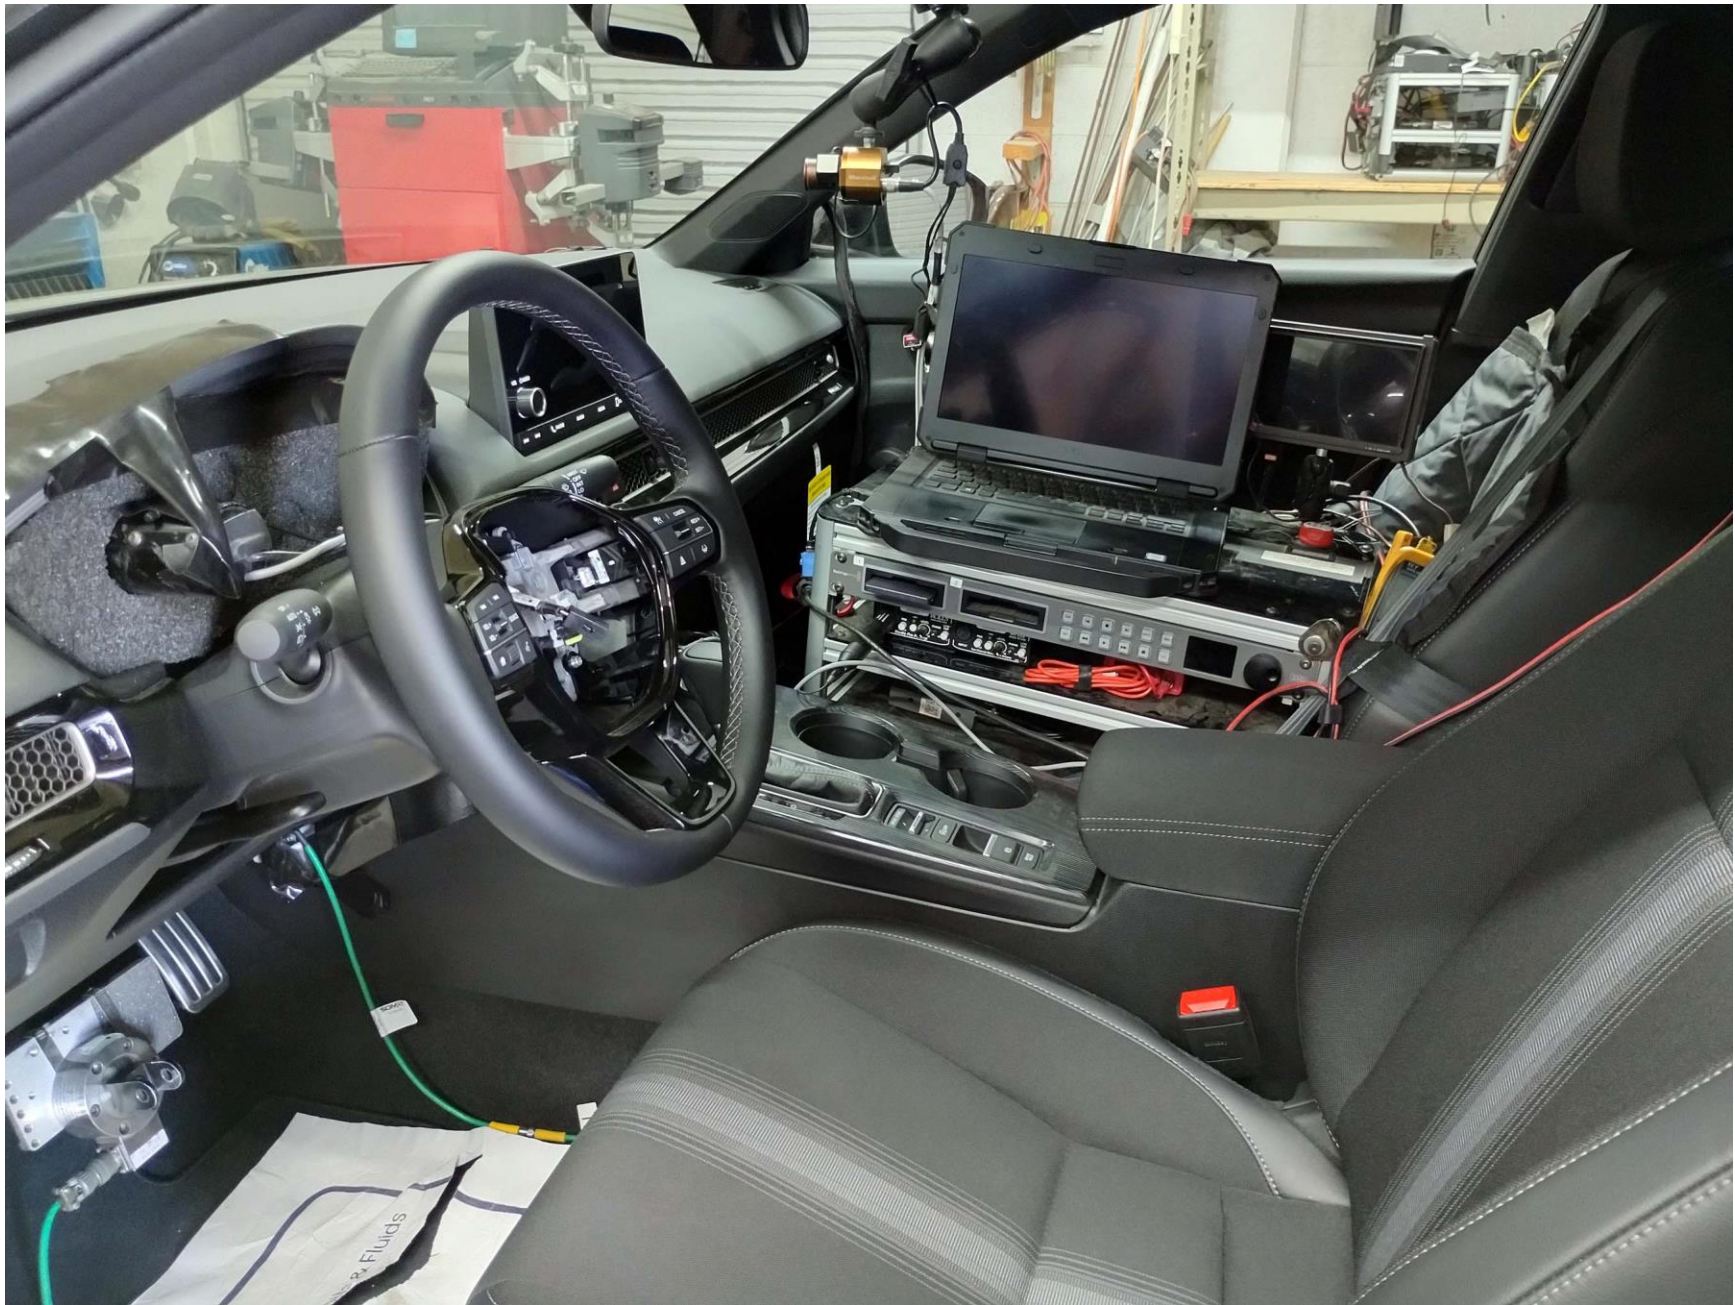
Figure A8. Computer Installed in Subject Vehicle

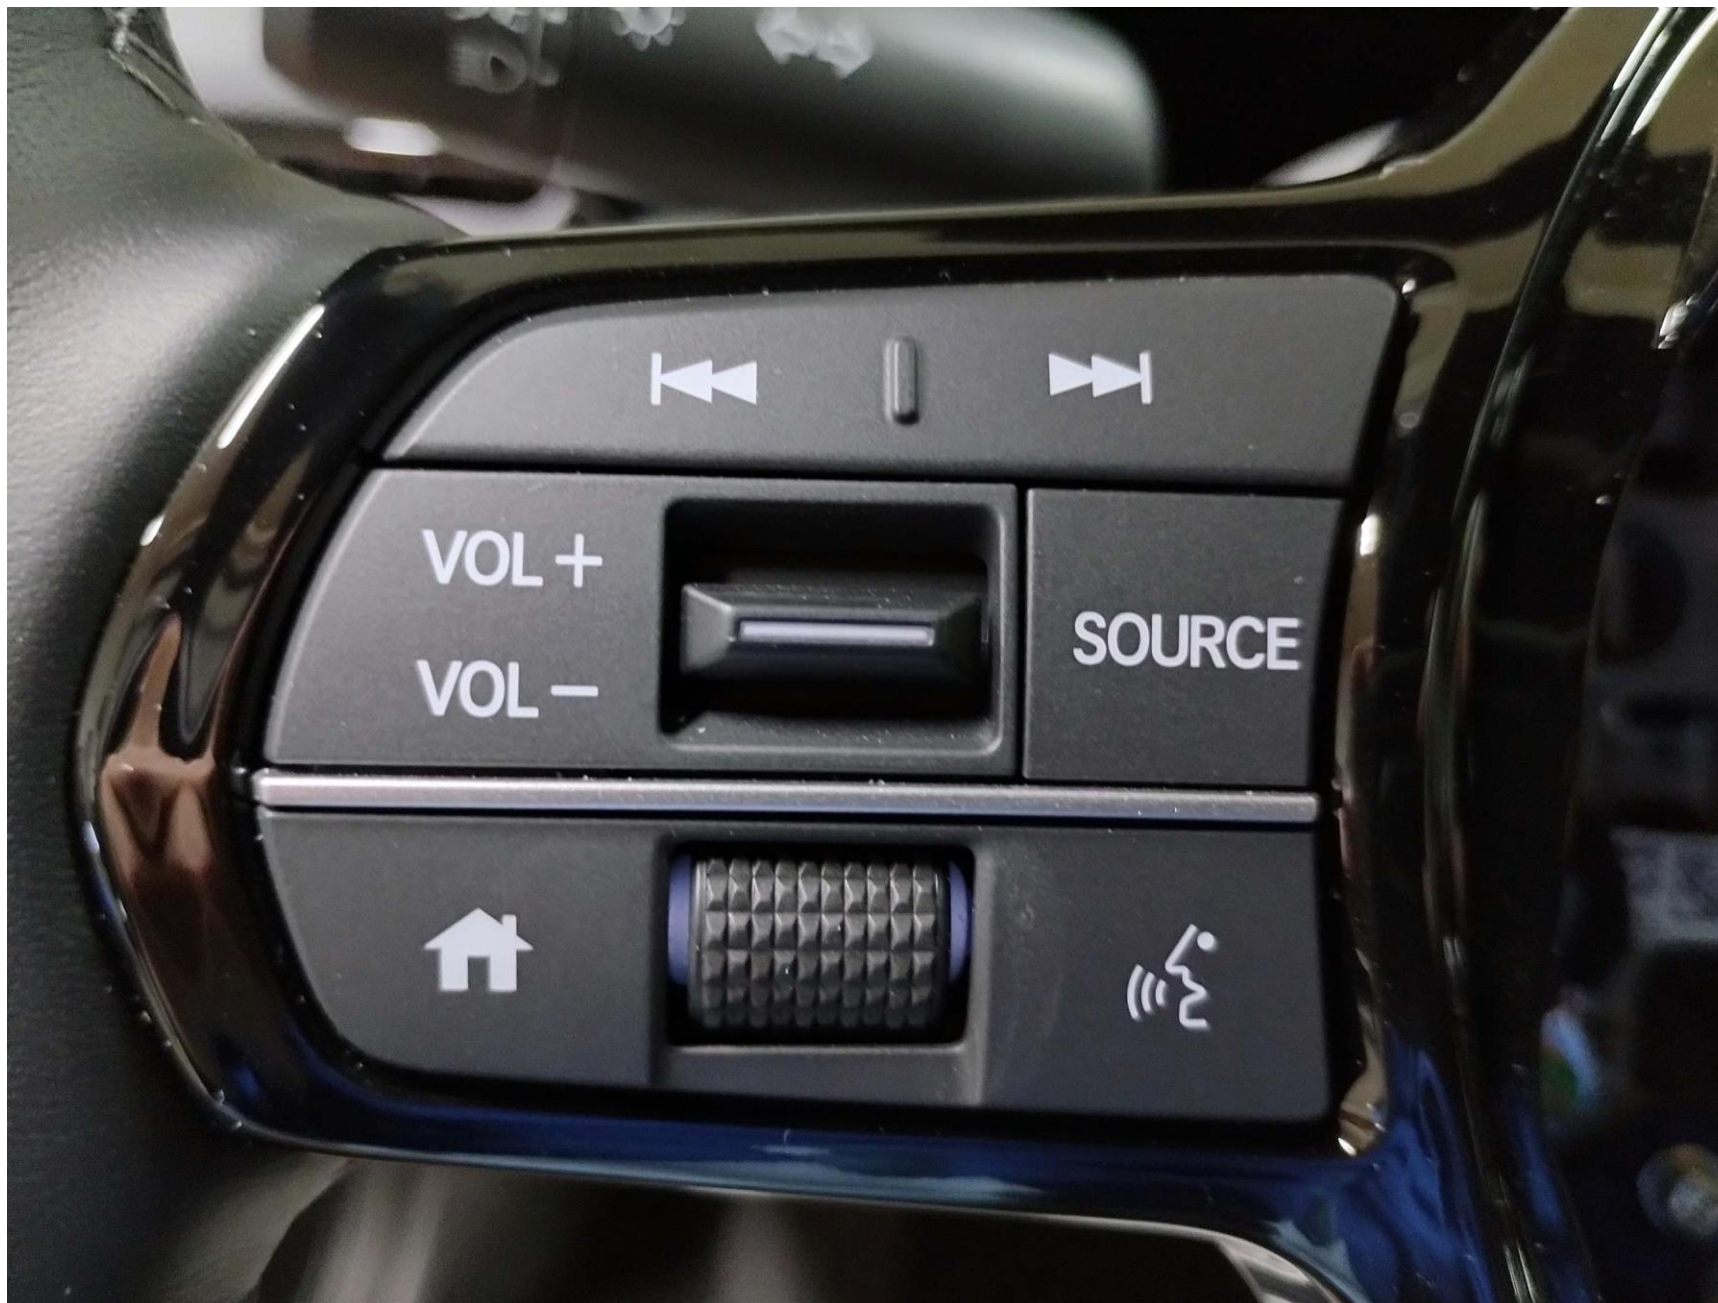
Figure A9. Steering Wheel Buttons

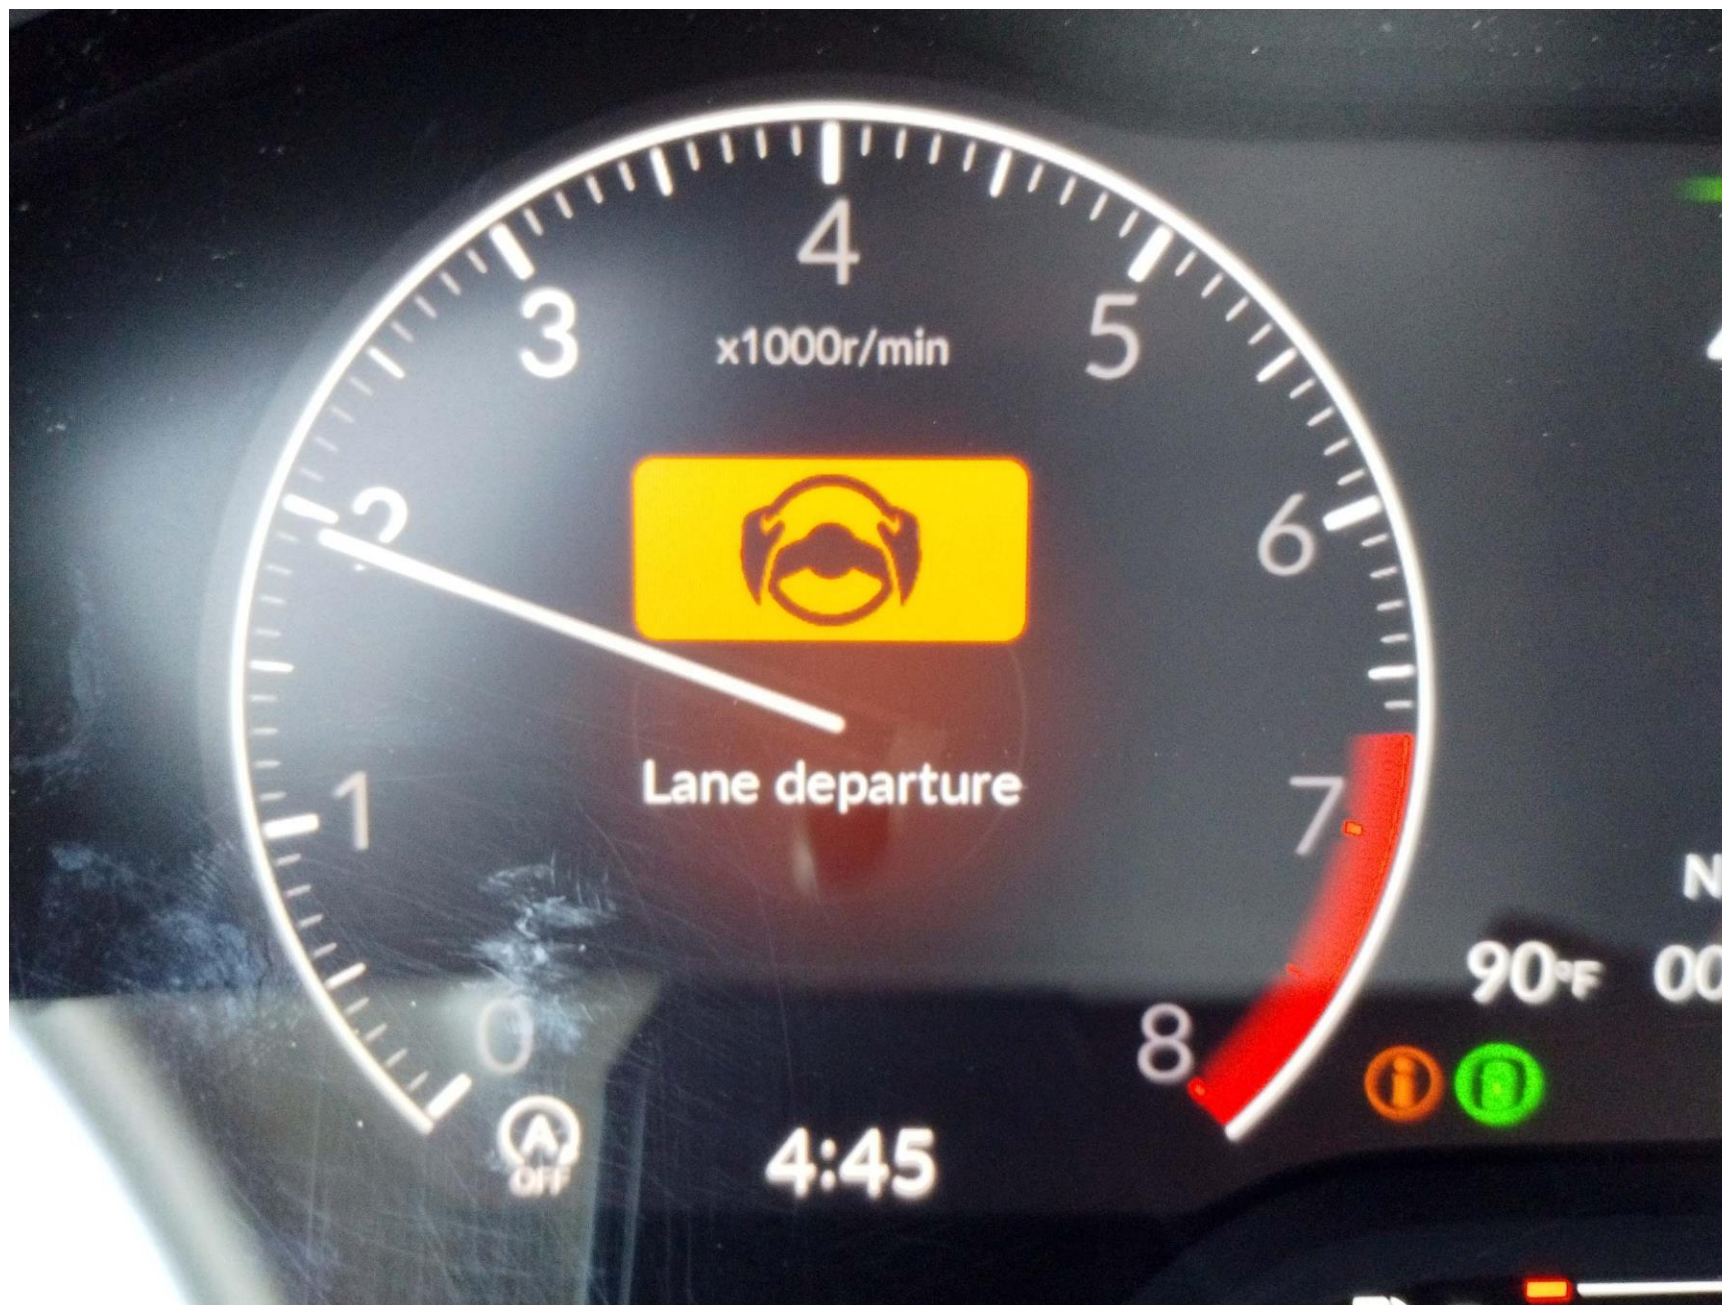
Figure A11. Visual Alert
