**NEW CAR ASSESSMENT PROGRAM  
LANE DEPARTURE WARNING CONFIRMATION TEST  
NCAP-DRI-LDW-22-01**

**2022 Chevrolet Bolt EUV Premier**

**DYNAMIC RESEARCH, INC.**

**Final Report**

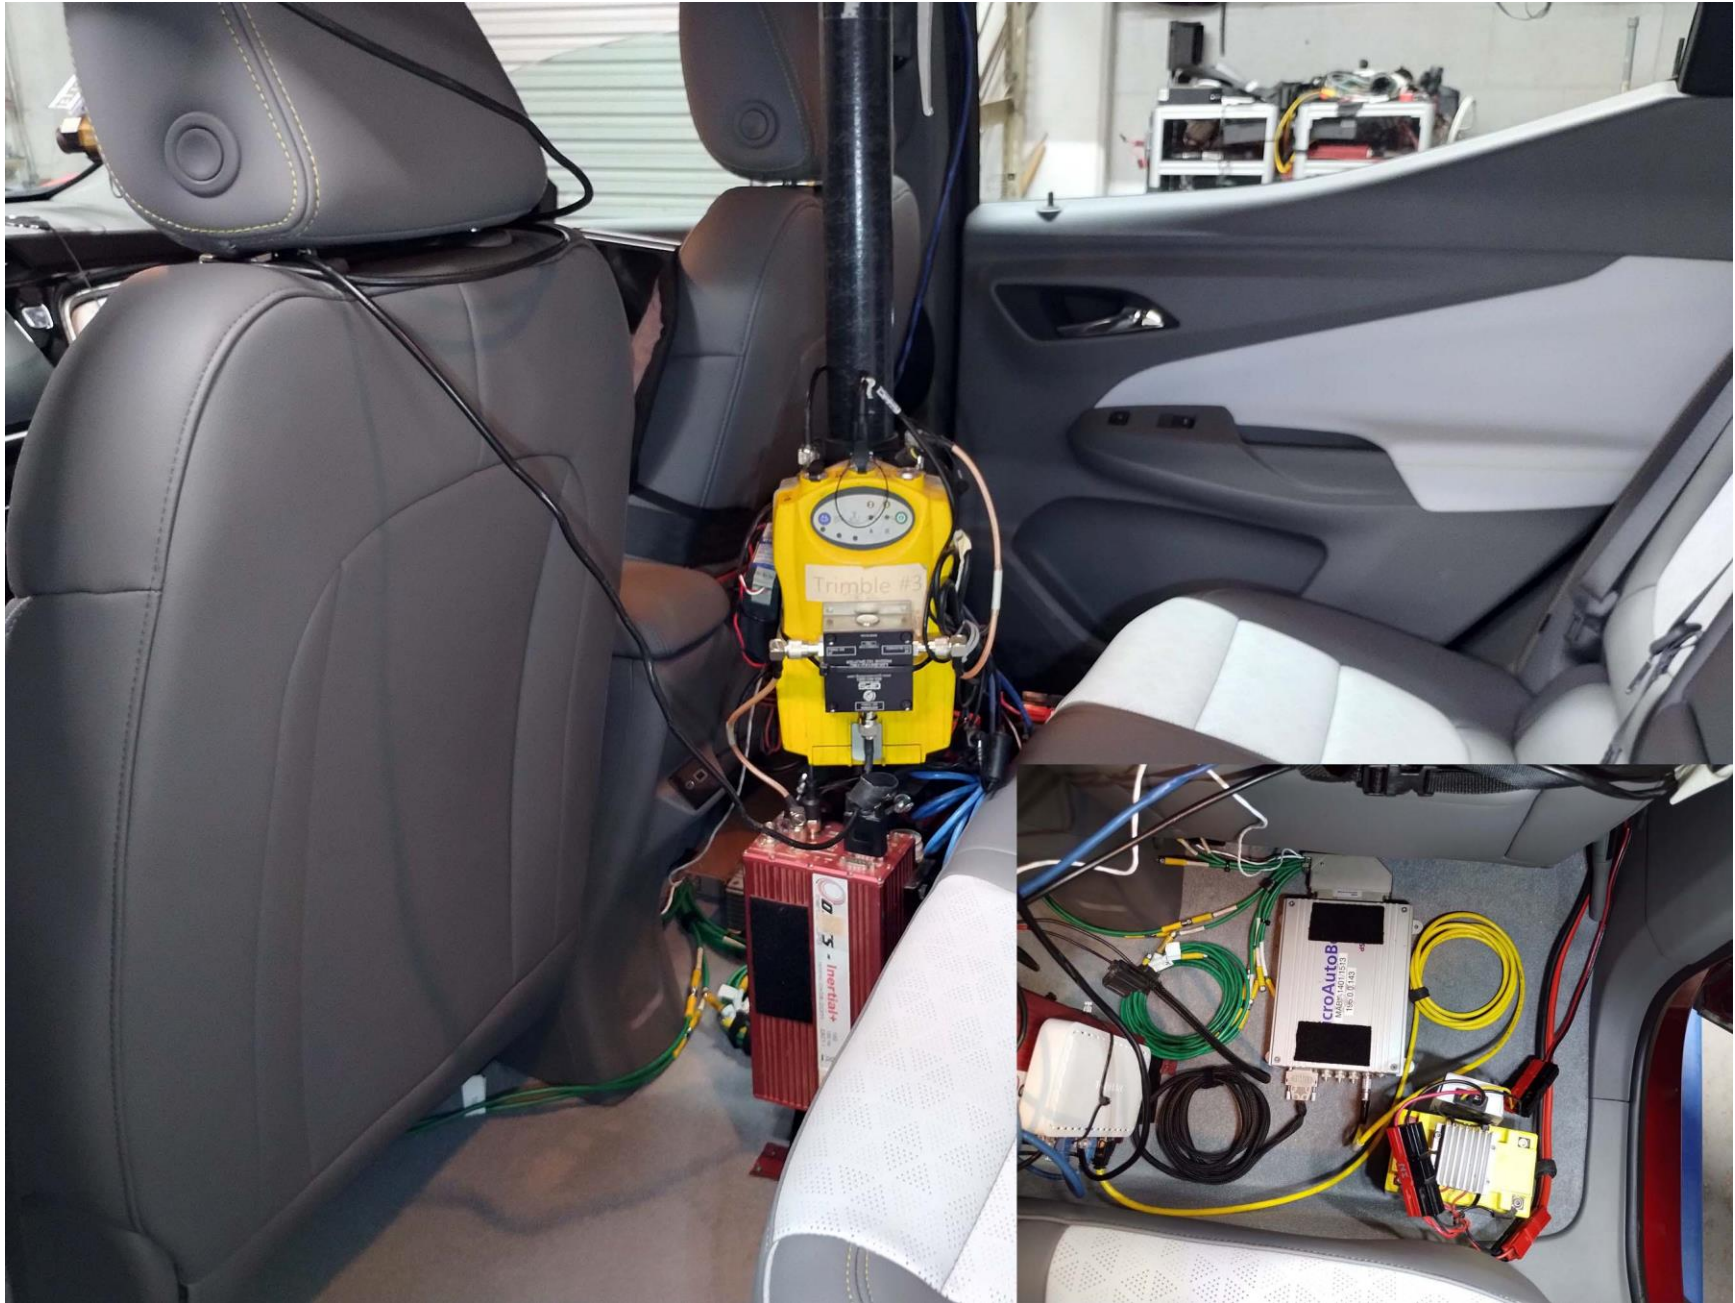
Figure A6. DGPS, Inertial Measurement Unit, and MicroAutoBox Installed in Subject Vehicle

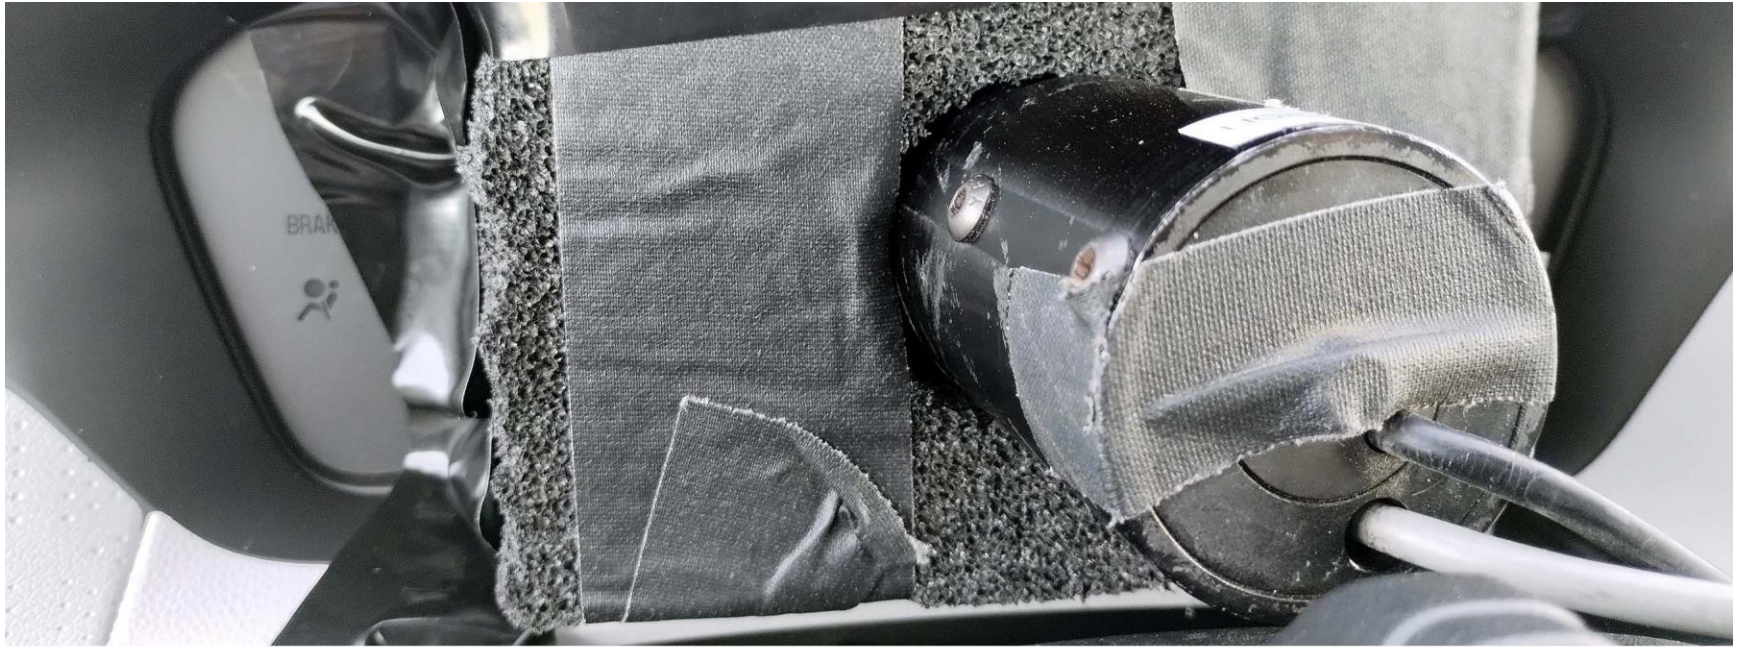
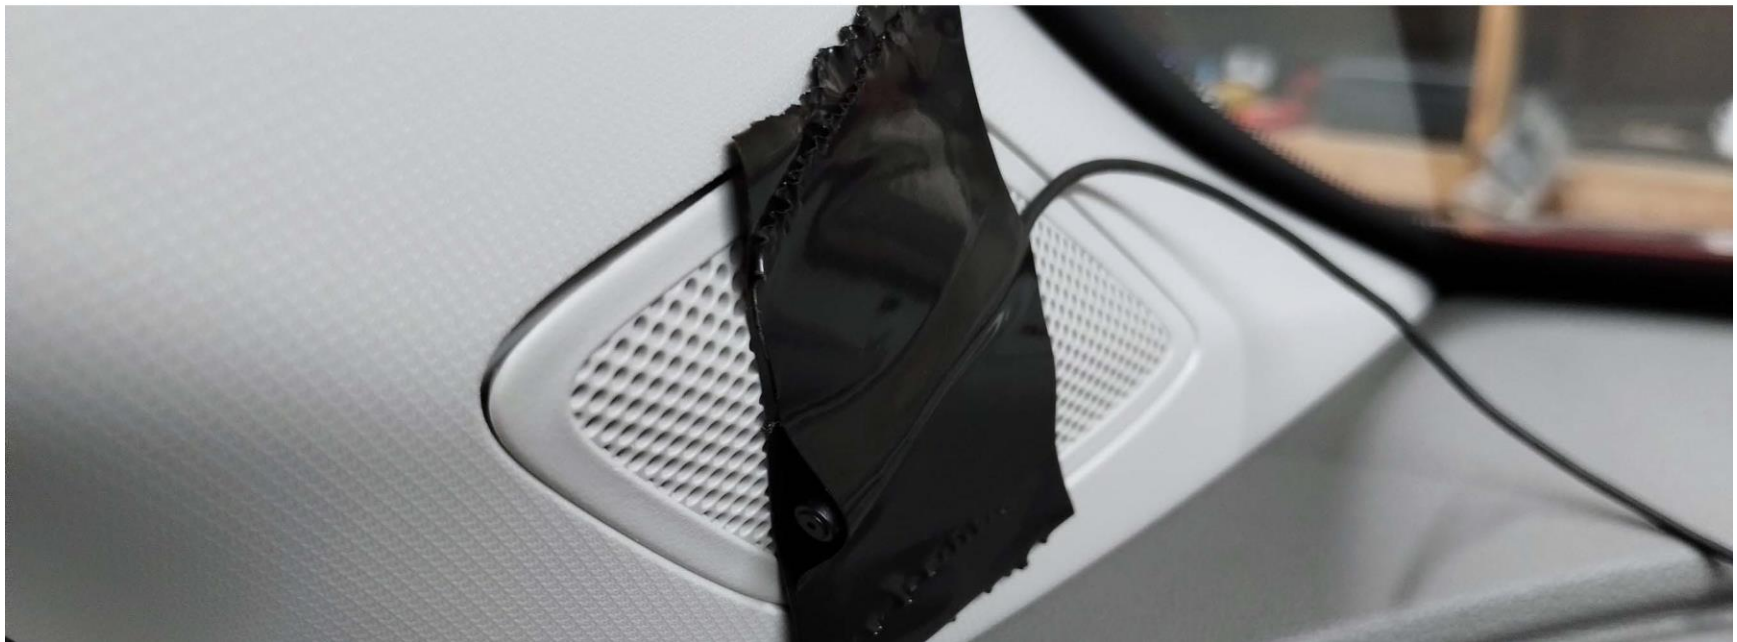
Figure A7. Sensors for Detecting Visual and Auditory Alerts

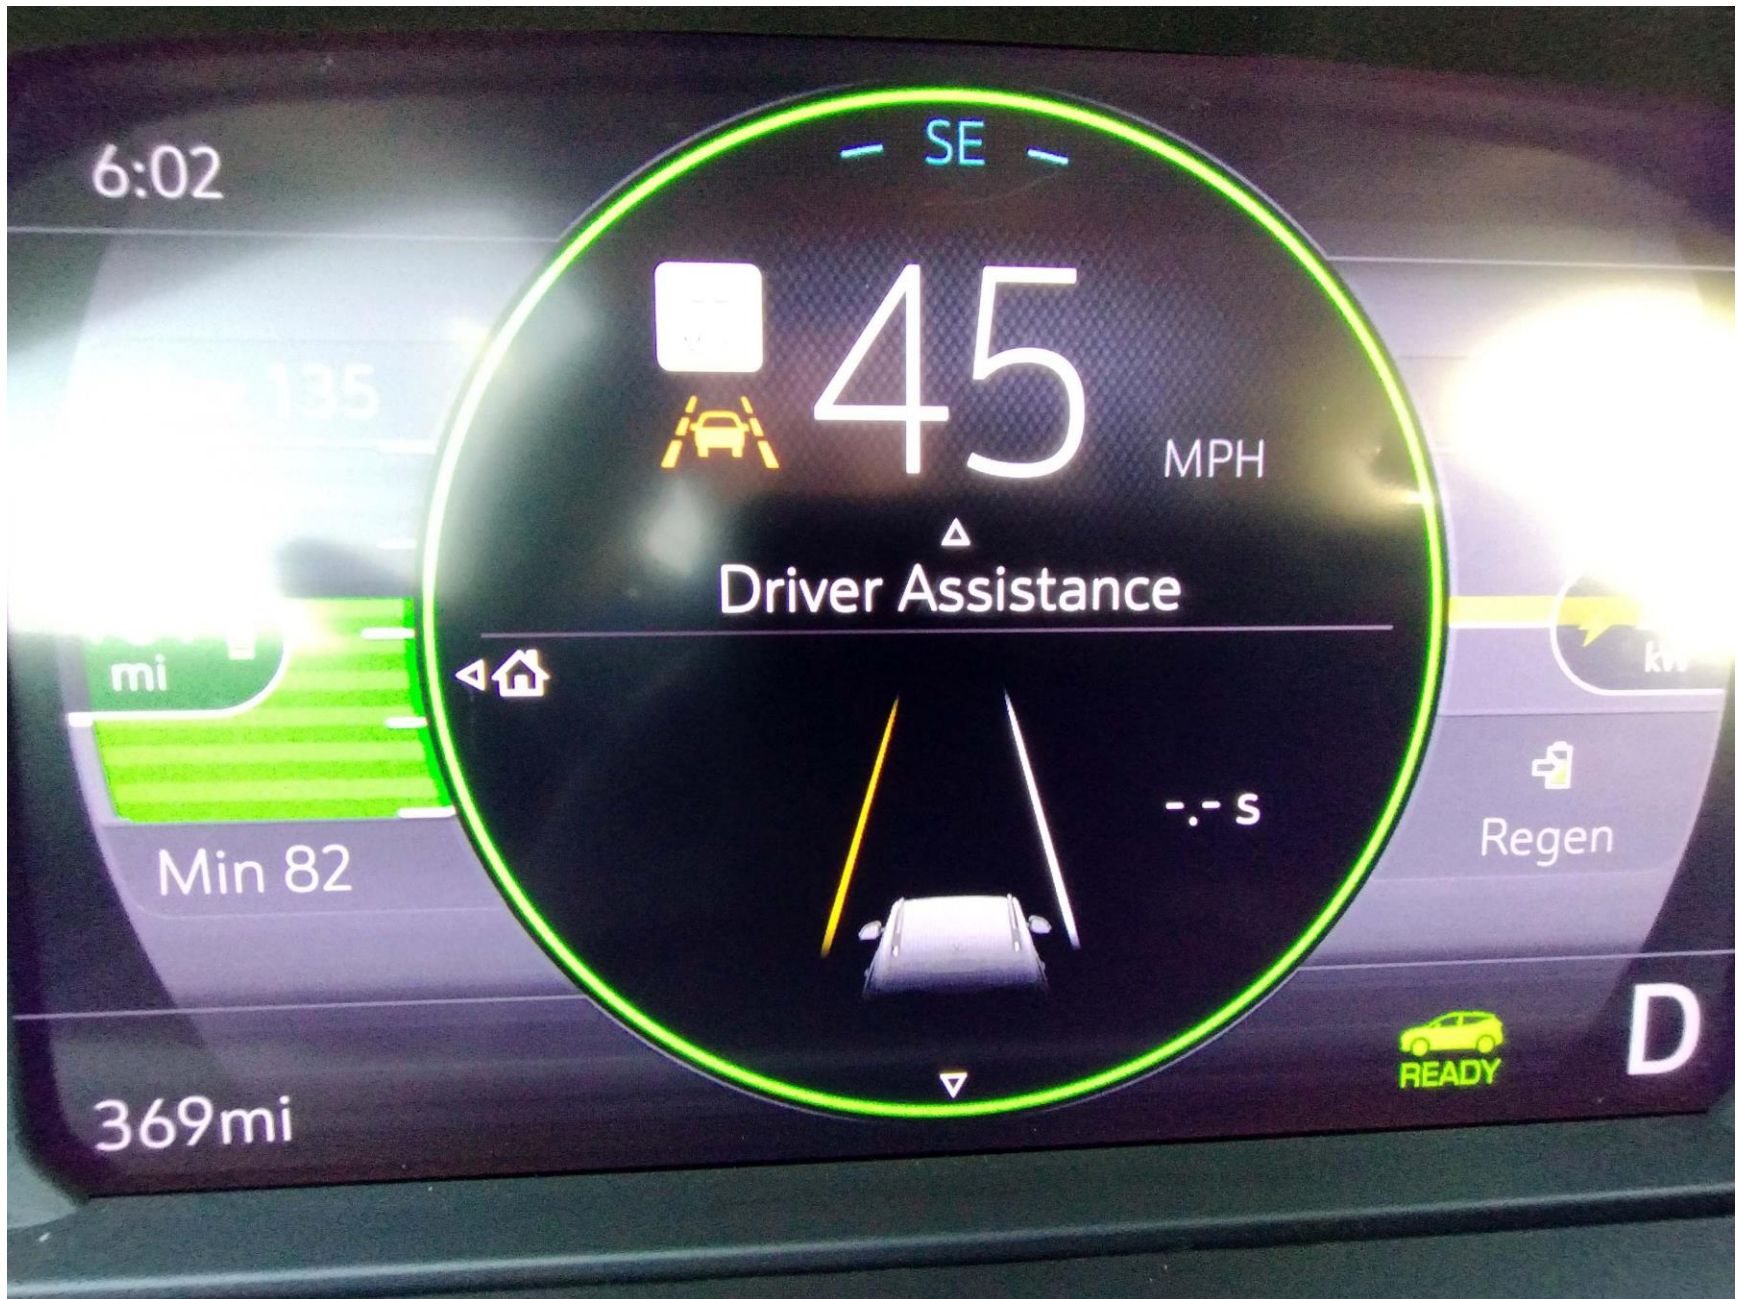
Figure A9. Visual Alert

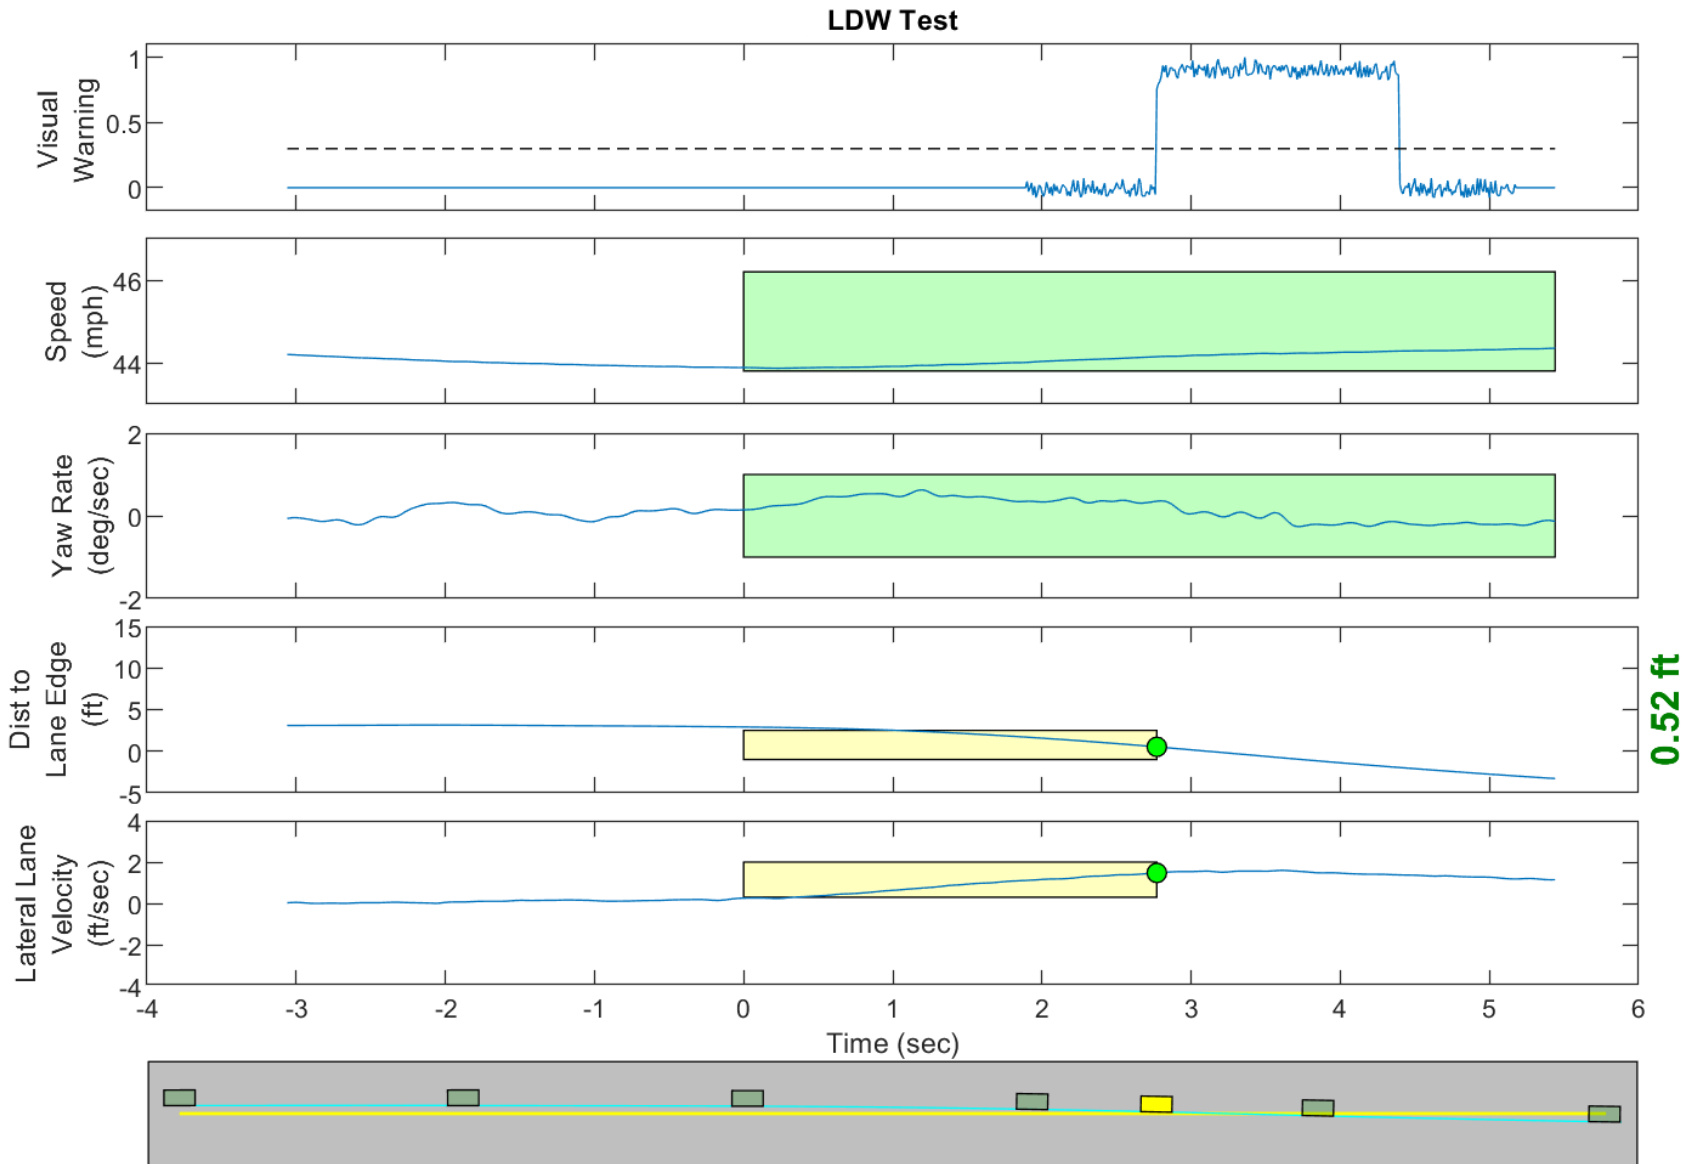
Figure D1. Example Time History for Lane Departure Warning Test, Passing

Examples of time history plots (including passing, failing and invalid runs) are shown in Figure D1 through Figure D3. Actual time history data plots for the vehicle under consideration are provided subsequently.
