NEW CAR ASSESSMENT PROGRAM FORWARD COLLISION WARNING CONFIRMATION TEST NCAP-DRI-FCW-22-05

2022 Hyundai Kona Electric

Final Report

1. Report No.	2. Government Accession No.	3. Recipient's Catalog No.		
NCAP-DRI-FCW-22-05				
4. Title and Subtitle		5. Report Date		
Final Report of Forward Collision W Hyundai Kona Electric.	arning Confirmation Test of a 2022	13 September 2022

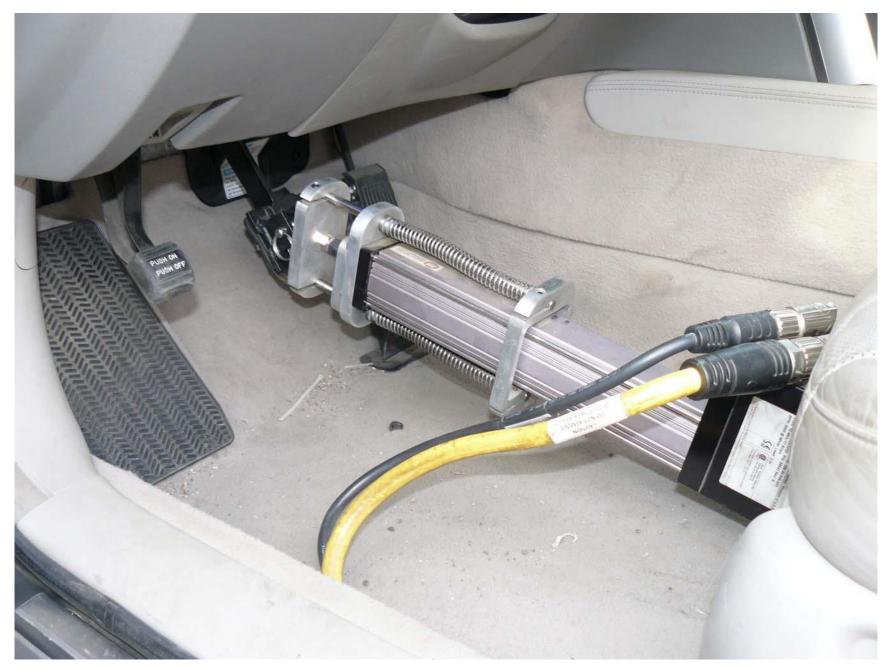
Figure A11. Brake Actuation System Installed in Principal Other Vehicle

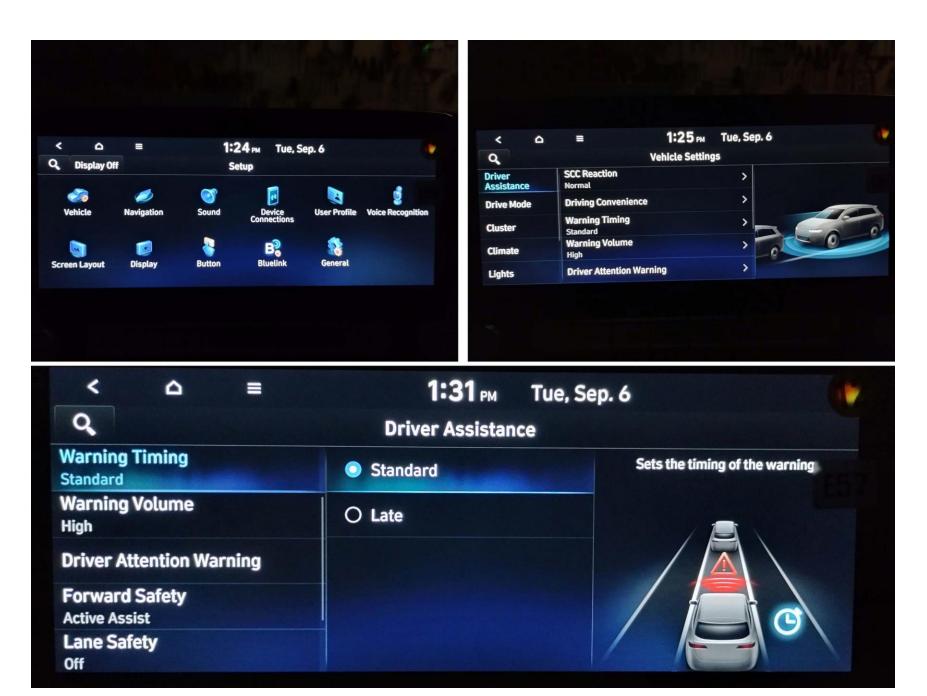
Figure A12. Menus for Adjusting FCW Timing

The warning timing setting can be adjusted using the touch screen display on the center dash. The procedure is as follows:

1. Select "Setup" to bring up the setup menu.

2. Select "Vehicle" -> "Driver Assistance" -> "Warning Timing".

3. Select between "Standard" and "Late".

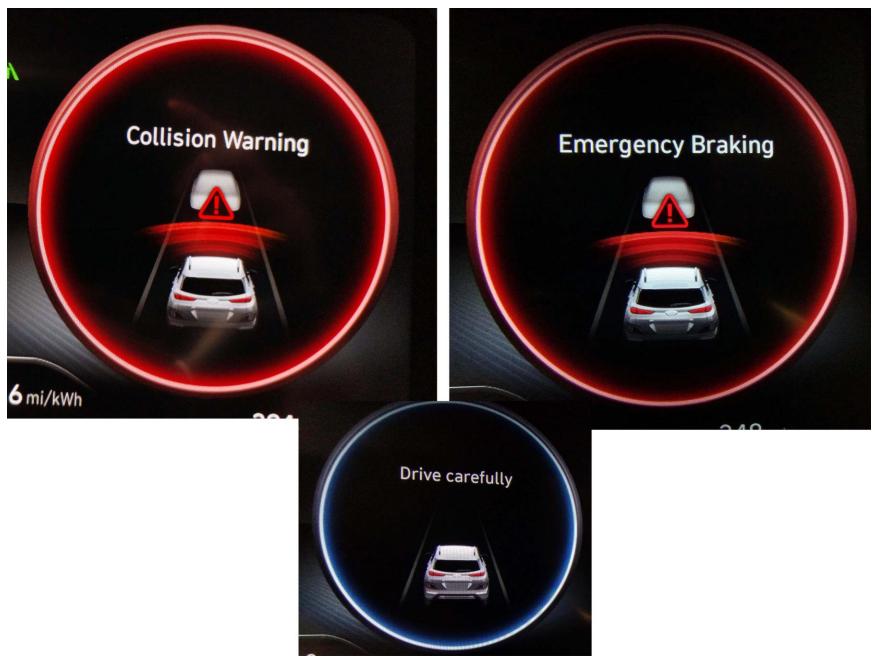
Figure A14. Visual Alert

The FCW system alerts the driver with a visual and auditory alert. The visual alert consists of an image of two vehicles between lane lines with the words "Collision Warning". The auditory alert consists of repeated beeps with a primary frequency at approximately 1515 Hz.

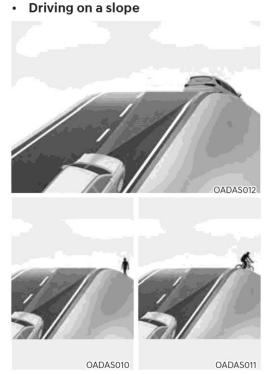
Forward Collision-Avoidance Assist may not detect other vehicles, pedestrians or cyclists in front of you while driving uphill or downhill, adversely affecting the performance of the sensors.

This may result in unnecessary warning, braking assist or steering assist (if equipped) or no warning, braking assist or steering assist (if equipped) when necessary.
