NEW CAR ASSESSMENT PROGRAM LANE DEPARTURE WARNING CONFIRMATION TEST NCAP-DRI-LDW-22-05

2022 Hyundai Kona Electric

Final Report

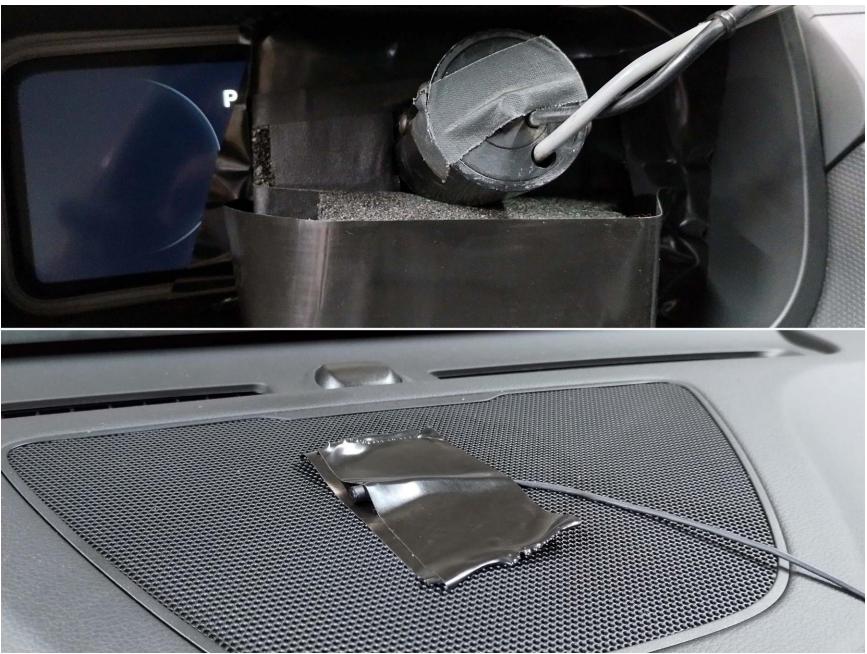
Figure A7. Sensors for Detecting Visual and Auditory Alerts

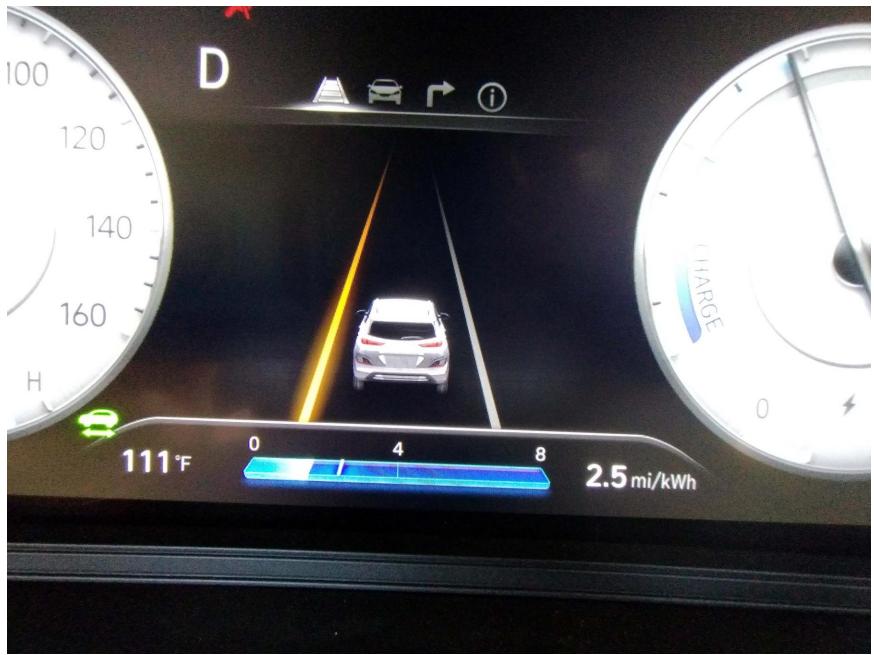
Figure A10. Visual Alert

The LDW system alerts the driver with a visual and auditory alert. The visual alert is displayed in the bottom left corner of the multi-information display and consists of a flashing green LDW icon. If the driver assistance display is selected, an image of a vehicle between lane lines is shown. The lane line corresponding to the lane marking the subject vehicle approaches turns from white to green. The auditory alert consists of a set of three consecutive beeps with a primary frequency at approximately 750 Hz.
