**NEW CAR ASSESSMENT PROGRAM  
CRASH IMMINENT BRAKING SYSTEM CONFIRMATION TEST  
NCAP-DRI-CIB-22-07**

**2022 Hyundai Kona Electric**

**Final Report**

1. Report No. NCAP-DRI-CIB-22-07	2. Government Accession No.	3. Recipient's Catalog No.	
4. Title and Subtitle Final Report of Crash Imminent Braking System Confirmation Test of a 2022 Hyundai Kona Electric.		5. Report Date 13 September 2022

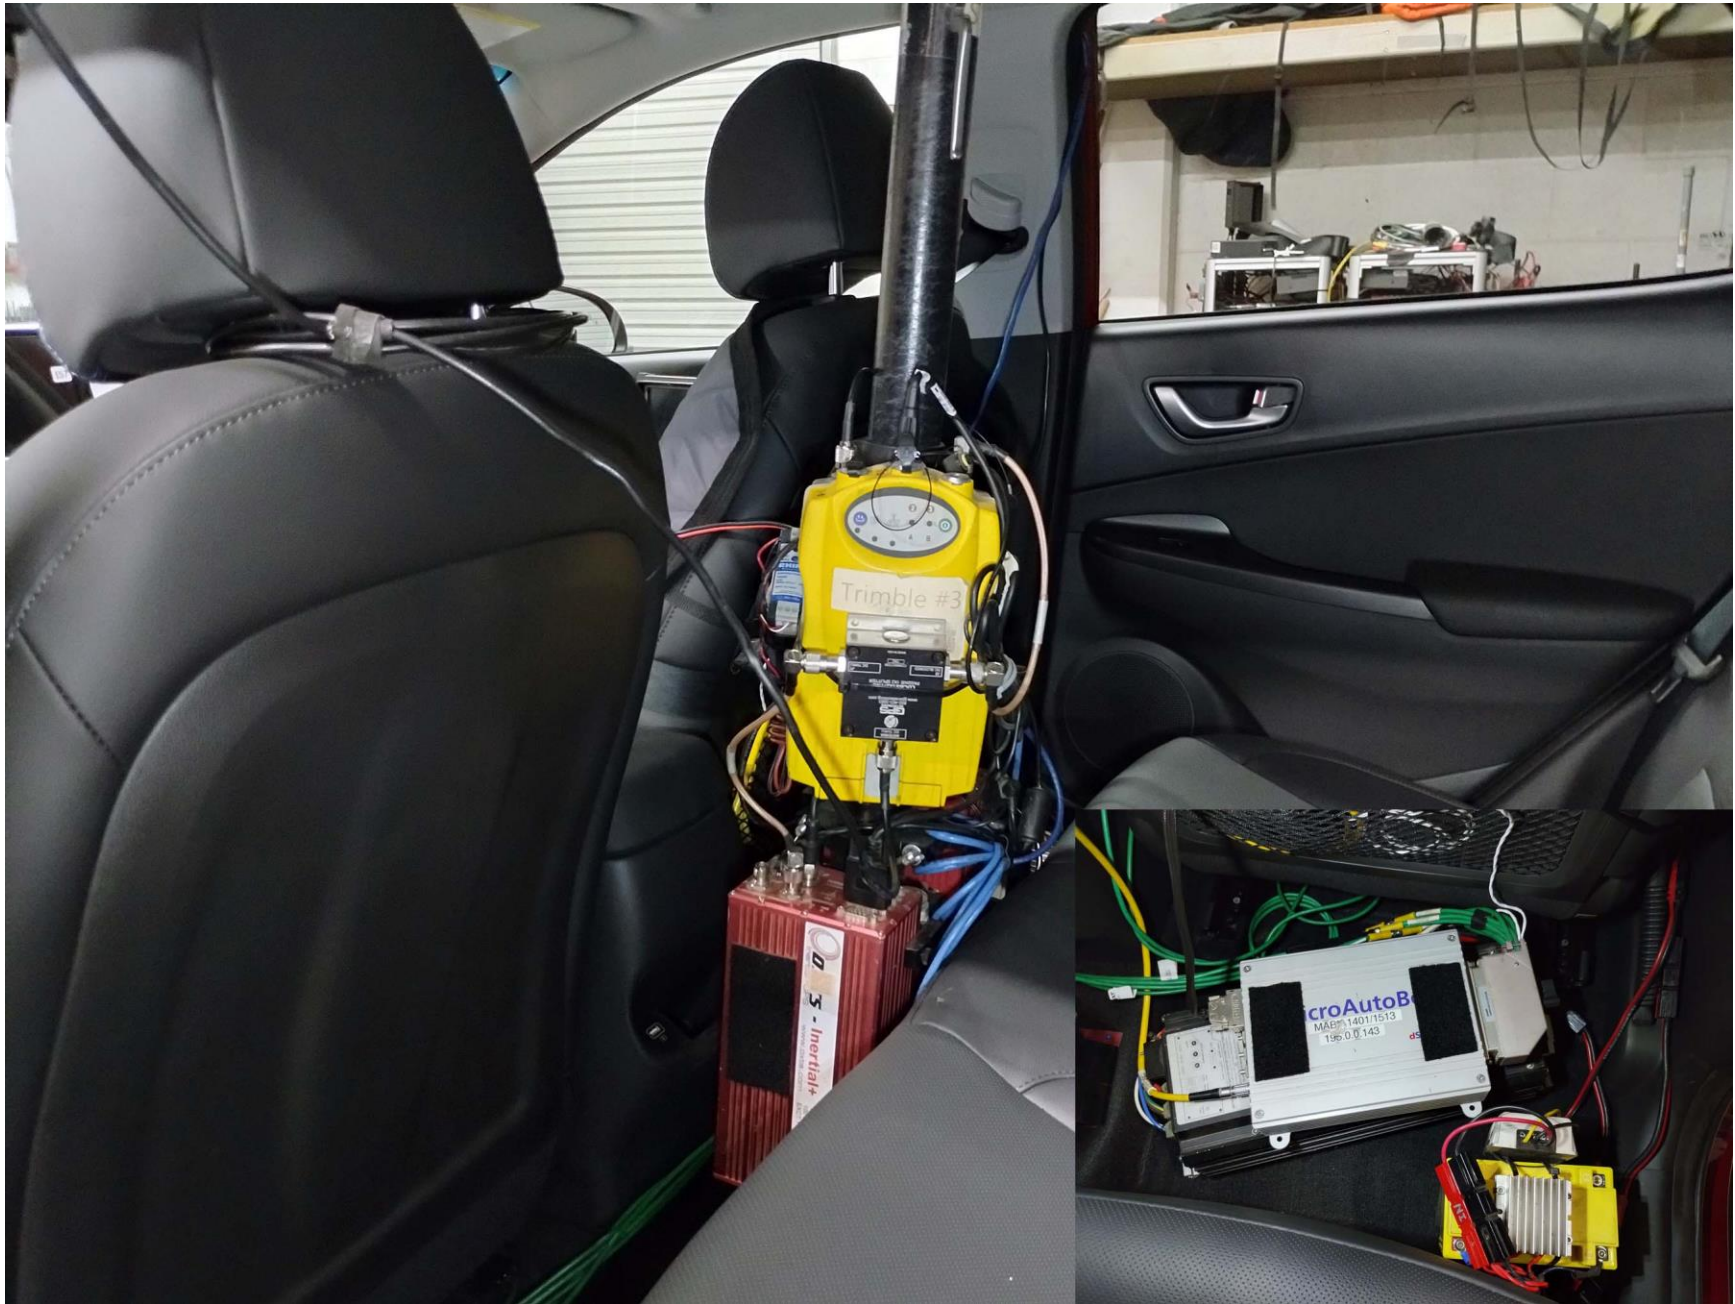
Figure A10. DGPS, Inertial Measurement Unit, and MicroAutoBox Installed in Subject Vehicle

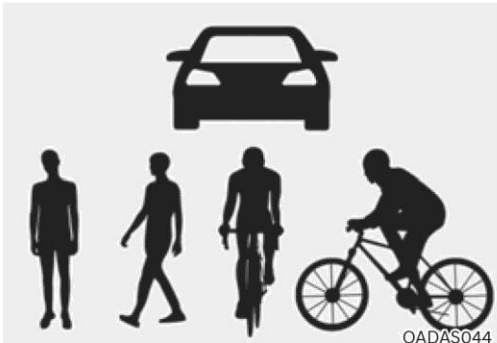
The illustration above shows the image the front view camera and front radar is capable of detecting as a vehicle, pedestrian and cyclist.

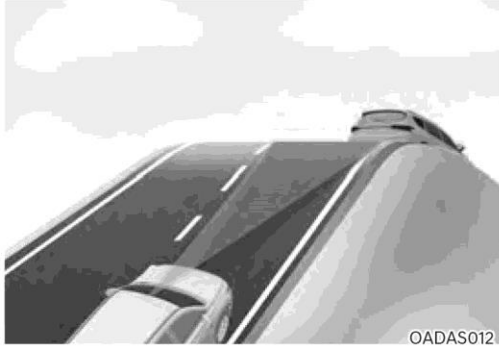
**Forward Collision-Avoidance Assist may not detect other vehicles, pedestrians or cyclists in front of you while driving uphill or downhill, adversely affecting the performance of the sensors.**

**This may result in unnecessary warning, braking assist or steering assist (if equipped) or no warning, braking assist or steering assist (if equipped) when necessary.**

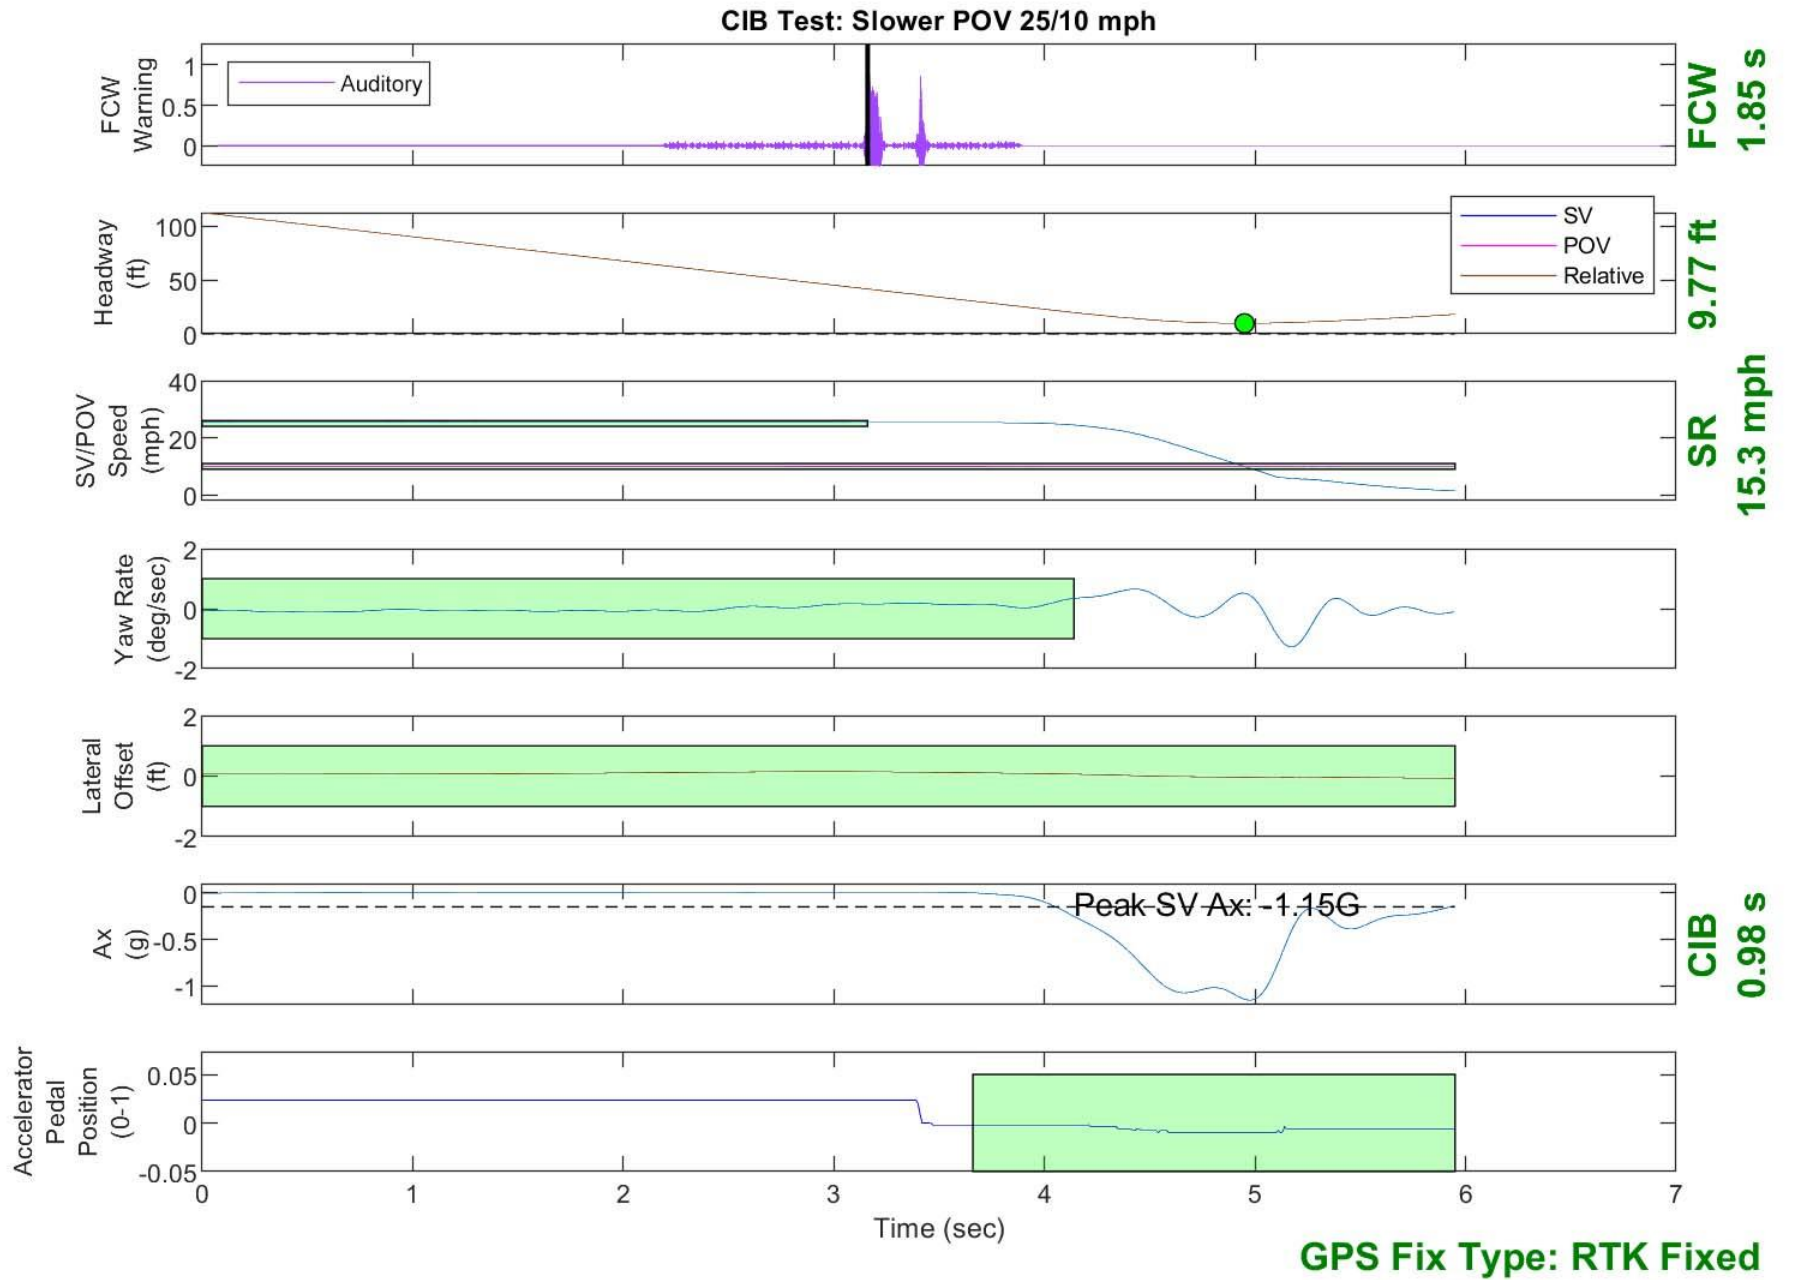
Figure D2. Example Time History for Slower POV 25 vs. 10, Passing

Examples of time history plots for each test type (including passing, failing and invalid runs) are shown in Figure D1 through Figure D9. Figures D1 through D6 show passing runs for each of the 6 test types. Figures D7 and D8 show examples of invalid runs. Figure D9 shows an example of a valid test that failed the CIB requirements.

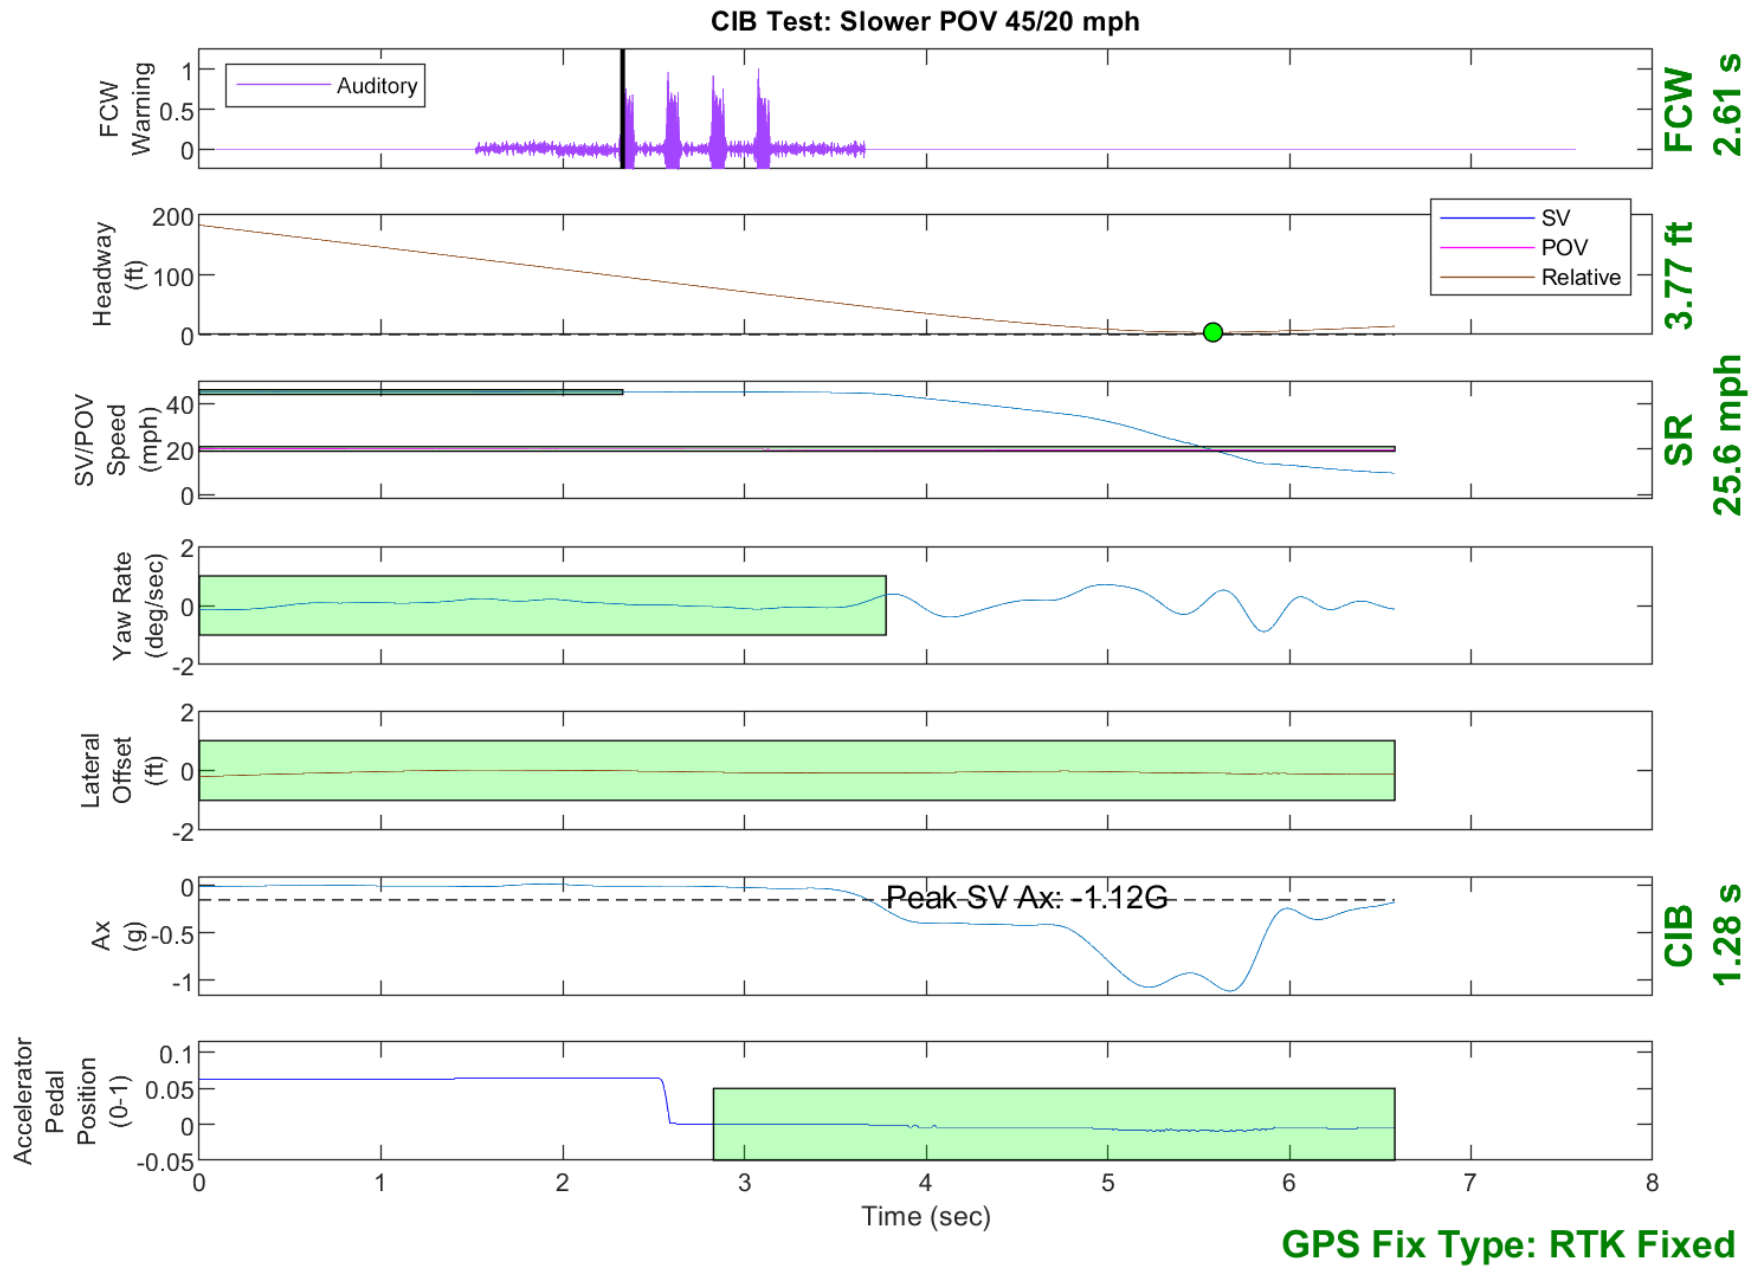
Figure D3. Example Time History for Slower POV 45 vs. 20, Passing

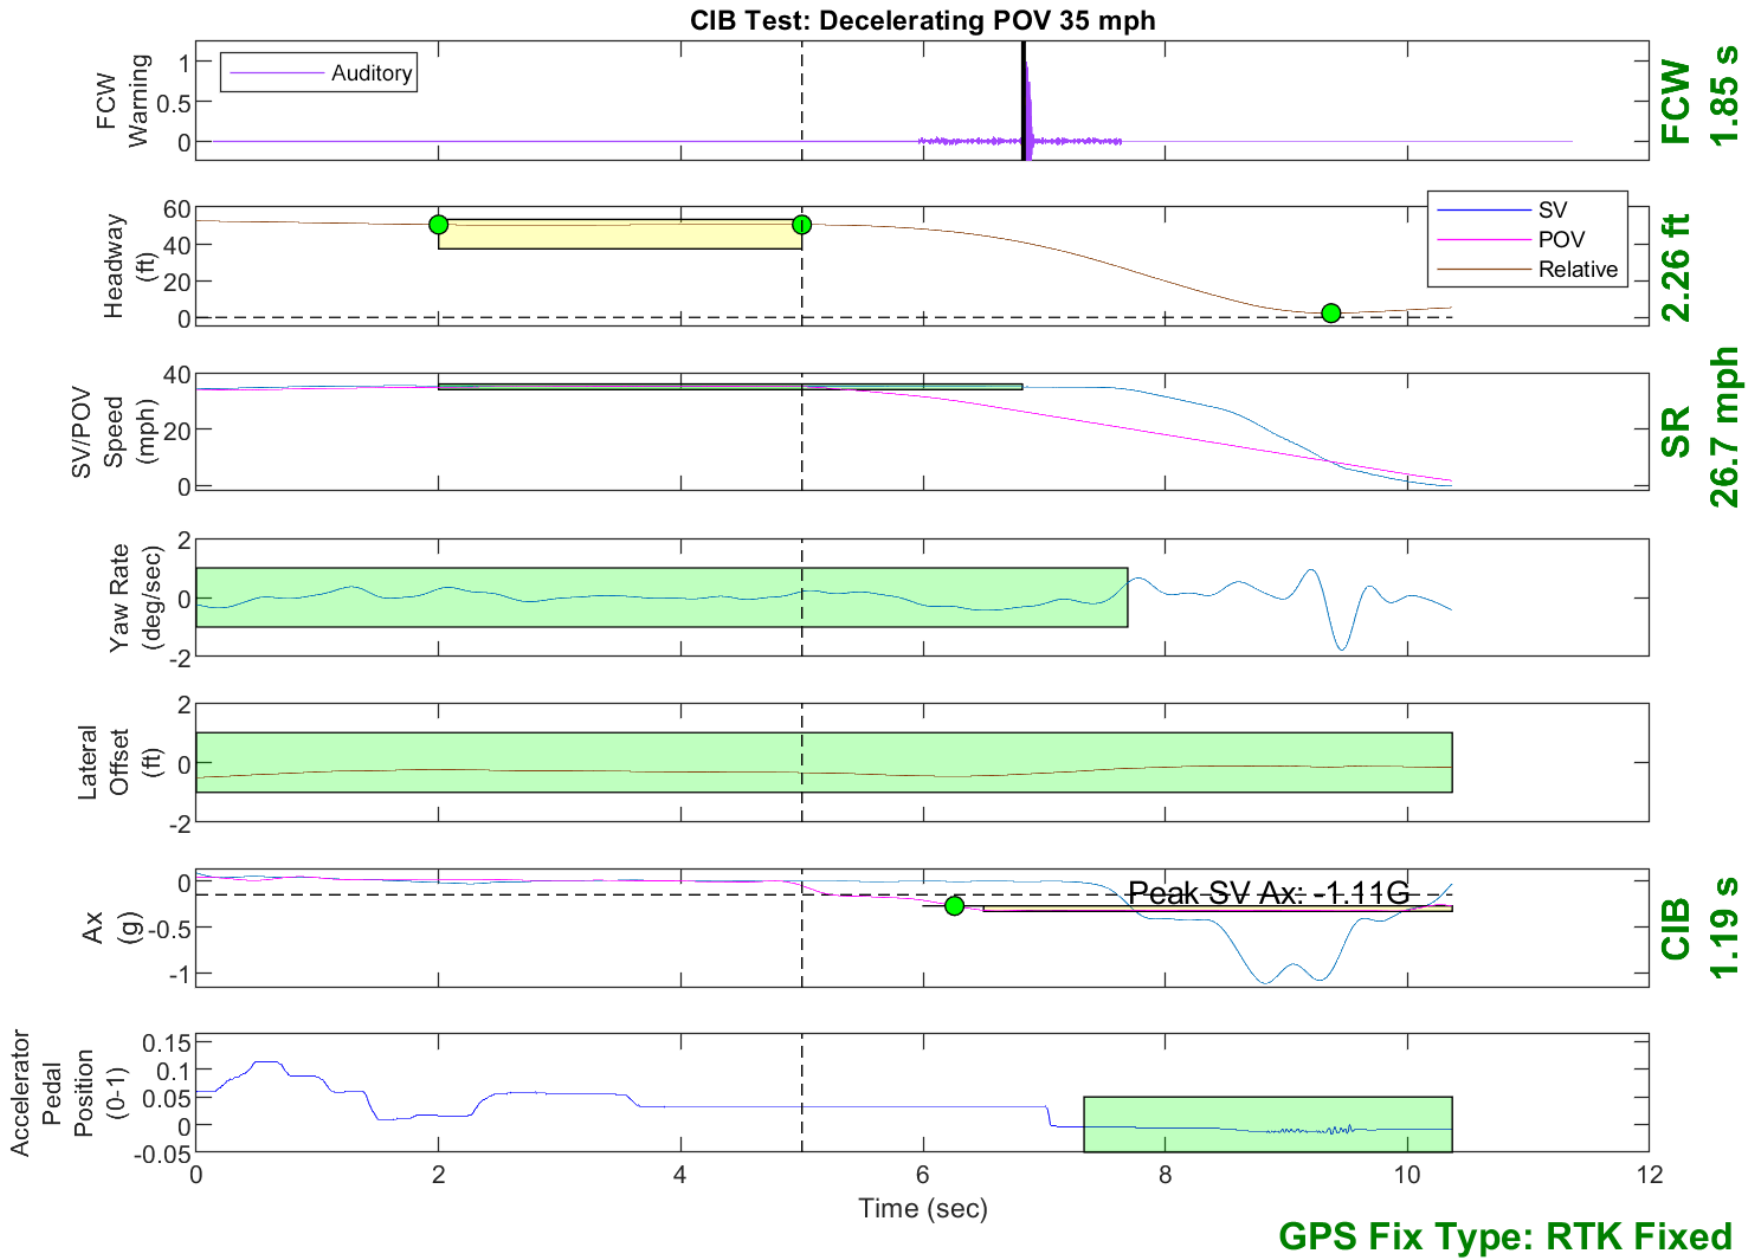
Figure D4. Example Time History for Decelerating POV 35, Passing

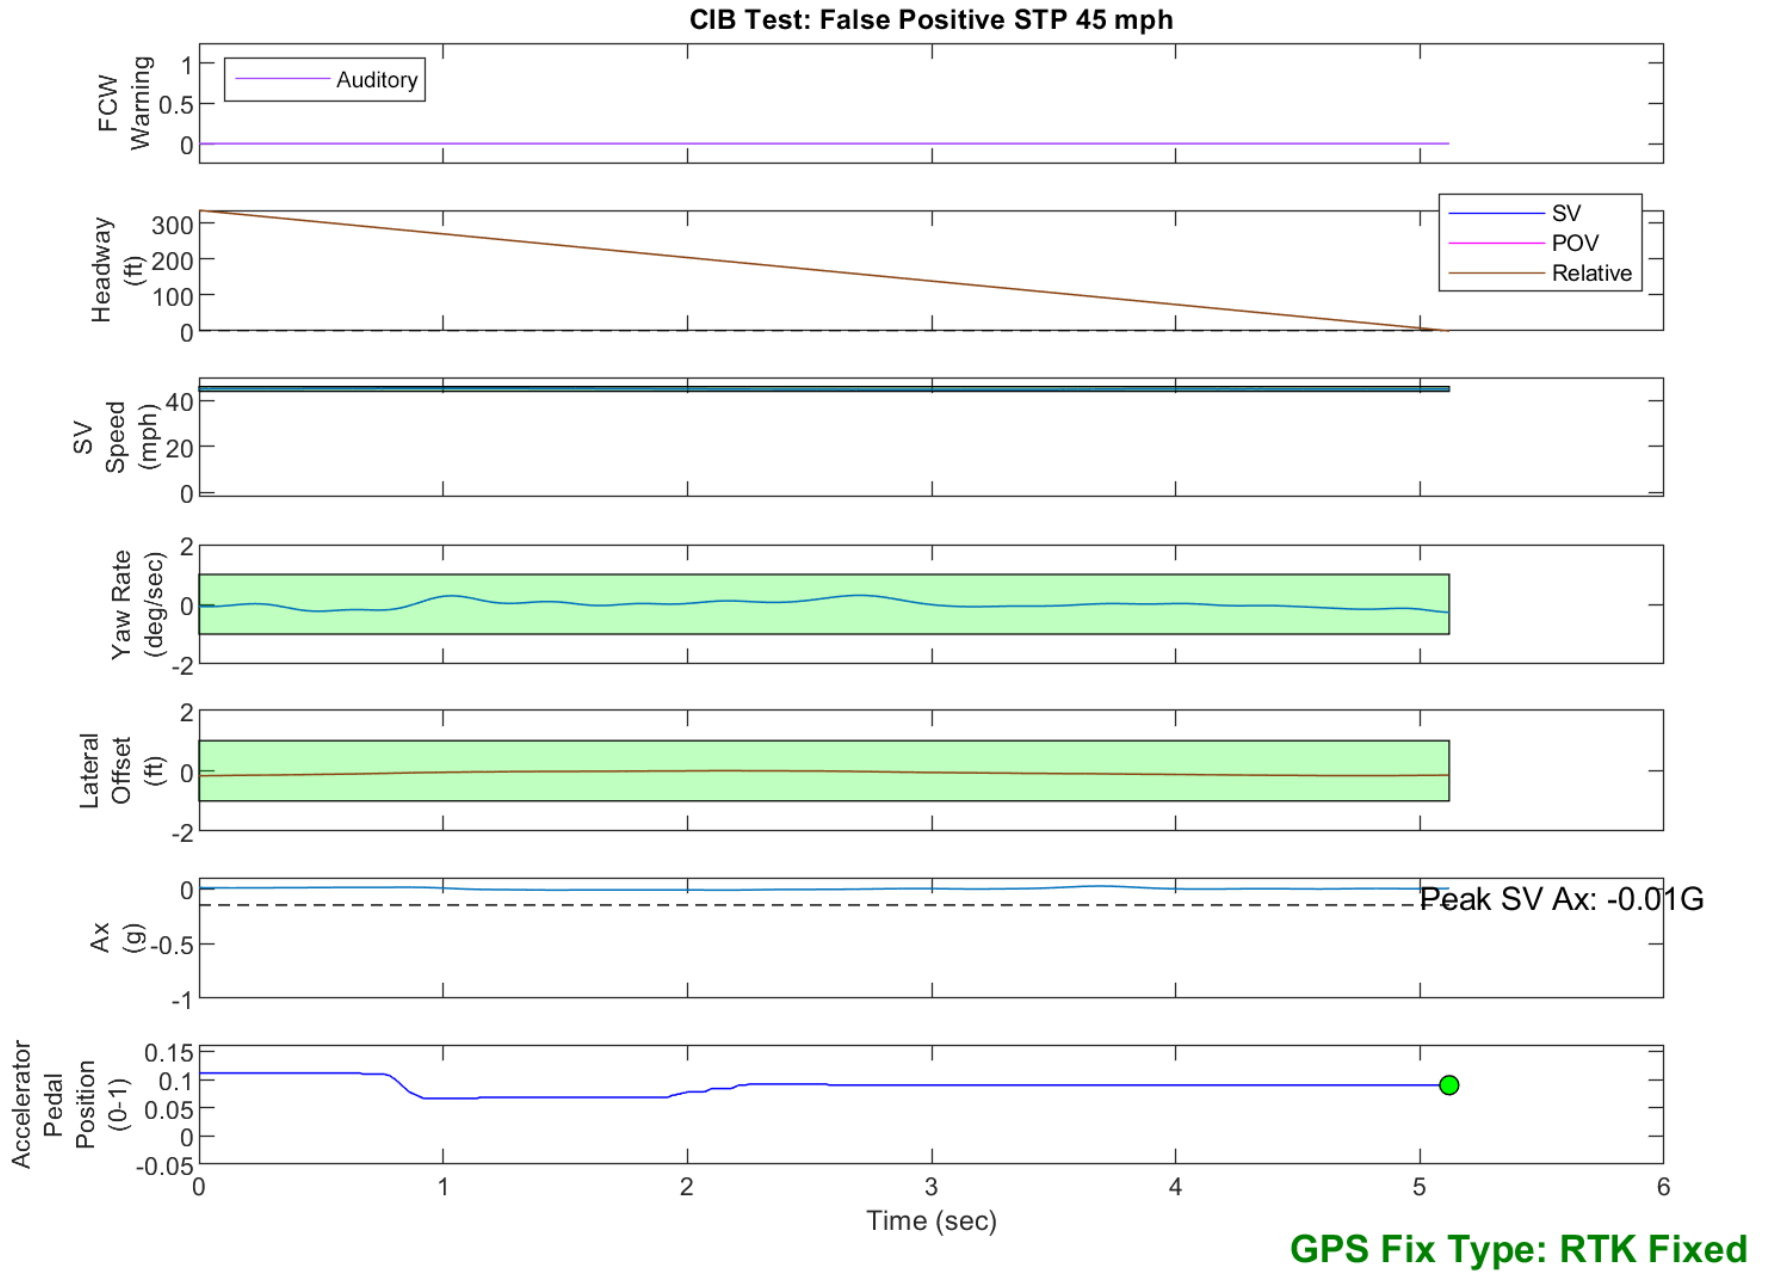
Figure D6. Example Time History for False Positive STP 45, Passing

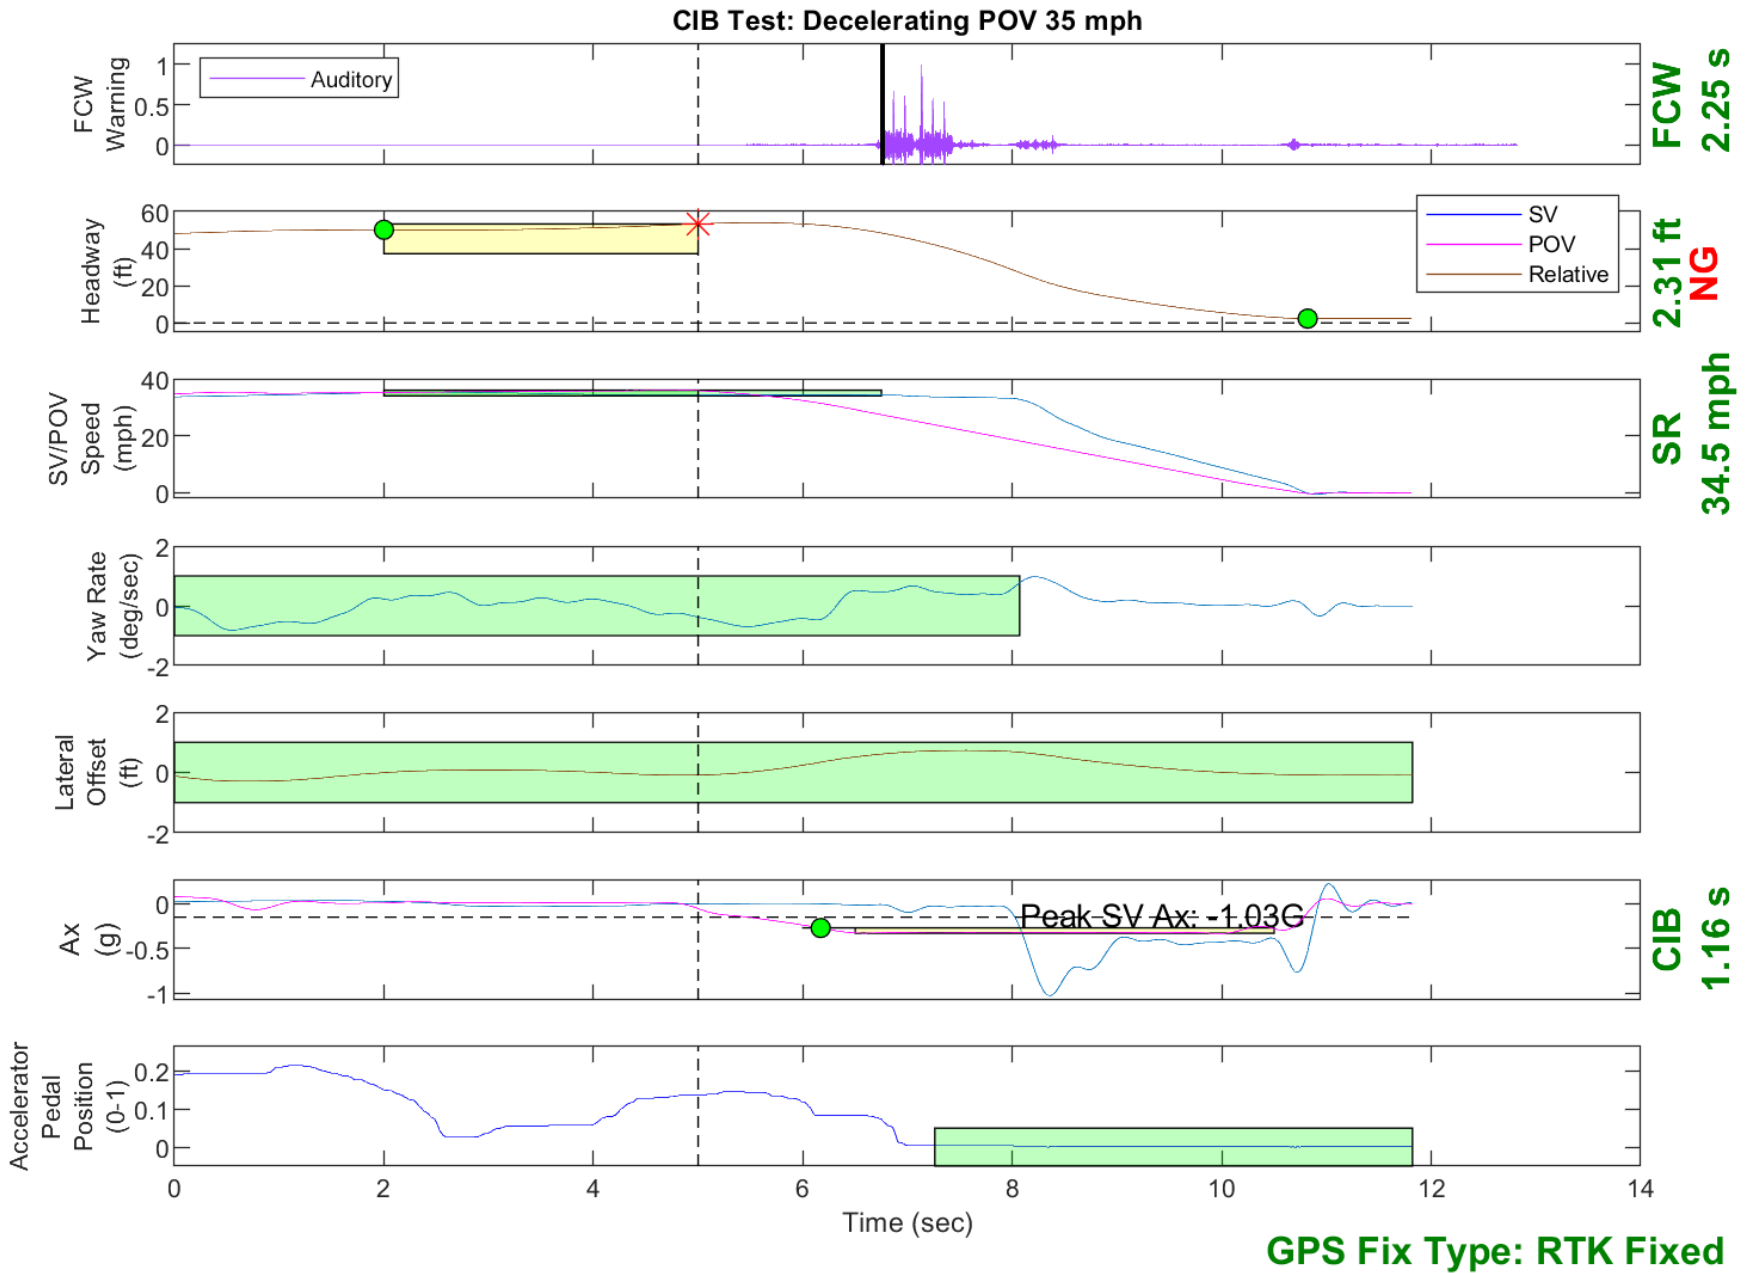
Figure D7. Example Time History Displaying Invalid Headway Criteria
