REPORT NUMBER: SPNCAP-CAL-19-007

NEW CAR ASSESSMENT PROGRAM (NCAP)
SIDE IMPACT POLE TEST

General Motors LLC
2019 Chevrolet Cruze
Four Door Sedan

NHTSA No: M20190115

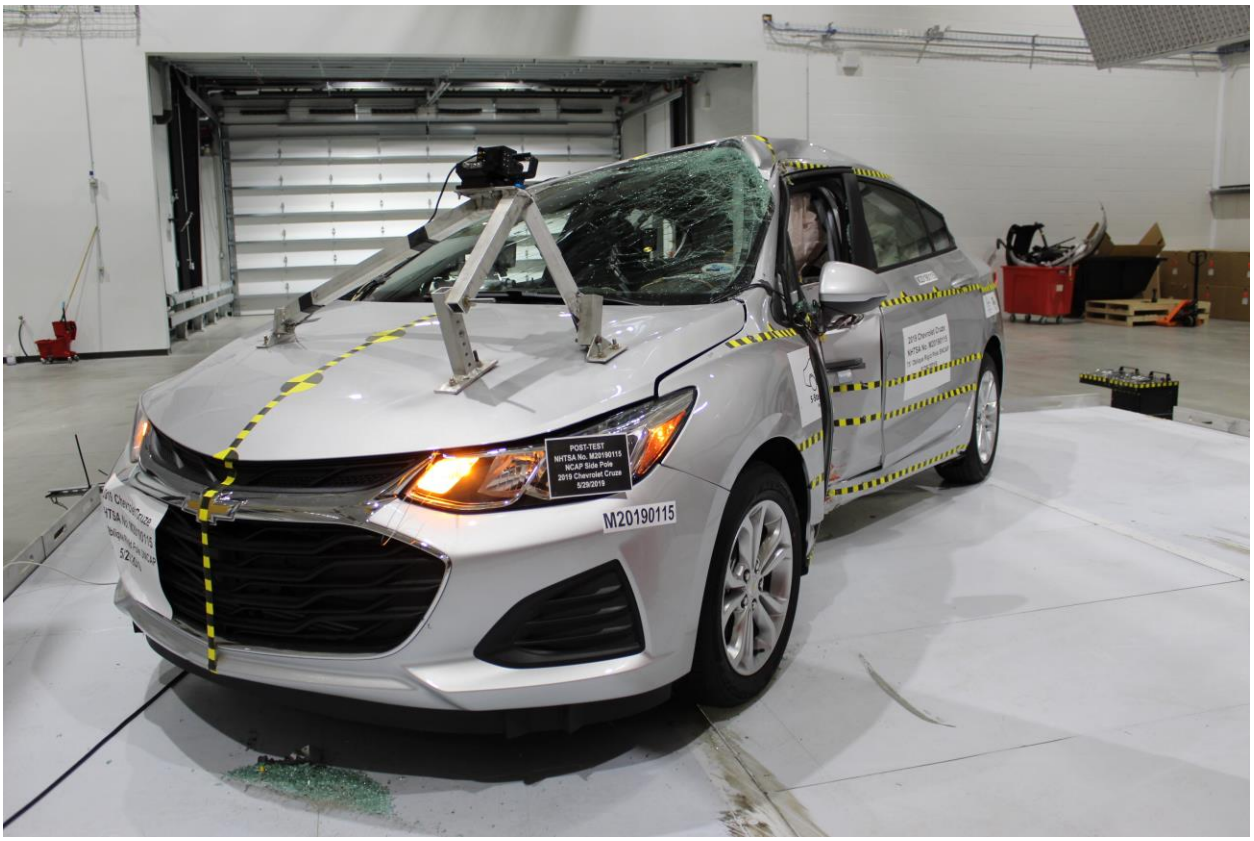
Figure A-6: Post-Test Left Front ¾ View of Test Vehicle

Critical Areas of Performance	Observations and Conclusions
Pillar Performance	A-Pillar Buckled
Sill Separation	None
Windshield Damage	Cracks throughout with some separation along drive A-Pillar
Side Window Damage	Driver window shattered during impact
Other Notable Effects	None
