REPORT NUMBER: NCAP-KAR-19-028

NEW CAR ASSESSMENT PROGRAM (NCAP)
FRONTAL BARRIER IMPACT TEST

HONDA OF AMERICA MFG., INC.
2019 HONDA CR-V AWD LX 5-DOOR MPV

FINAL REPORT

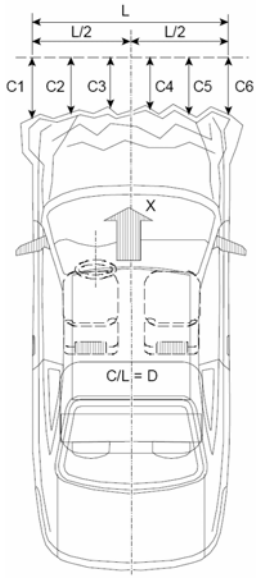
Midpoint of Damage: Vehicle Centerline

Damage Region Length (mm): 1318

No.	Measurement Description	Units	Pre-Test	Post-Test	Difference
C1	Crush Zone 1 at Left Side	mm	150	380	230
C2	Crush Zone 2 at Left Side	mm	40	360	320
C3	Crush Zone 3 at Left Side	mm	0	330	330
C4	Crush Zone 4 at Right Side	mm	0	330	330
C5	Crush Zone 5 at Right Side	mm	40	390	350
C6	Crush Zone 6 at Right Side	mm	150	400	250
L	C1 to C6	mm	1318

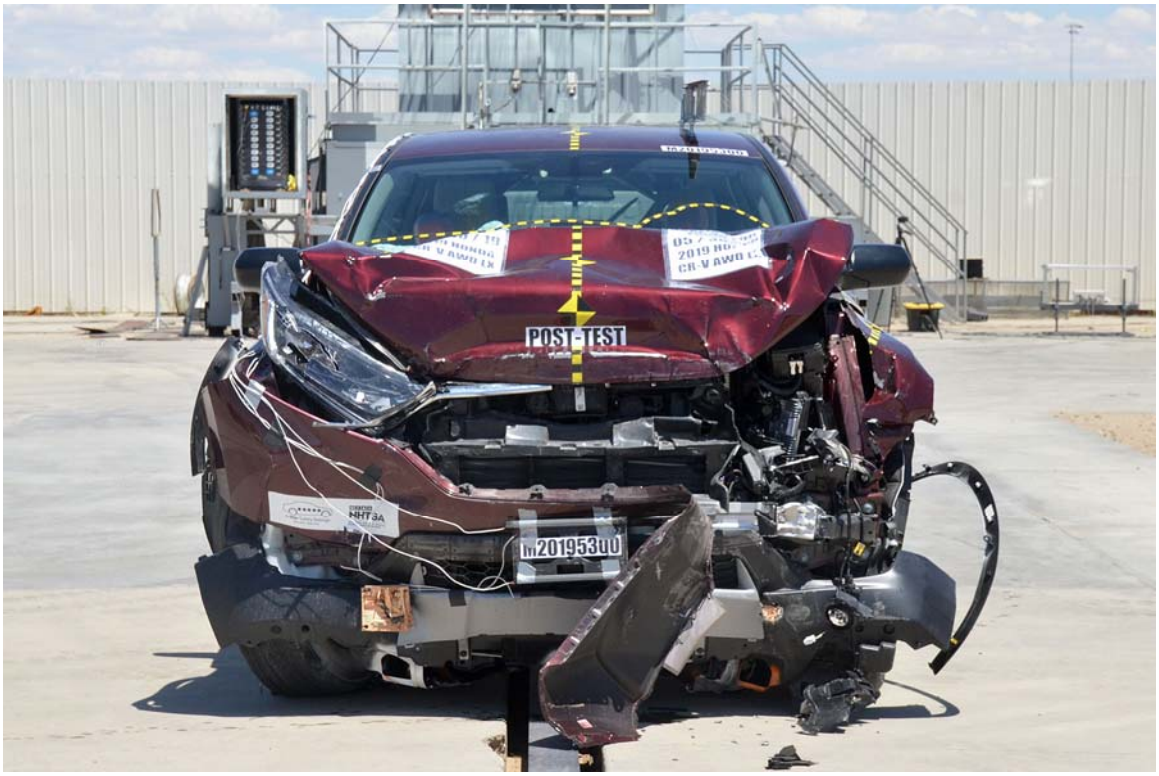
The maximum static crush was 350 mm at DPD 5 right of the vehicle's centerline. Both the driver and passenger side doors remained closed during the impact event and were operable after the impact.

FIGURE 9. Post-Test Front View of Test Vehicle
