REPORT NUMBER: SPNCAP-CAL-20-004

NEW CAR ASSESSMENT PROGRAM (NCAP)
SIDE IMPACT POLE TEST

Mazda Motor Manufacturing de Mexico S.A. de C.V.
2020 Mazda CX-30
SUV

NHTSA No: M20205401

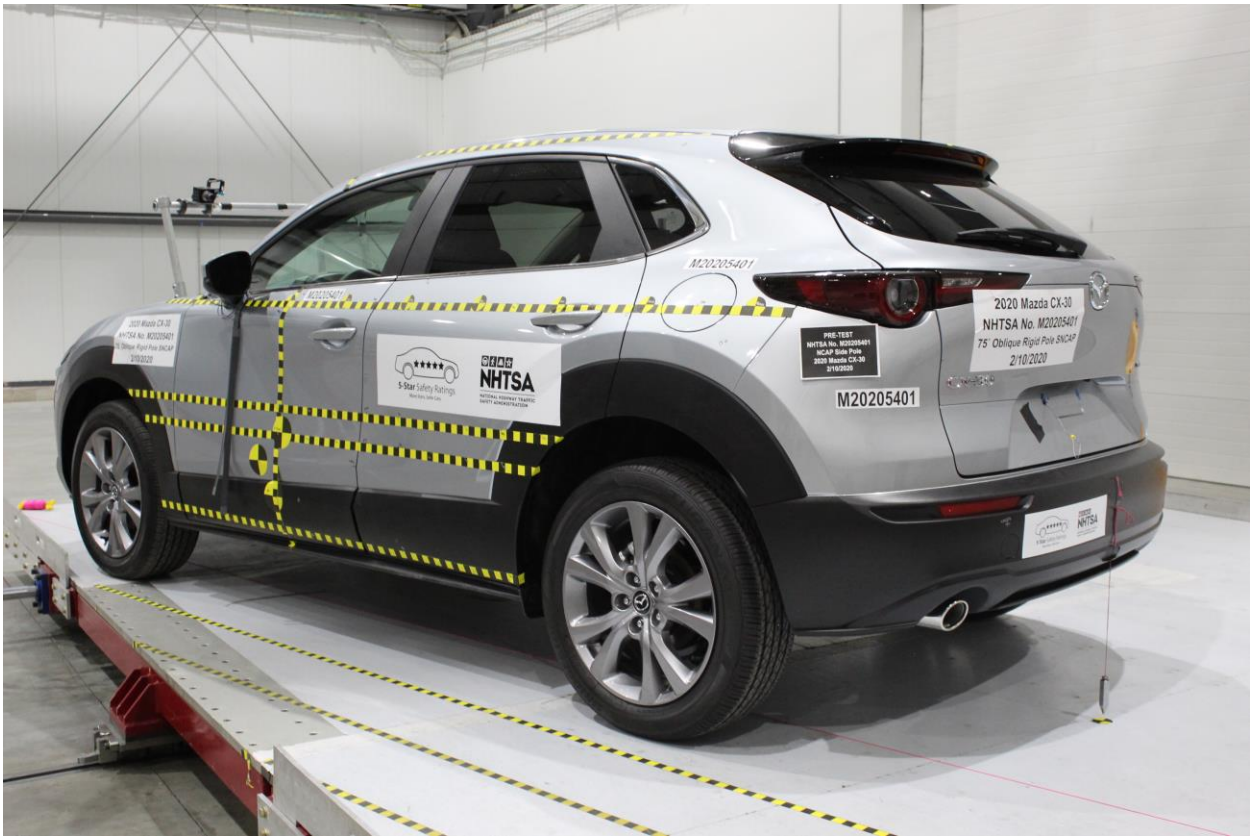
Figure A-8: Post-Test Left Side View of Test Vehicle

Critical Areas of Performance	Observations and Conclusions
Pillar Performance	A-Pillar and C-Pillar Buckled
Sill Separation	None
Windshield Damage	Cracks throughout with separation along A-Pillar
Side Window Damage	Driver window shattered
Other Notable Effects	None
