REPORT NUMBER: SPNCAP-CAL-20-010

NEW CAR ASSESSMENT PROGRAM (NCAP)
SIDE IMPACT POLE TEST

FCA US LLC
2020 Chrysler Pacifica Hybrid
5 Door Minivan

NHTSA No: M20200302

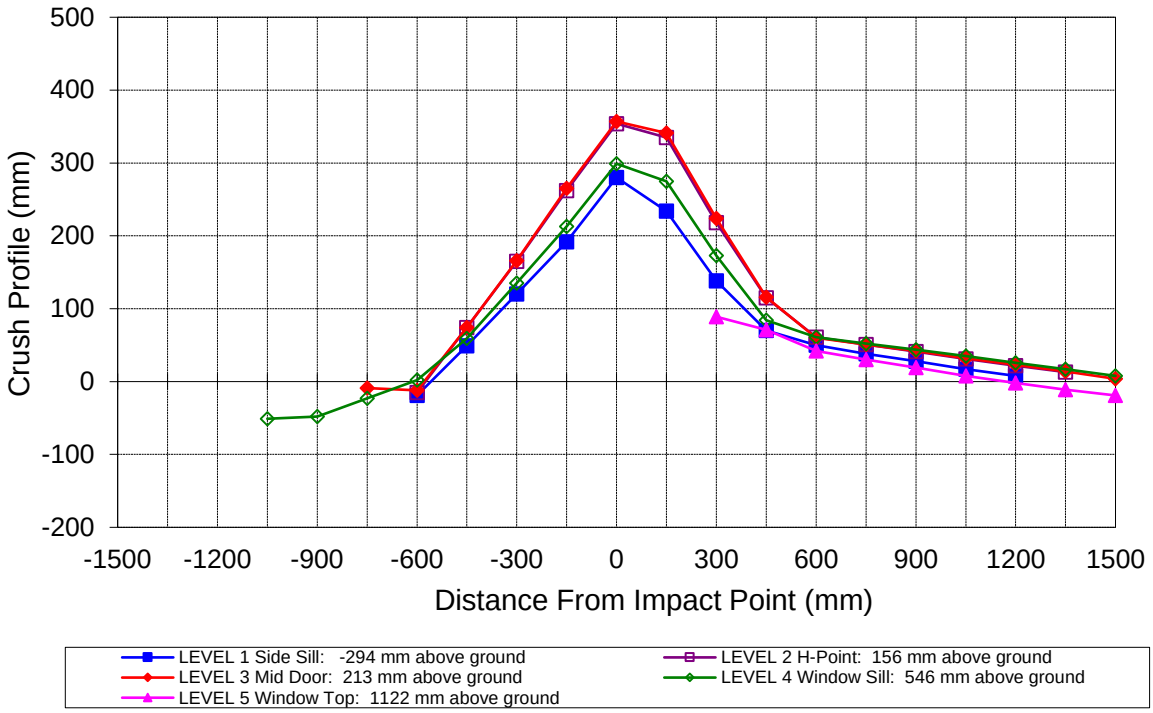
Vehicle Exterior Crush Measurements - Visual Representation

Critical Areas of Performance	Observations and Conclusions
Pillar Performance	A-Pillar Buckled
Sill Separation	None
Windshield Damage	Cracks throughout with separation along A-pillar and roof
Side Window Damage	Driver window cracked throughout
Other Notable Effects	Windshield separation along roof

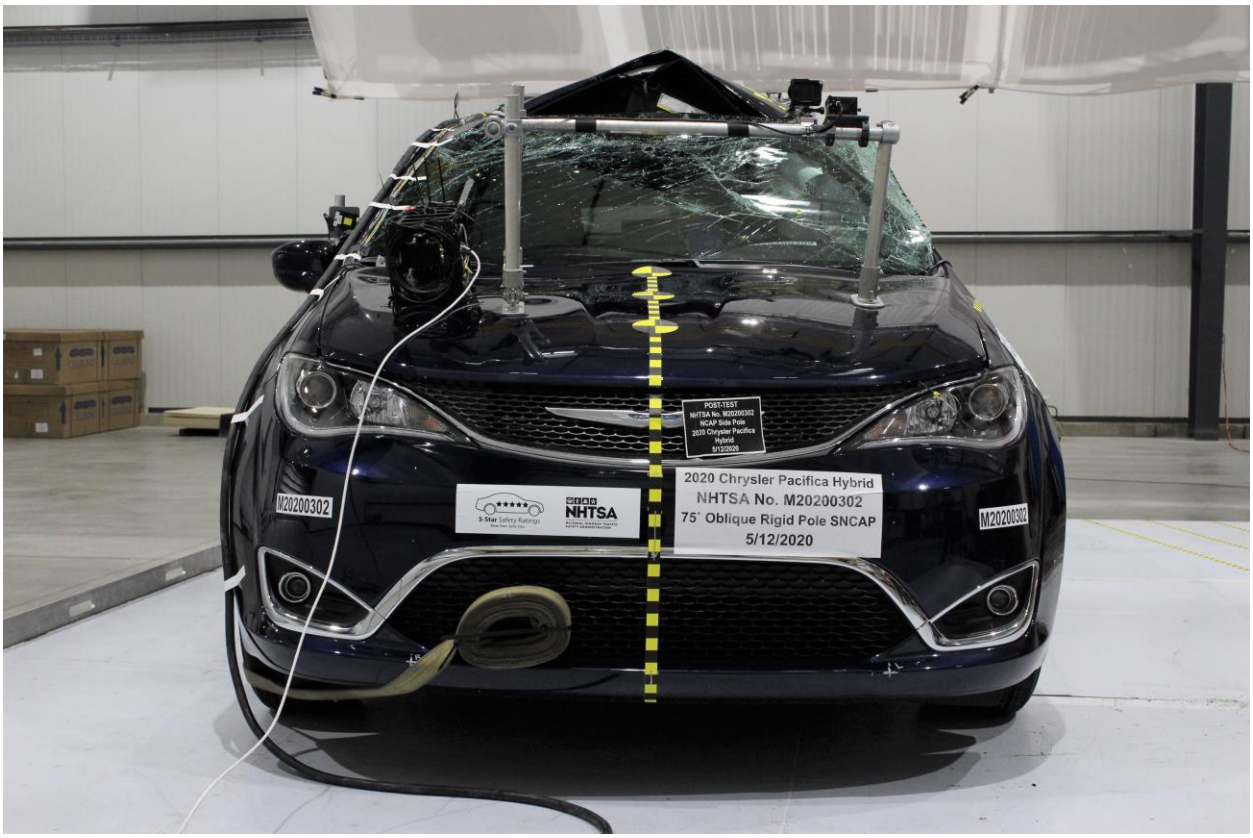
Figure A-4: Post-Test Frontal View of Test Vehicle

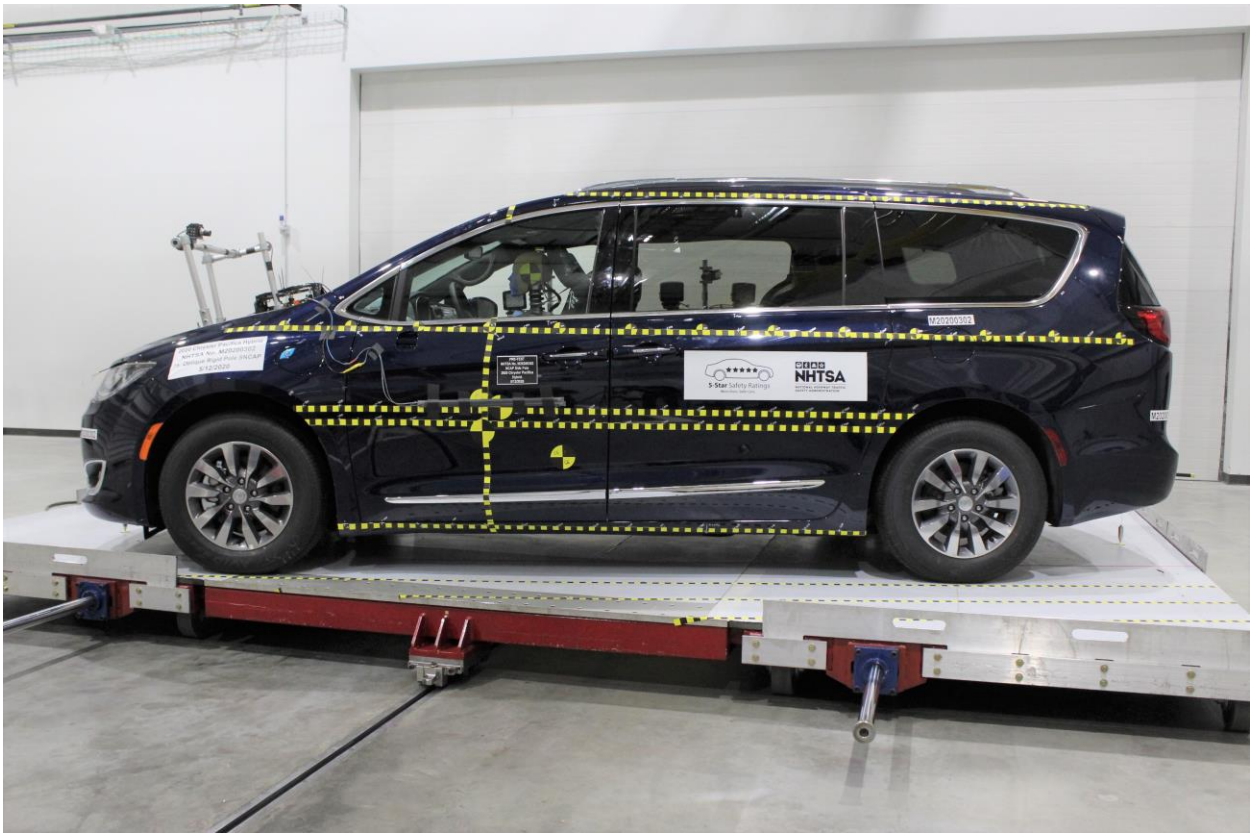
Figure A-8: Post-Test Left Side View of Test Vehicle

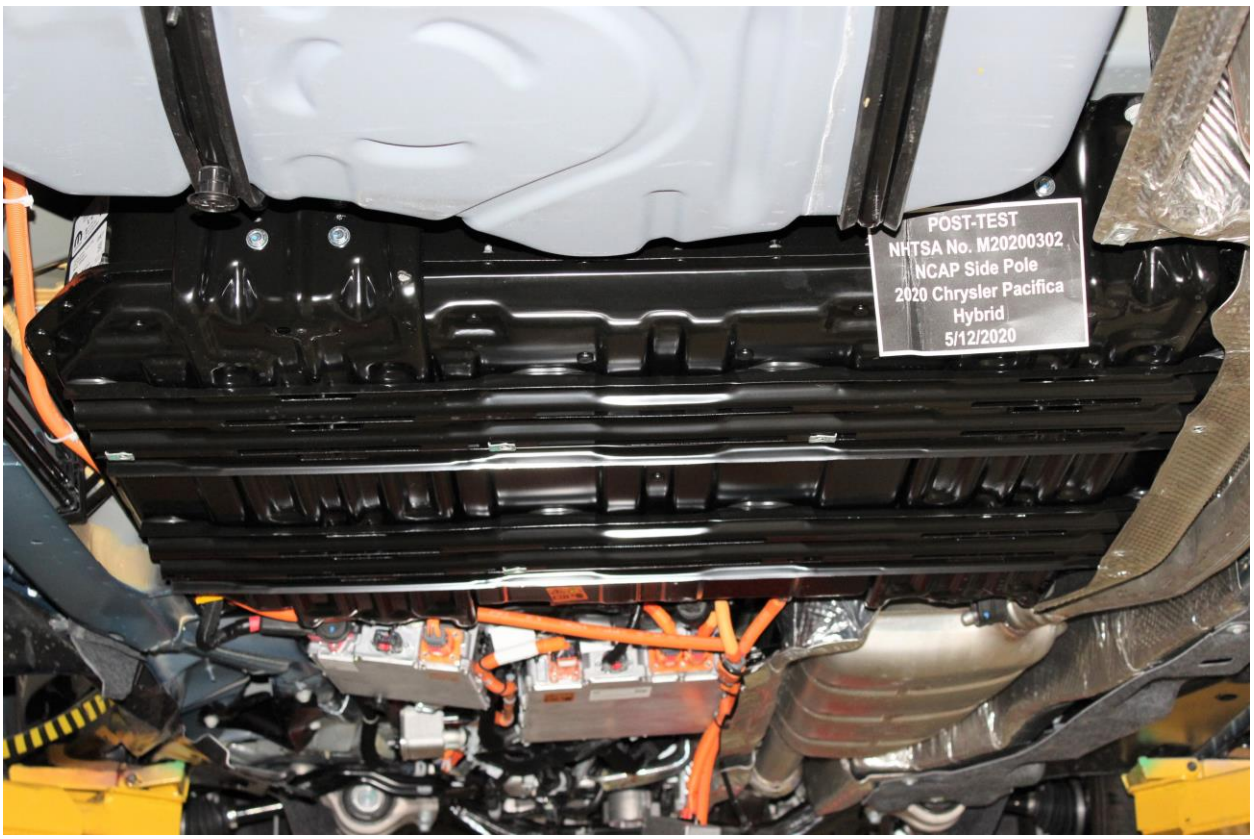
Figure 305-10: Post-Impact Front View of Propulsion Battery

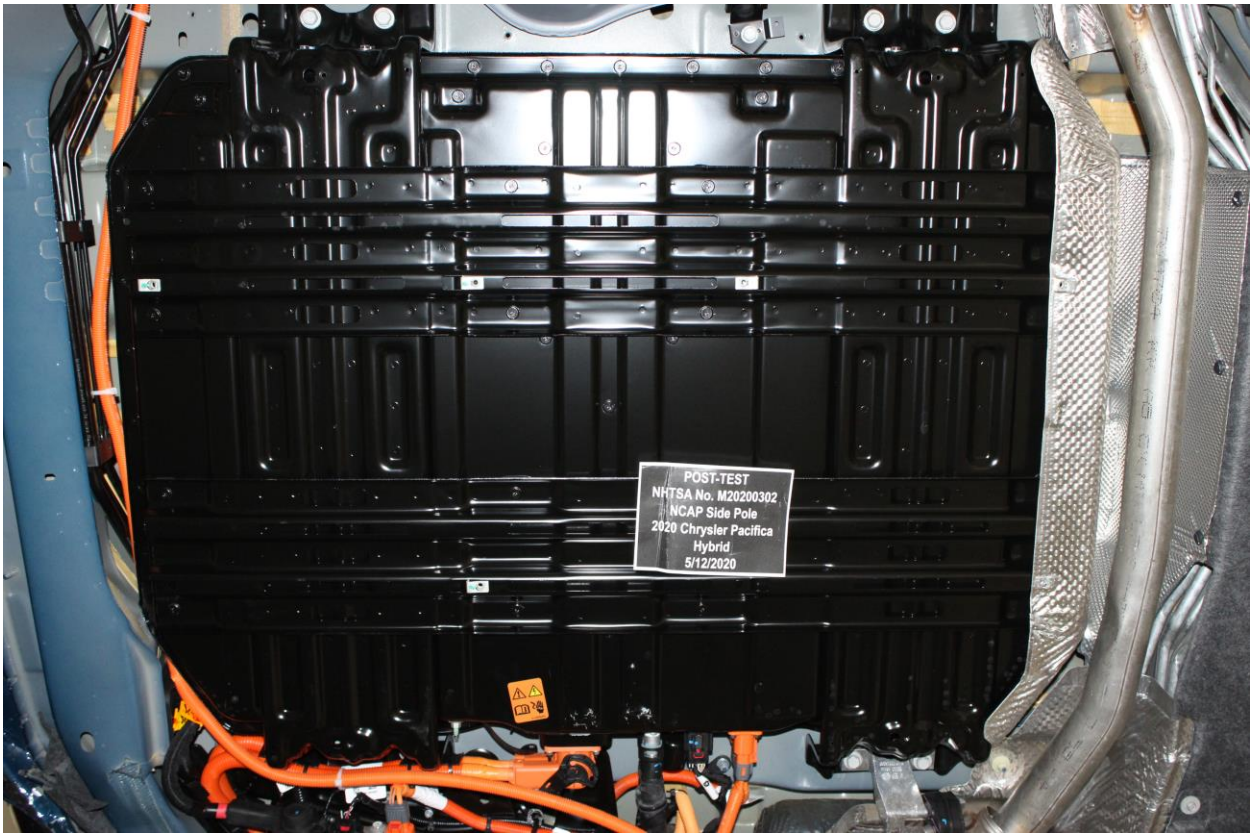
Figure 305-13: Post-Impact View of Battery Box(s) or Container(s) Which Holds Individual Battery Modules
