NHTSA Report No. 108-CAN-18-016-I

LAMPS, REFLECTIVE DEVICES AND ASSOCIATED EQUIPMENT FMVSS-108

Haze Study - 2005 Acura TL VOR Replaceable Bulb Headlamp

FINAL INDICANT REPORT

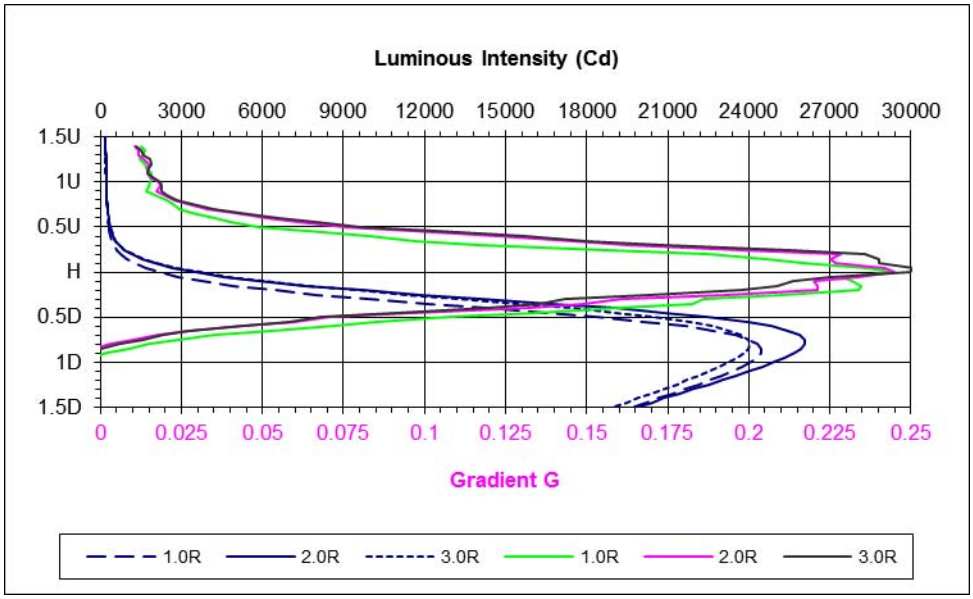
LH1 (New)

Location	Value	Required
H/1.0R	0.244	> 0.13
H/2.0R	0.245	
0.05U/3.0R	0.251

Horizontal width of cutoff is greater than 2° centered at 2.0R.

Maximum inclination of cutoff is within ±0.2°.

New sample meets S10.18.9 Visual/Optical Aiming cutoff requirements.
H-LH1 aged sample meet S10.18.9 Visual/Optical Aiming cutoff requirements.

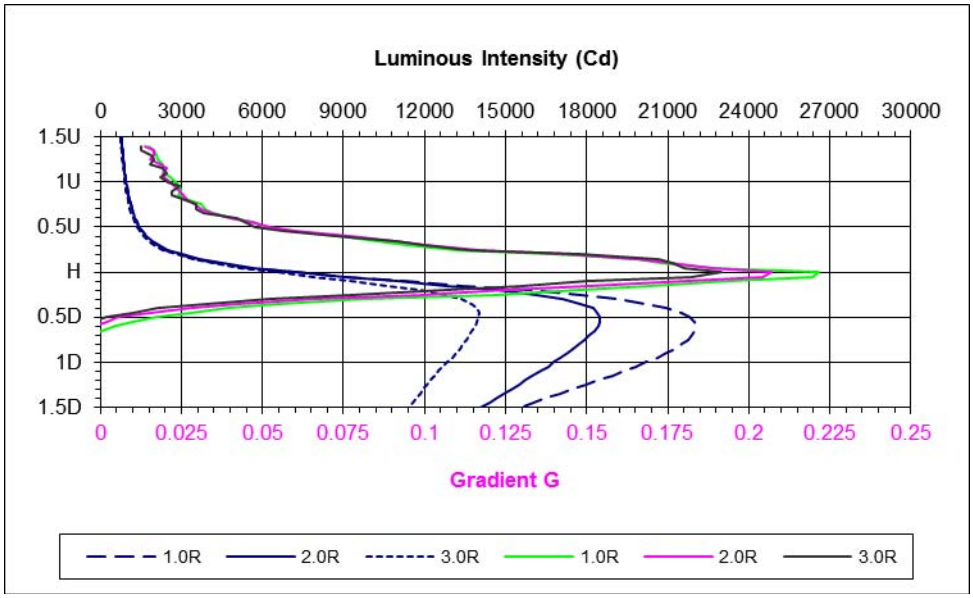
H-LH1 (Haze)

Location	Value	Required
H/1.0R	0.142	> 0.13
H/2.0R	0.133	
H/3.0R	0.129

Horizontal width of cutoff is greater than 2° centered at 2.0R.

Maximum inclination of cutoff is within ±0.2°.

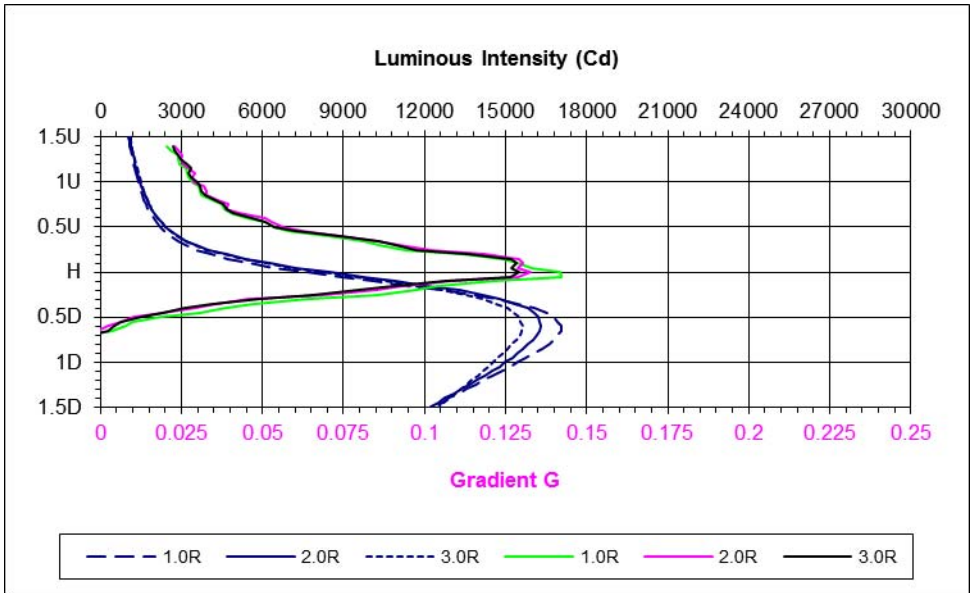
H-LH2 (Haze)

Location	Value	Required
0.05D/1.0R	0.142	> 0.13
H/2.0R	0.133	
H/3.0R	0.129*

* - denotes failure.

H-LH2 aged sample does not meet S10.18.9 Visual/Optical Aiming cutoff requirements.

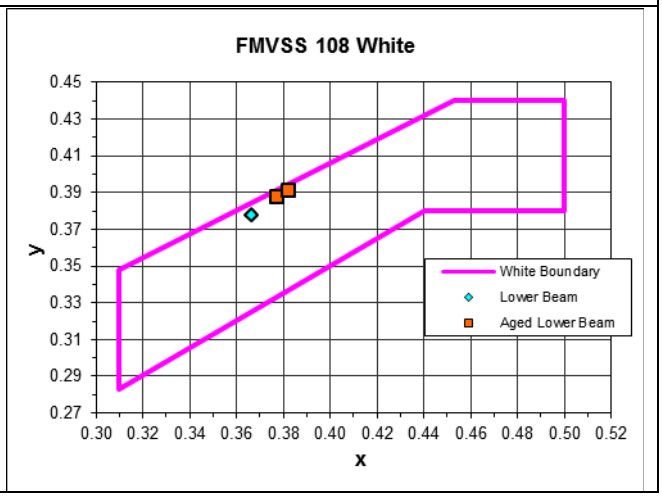
Measured (x, y)	Required	Chart
New LH1 (0.3664, 0.3773) Aged H-LH1 (0.3773, 0.3873) H-LH2 (0.3824, 0.3912)	0.31 ≤ x ≤ 0.50 0.38 ≤ y ≤ 0.44 y ≥ 0.75x + 0.05 y ≤ 0.64x + 0.15

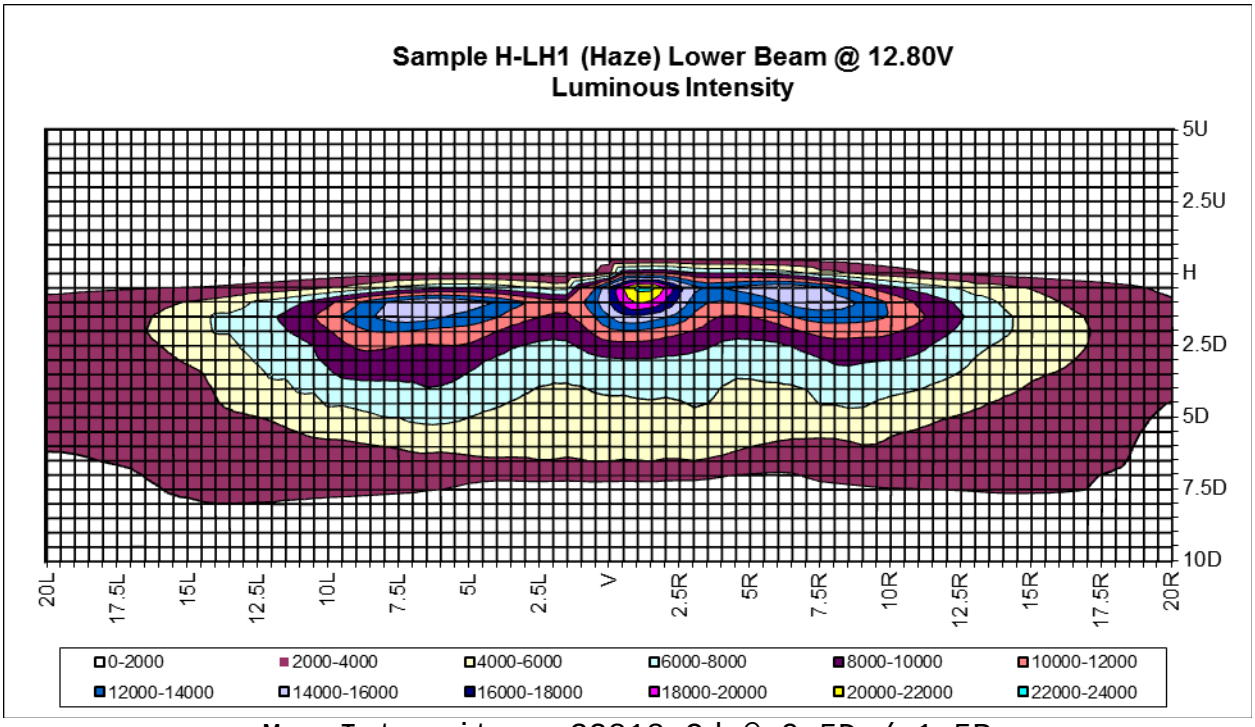
Max Intensity: 22818 Cd @ 0.5D / 1.5R
Beam Flux: 564 Lm

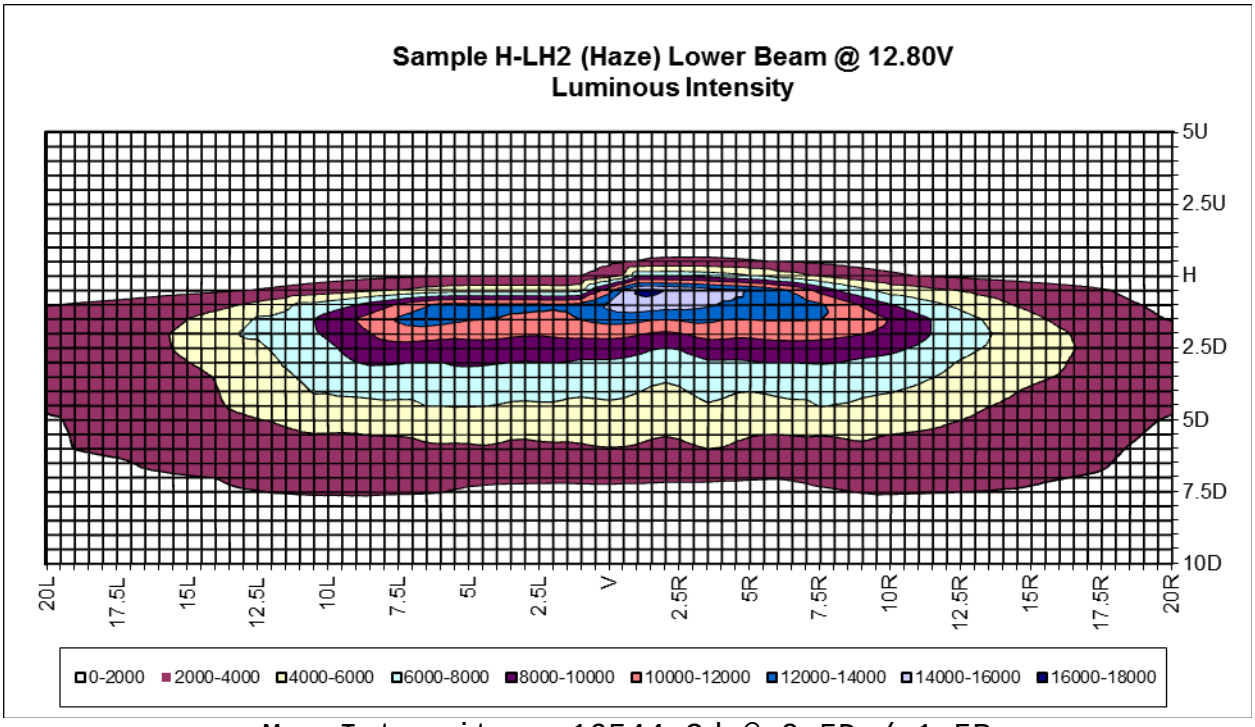
Max Intensity: 16544 Cd @ 0.5D / 1.5R
Beam Flux: 522 Lm

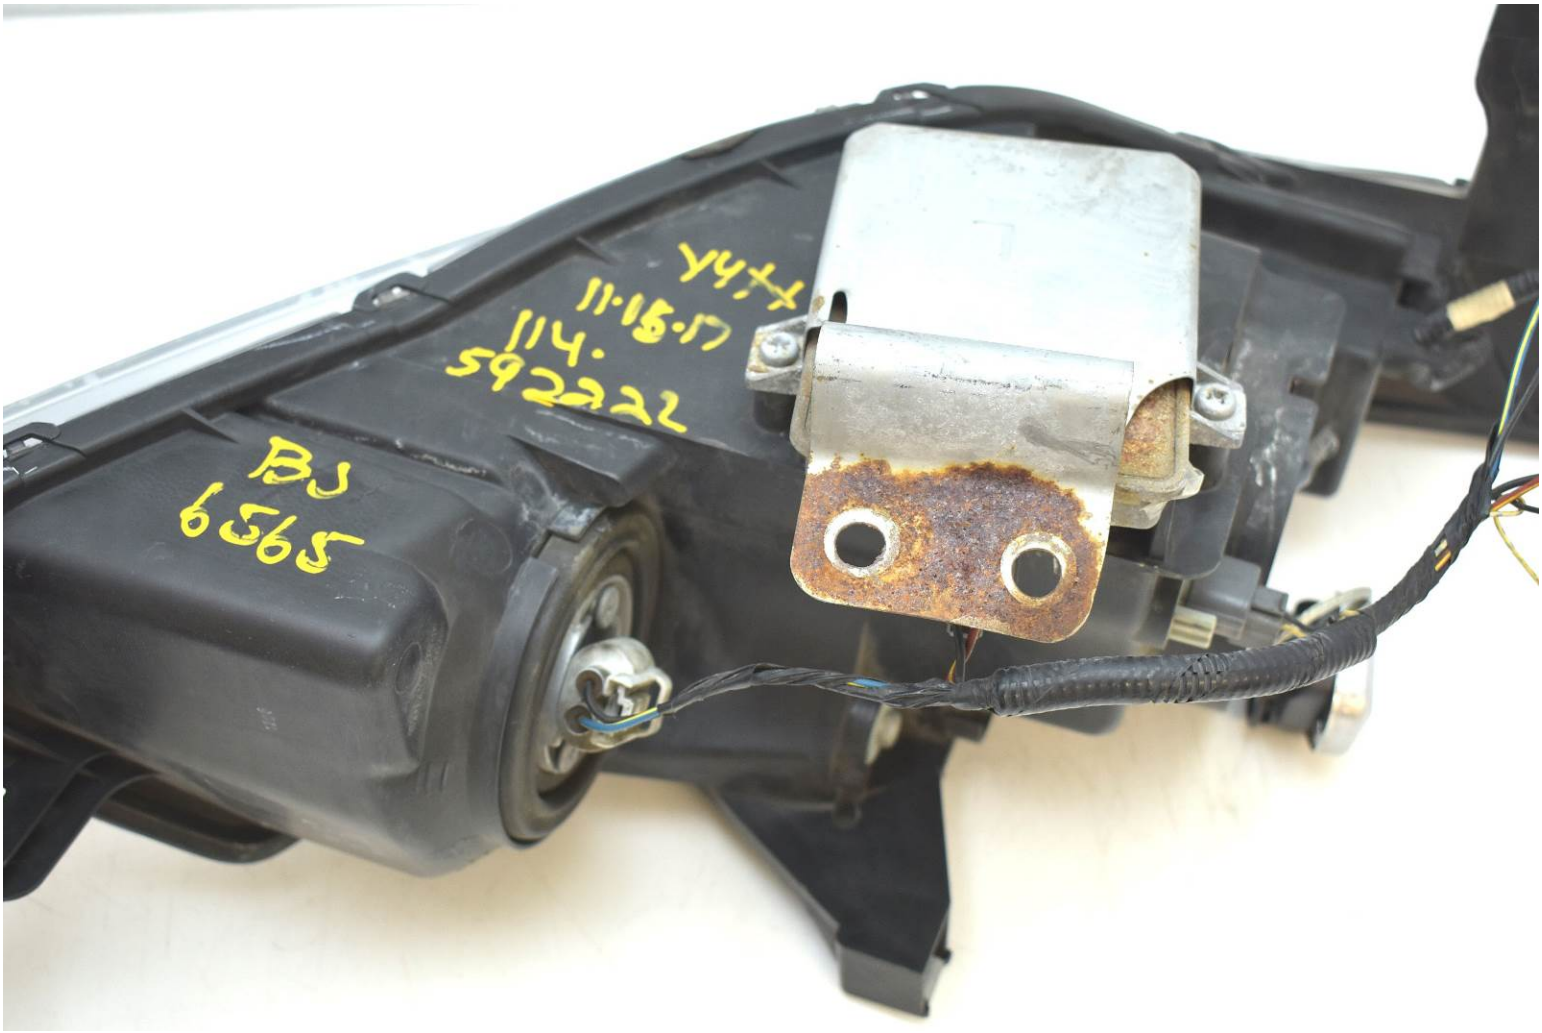
H-LH1 ballast as received

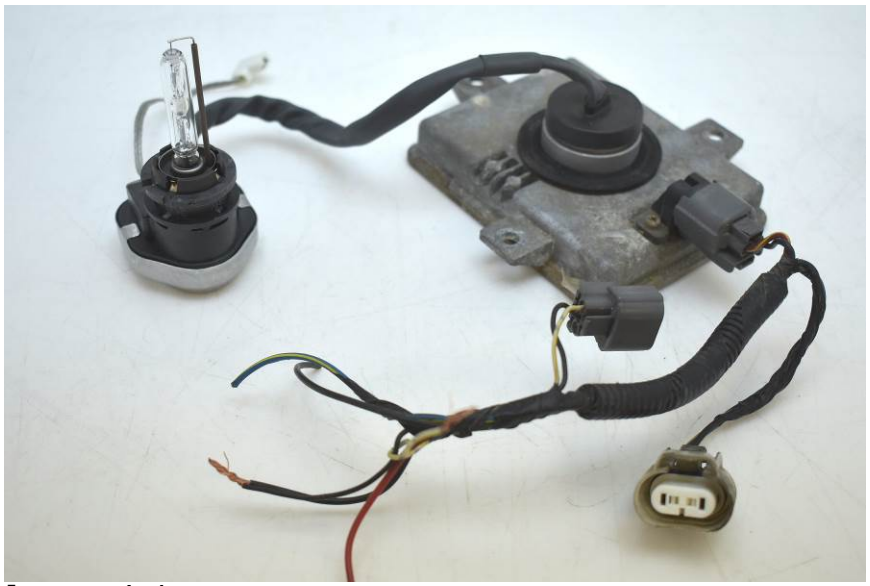
H-LH1 Ballast with H-LH2 D2S
