# The More You Know About The 10R80... The Better Off You Are!

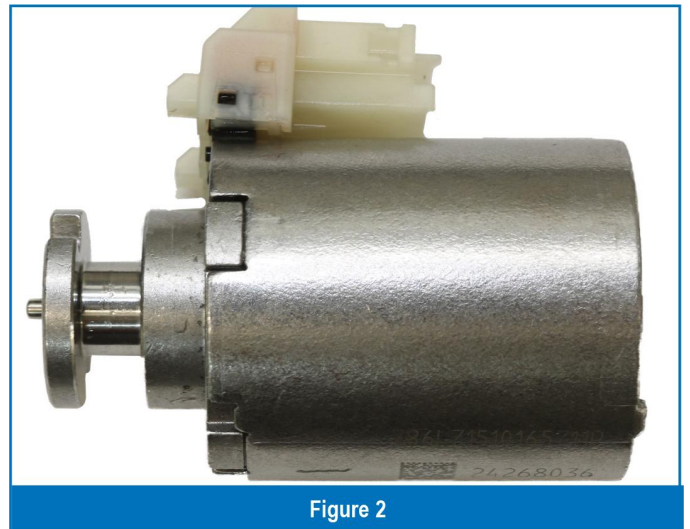
Figure 2

quick reminder of their location. Unlike previous shift solenoids, they are mechanical in nature in that no transmission fluid passes through them (Figure 2).

The solenoids are calibrated from the factory and are not all the same. The *CIDAS* (Casting Integrated Direct Acting Solenoid) are all normally low solenoids. The solenoids can be replaced separately, but only with the same type of solenoid.
