COMPONENT LEG TESTING OF VEHICLE FRONT STRUCTURES

Paper Number 05-0194

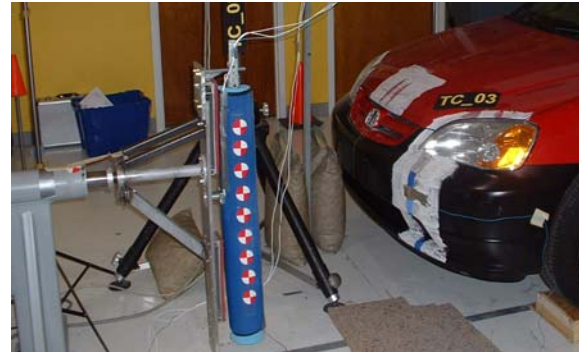
Legforms were launched in this test series by a carriage mounted to a hydraulic linear ram. During acceleration, the legforms were suspended from a pin at the top of the carriage and supported horizontally by padded fixtures mounted on the carriage adjacent to the upper leg and the lower leg (Figure 1).

Figure 1. Test setup.

Legform acceleration to free-flight speed was achieved over a distance of approximately 24 cm for the TRL legform and 28 cm for the FlexPLI legform. Legform height at the time of impact with the bumper was such that the bottom of the legform was within ± 10 mm of ground reference level, which is defined as the horizontal plane that passes through the lowest points of contact for the tires of the vehicle in normal ride attitude. As defined in the EuroNCAP procedure, the legform was vertical in the sagittal and coronal planes and aligned about the z-axis so that the lateral side of the legform contacted the bumper.

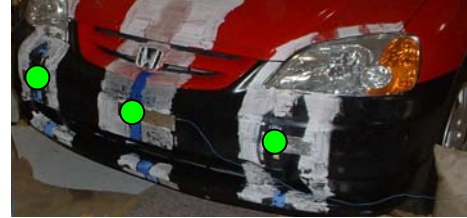
Honda Civic

Bumper impacts were targeted at the areas near the left and right side bumper supports and centrally at the bumper midline. Figure 2 illustrates the impact points on each vehicle bumper. The locations of the off-center (hereafter referred to as “lateral”) impacts on each vehicle were symmetrical about the vehicle centerline. No impact points were within 65 mm of the bumper corner, as defined in the EuroNCAP procedure. Tire pressure was set according to manufacturer’s instructions. The emergency brake was engaged. No additional ballast was added to the vehicle weight. Tests were performed at all three locations before replacing the entire bumper system.

Figure 2. Impact points on each bumper system.

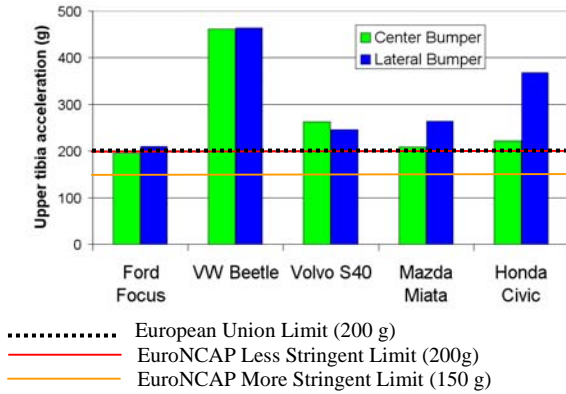
Figures 7 through 9 compare the averaged peak values for each vehicle and impact location to European Union requirements [7] and to the more stringent and less stringent performance limits used to rate vehicles in the EuroNCAP point system. In the EuroNCAP system, injury measurements meeting the more stringent limit receive 2 points, measurements between the two limits receive an interpolated point value, and measurements exceeding the less stringent limit earn 0 points [5]. The total point value awarded for an individual test is equal to the lowest of the calculated acceleration, bending and shear point values. The point values for three lower extremity tests are added to the point values earned in head impact and upper leg press tests to calculate the vehicle's overall pedestrian star rating.

Figure 7. Peak upper tibia acceleration

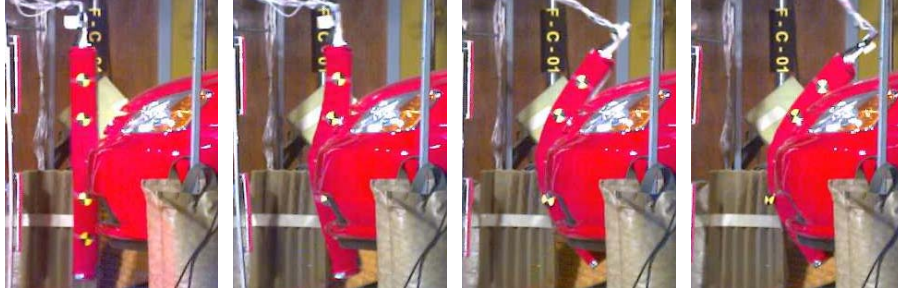
Honda Civic
(Right side full speed)

Kinematics of the FlexPLI are shown for tests into the lateral bumper of the Honda Civic, Mazda Miata, and Volvo S40 in Figure 10. The frames at 10 to 20 milliseconds show the knee end of the femur, and to a lesser extent the tibia, bending away from the bumper after contact in the knee area. The resulting convex curvature of the thigh and leg away from the bumper is

Figure 10. Kinematics of FlexPLI legform for three vehicles.

Figures 3 and 10 show the marked difference between how the TRL and FlexPLI legforms interact with the vehicles. The single-jointed TRL bent only at the knee while the FlexPLI's flexible femur and tibial elements allowed it to wrap around the front of the vehicle. This difference in how the legforms conform to the vehicle shape is likely to affect not only the magnitude of bending angle at the knee but all injury measures. Variations in the shape of the bumper, grille, and hood leading-edge structures may have a different effect on injury measures recorded by one legform than they do on the other legform.
