PERFORMANCE OF VEHICLE BUMPER SYSTEMS WITH THE EEVC/TRL PEDESTRIAN LOWER LEGFORM

Paper No. 09-0318

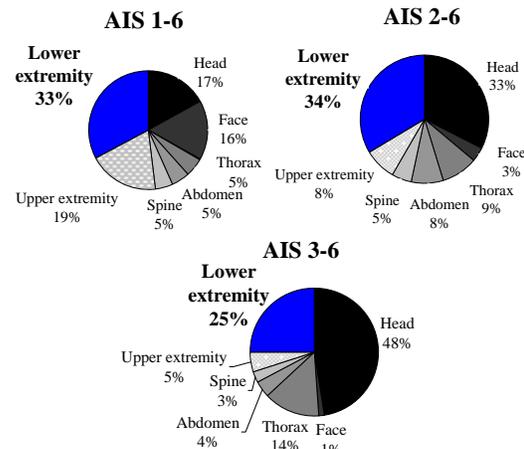
Figure 1. Distribution of injuries in the PCDS by body region (Mallory and Stammen 2006).

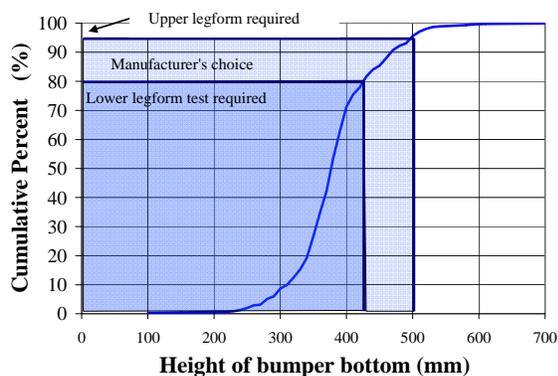
Figure 2. Lower bumper reference line height (Mallory and Stammen 2006).

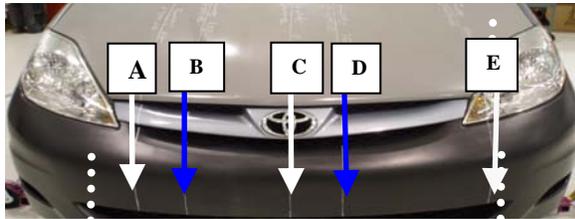
Figure 3. Example of five test locations on Toyota Sienna. Dashed boundaries show limits of test area and solid lines are impact locations. White and blue arrows indicate impacts performed on different bumper systems.

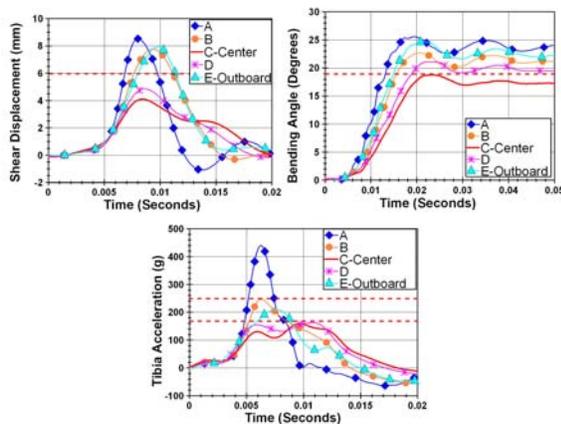
Figure 4. Time histories for shear displacement, knee bending angle, and tibia acceleration for Mazda Miata, with GTR limits shown in red.

Mazda Miata - Time histories for injury measures on all tests are shown in Figure 4 and peak values are tabulated in Table 4. The Mazda Miata was below GTR limits for the impact to the center bumper (Impact C) only. In impact C, peak bending angle was within 0.3 degrees of the GTR limit of 19 degrees. In all other impacts, the bending angle limit was exceeded. Impact A, which was close to the bumper support location, resulted in the highest shear displacement, bending angle, and tibia acceleration of any of the Miata test locations.

As indicated in Table 4, impact B was slower than the required impact speed range of 10.9 -11.3 m/s and impact D was faster than the required speed.

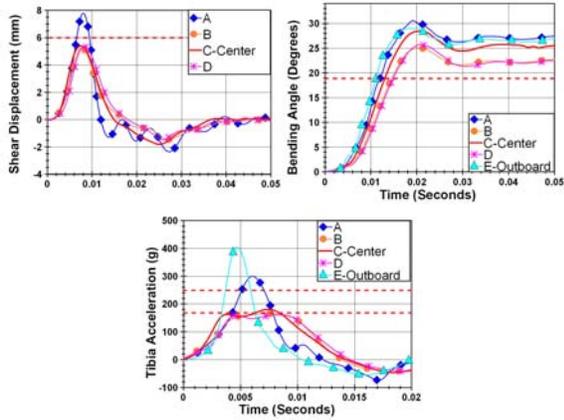
Figure 6. Time histories for shear displacement, knee bending angle, and tibia acceleration for Volkswagen Passat, with GTR limits shown in red.

Volkswagen Passat - None of the impacts to the Volkswagen Passat met the GTR requirements, as shown by the time histories in Figure 6 and the peak values in Table 5. Peak bending angle exceeded the 19 degree limit in every test. Shear displacement exceeded the GTR limit only in impact A. Tibia acceleration was over 170 g centrally, and exceeded 250 g in the more outboard test locations.

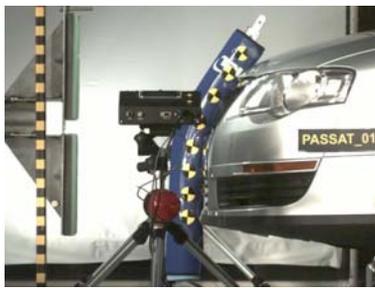
Figure 7. Legform at time of maximum bending angle in Volkswagen Passat center impact (C).

Figure 7 shows the legform at the moment of peak bending deformation in the center impact. At all impact locations, the legform conformed with the vehicle front by the time of maximum bending with the tibia segment essentially vertical against the bumper structures and the femur segment wrapped around the grille structures.

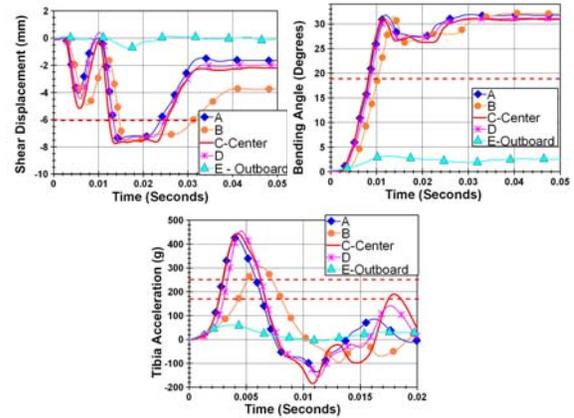
Figure 8. Time histories for shear displacement, knee bending angle, and tibia acceleration for Jeep Wrangler, with GTR limits shown in red.

Jeep Wrangler - In four of the five Jeep Wrangler impacts, all three injury measures were above the GTR limit (Figure 8, Table 6). In the fifth impact, the outboard-most point tested, the injury measures were well below the GTR limits. The negative shear displacement documented in the Wrangler tests indicates that, relative to the femur, the tibia segment moved toward the vehicle. Figure 9

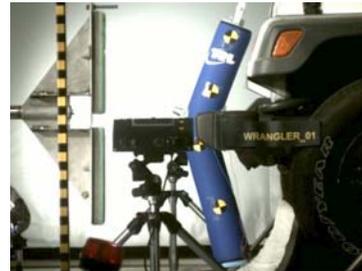
Figure 9. Legform at time of maximum bending angle in Jeep Wrangler center impact (C).

shows a video frame from the moment of maximum bending angle in impact C.

Video showed that there was little to no bumper deformation in the four failed impacts, but there was significant deformation of the bumper end in the passing outboard impact. The end cap of the bumper bent rearward, allowing the legform to move into the front surface of the tire and fender, supporting the

legform along its full length to limit bending and shear.

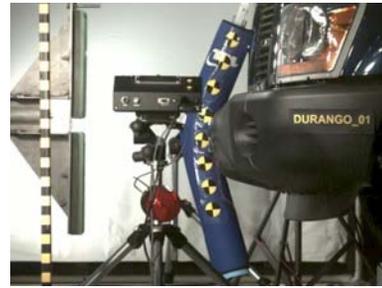
Figure 11. Legform at time of maximum bending angle in Dodge Durango center impact (C).

A video frame from the moment of maximum displacement (Figure 11) shows that the upper leg and lower leg both rotate toward the car around the bumper. In the outboard-most impact at location E, the legform has started to rotate outboard by the time of maximum bending.

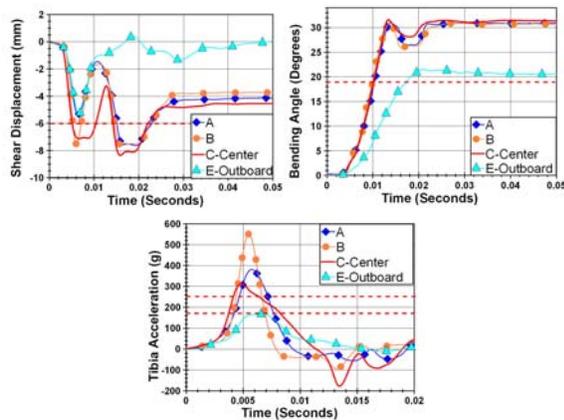
Figure 10. Time histories for shear displacement, knee bending angle, and tibia acceleration for Dodge Durango, with GTR limits shown in red.

Dodge Durango - The Dodge Durango was tested in only four locations because legform damage was sustained in three of the first four impacts. The Durango exceeded the bending angle limit by a wide margin in three impacts, and by a narrow margin in the outboard-most impact (Figure 10 and Table 7). Tibia acceleration limits were exceeded by all but the outboard-most impact. Shear limits were exceeded at points B and C. The negative shear values indicate that, relative to the femur, the tibia moved toward the car in all impacts.

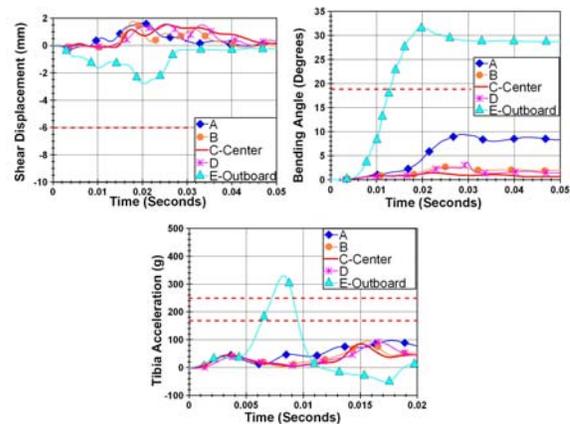
Figure 12. Time histories for shear displacement, knee bending angle, and tibia acceleration for Honda CR-V, with GTR limits shown in red.

Honda CR-V - In four of the five impacts, the Honda CR-V was well below GTR limits in all measures. The exception was the outboard-most impact, where the tibia acceleration exceeded even the relaxed limit of 250 g, and the bending angle exceeded the 19 degree limit (Figure 12, Table 8). Shear displacement in the outboard impact E was negative, indicating that the tibia displacement was toward the vehicle relative to the femur, rather than away from the vehicle relative to the femur as was seen in the other four tests.

As indicated in Table 8, the rotation about the Z axis exceeded the GTR limit of 5 degrees in the impacts at locations D and E. Table 8 also shows the higher peak bending angle in outboard impact E, compared to the much lower peak bending angles in the remaining tests. The outboard impact E also shows dramatically less bumper and vehicle-front deformation than the inboard, passing impacts.

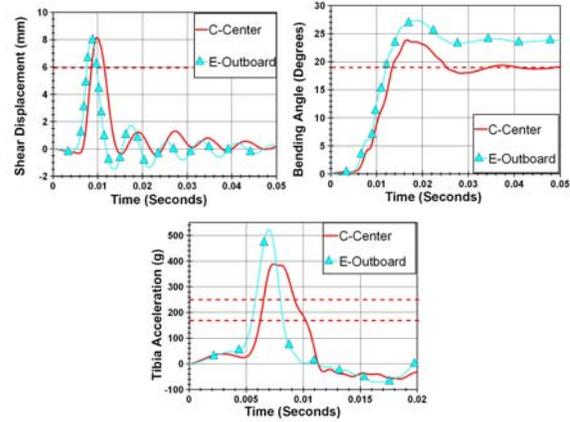
Figure 14. Time histories for shear displacement, knee bending angle, and tibia acceleration for Toyota Tacoma, with GTR limits shown in red.

Toyota Tacoma - Only two tests were performed on the Toyota Tacoma due to vehicle damage. After two tests there was extensive unforeseen damage to the grille, the grille surround and to the headlamp mounts. With no replacement parts available, subsequent testing was suspended because these structures could potentially have been limiting the peak bending angle and shear displacement of the legform. Therefore, testing with damaged structures may not have been valid. Figure 14 and Table 9 show that all injury limits were exceeded in both tests. Figure 15 shows that the upper leg tended to rotate into the grille structures while the tibia segment of the legform rotated much less.

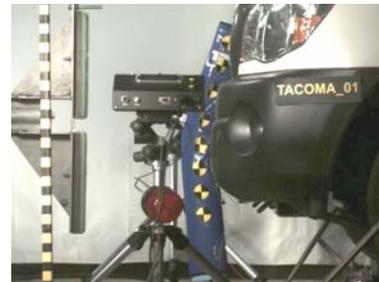
Figure 15. Legform at time of maximum bending angle in Toyota Tacoma center impact (C).

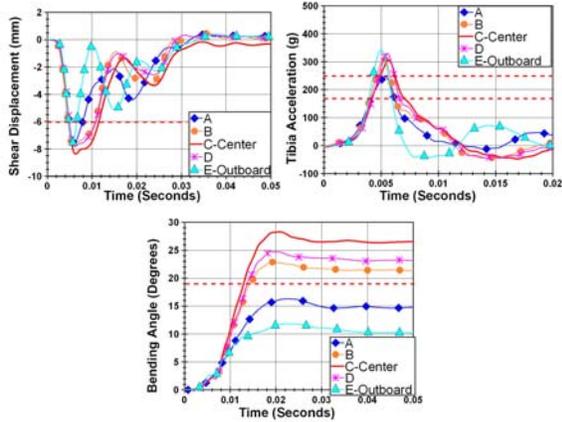
Figure 16. Time histories for shear displacement, knee bending angle, and tibia acceleration for Chevrolet Silverado, with GTR limits shown in red.

Chevrolet Silverado - None of the Chevrolet Silverado impacts met the GTR requirements. In contrast to other vehicles, two of the failing impacts did meet bending angle requirements (Figure 16 and Table 10). Shear displacement limits were exceeded in every test. Tibia acceleration was over 170 g in all tests, but below the relaxed limit of 250 g in one test.

As indicated in Table 10, impact location B was tested with the lower legform in spite of the fact that the Lower Bumper Reference Line at this test location put it in a zone where upper legform testing would have been required per the GTR requirements.

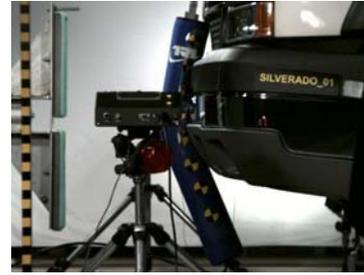
Figure 17. Legform at time of maximum bending angle in Chevrolet Silverado center impact (C).

Figure 17 illustrates the interaction of the legform with the bumper at peak bending angle, with the lower leg bending under the bumper and the upper leg supported almost vertically by the bumper structures.

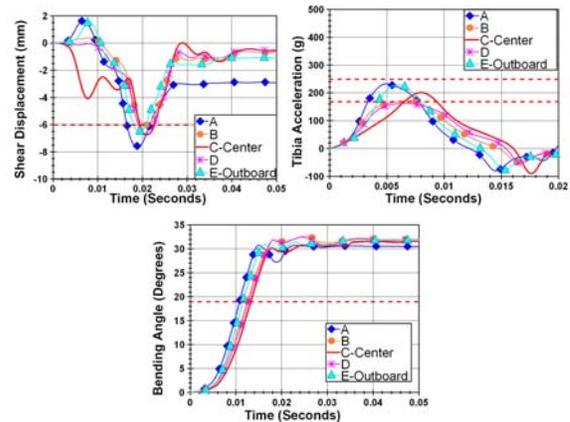
Figure 18. Time histories for shear displacement, knee bending angle, and tibia acceleration for Toyota Sienna, with GTR limits shown in red.

Toyota Sienna - All impacts to the Toyota Sienna failed to meet GTR requirements. Although the center impact (C) was below the shear displacement limit and impact D was below the 170 g limit on tibia acceleration, bending angle was well over the 19 degree limit in all tests (Figure 18 and Table 11). The video frame at the moment of maximum bending angle show that the top of the bumper contacts the legform near the knee and the upper portion of the legform wrapped down to the hood of the Sienna in all impacts (Figure 19).

As indicated in Table 11., the rotation about the vertical axis exceeded the GTR limit of 5 degrees in the impact at location B.

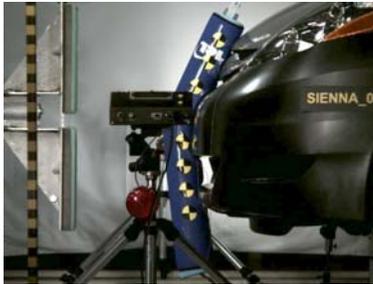
Figure 19. Legform at time of maximum bending angle in Toyota Sienna center impact (C).

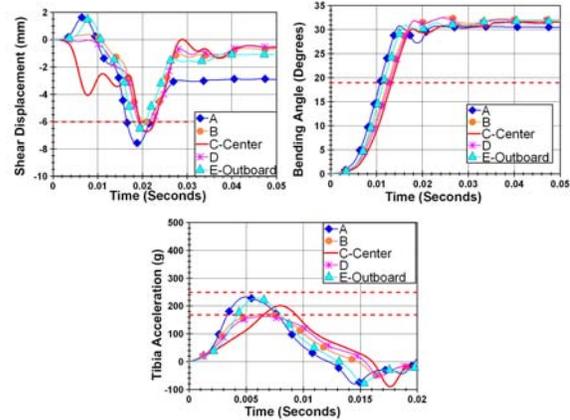
Figure 20. Time histories for shear displacement, knee bending angle, and tibia acceleration for Toyota Sienna, with GTR limits shown in red.

Ford E-350 Van - The first four impacts to the Ford E-350 bumper exceeded injury limits by a wide margin with bending angle over 31 degrees in all tests and tibia acceleration exceeding 350 g's in three tests (Figure 20 and Table 12). In the center impact (C), acceleration data was not collected due to wire damage. In the fourth impact (B) the pot arm of the potentiometer sustained damage. Due to a limited number of replacement pot arms, and the assumption that point D results would be similar to points B and C, testing was suspended prior to testing point D. Figure 21 shows that the femur segment tended to rotate into the grille while the tibia segment rotated under the bumper in all impacts. The knee was approximately centered over the height of the bumper.

As indicated in Table 12, the rotation about the vertical axis exceeded the GTR limit of 5 degrees in the impact at location C.

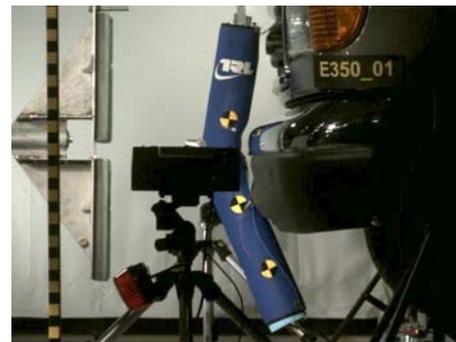
Figure 21. Legform at time of maximum bending angle in Ford E-350 center impact (C).

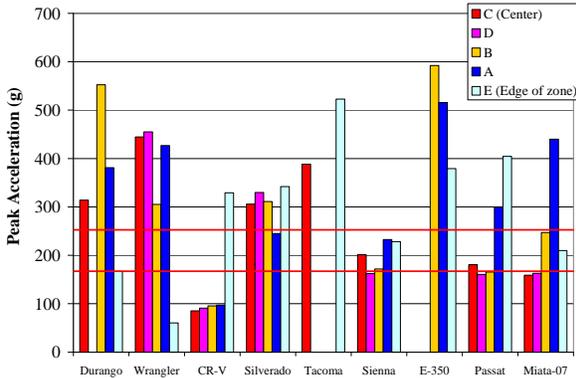
Figure 22. Peak acceleration for all impacts by vehicle and impact location.

Peak results for tibia acceleration are shown for all vehicles in Figure 22. The acceleration limit of 170 g and the relaxation limit of 250 g are indicated in red.

Only five of 39 (13%) test locations met the 170 g limit with a wide margin: the four passing CR-V impacts and the outboard Wrangler impact. The remaining impacts were all either very close to, or in excess of, 170 g. Some tests exceeded the acceleration limits dramatically and six vehicles exceeded 400 g in at least one test location.

Six of the nine vehicles tested met the 170 g limit on *upper tibia acceleration* in at least one test location. Of the 39 impacts where acceleration was measured, 20 indicated upper tibia acceleration over 250 g, and 8 were above 170 g but below the relaxed limit of 250 g (Figure 22). Of the 11 impacts that were below 170 g, only 5 impacts met the requirement with a margin wider than 10 g. The relaxed GTR acceleration limit of 250 g applies only to a width of bumper equal to approximately 2 widths of the legform, which is equivalent to one test location on each side of the car. In the current series, it is assumed that a vehicle could potentially pass the requirements if it has only one test over 170 g (but under the relaxed limit of 250 g) with the remainder of the tests under 170 g. The CR-V came closest to achieving those requirements with four of five tests under 170 g, but exceeded the limits with a fifth test over the relaxed limit of 250 g. The Sienna was able to remain under 250 g for all tests, but exceeded the 170 g limit in four out of five tests; given that there is not enough relaxation zone to cover all four of those impact locations, this vehicle would not meet the GTR acceleration requirement.

As shown in Figure 22, whether acceleration was higher in inboard locations or outboard locations was design-specific. The highest measures of acceleration were often measured near the bumper support, suggesting that tibia acceleration is more sensitive to stiffness of structures under the bumper than to the gradual changes in profile shape that occur across the front of the vehicle. Among vehicle types, the pickup trucks and the full-size van showed consistently high levels of acceleration, with all impacts close to or in excess of the 250 g limit.

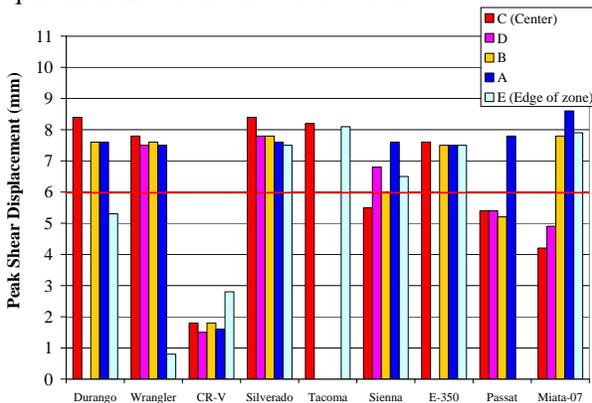
Figure 23. Peak shear displacement for all impacts, by vehicle and impact location.

Peak magnitude of shear displacement is shown in Figure 23. This peak is an absolute value, representing the peak magnitude. The GTR shear displacement limit of 6 mm is indicated in red. Only the CR-V passed shear limits in all tests, but six of the nine vehicles were able to pass the shear requirement in at least one test location.

Six of nine vehicles tested passed the *knee shear displacement* limit in at least one location, and one vehicle (CR-V) passed the shear requirement in all locations tested (Figure 23). Fourteen impact locations were at or below the shear limit of 6 mm, and 25 impact locations exceeded the knee shear limit of 6 mm. Many of the tests that exceeded 6 mm indicated shear displacements in the range of 7.5 mm to 8.5 mm suggesting a possible physical limit on the magnitude of shear displacement allowed by the EEVC/TRL legform. If this injury measure is bottoming-out, estimates of injury risk based on this level of shear may be underestimated.

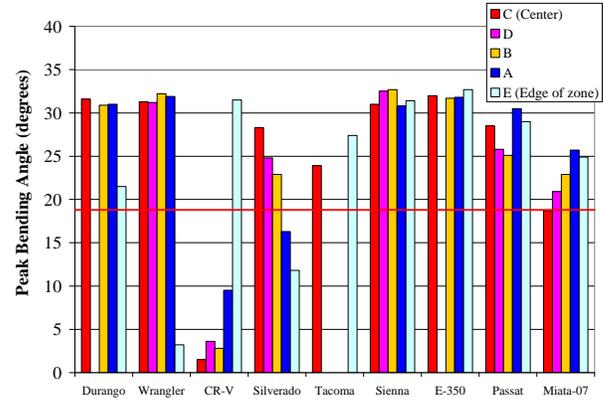
Figure 24. Peak bending angle for all impacts, by vehicle and impact location.

Peak knee bending angle is shown in Figure 24. Only 8 of 40 (20%) impacts resulted in bending angle peaks below the injury limit of 19 degrees, which is shown in red. The majority of the failing impacts showed bending angles in excess of 30 degrees.

The *knee bending angle* limit appeared to be the most challenging to meet for the vehicles tested. Only four of the nine vehicles tested met the 19 degree bending angle limit in at least one location, and only 8 impacts in the series passed this limit. Many of the failing impacts showed peak bending angle clustered between 30 and 32 degrees, suggesting a physical limit on knee bend in this range. It is likely that the legform is physically bottoming out so estimates of injury risk based on this level of bending may be underestimated.

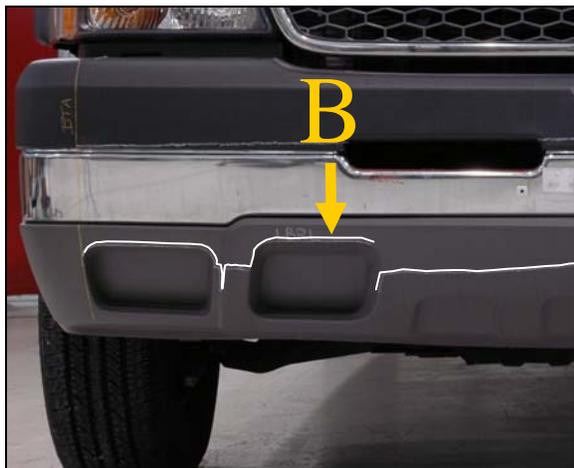
Figure 25. Chevy Silverado bumper showing Lower Bumper Reference Line (LBRL) in white and impact location B in yellow, where LBRL is greater than 500 mm.

Impact B on the Silverado (Figure 25) deviated from the requirements of the GTR in that it was performed at a location where the Lower Bumper Reference Line exceeded 500 mm and therefore was not subject to lower legform testing. Shear and bending measurements may have been affected by LBRL height, as these measures were lower for impacts C and D in the lower central portion of the bumper. However, all tests on the Silverado failed the GTR limits by a wide margin. The height of the LBRL at location B was not believed to have been the cause of the failure at this test location.

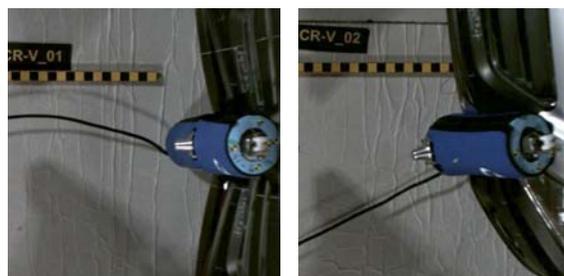
Figure 26. Passing CR-V center impact C on left (acceleration 85.3 g) and failing CR-V outboard impact E on right (acceleration 329 g).

In the passing impacts, video showed visibly more bumper deformation than there was in impacts that exceeded acceleration limits. Passing and failing CR-V impacts (Figure 26), Miata impacts (Figure 27), and Wrangler impacts (Figure 28) are compared below to illustrate that deformation appears to be associated with better performance relative to upper tibia acceleration. In all three passing impacts illustrated below, there was visible deformation of the bumper, resulting in varying degrees of damage. In the CR-V center impact (C), the CR-V sustained permanent deformation to the bumper cover, the underlying bumper support, and adjacent grille and air conditioning structures. The Miata center impact (C) resulted in damage to the ribbed energy absorber immediately adjacent to the impact point but showed no external evidence of damage. On the Wrangler, the end-cap on the bumper snapped off at impact allowing the legform to move into the front face of the fender and the tire tread. The fender, which is parallel to the bumper in its undeformed state, then deformed to absorb additional energy from the impact. In the passing impacts, the bumper and underlying structures absorbed energy and reduced the levels of deceleration in the legform by deforming during impact.

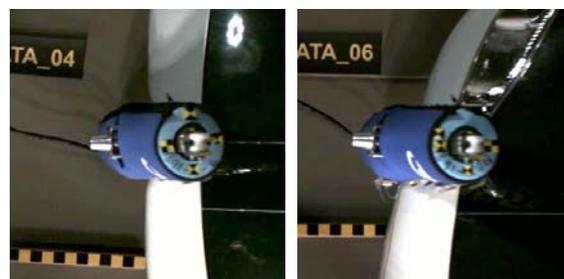
Figure 27. Passing Miata center impact C on left (acceleration 159 g) and failing Miata impact A on right (acceleration 40 g).

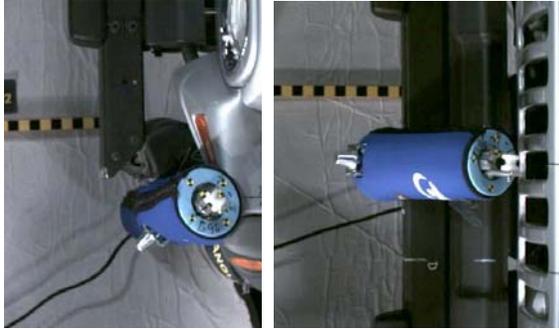
Figure 28. Passing outboard Wrangler impact E on left (acceleration 60 g) and failing Wrangler impact center impact C on right (acceleration 445 g).

It should be noted that the low injury measures indicated in passing Wrangler impact E do not account for the potential injury risk posed by striking the tread of a tire on a moving vehicle.

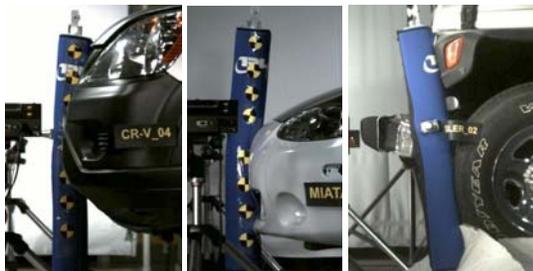
Figure 29. Bumper contact area in passing impacts CR-V (C), Miata(C), and Wrangler(E).

Another characteristic of passing impacts appears to be the distribution of impact forces over a large area on the legform above *and* below the knee. In passing CR-V tests, the load is applied over a relatively tall bumper that makes contact above and below the knee of the legform (Figure 29). In the Miata passing impact C, the top of the bumper is adjacent to the lower femur, and tibia loads are shared by a lower spoiler. On the passing Wrangler test, the failure of the bumper end-cap allowed the femur to move into the vertical fender and the tibia to move into the tire tread, sharing the loads over a large portion of the legform.

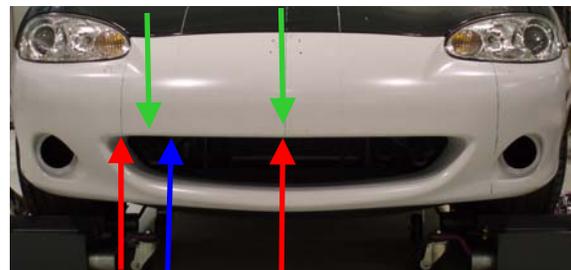
Figure 30: Photograph of Mazda Miata showing comparable impact locations in 2005 EuroNCAP testing (green, upper arrows) and in 2007 GTR testing (red and blue, lower arrows).

Test data from the Mazda Miata was compared for the two series in order to evaluate whether the passenger car results from the first series of EuroNCAP testing at VRTC could be combined with the results from the currently reported GTR testing. Figure 30 shows the location of comparable impacts in the two series. Each series had at least one test at the center of the bumper that can be compared directly. The 2005 EuroNCAP tests included an impact directly over the bumper support that can be compared to tests adjacent to the bumper support in 2007 GTR testing. Figure 31 compares the test results for impacts in the center of the bumper for both series, and Figure 32 compares the results for impacts near the bumper support.

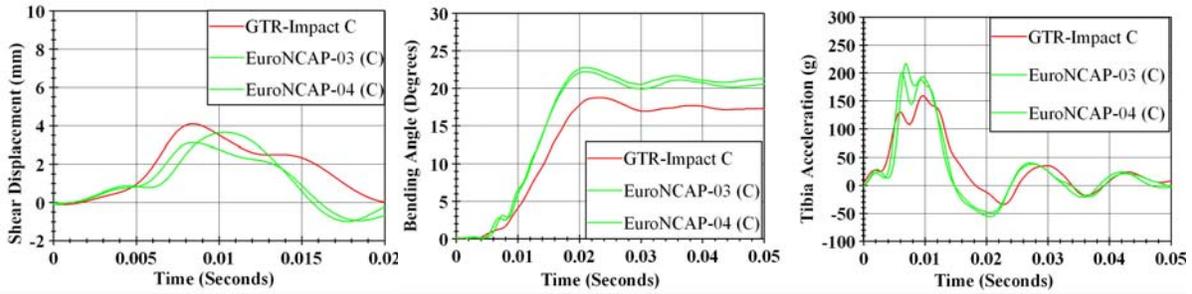
Figure 31: Shear displacement, bending angle and tibia acceleration for center impact using GTR procedure in 2007 VRTC testing (red) compared to prior testing at the center bumper according to 2005 EuroNCAP testing (green).

Figure 31 and Figure 32 show that the differences between the peak values from 2005 EuroNCAP testing and 2007 GTR testing do not appear significantly greater than the differences in peak results among repeats of individual 2005 EuroNCAP tests over the lateral bumper in spite of difference in leg-to-ground-reference height. However, it should be noted that the difference in test results at the center bumper location in Figure 32 are important, in that the 2005 tests failed the acceleration and bending angle requirements in the current GTR (175 g and 19 degrees, respectively), while the 2007 tests passed.

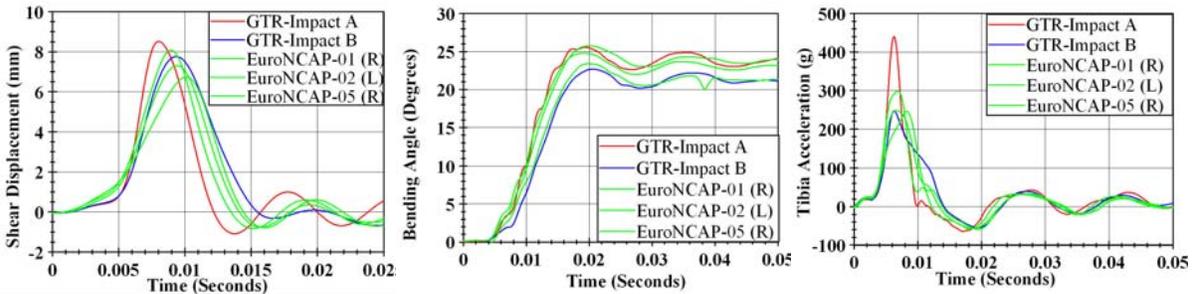
Figure 32: Shear displacement, bending angle and tibia acceleration for impacts adjacent to bumper support 2007 GTR testing (red, blue) compared to prior testing over left and right bumper support according to 2005 EuroNCAP testing (green).
