BEFORE THE
PIPELINE AND HAZARDOUS MATERIALS SAFETY ADMINISTRATION
U.S. DEPARTMENT OF TRANSPORTATION

Advance Notice of Proposed Rulemaking

Hazardous Materials:
Rail Petitions and Recommendations To Improve the
Safety of Railroad Tank Car Transportation

PHMSA-2012-0082 (HM-251)
Published: 78 Fed. Reg. 54,849 (Sept. 6, 2013)

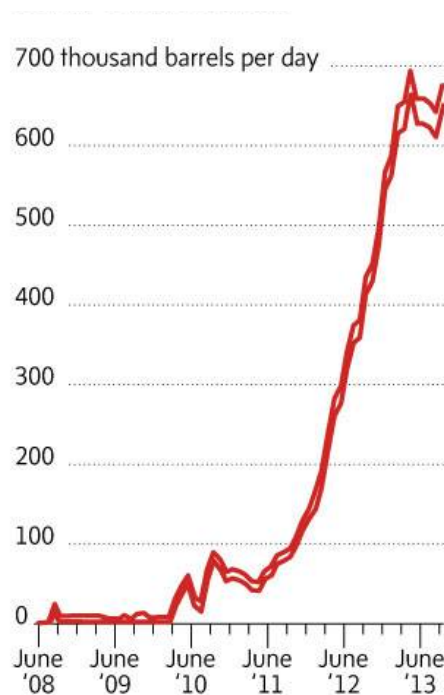
**ND Oil Export Volumes by Rail
(June 2008-September 2013)
High-Low Estimates¹⁰**

¹⁰ Rail volumes are estimated as a range based on estimates of total crude production, less volumes to pipeline, truck, and local refining. <http://northdakotapipelines.com/rail-transportation>

¹¹ See Figure 2 and North Dakota Pipeline Authority. Ibid.

¹⁴ Ibid. See also Figure 2.
