### BLIND SPOT INTERVENTION SYSTEM CONFIRMATION TEST NCAP-DRI-BSI-20-05

2020 Infiniti QX60 LUXE

DYNAMIC RESEARCH, INC.

**Final Report**

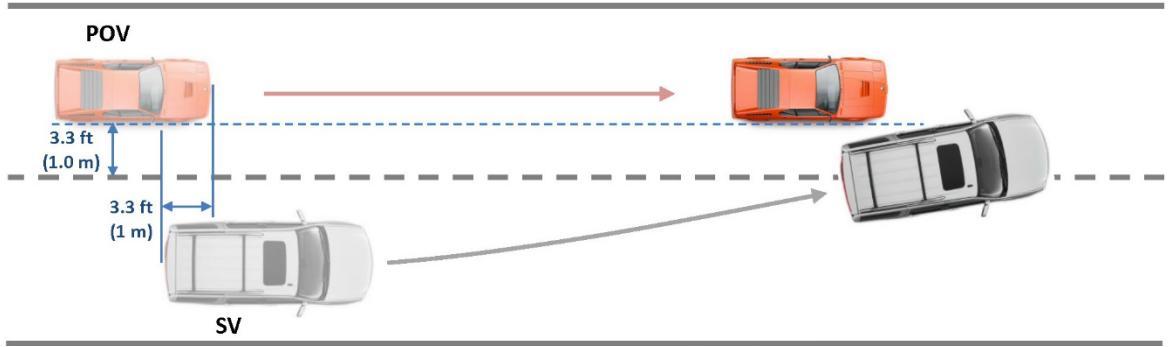
Figure 1. SV Lane Change with Constant Headway Test Scenario

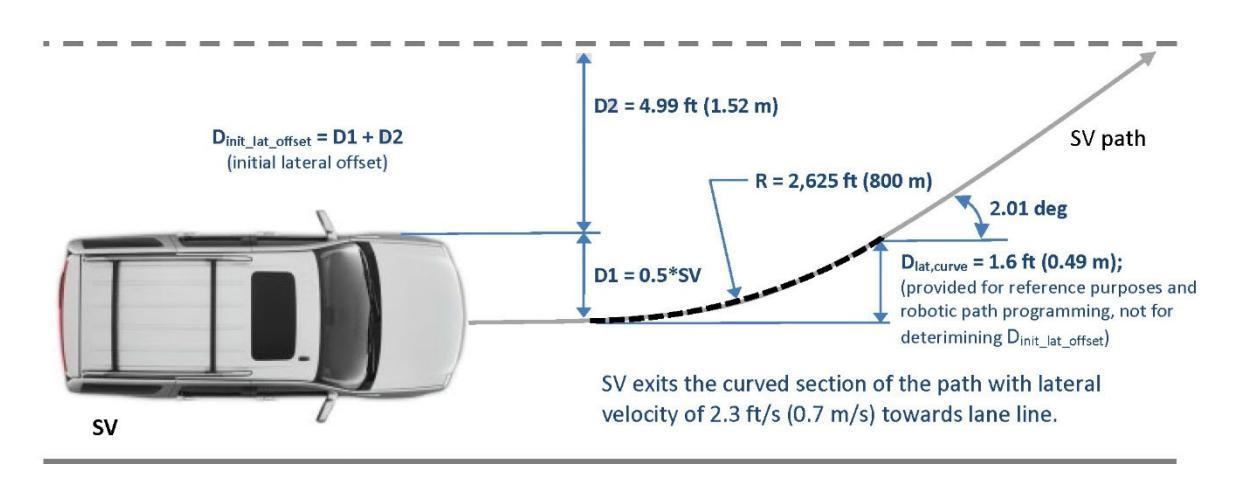
Figure 2. Input Parameters Used to Define the SV Path During the SV Level 0 and 1 Lane Change with Constant Headway Scenario

The tests with SV automated vehicle level 0 or 1 were performed with manual steering input from a robotic steering controller. The SV and POV began in their respective travel lanes with their longitudinal axes oriented parallel to the roadway edge. The initial SV path was offset in the lane as shown in Figure 2. Both vehicles then accelerated to an initial speed of 45 mph (72.4 km/h). This speed and specified headway overlap between the front-most point of the POV and the rear-most point of the SV were maintained throughout the test. The headway overlap is specified with the front bumper of the POV located  $1.0 \pm 0.5$  m ( $3.3\pm1.6$  ft) ahead of the rear of the SV (therefore the specified headway distance is a negative value indicating longitudinal overlap).

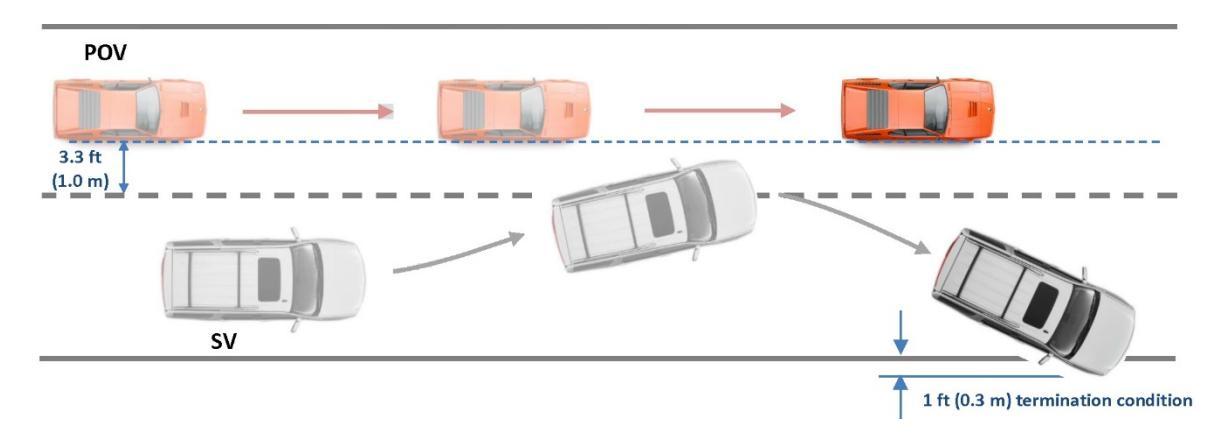
Figure 3. Valid SV Lane Change Intervention Test Interval End Condition 3

- The SV impacted the POV; or
- five seconds after the SV had established a heading away from the POV and was completely within its original travel lane; or
- one second after the SV traveled ≥ 1 ft (0.3 m) beyond the inboard edge of the lane line separating the SV travel lane from the lane adjacent and to the right of it, as shown in Figure 3.

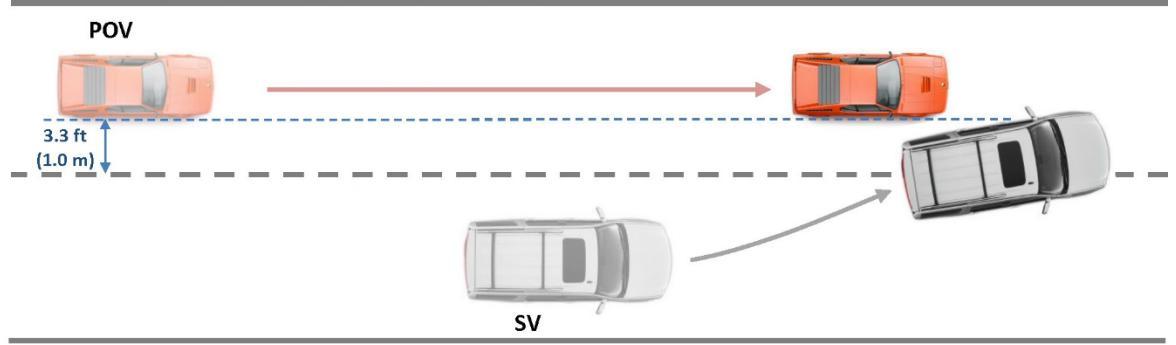
Figure 4. SV Lane Change with Closing Headway Test Scenario

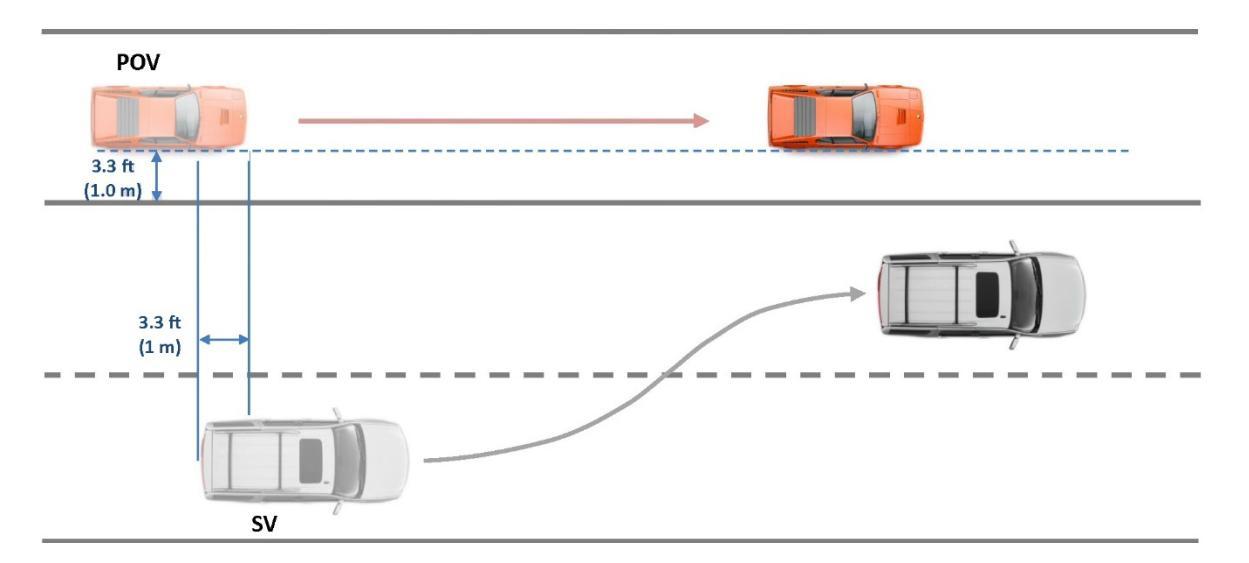
Figure 5. Lane Change with Constant Headway, False Positive Test Scenario

This test scenario was performed in two parts comprised of "baseline" and "evaluation" trials, with SV automation level 0, 1, 2, or 3 depending on the highest SAE automation level available on the SV. The main difference between the baseline and evaluation trials is that evaluation trials were performed with the POV present and the baseline trials were performed without the POV. The BSI system was expected to not respond any differently to the presence of the POV compared to a similar baseline test trial without the POV.

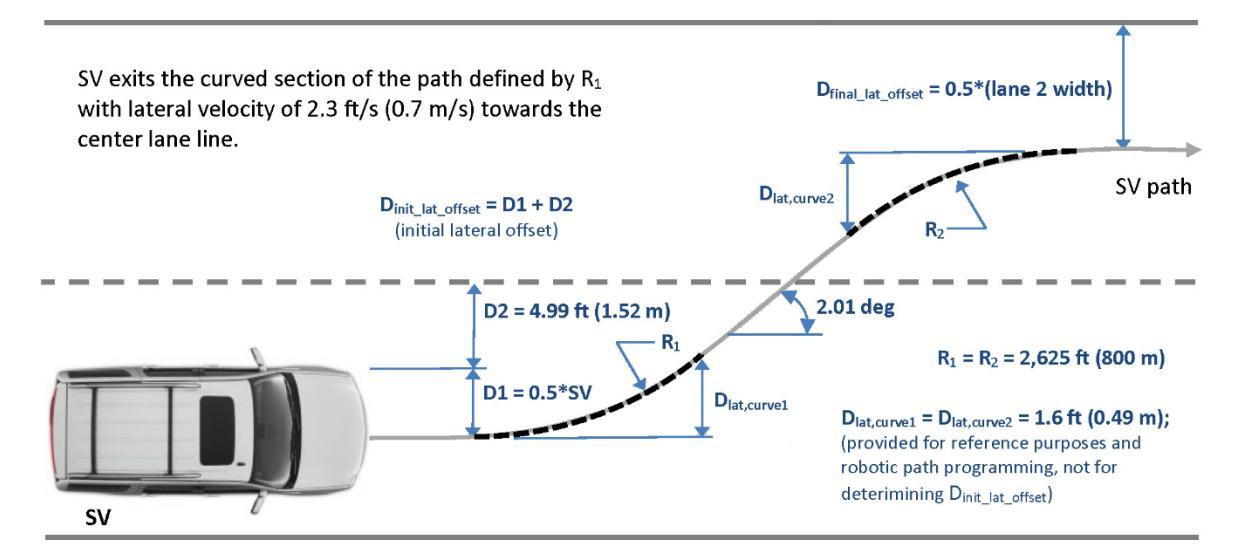
Figure 6. Input Parameters used to define the SV path during the SV Lane Change with Constant Headway, False Positive Scenario

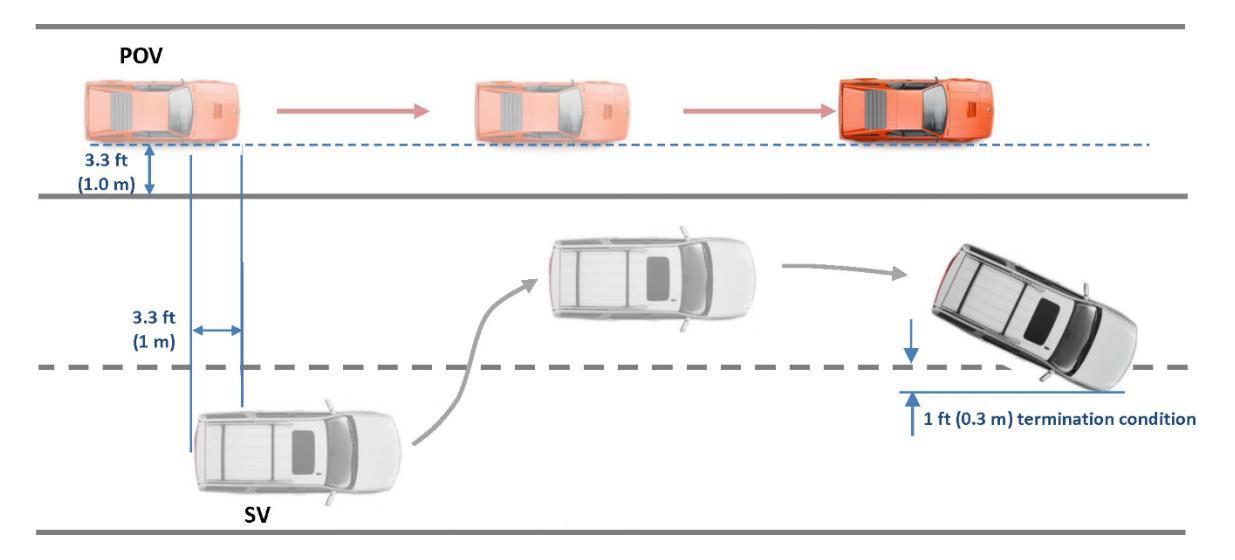
Figure 7. Valid SV Lane Change False Positive Test Interval End Condition 3

- 1. The SV impacted the POV; or
- 2. Five seconds after the SV had completed the single lane change into the left lane adjacent to the SV's original travel lane without a BSI intervention; or
- One second after a BSI intervention caused the SV to travel ≥ 1 ft (0.3 m) beyond the inboard edge of the lane line separating the post lane change SV travel lane and the lane adjacent and to the right of it, as shown in Figure 7.

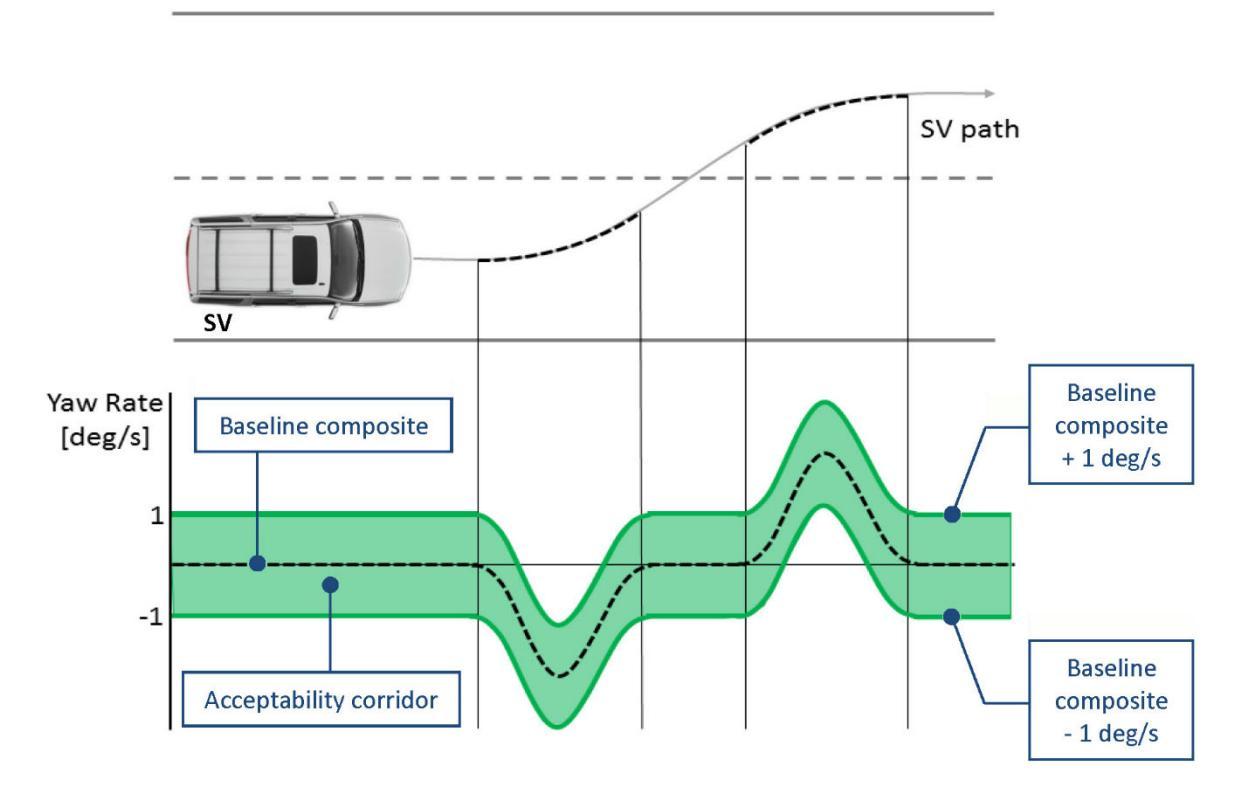
Figure 8. Definition of a Yaw Rate Acceptability Corridor

The first step was to determine an acceptable yaw rate time history corridor for each SV automation condition, as illustrated by the hypothetical example in Figure 8. The

yaw rate time histories for the 3 baseline trials were first synchronized in time so that the onsets of the respective lane changes occurred within 20 ms of each other. The baseline composite yaw rate was then calculated by averaging the yaw rates from the 3 baseline trials, at each time point in the synchronized time history. The acceptability corridor was then the baseline composite yaw rate value  $\pm 1$  deg/s.

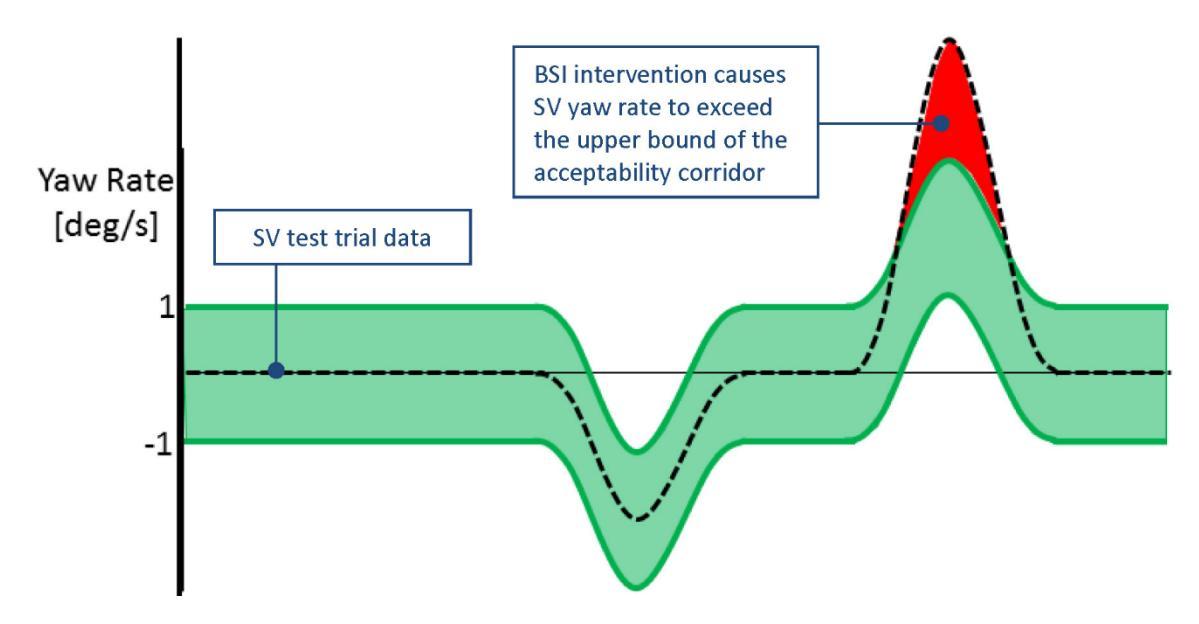
Figure 9. BSI False Positive Example

The second step was to compare the SV yaw rate from each evaluation trial to the acceptable yaw rate time history corridor, as illustrated by the hypothetical example in Figure 9. If, after data synchronization, the SV yaw rate exceeded the acceptability corridor any time during the test validity period defined in Section III.A.3.b, then a false positive intervention test result was determined to have occurred.

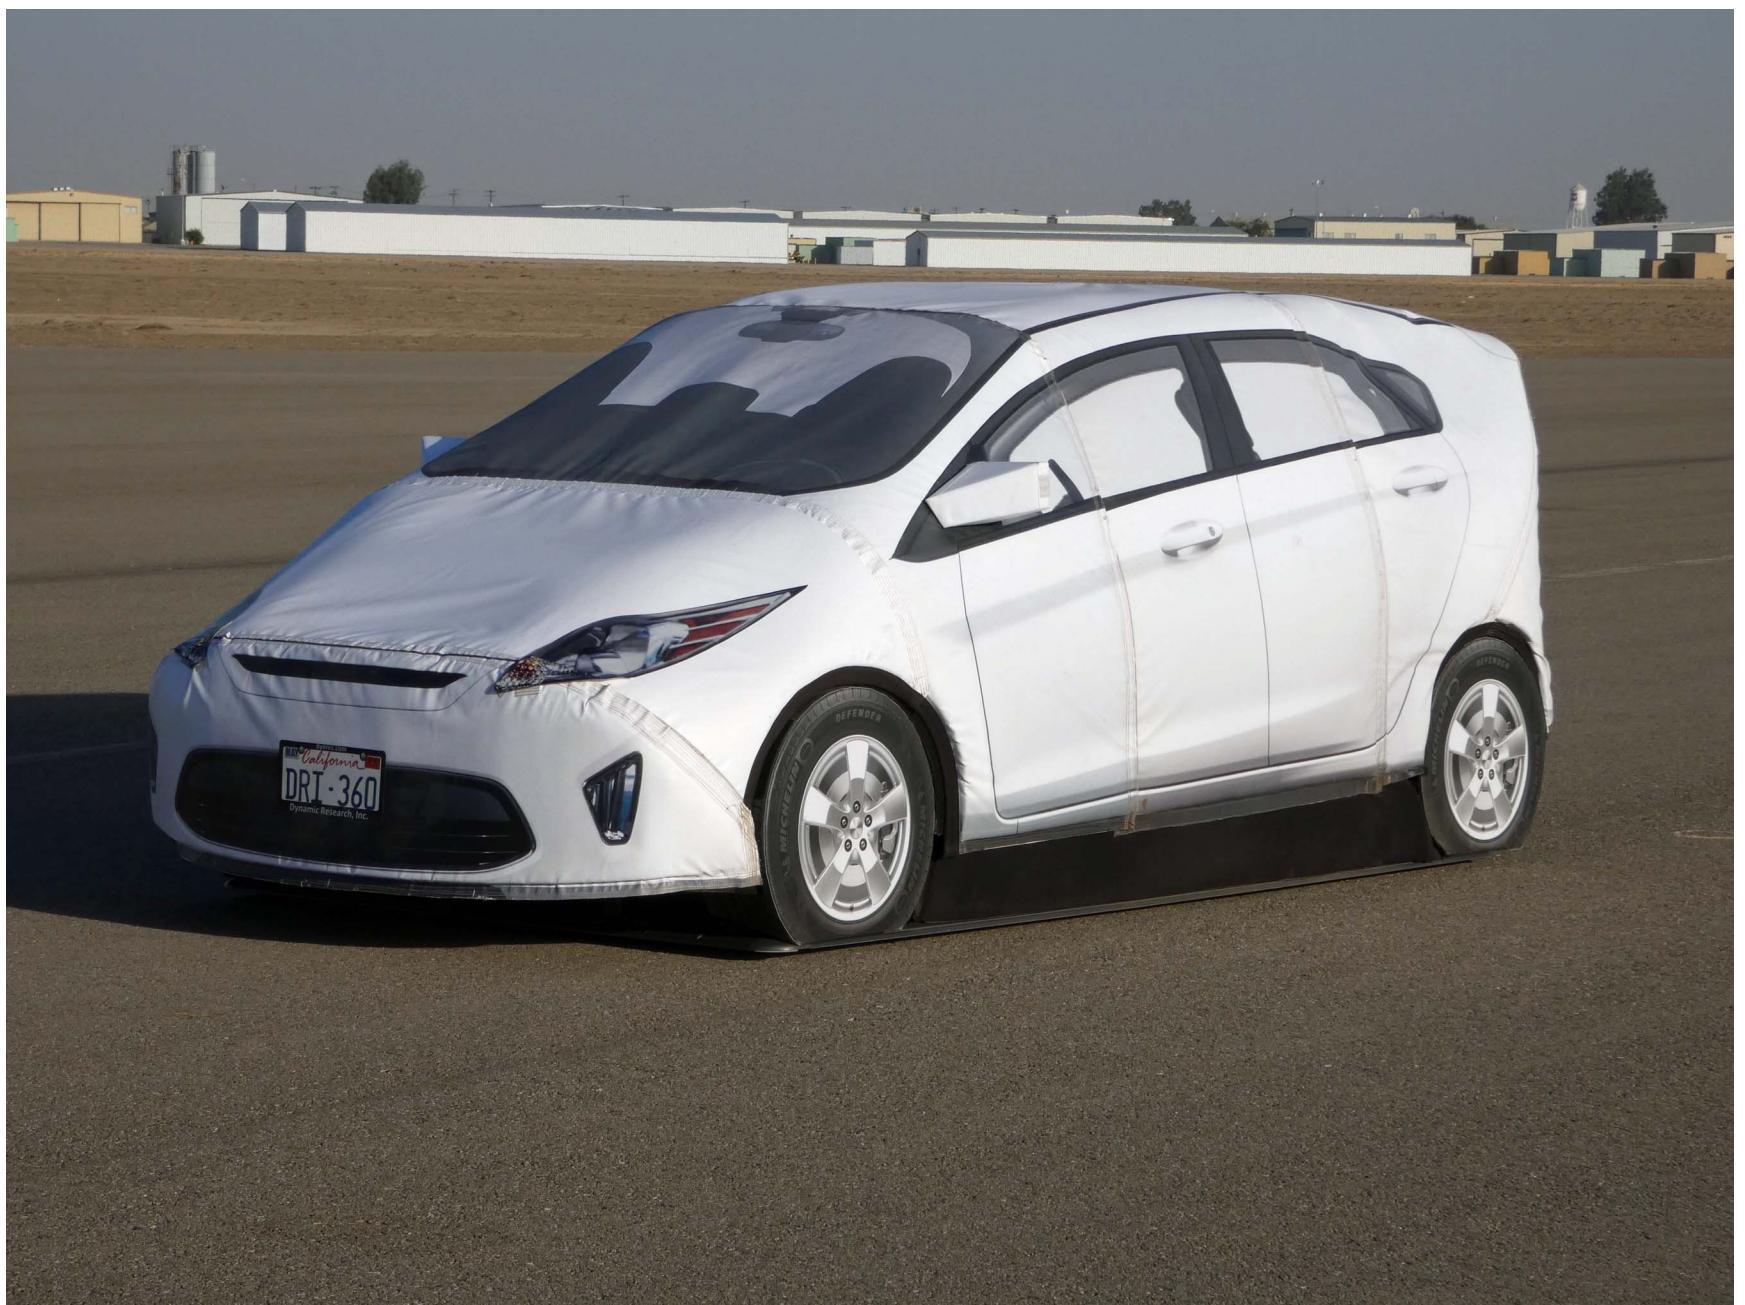
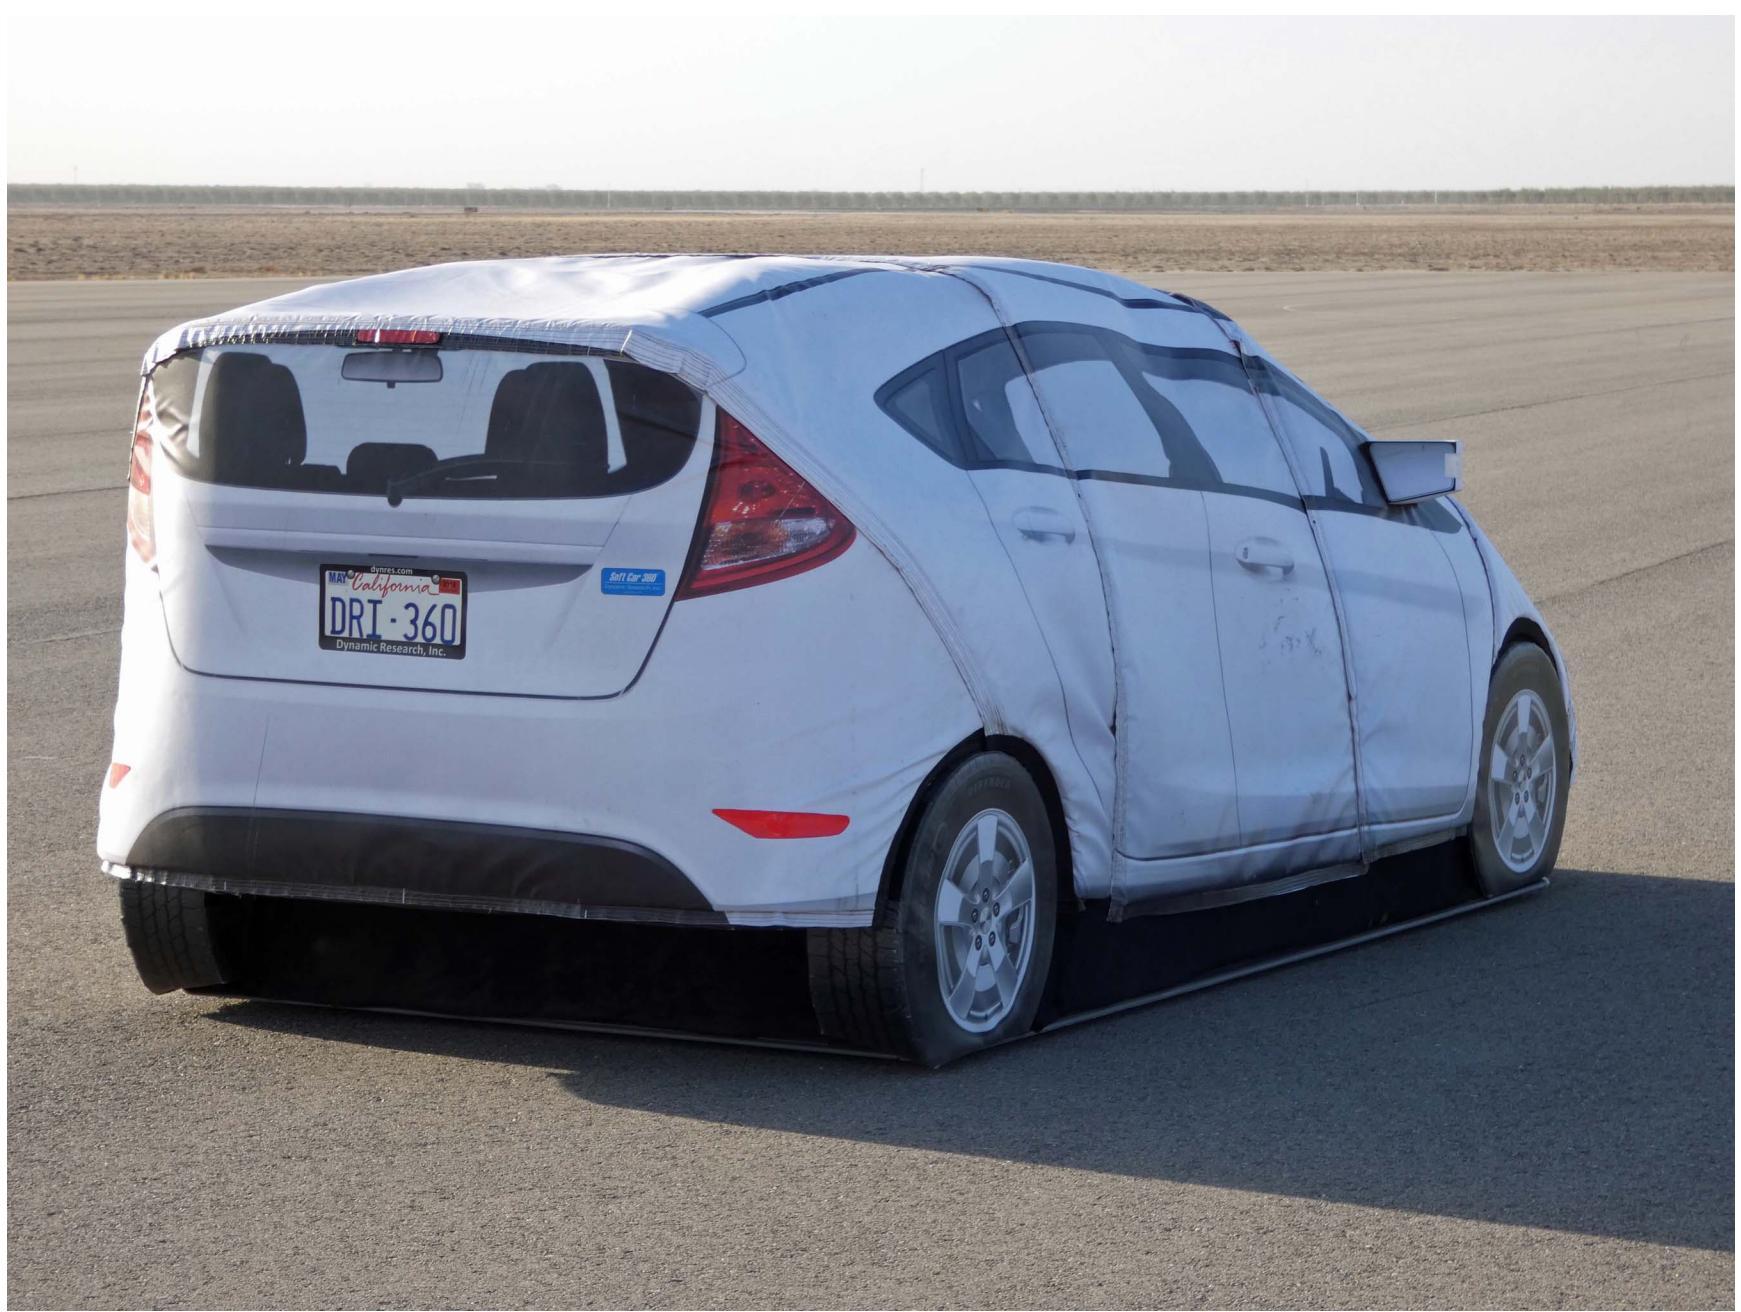
Figure A6. Front View of Principal Other Vehicle - GVT (Tests 1 and 2)

Figure A7. Rear View of Principal Other Vehicle - GVT (Tests 1 and 2)

Operationally, the GVT body is attached to LPRV using Velcro hook and loop fasteners. The GVT and LPRV are designed to separate if the GVT is struck by the SV. The GVT/LPRV system is shown in Figures A6 and A7 in Appendix A and a detailed description can be found in the NHTSA report: "A Test Track Comparison of the Global Vehicle Target (GVT) and NHTSA's Strikeable Surrogate Vehicle (SSV)".<sup>3</sup>

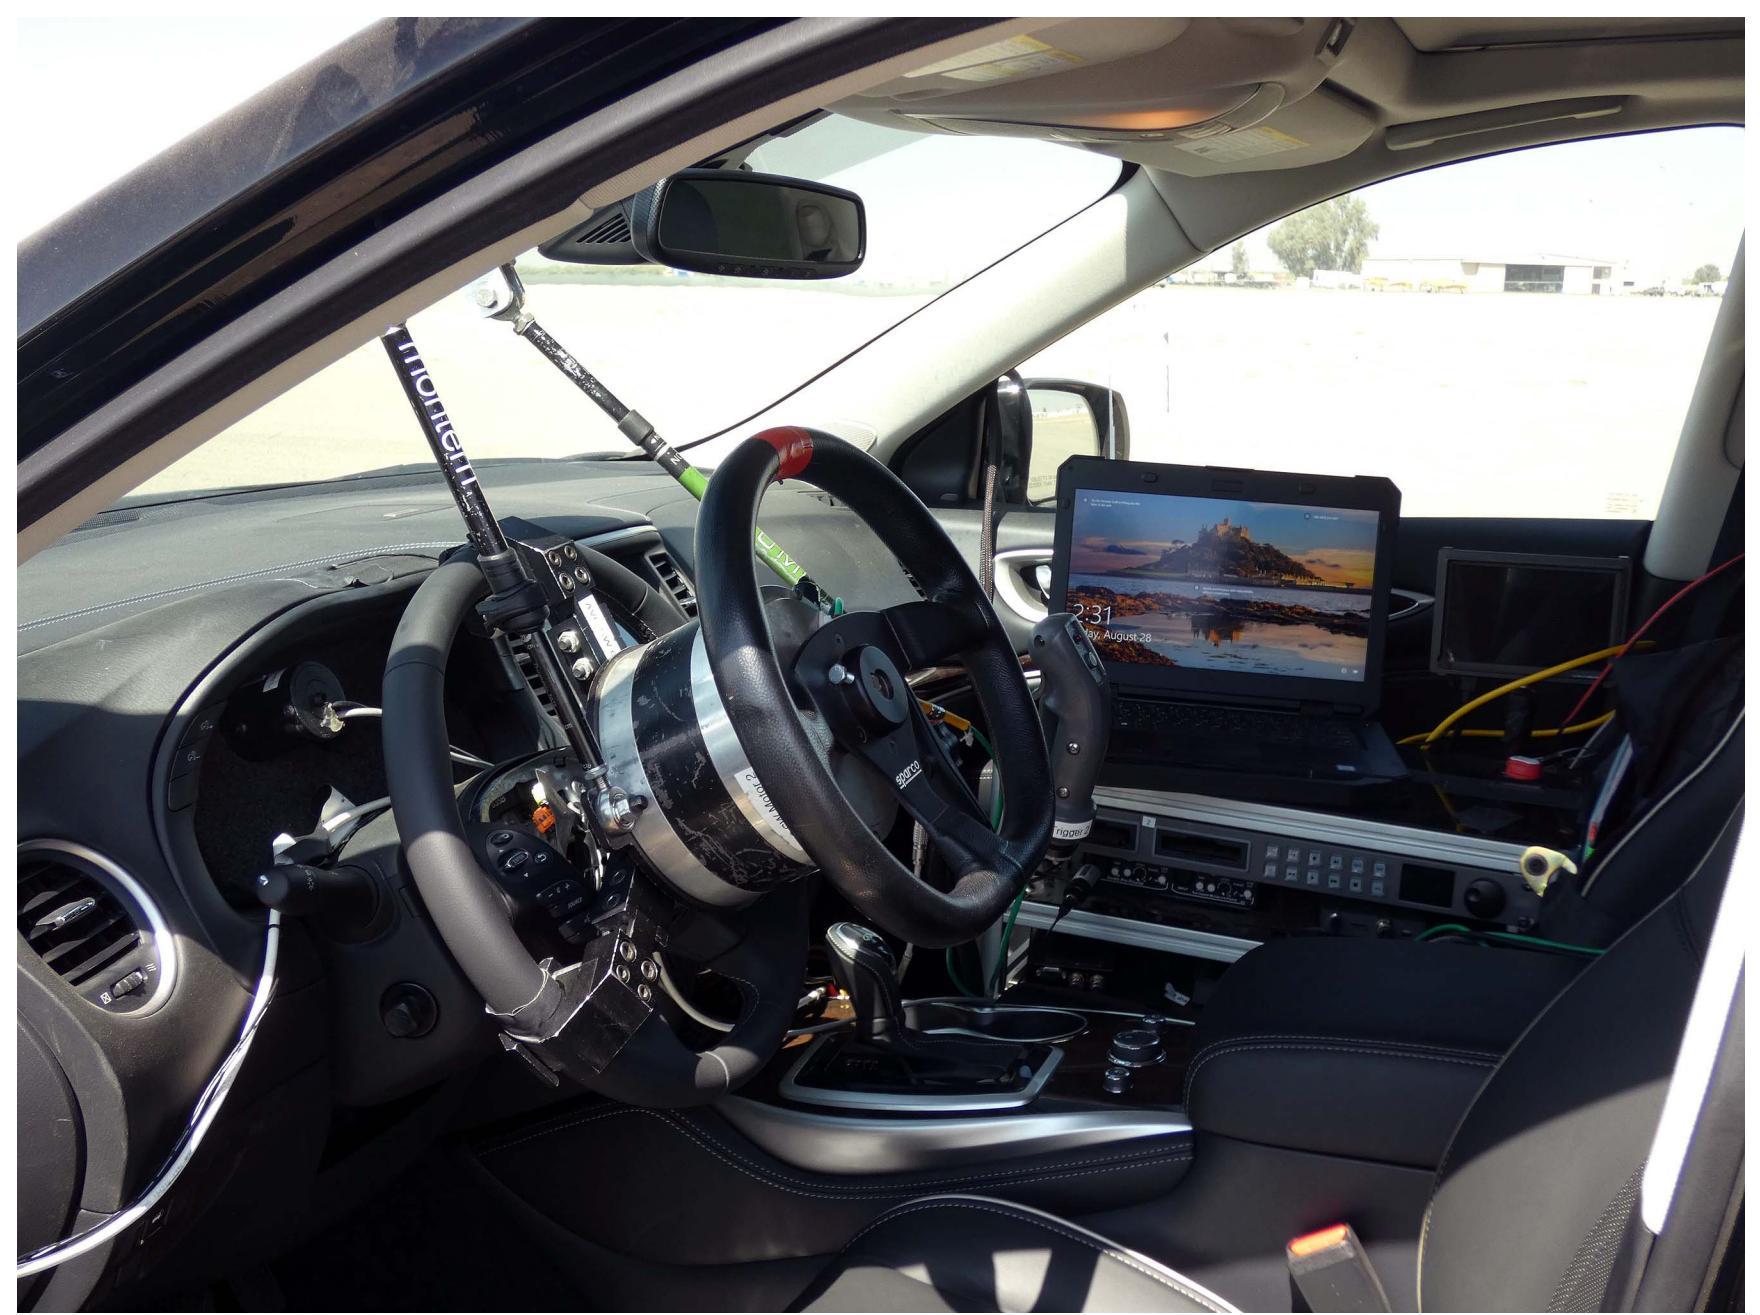
Figure A10. Computer and Steering Controller Installed in Subject Vehicle

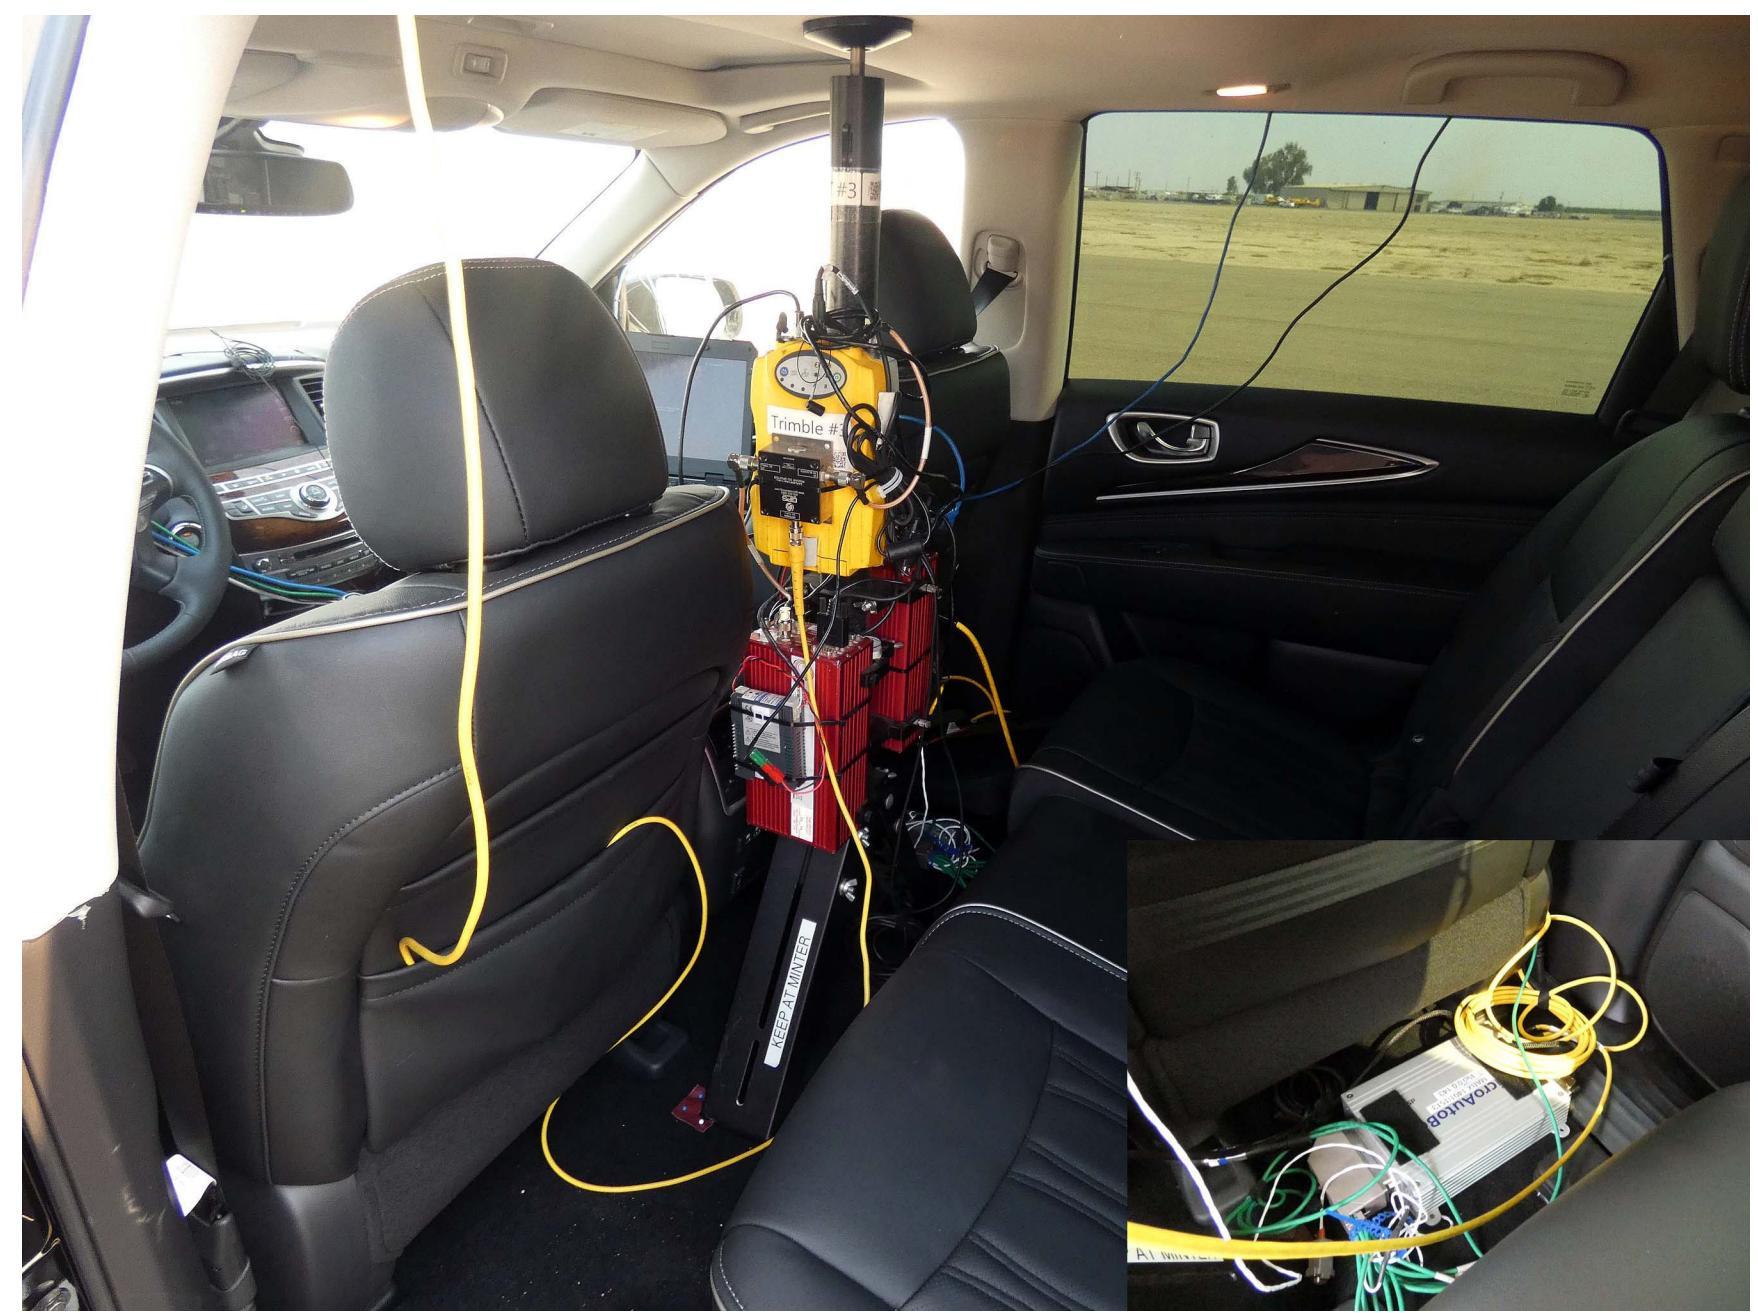
Figure A11. DGPS, Inertial Measurement Unit, and MicroAutoBox Installed in Subject Vehicle

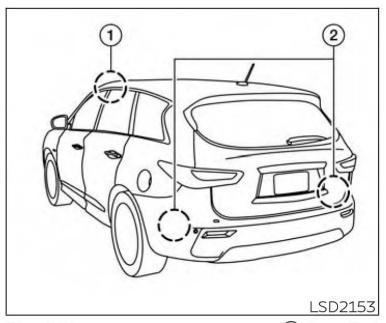
The BSI system uses a camera ① installed behind the windshield to monitor the lane markers of your traveling lane and radar senors ② installed near the rear bumper to detect other vehicles in an adjacent lane.

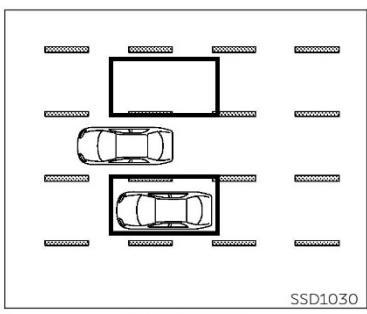
Detection zone

The BSI system operates above approximately 37 mph (60 km/h). If the system detects a vehicle in the detection zone and your vehicle is approaching the lane marker, the BSI system provides an audible warning (three times), flashes the side indicator light and slightly applies the brakes for a short period of time on one side to help return the vehicle back to the traveling lane. The BSI system provides an audible warning and turns on or flashes the side indicator light even if the BSW system is off.

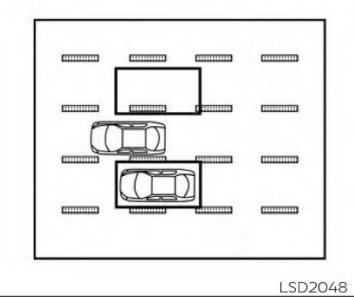
**Illustration 3 – Approaching from behind** Illustration 3: If the BSI system is on and your vehicle is approaching a lane marker and a vehicle is in the detection zone, the system chimes a sound (three times), and the side indicator light flashes. Then the BSI system slightly applies the brakes on one side to help return the vehicle back to the center of the driving lane.

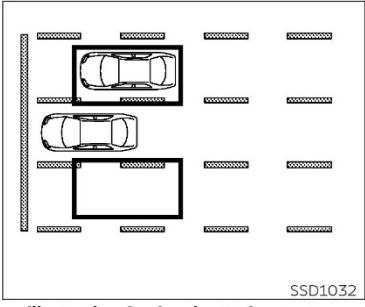
Illustration 4 – Accelerate from a stop NOTE:

Illustration 4: If you accelerate from a stop with a vehicle in the detection zone, the other vehicle may not be detected.

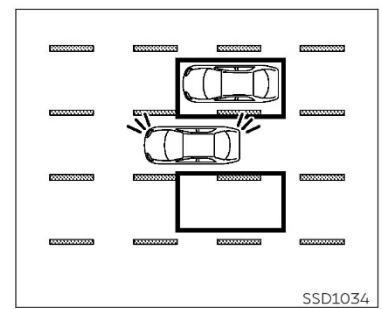
Illustration 6 - Overtaking another vehicle Illustration 6: If the driver activates the turn signal while another vehicle is in the detection zone, then the system chimes a sound (twice) and the side indicator light flashes.

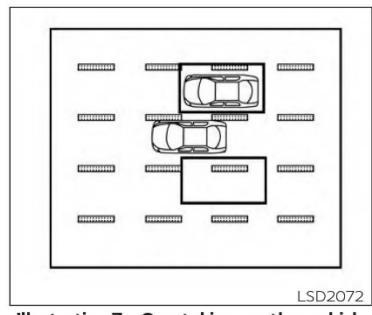
**Illustration 7 - Overtaking another vehicle** Illustration 7: If the BSI system is on and your vehicle approaches a lane marker while another vehicle is in the detection zone the system chimes a sound (three times) and the side indicator light flashes. Then, the BSI system slightly applies the brakes on the appropriate side to help return the vehicle back to the center of the driving lane.

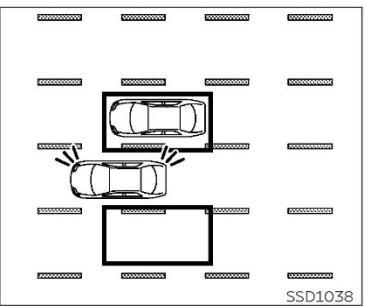
Illustration 10 – Entering from the side Illustration 10: If the driver activates the turn signal while another vehicle is in the detection zone, then the side indicator light flashes and a chime will sound twice.

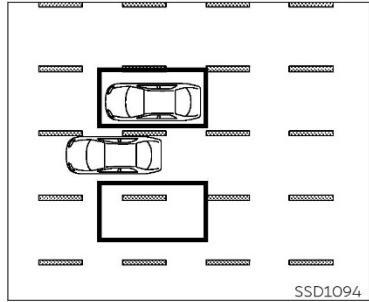
**Illustration 11 - Entering from the side** Illustration 11: If the BSI system is on and your vehicle approaches the lane marker while another vehicle is in the detection zone, the side indicator light flashes and a chime will sound three times. Then, the BSI system slightly applies the brakes on the appropriate side to help return the vehicle back to the center of the driving lane.

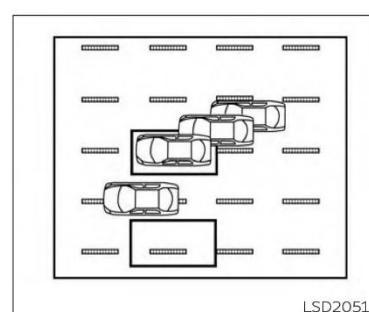
Illustration 12 – Entering from the side NOTE:

- Illustration 12: The BSI system will not operate if your vehicle is on a lane marker when another vehicle enters the detection zone. In this case, only the BSW system operates.
- BSI braking will not operate or will stop operating and only a warning chime will sound under the following conditions:
  - When the brake pedal is depressed.
  - When the vehicle is accelerated during BSI system operation.
- 5-58 Starting and driving

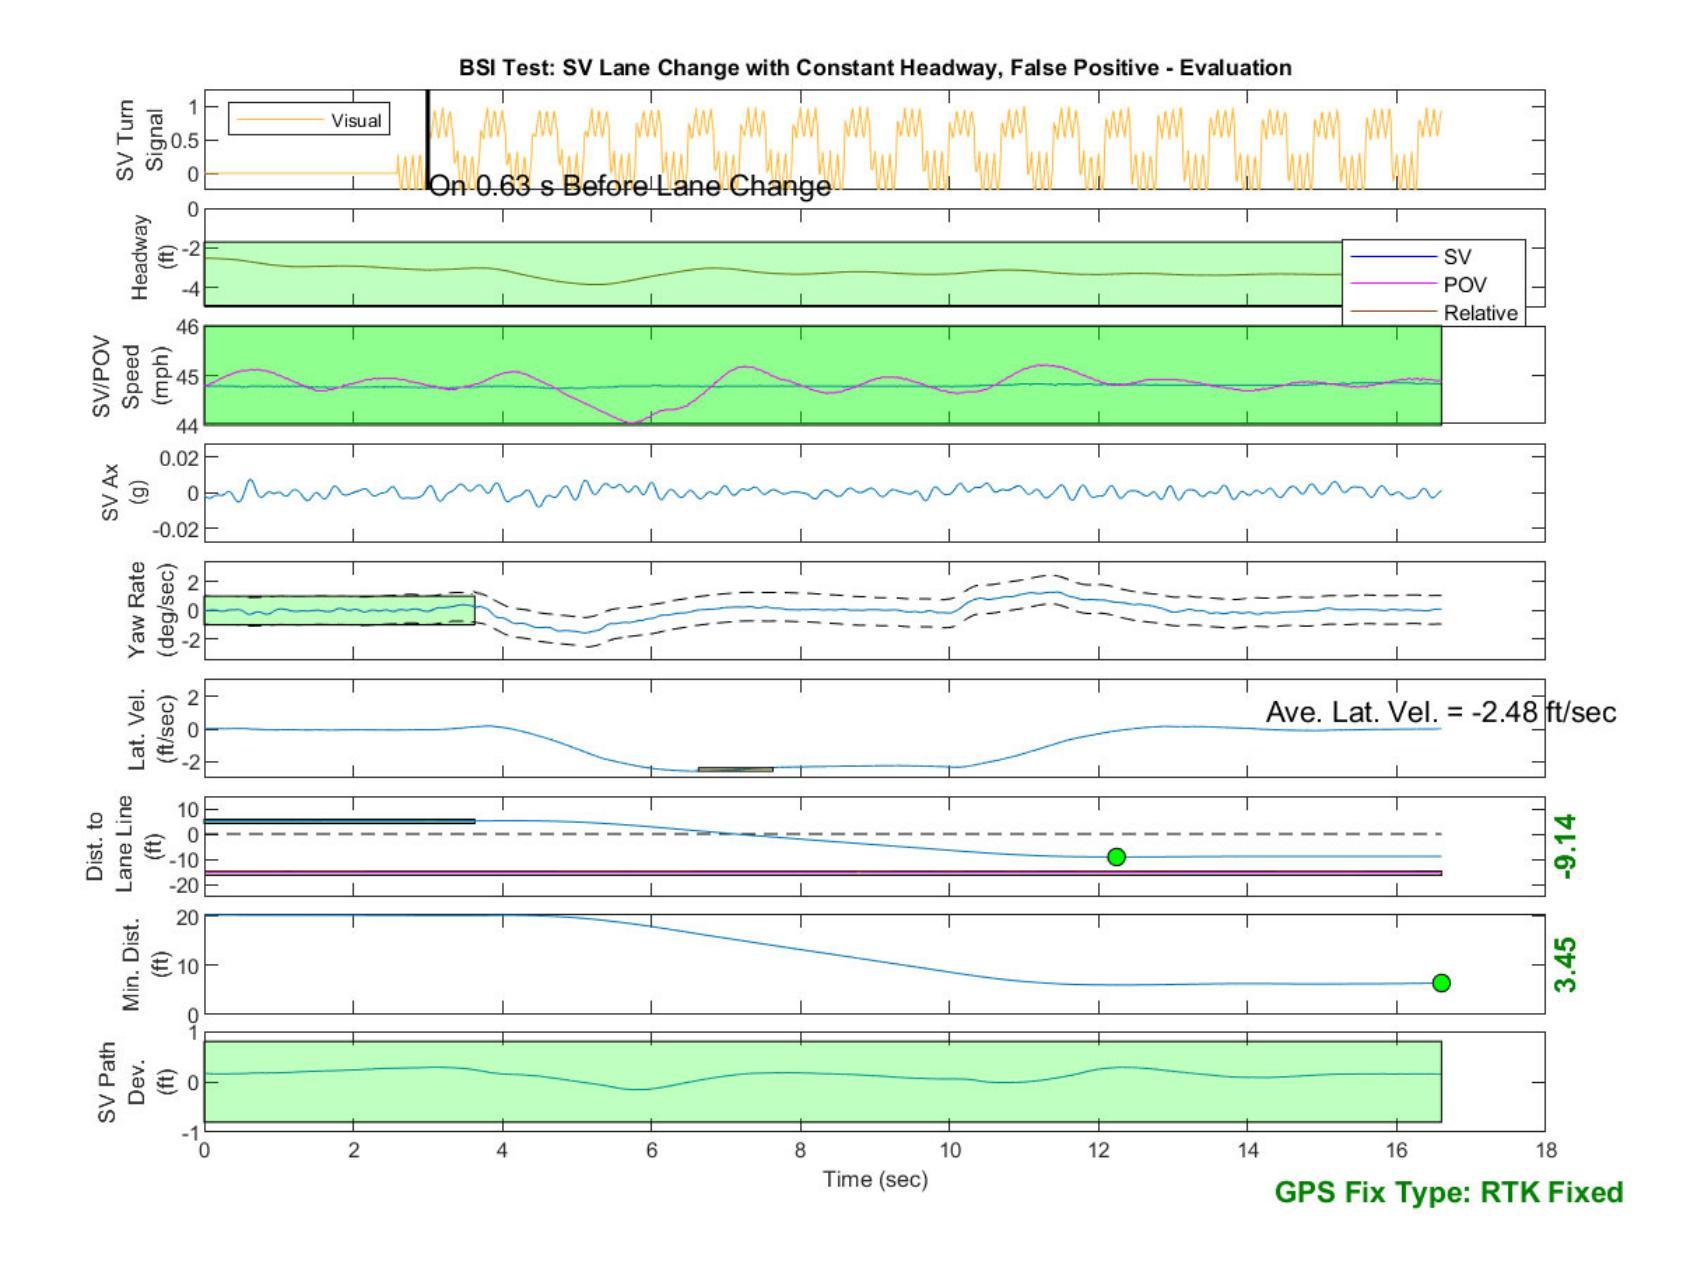
Figure D1. Example Time History for False Positive Evaluation, Passing

Examples of time history plots for each test type (including passing, failing, and invalid runs) are shown in Figures D1 through D3. Time history data plots for the tests of the vehicle under consideration herein are provided beginning with Figure D4.

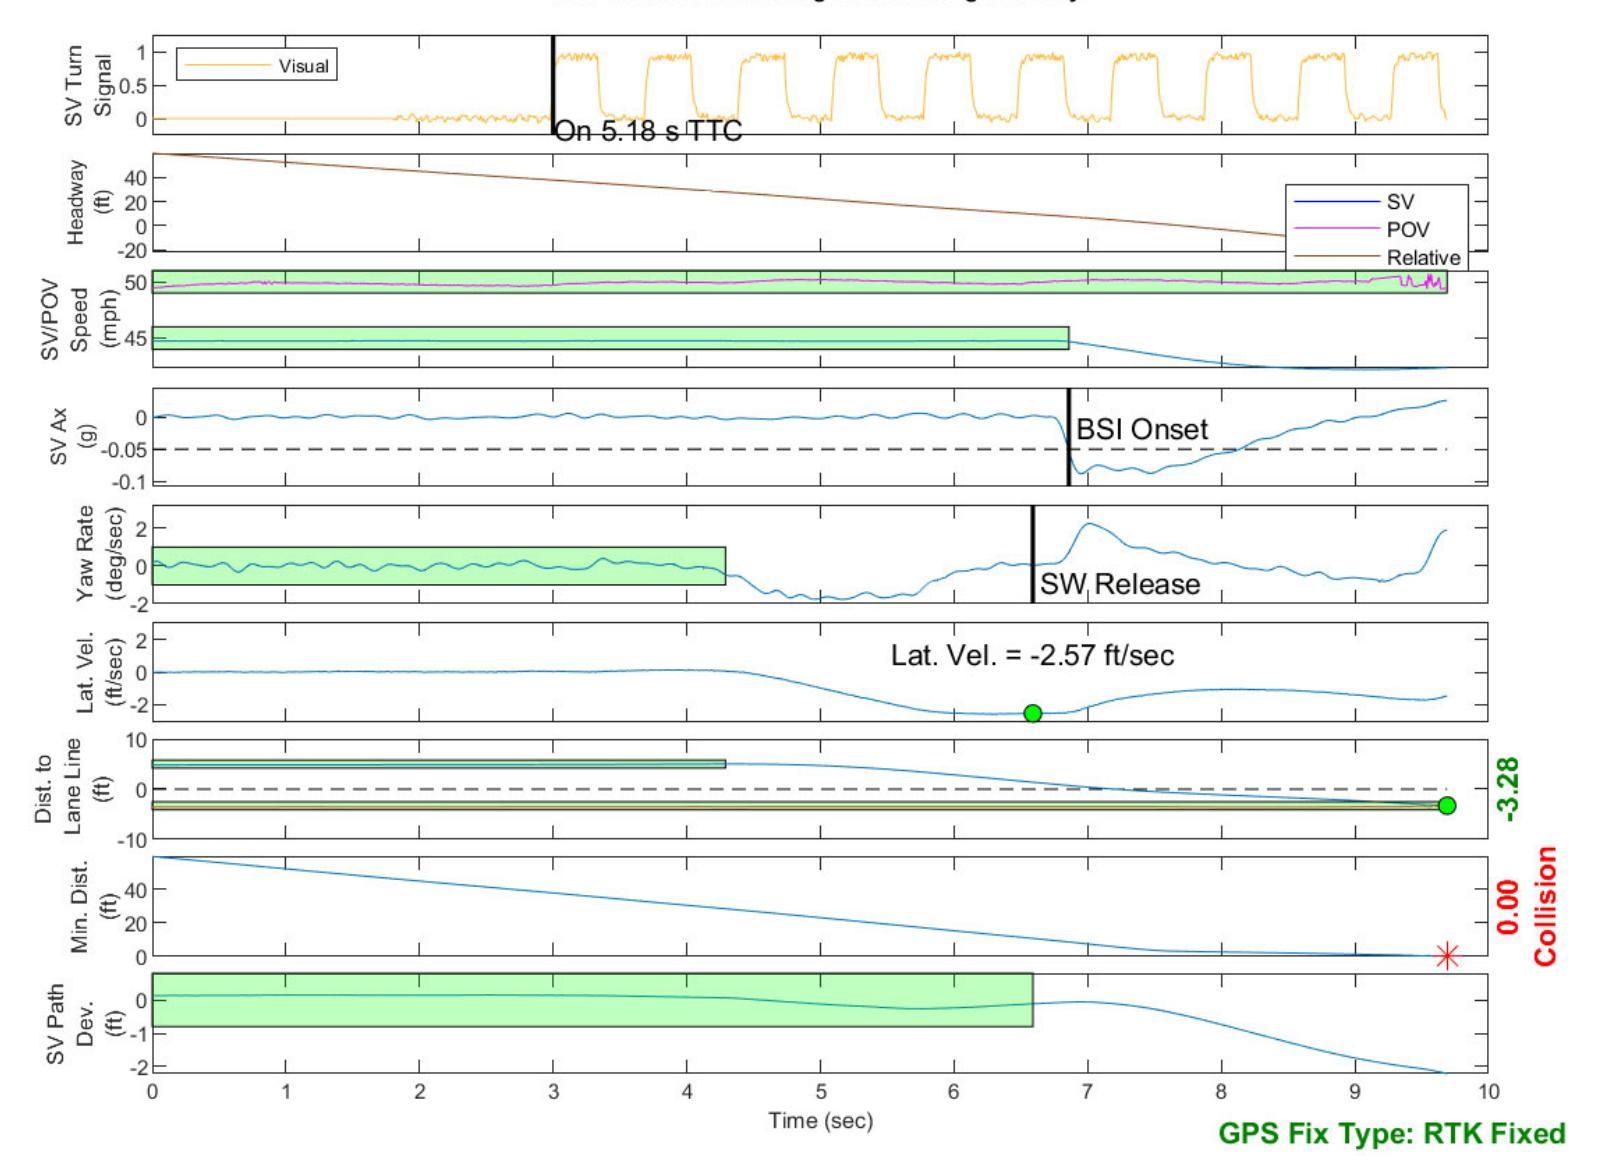
Figure D2. Example Time History for Subject Vehicle with Closing Headway Test, Failing
