### BLIND SPOT INTERVENTION SYSTEM CONFIRMATION TEST NCAP-DRI-BSI-20-05

2020 Infiniti QX60 LUXE

DYNAMIC RESEARCH, INC.

**Final Report**

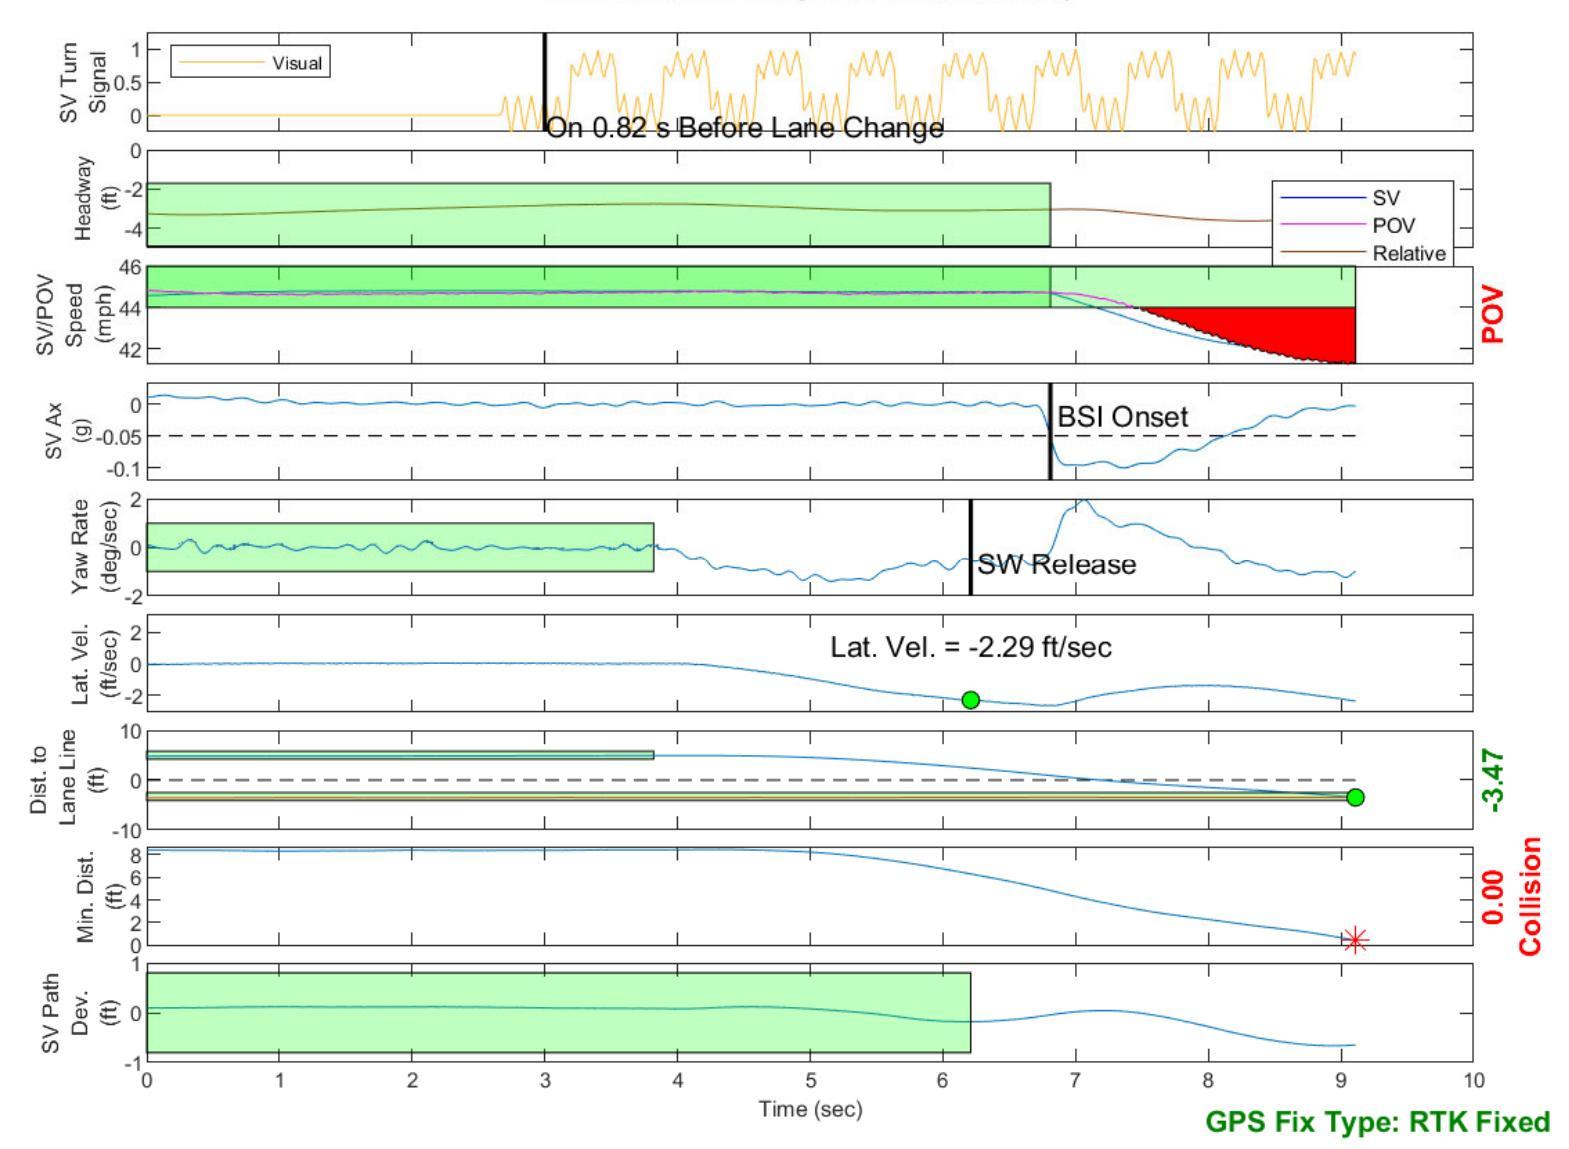
Figure D3. Example Time History for Subject Vehicle with Constant Headway Test, Invalid POV Speed Criteria

Examples of time history plots for each test type (including passing, failing, and invalid runs) are shown in Figures D1 through D3. Time history data plots for the tests of the vehicle under consideration herein are provided beginning with Figure D4.
