NHTSA Evaluation of the Flex-GTR Legform on US Vehicles

Brian Suntay & Ann Mallory
Transportation Research Center Inc.

Jason Stammen
NHTSA Vehicle Research and Test Center

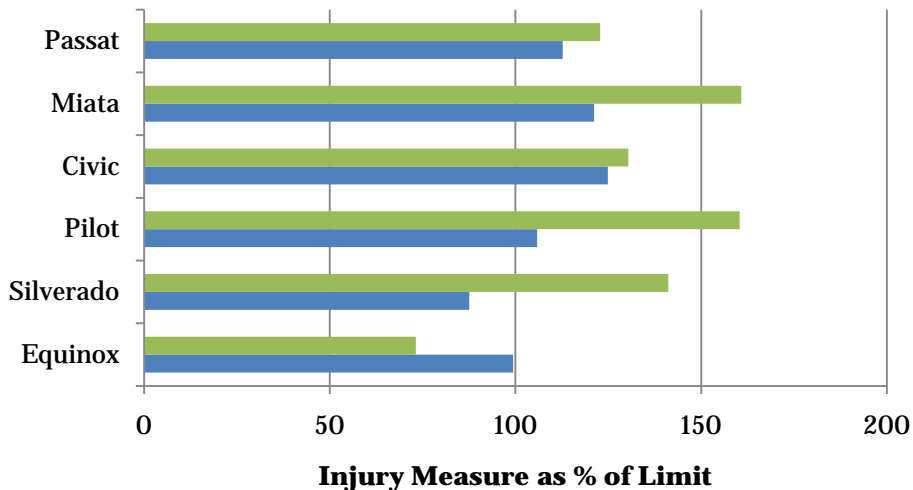
Fracture Measures

■ TRL - Tibia Acceleration ■ Flex-GTR - Max Tibia Bend Moment

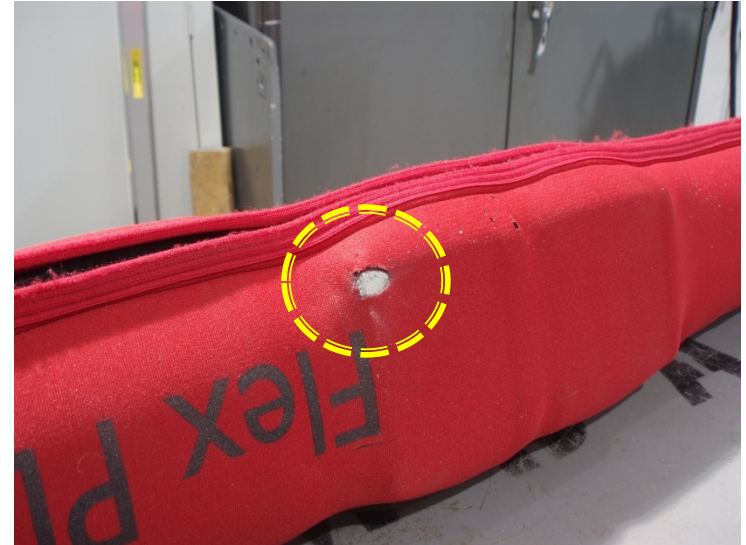
Tear in the neoprene skin and scratches on the femur knee block
