**OCAS-DRI-CIB-19-20
NEW CAR ASSESSMENT PROGRAM
CRASH IMMINENT BRAKE SYSTEM CONFIRMATION TEST**

2019 Subaru Ascent

Final Report

1. Report No. OCAS-DRI-CIB-19-20	2. Government Accession No.	3. Recipient's Catalog No.	
4. Title and Subtitle Final Report of Crash Imminent Brake System Confirmation Testing of a 2019 Subaru Ascent.		5. Report Date 14 November 2019

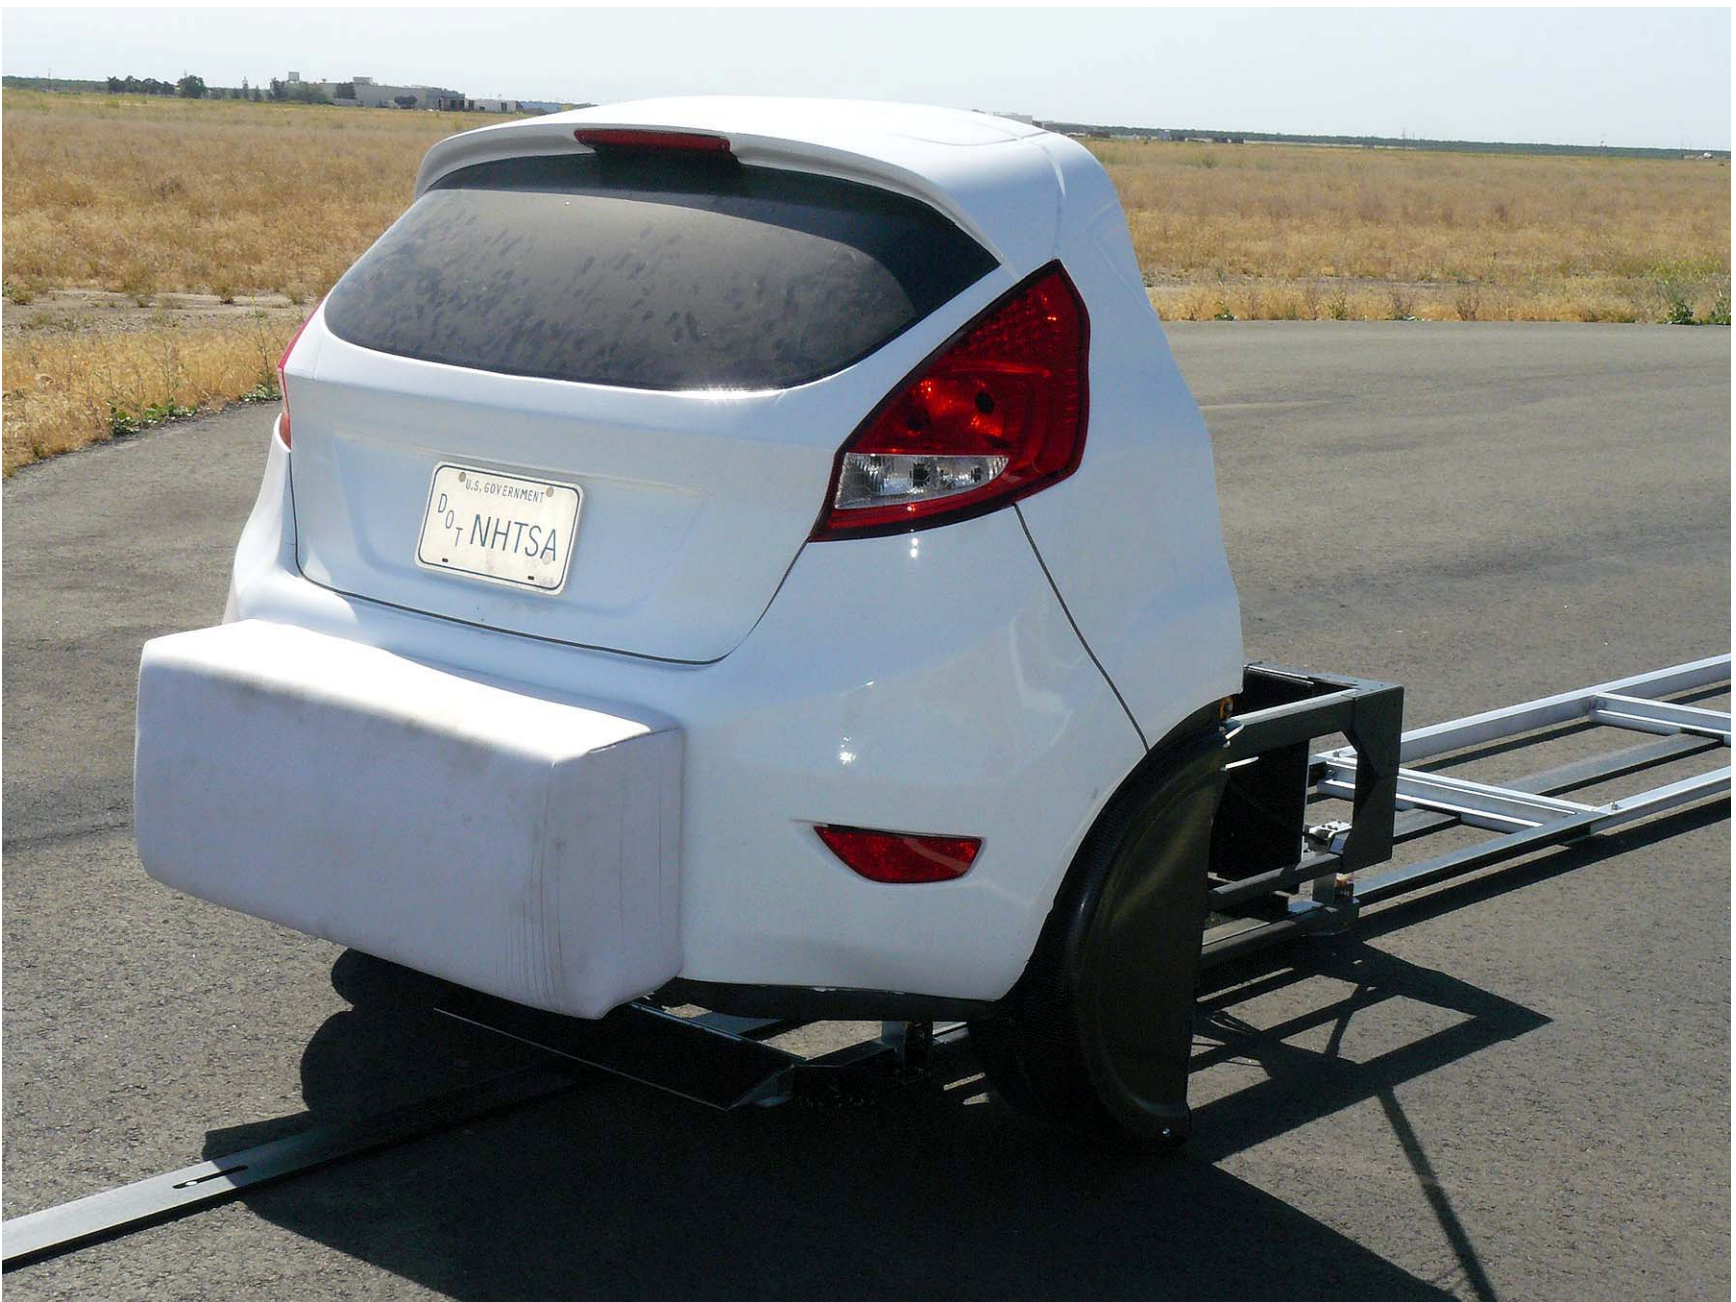
Figure A6. Rear View of Principal Other Vehicle (SSV)

CIB testing requires a POV that realistically represents typical vehicles, does not suffer damage or cause damage to a test vehicle in the event of collision, and can be accurately positioned and moved during the tests. The tests reported herein made use of the NHTSA developed Strikeable Surrogate Vehicle (SSV).

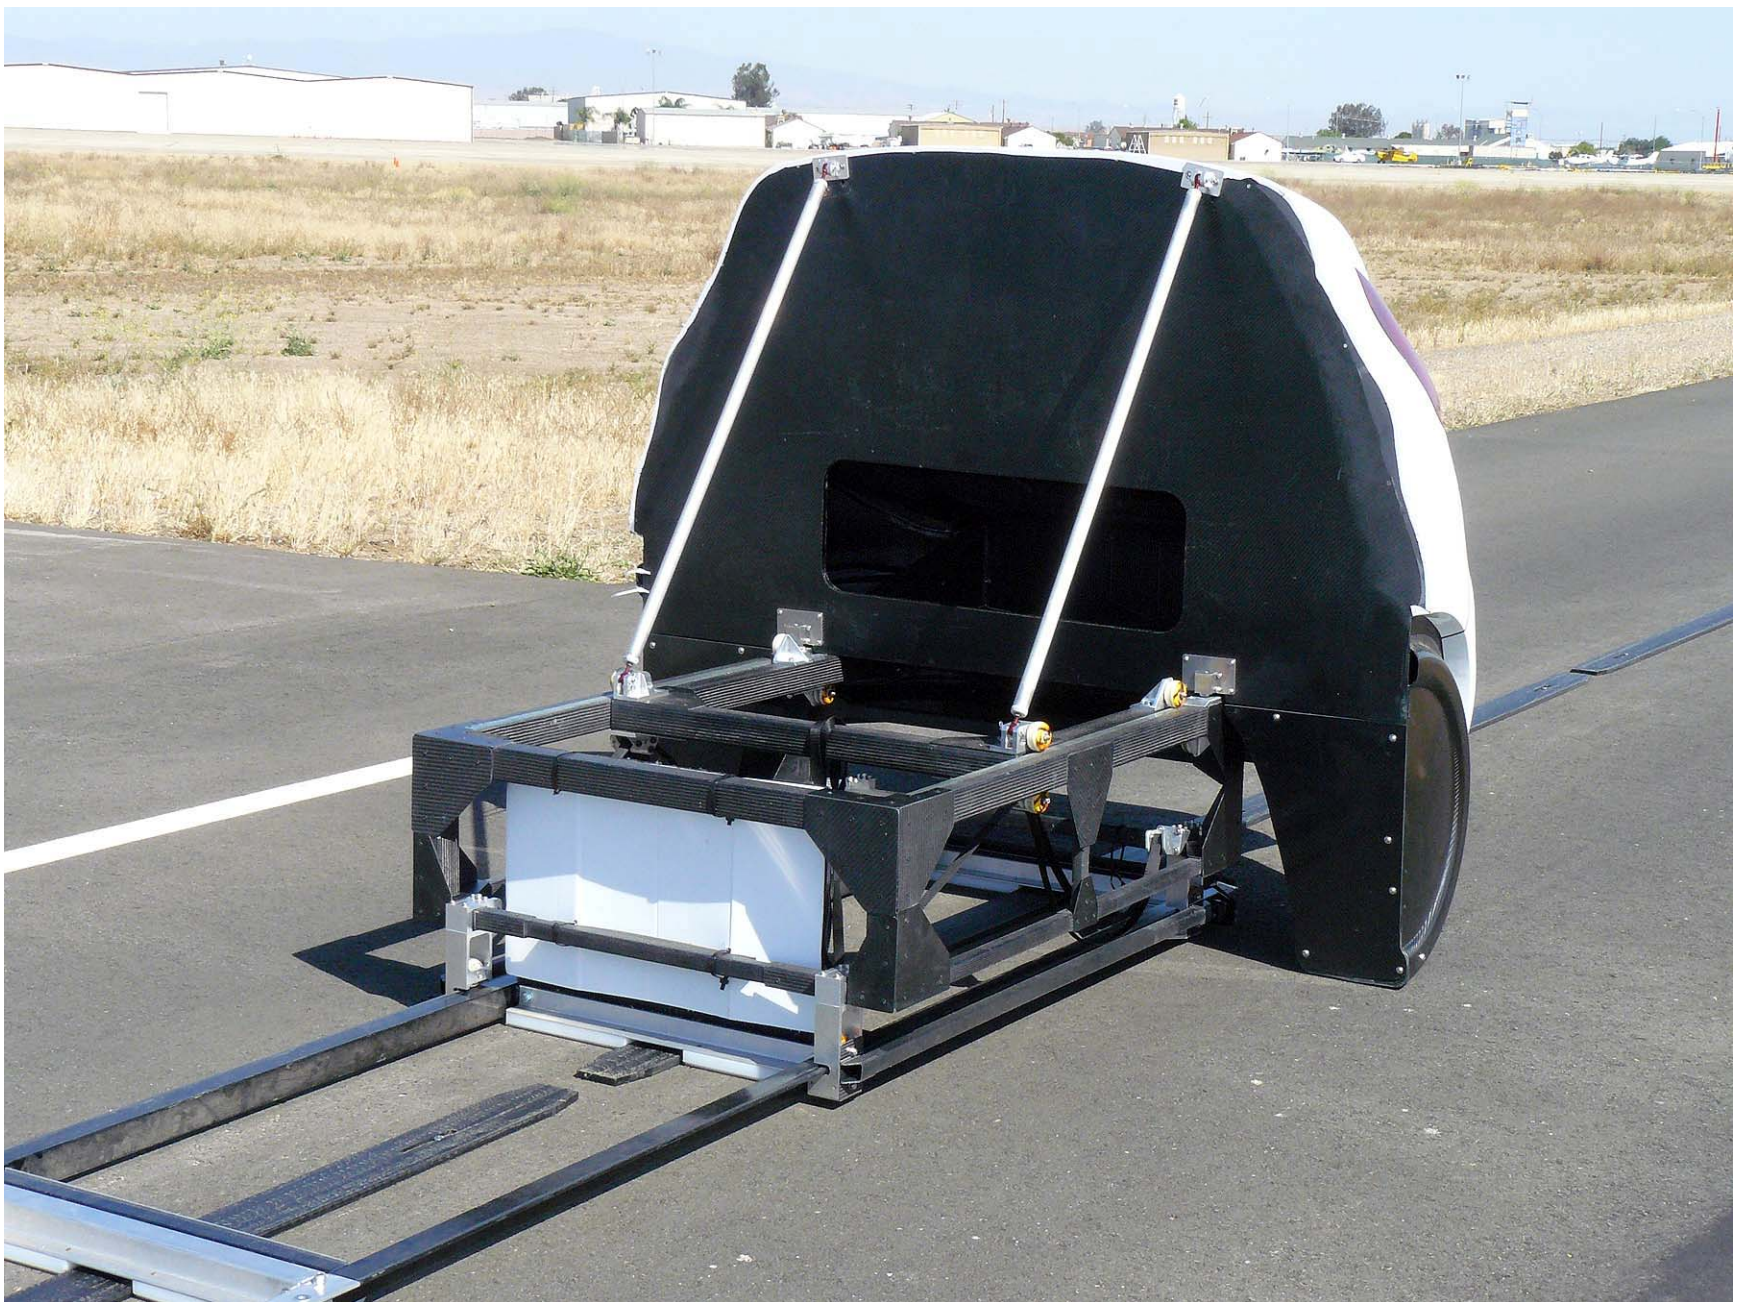
Figure A7. Load Frame/Slider of SSV

from the SV. The forward end of the rail has a cushioned stop to restrain forward motion of the shell/roller assembly. After impacting the SSV, the SV driver uses the steering wheel to maintain SV position in the center of the travel lane, thereby straddling the two-rail track. The SV driver must manually apply the SV brakes after impact. The SSV system is shown in Figures A6 through A8 and a detailed description can be found in the NHTSA report: NHTSA'S STRIKEABLE SURROGATE VEHICLE PRELIMINARY DESIGN + OVERVIEW, May 2013.

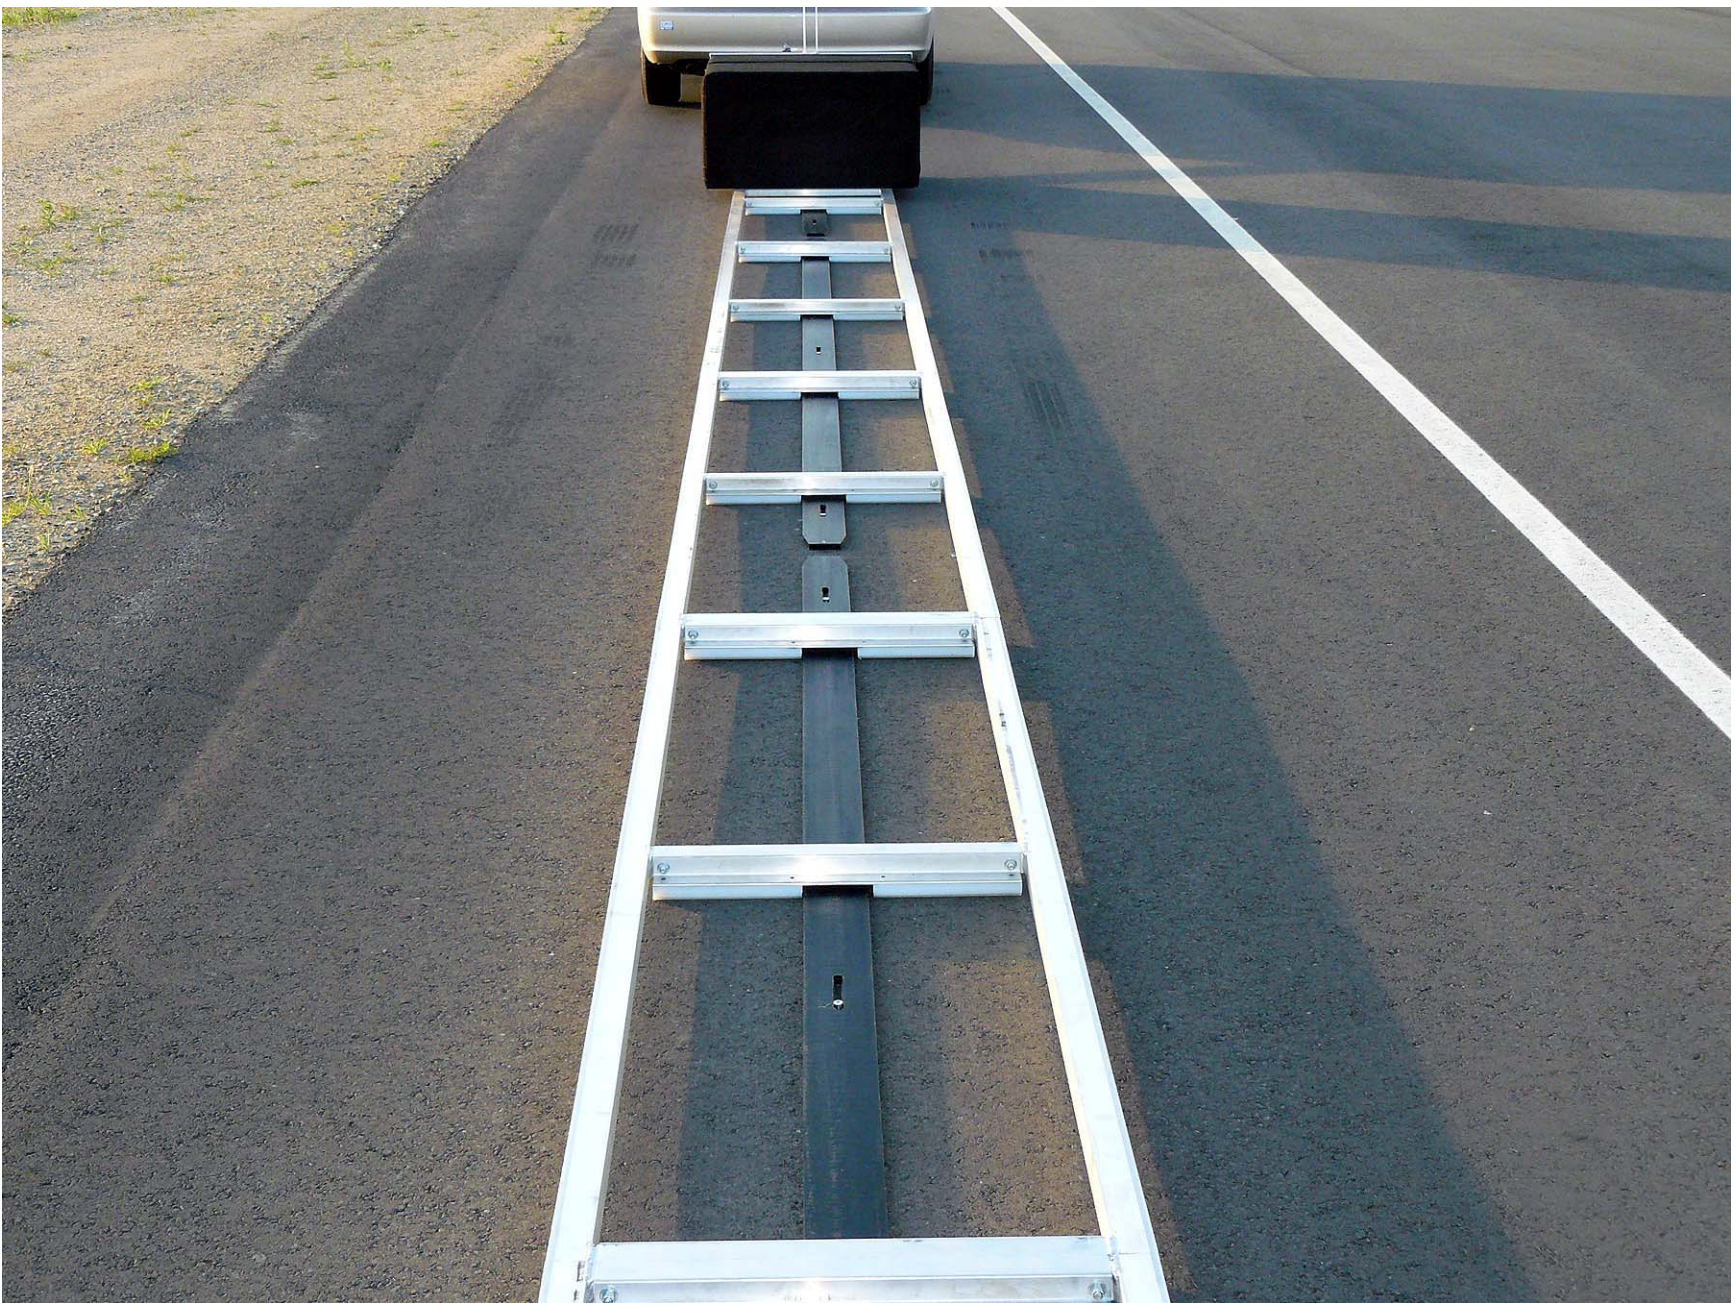
Figure A8. Two-Rail Track and Road-Based Lateral Restraint Track

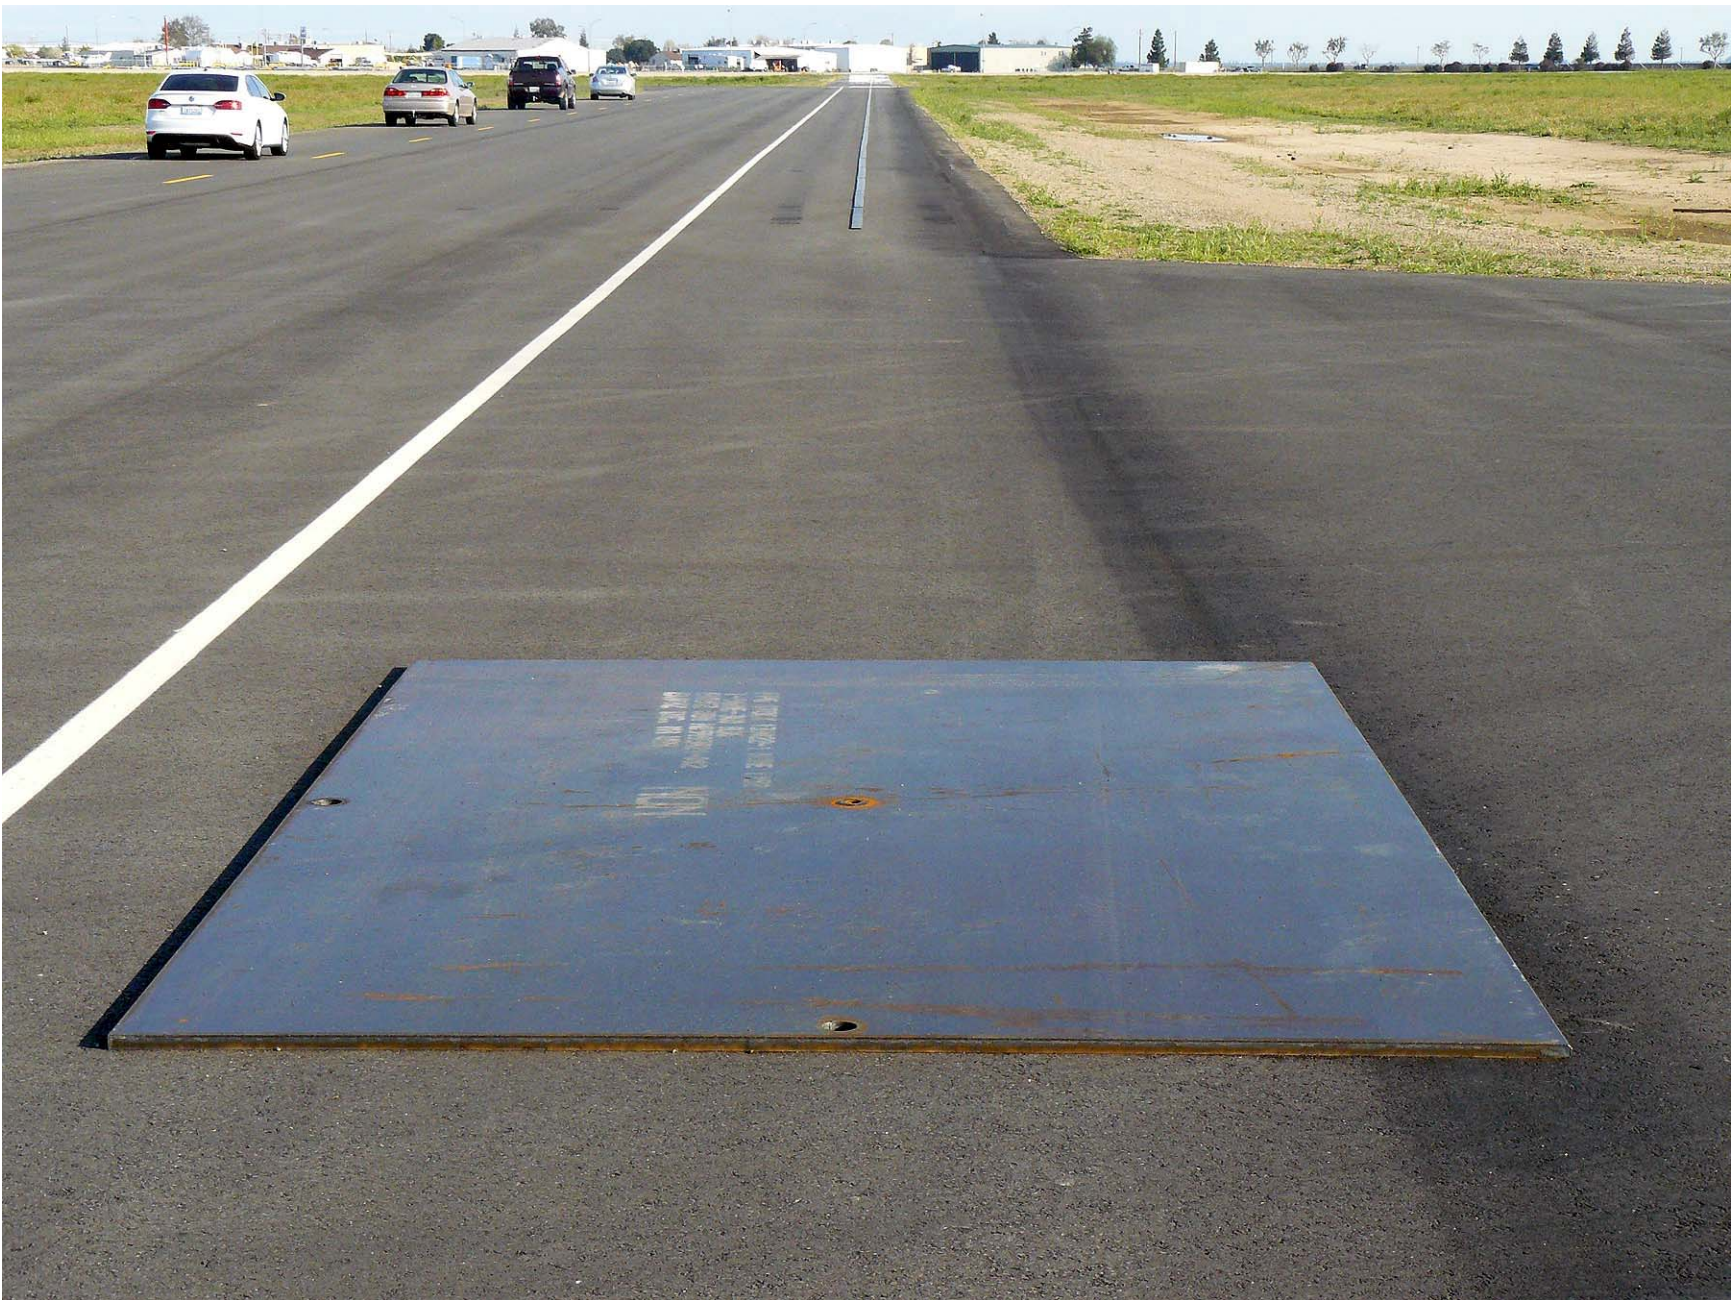
Figure A9. Steel Trench Plate

The false positive suppression test series evaluates the ability of a CIB system to differentiate a steel trench plate (STP) from an object presenting a genuine safety risk to the SV. Although the STP is large and metallic, it is designed to be driven over without risk of injury to the driver or damage to the SV. Therefore, in this scenario, the automatic braking available from CIB is not necessary and should be suppressed. The test condition is nearly equivalent to that previously defined for Test 1, the stopped POV condition, but with an STP in the SV forward path in lieu of a POV.

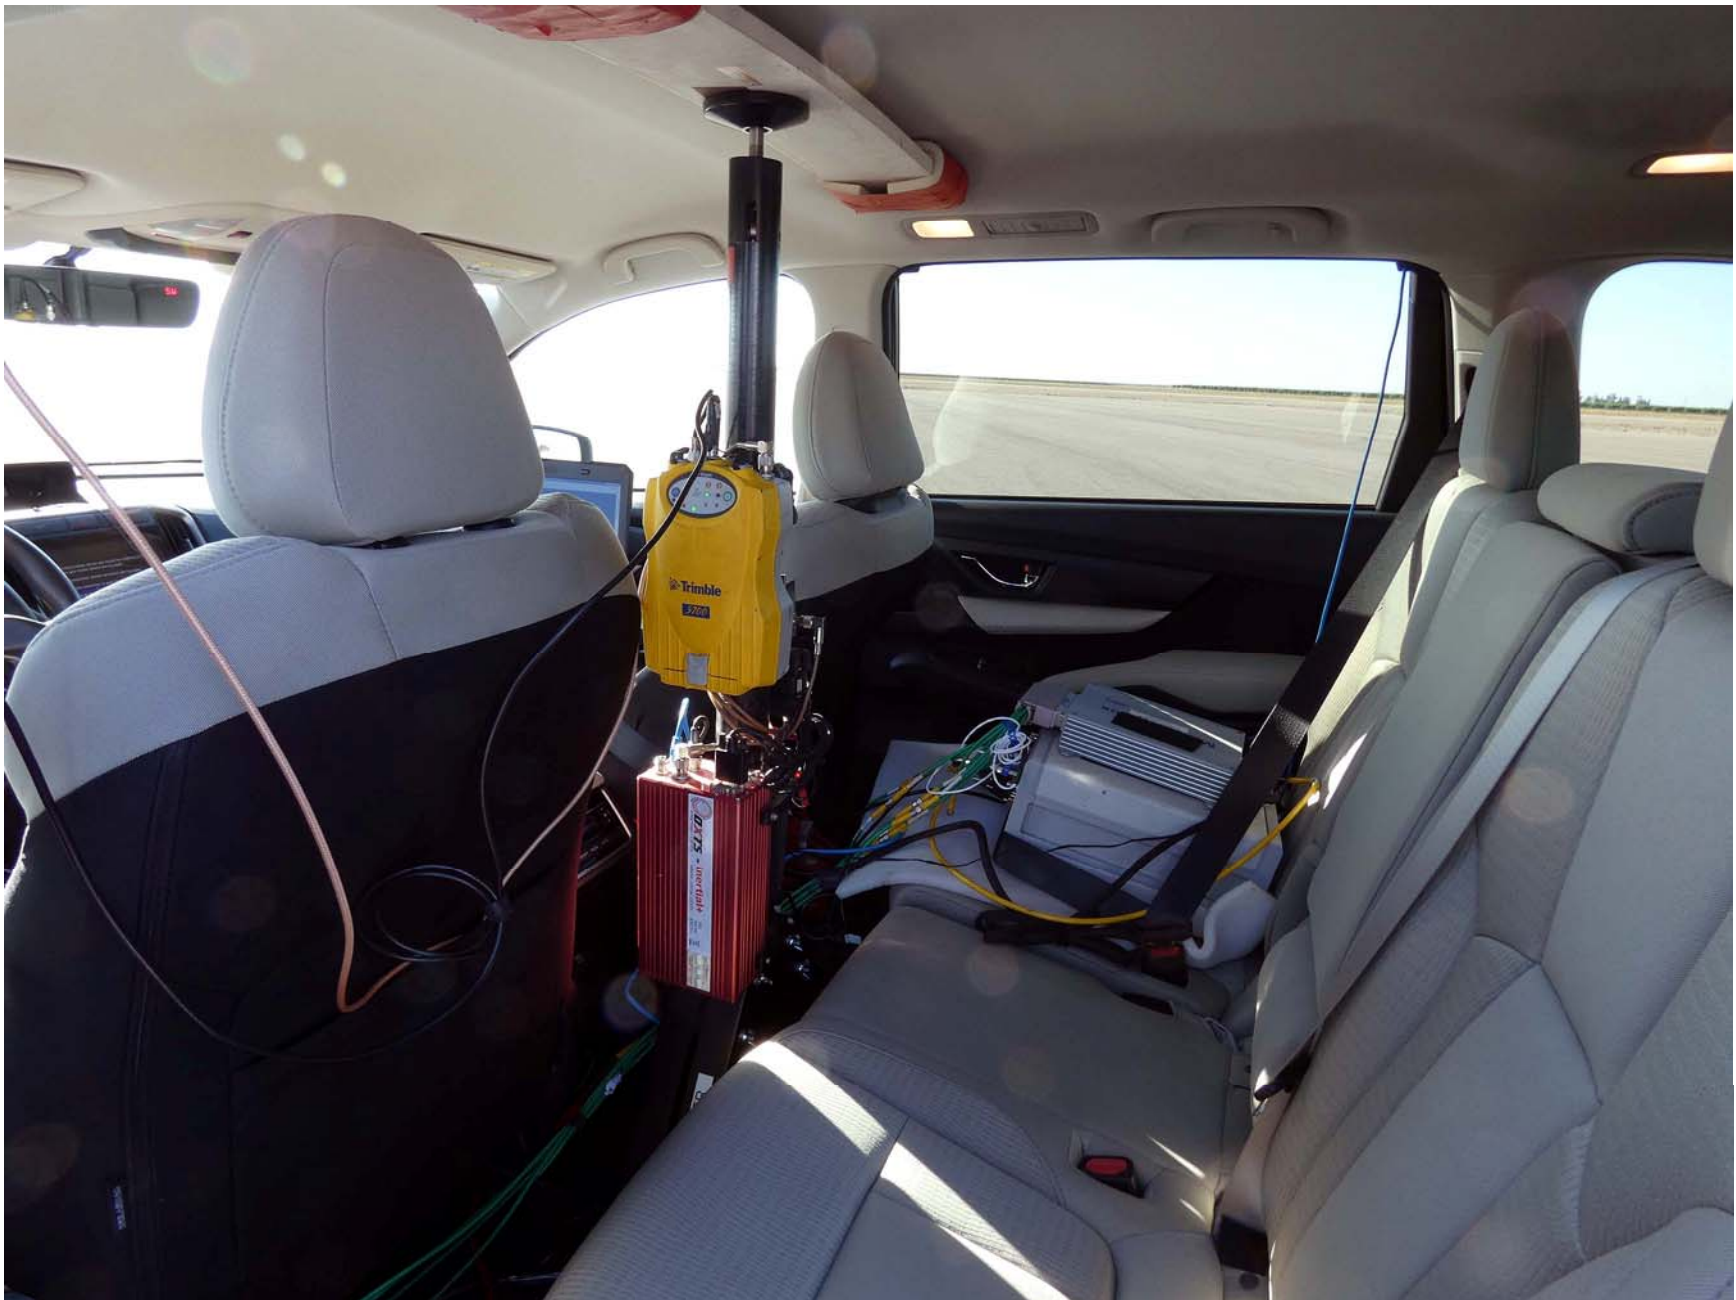
Figure A10. DGPS, Inertial Measurement Unit and MicroAutoBox Installed in Subject Vehicle

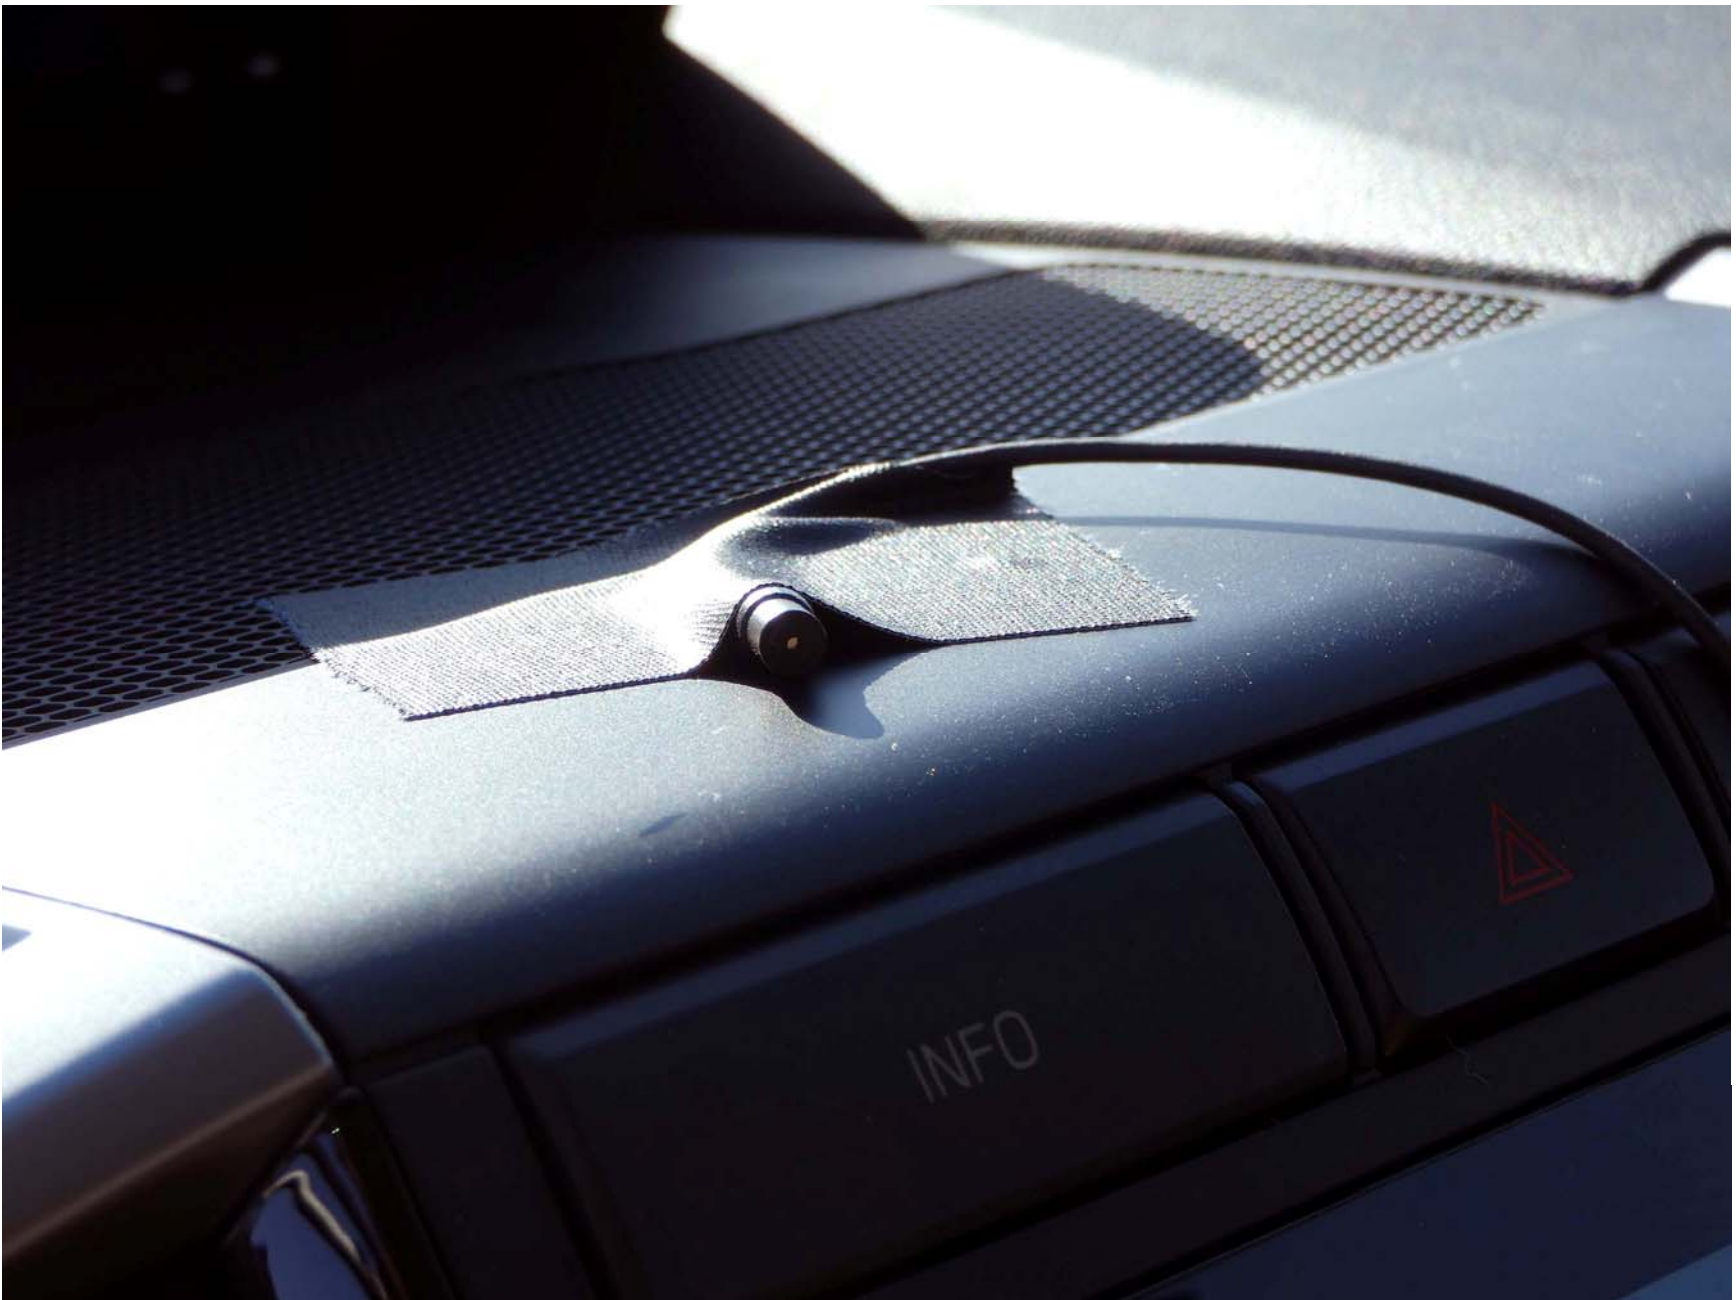
Figure A11. Sensor for Detecting Auditory Alerts

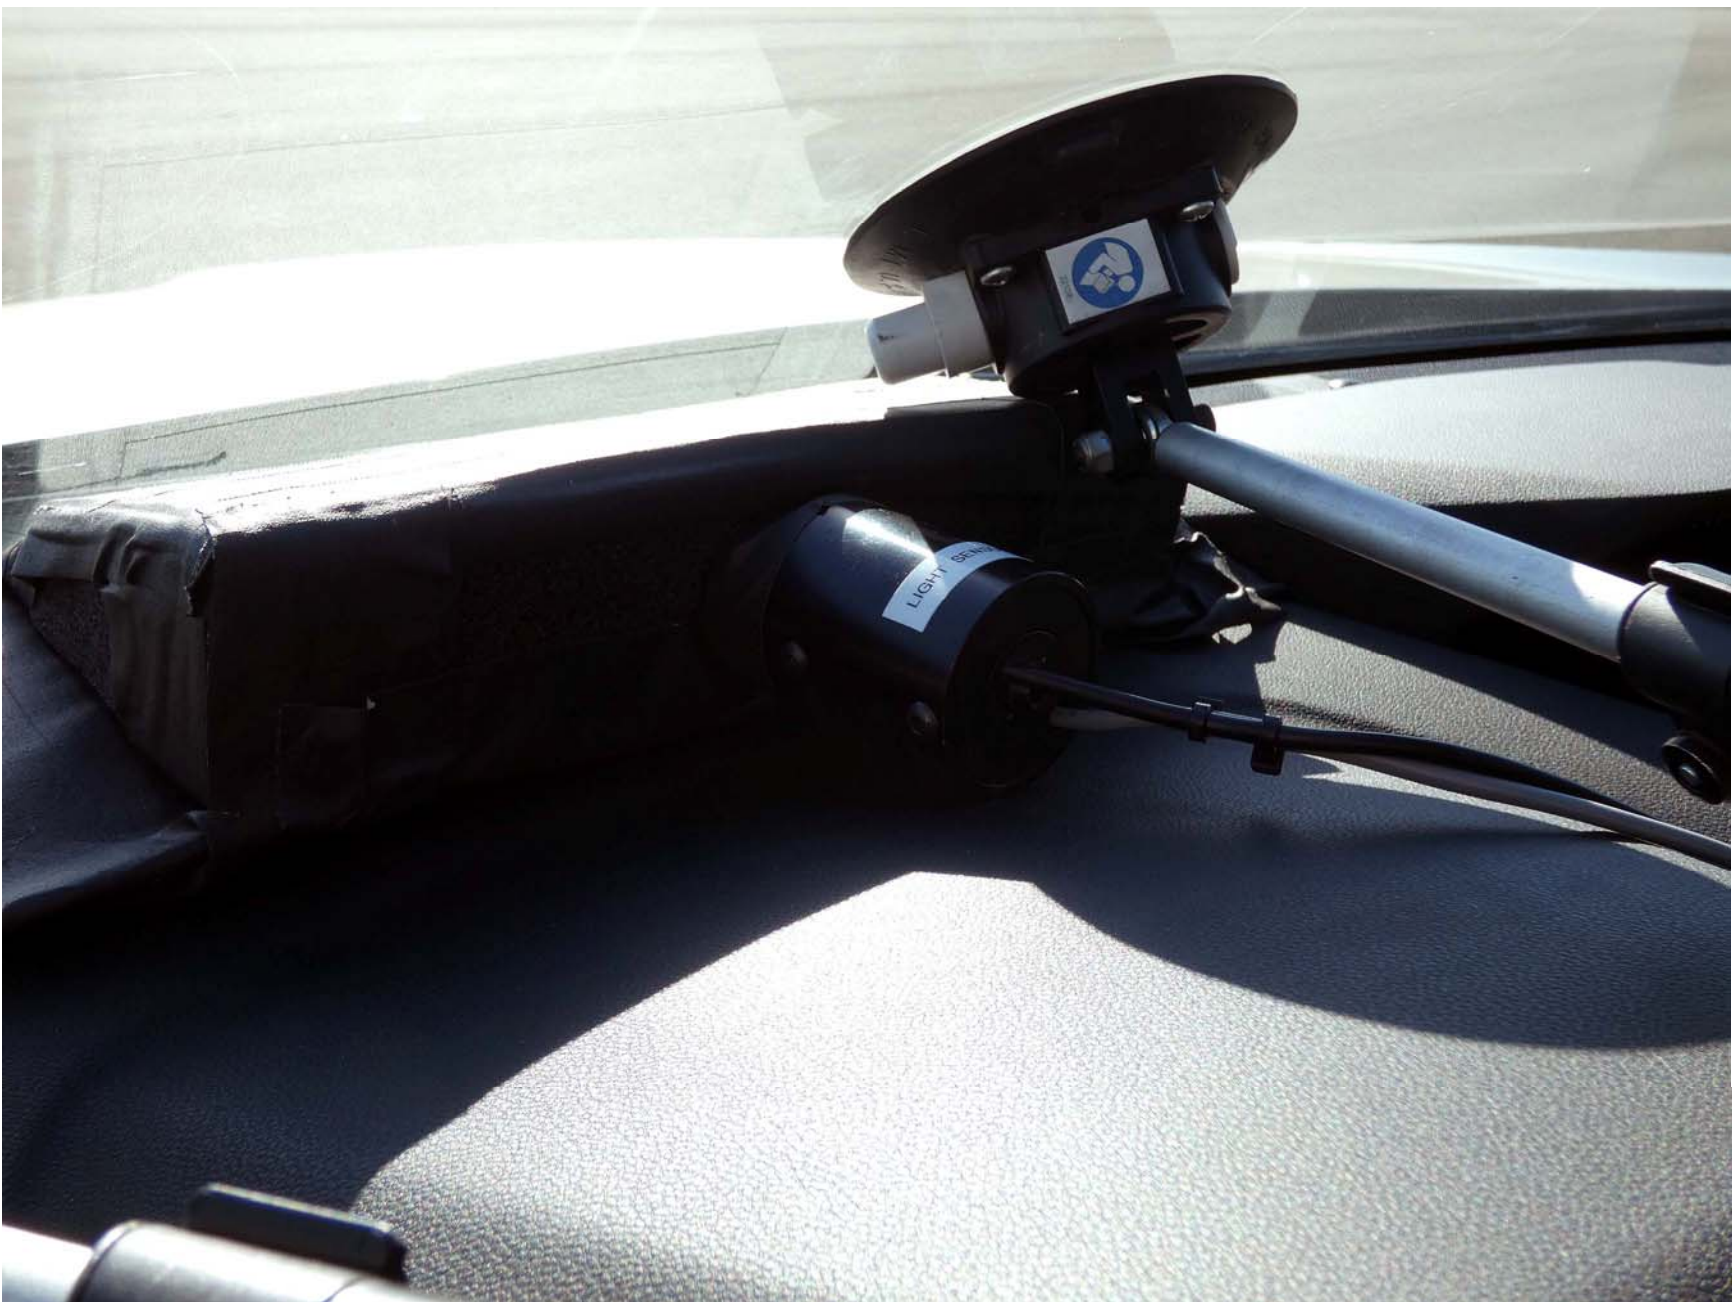
Figure A12. Sensor for Detecting Visual Alert

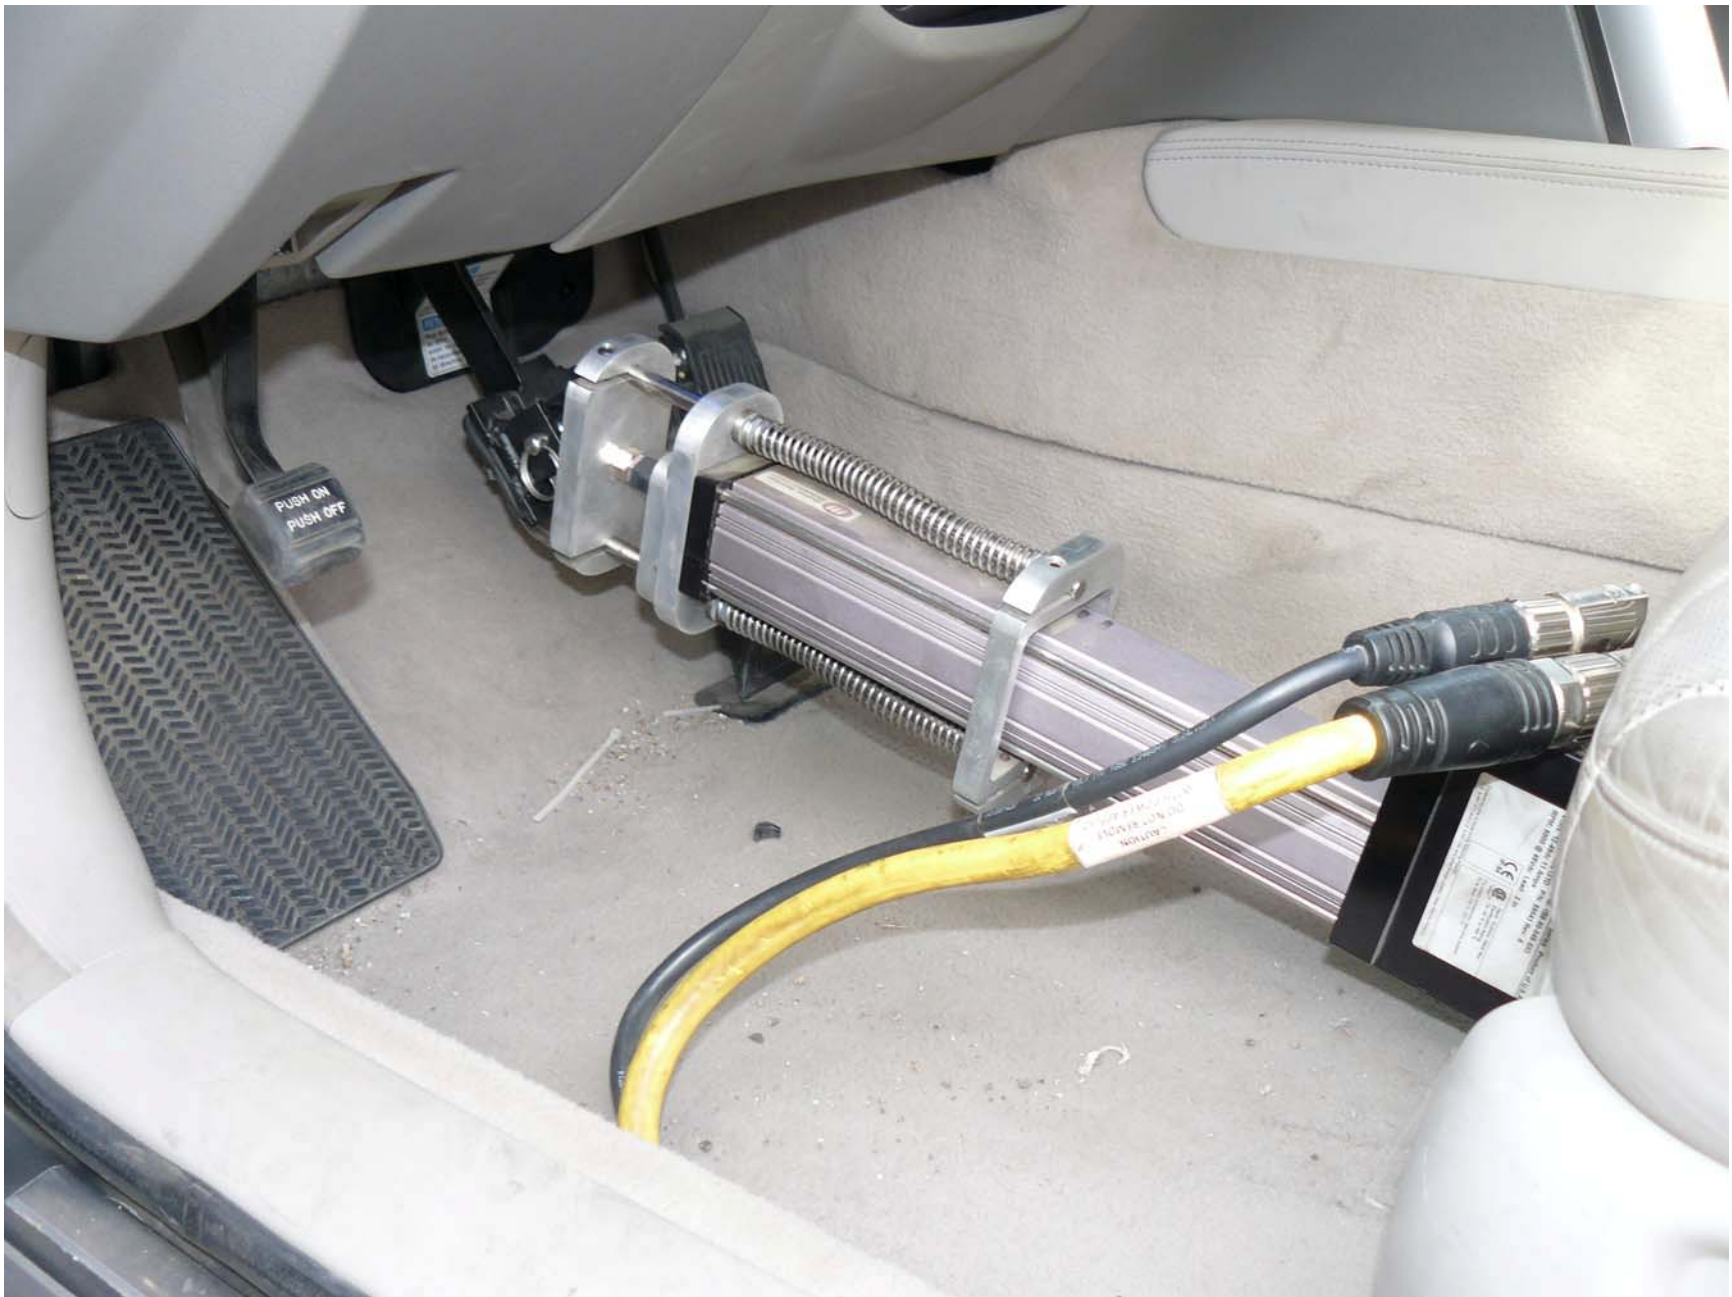
Figure A14. Brake Actuator Installed in POV System

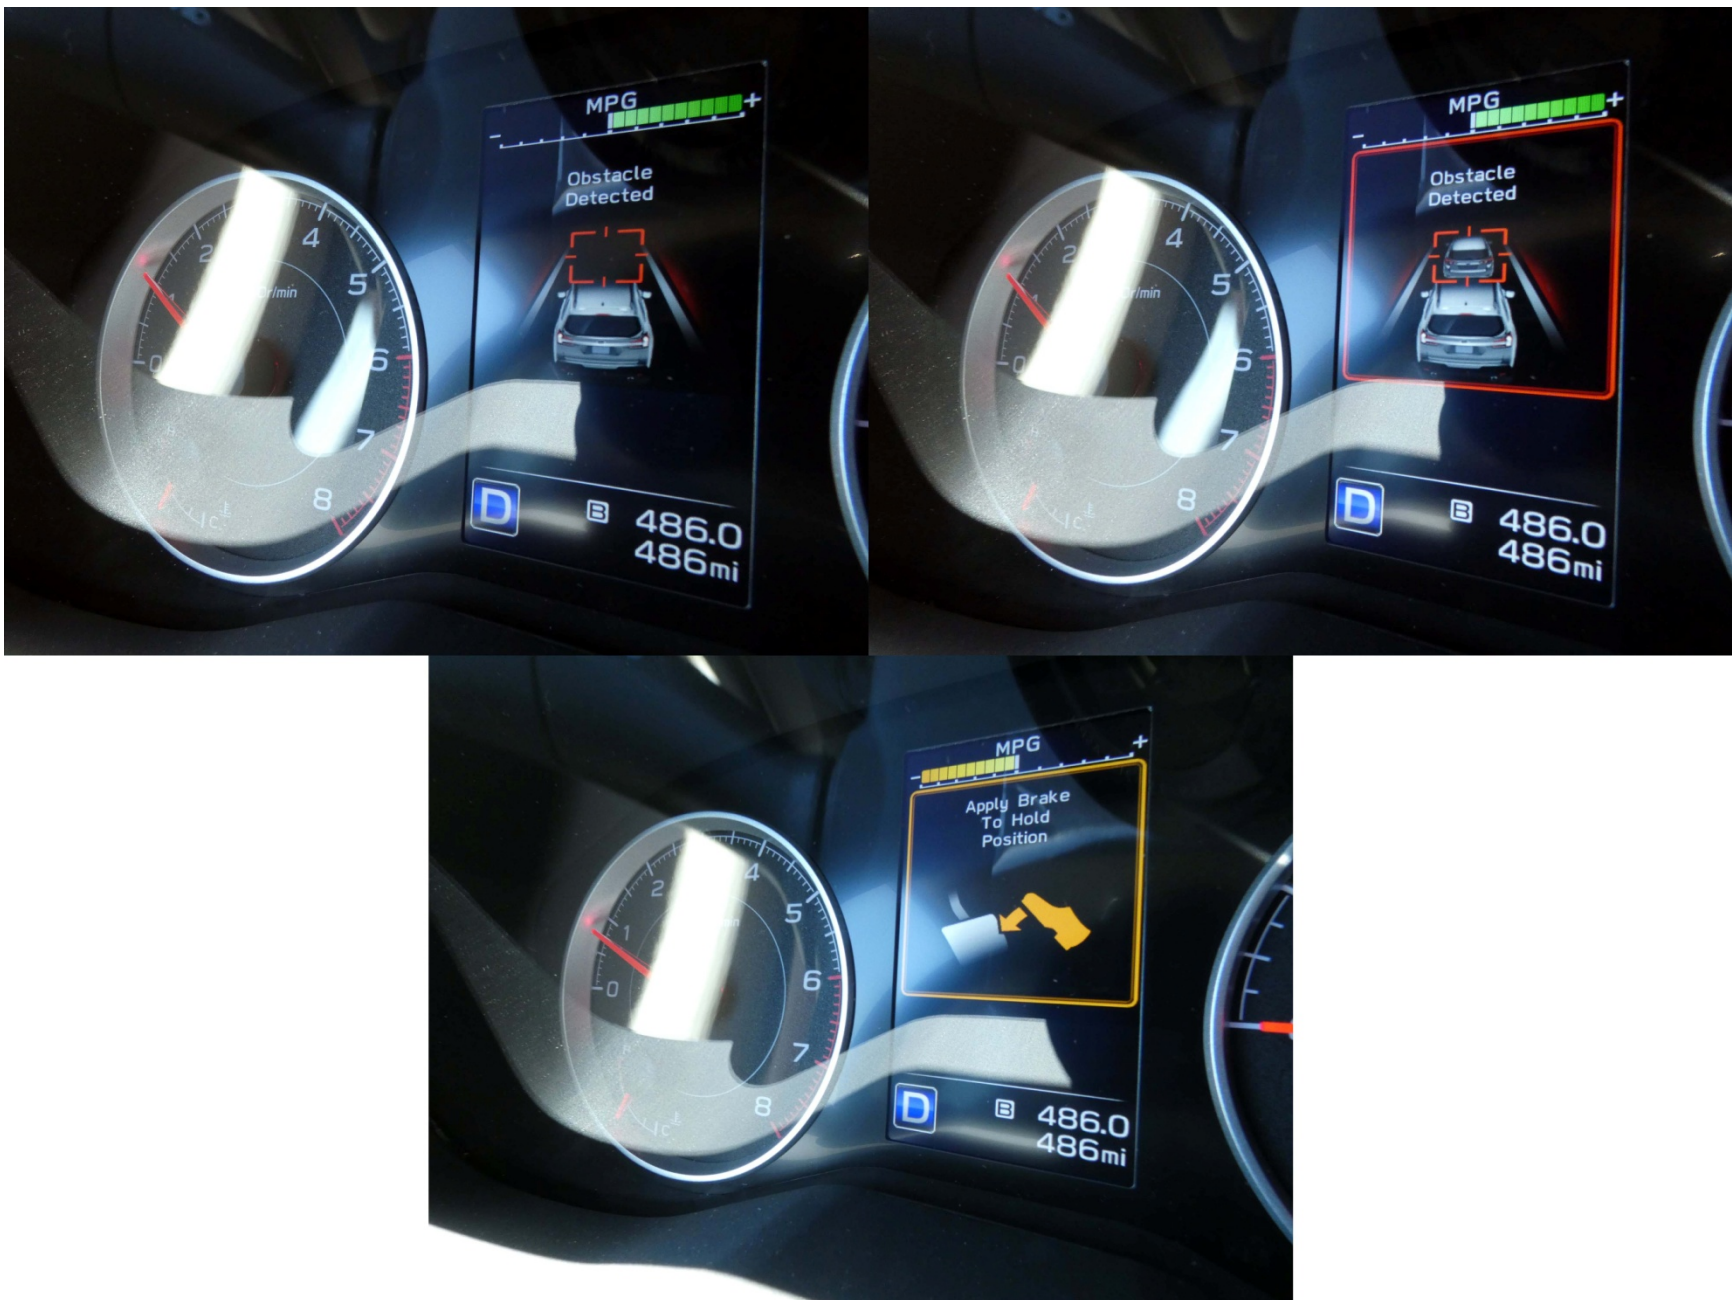
Figure A16. AEB Instrument Panel Visual Alert

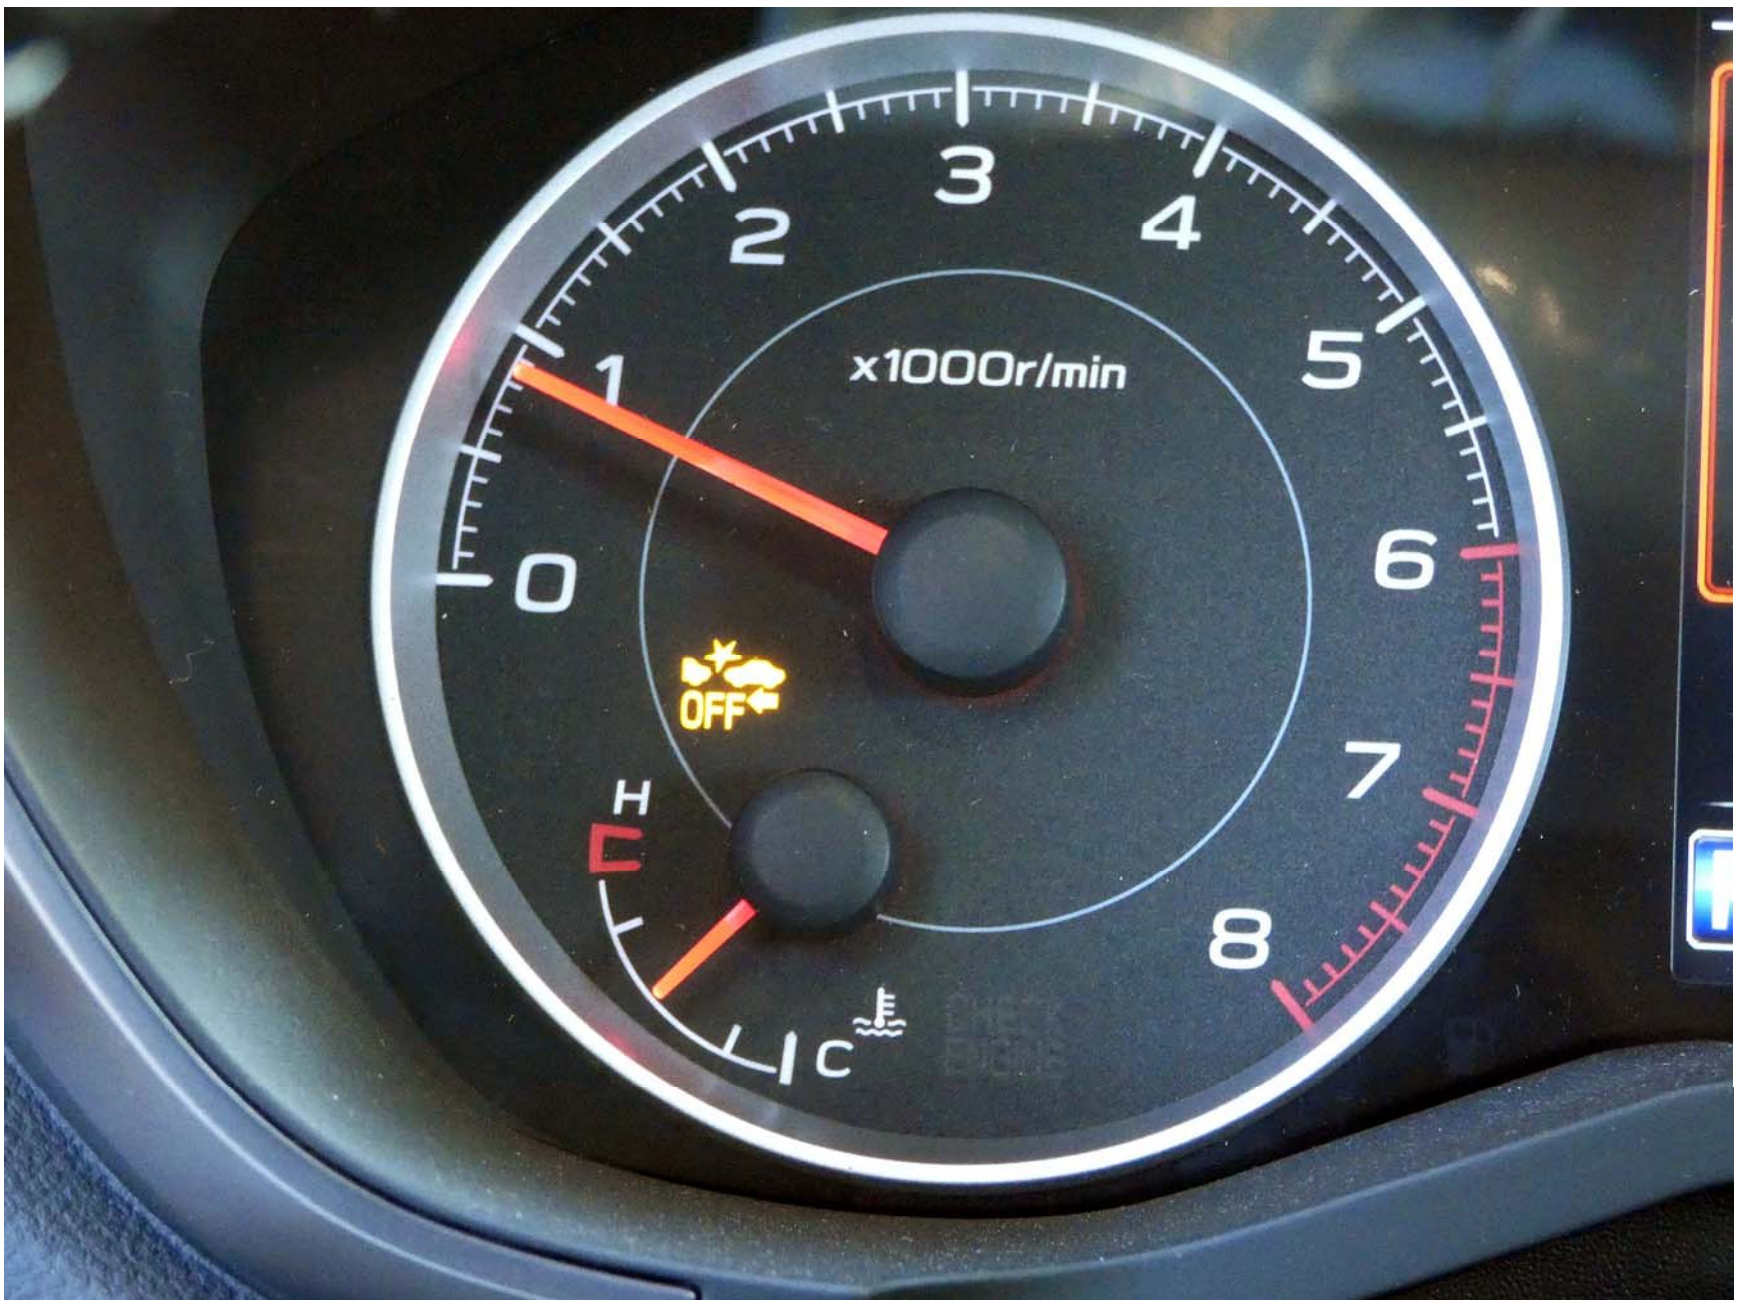
Figure A17. AEB Off Indicator Light
