**OCAS-DRI-CIB-19-20
NEW CAR ASSESSMENT PROGRAM
CRASH IMMINENT BRAKE SYSTEM CONFIRMATION TEST**

2019 Subaru Ascent

Final Report

1. Report No. OCAS-DRI-CIB-19-20	2. Government Accession No.	3. Recipient's Catalog No.	
4. Title and Subtitle Final Report of Crash Imminent Brake System Confirmation Testing of a 2019 Subaru Ascent.		5. Report Date 14 November 2019

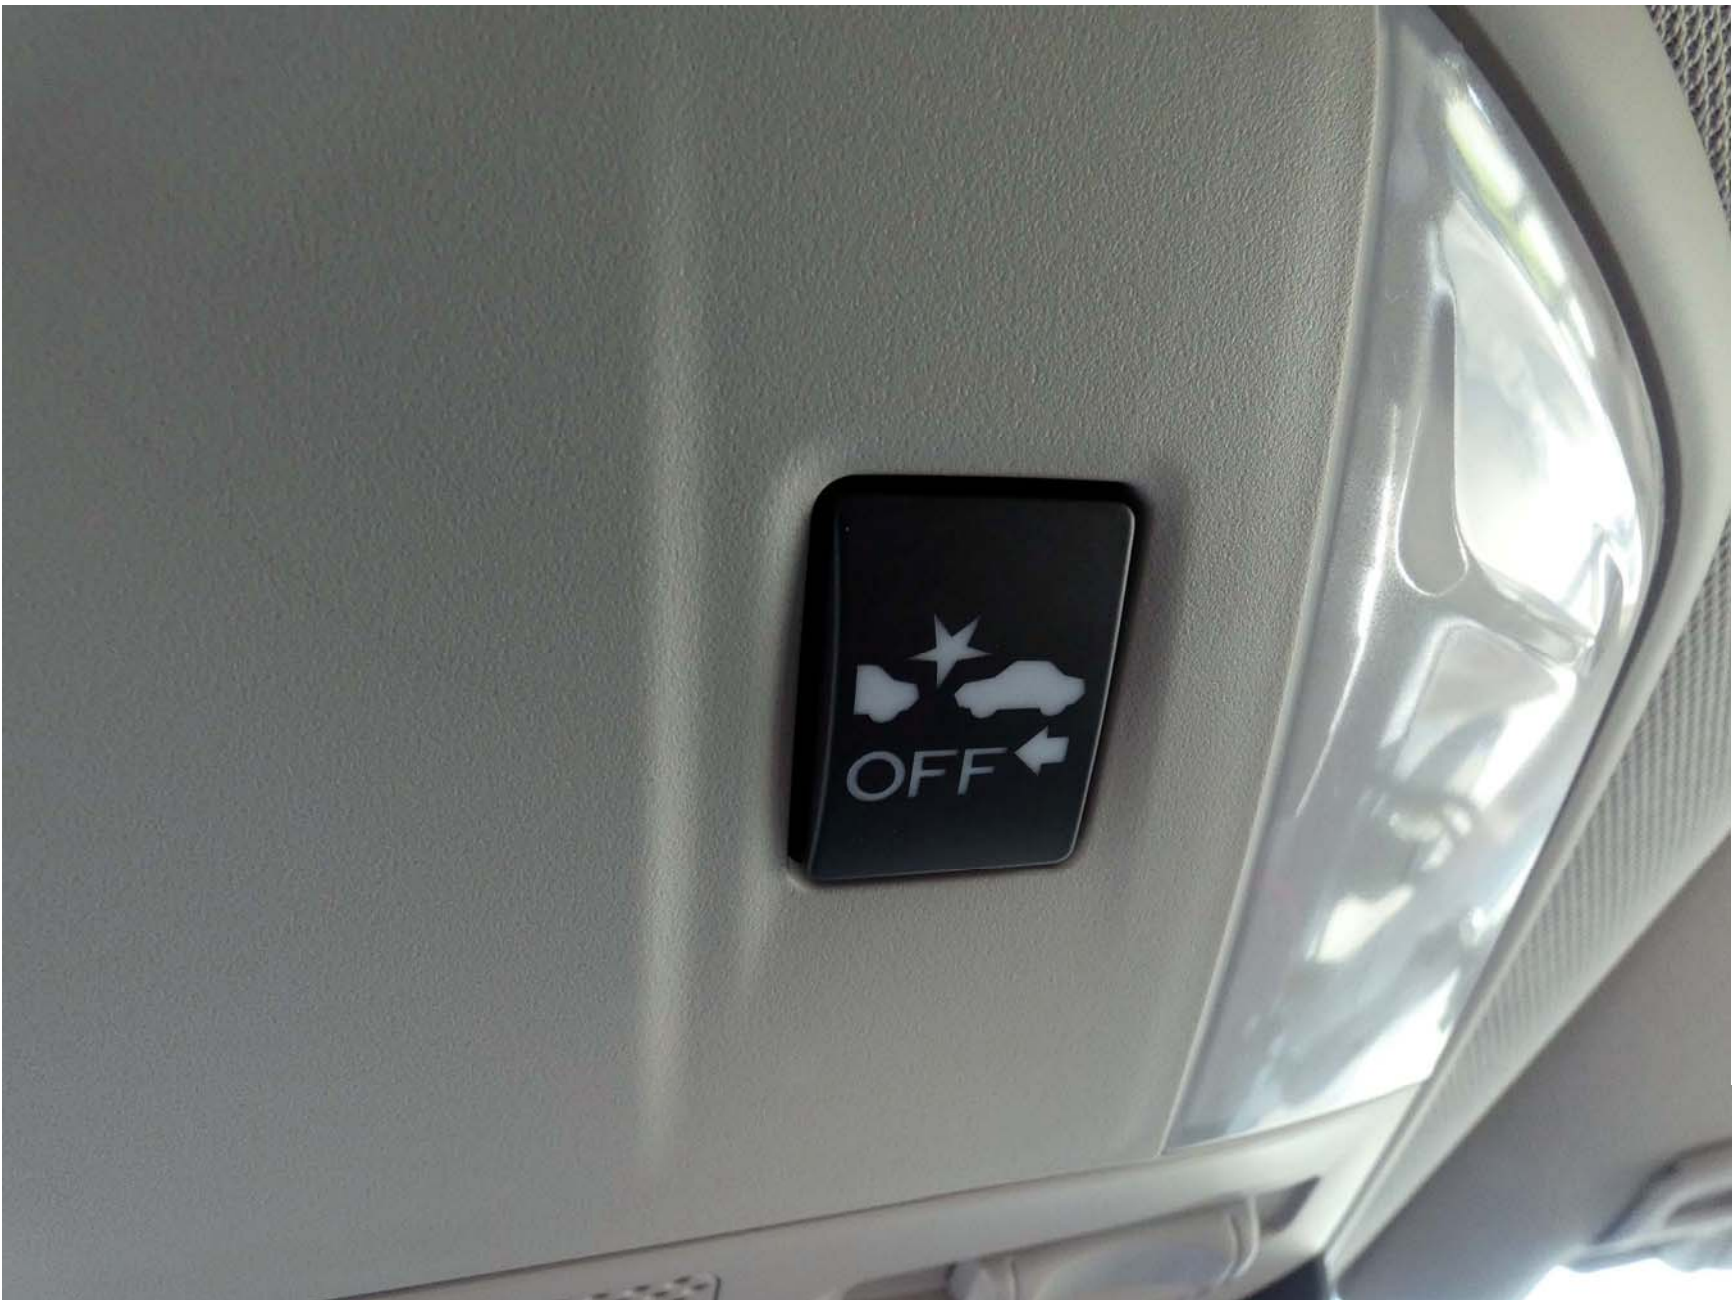
Figure A18. AEB On/Off Switch
